COAL DAM

NDI No. PA 00464
PennDER No. 65-45

PHASE I INSPECTION REPORT
NATIONAL DAM INSPECTION PROGRAM

Coal Dam, Westmoreland County, Pennsylvania
NDI No. PA 00464, PennDER No. 65-45
Tributary of Brush Creek
Inspected 14 December 1979

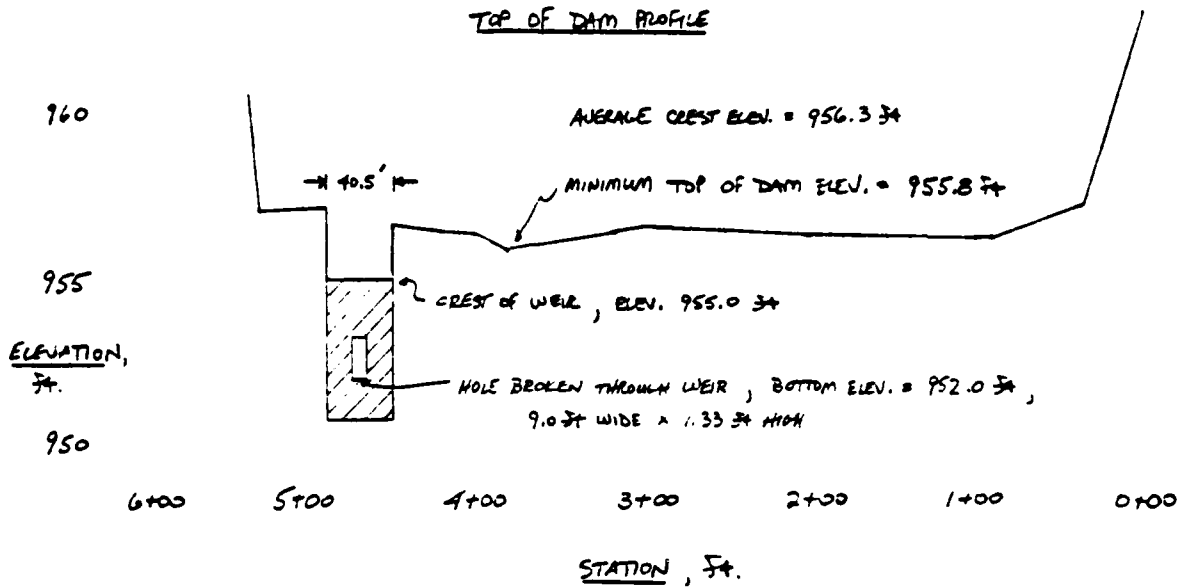
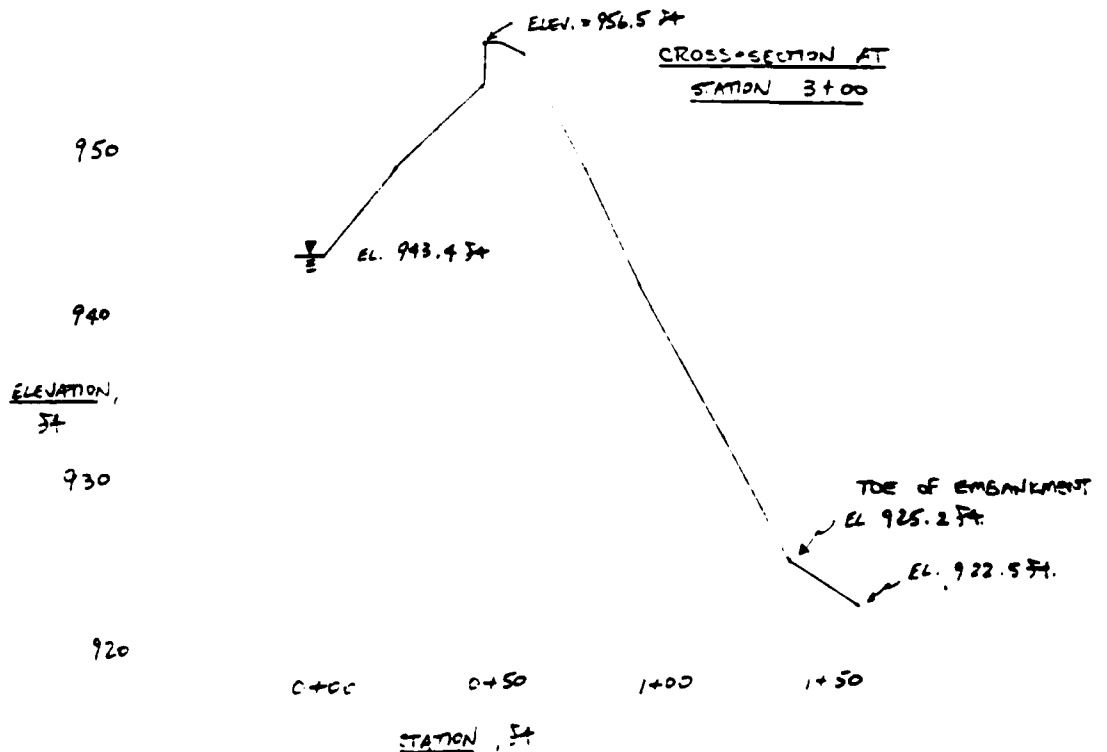
COAL DAM
TOP OF DAM PROFILE
TYPICAL CROSS-SECTION

- b. Dam - The following is a list of obvious deficiencies noted during the visual inspection of the embankment.
 - 1) There are two level-areas (depressions) on the downstream face of the dam; one at Station 2+00 and one at Station 2+50.

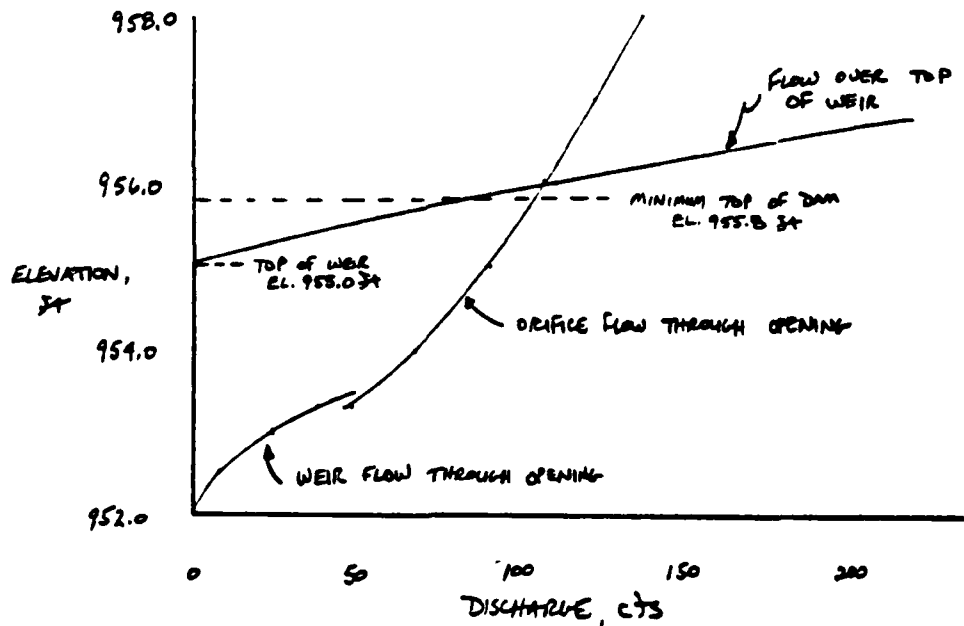
Subject COAL DAM S.O. No. _____
SPILLWAY RATING CURVE Sheet No. 6 of 12
Drawing No. _____
Computed by WDL Checked by JAG Date 3-17-80

ELEVATION, FT	TOTAL DISCHARGE, CFS	REMARKS
952.0	0.0	↑
952.5	8.40	WEIR FLOW THROUGH OPENING
953.0	23.76	↓
953.33	36.44	X
954.0	66.72	ORIFICE FLOW THROUGH OPENING
955.0	88.17	X
956.0	213.47	ORIFICE FLOW + FLOW OVER CREST OF WEIR
958.0	675.08	↓

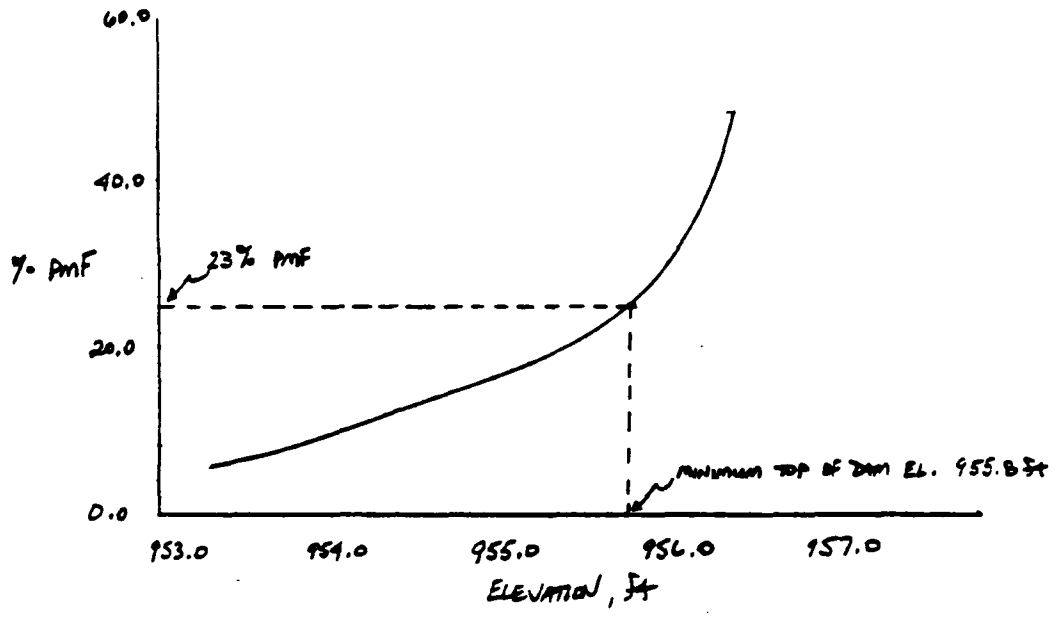
Subject COAL DAM S.O. No. _____
SPILLWAY CAPACITY ANALYSIS Sheet No. 7 of 12
Drawing No. _____
Computed by WDC Checked by _____ Date 2-17-80

SPILLWAY CAPACITY = 180 CFS AT EL. 955.8 FT
