# PINE RUN DAM (PA 491)

NDI No. PA 00737  
PennDER No. 43-55  
SCS No. PA 491

## PHASE I INSPECTION REPORT NATIONAL DAM INSPECTION PROGRAM

May 1980

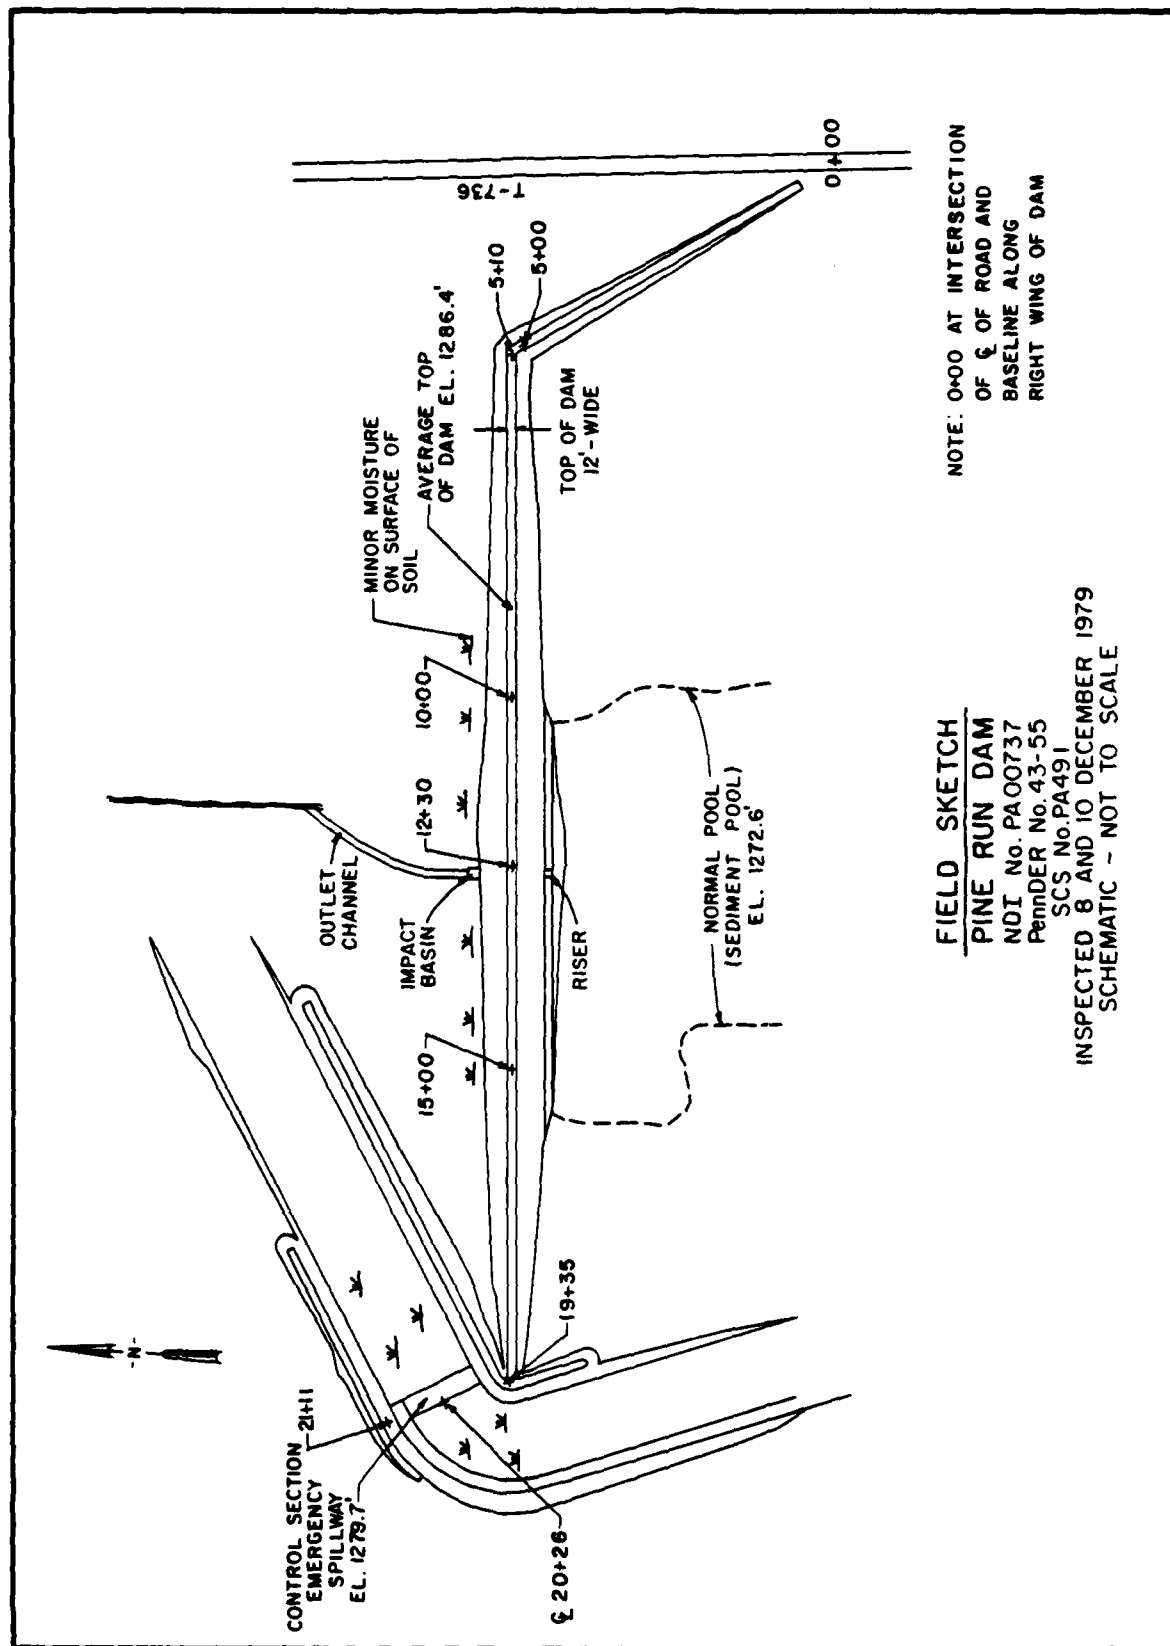
**FIELD SKETCH**  
**PINE RUN DAM**  
 NDI No. PA00737  
 PennDer No. 43-55  
 SCS No. PA491  
 INSPECTED 8 AND 10 DECEMBER 1979  
 SCHEMATIC - NOT TO SCALE
