DELAWARE RIVER BASIN
TRIBUTARY TO MAIDEN CREEK
BERKS COUNTY
PENNSYLVANIA
NDS ID PA. 00721
DER ID 6-460

CHRISTMAN DAM

PHASE I INSPECTION REPORT NATIONAL DAM INSPECTION PROGRAM

MARCH 1980

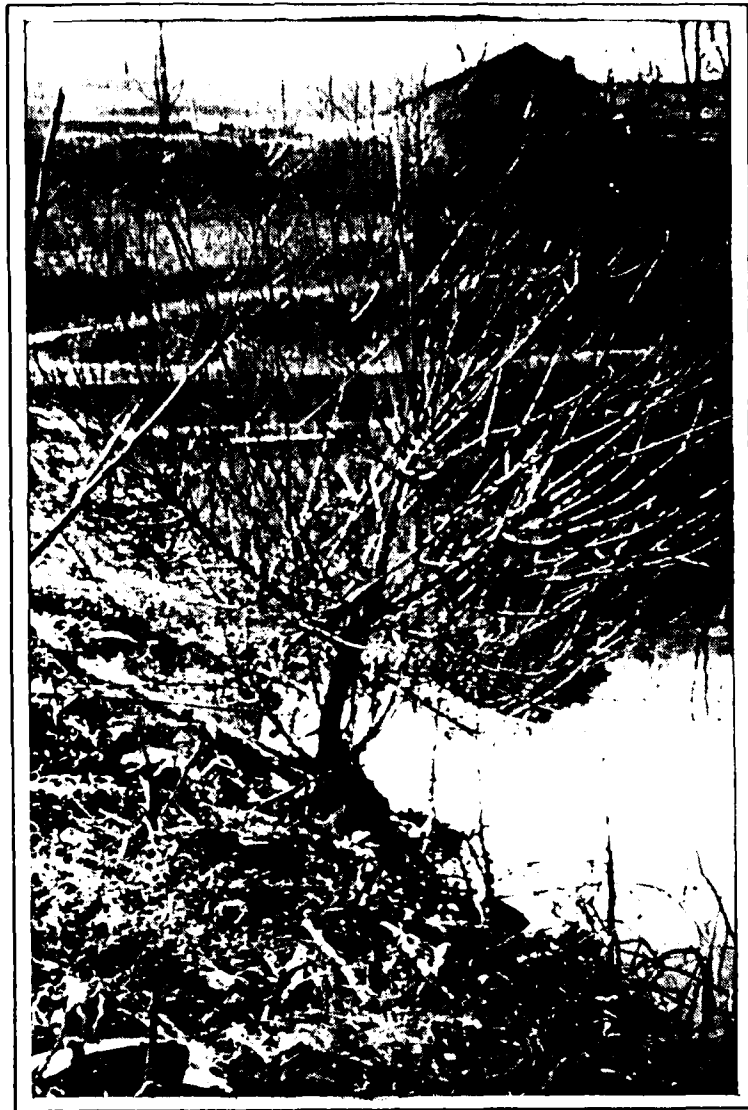
PHOTOGRAPH NO. 4

e. Downstream Channel. For about 1,000 feet below the dam, the channel flows through a fairly wide floodplain, as shown in Photograph 4. At about 1,000 feet below the dam, water passes under PA Route 143 through two four foot diameter corrugated metal culverts. Debris has accumulated at the upstream end so that water is ponded above the top of the culverts. The channel between the dam and the culverts is about 11 feet wide and 0.5 to 1.5 feet deep. The floodplain is open to brush covered. About 2,000 feet below the dam, the stream enters Maiden Creek. About 1.25 miles farther downstream is Virginville, where several homes are built in the floodplain. At Virginville, Pennsylvania, Route 143 crosses Maiden Creek. Although the Maiden Creek floodplain is fairly wide just below Christman Dam, it narrows considerably at Virginville. The Route 143 highway bridge also forms a constriction at Virginville, so that when water is flowing over the bridge, the first stories of the houses immediately upstream will be flooded. Failure of Christman Dam would result in excessive property damage and possible loss of life at this location, thus justifying a "High" hazard classification.

OVERALL VIEW OF DOWNSTREAM AREA.

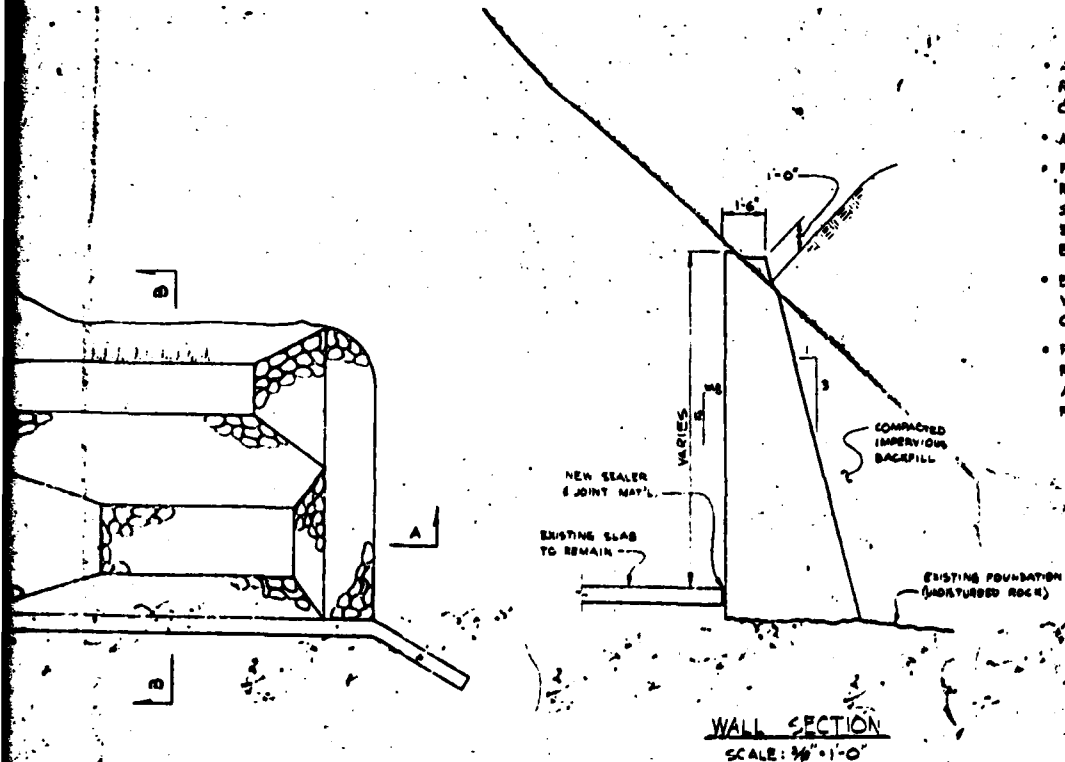
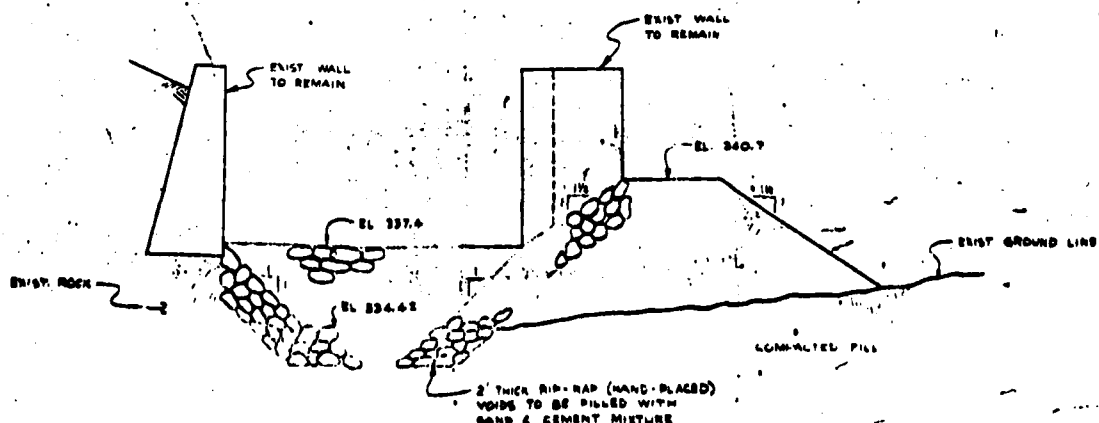
WALL SECTION
SCALE: 3/8" = 1'-0"

- Sec. A-A*
- ① Cut off wall with weepholes under and of slab.
 - ② Upper wire screen behind weepholes.
 - ③ This sheet is new. If there are any changes on other sheets they should be marked.
 - ④ It would be better if have fill go to top of walls & properly rounded so surface run off would not be trapped behind the walls.
 - ⑤ No detail of vert. joint

- REMOVE DETEIORATED CONCRETE TO SOUND CONCRETE (SQUARE-CUT ENDS).
- REBAR REINFORCING SHALL BE CUT TO SOUND CONCRETE.
- DETERIORATED CONCRETE SHALL BE REPLACED WITH PRESSURE PORTLAND CEMENT CONCRETE.
