SPRING MILL DAM

LEHIGH COUNTY, PENNSYLVANIA

PHASE I INSPECTION REPORT  
NATIONAL DAM INSPECTION PROGRAM

Name of Dam: Spring Mill Dam  
County Located: Lehigh County  
State Located: Pennsylvania  
Stream: Spring Creek  
Coordinates: Latitude 40° 42.0'  
Longitude 75° 31.1'  
Date of Inspection: November 16, 1979

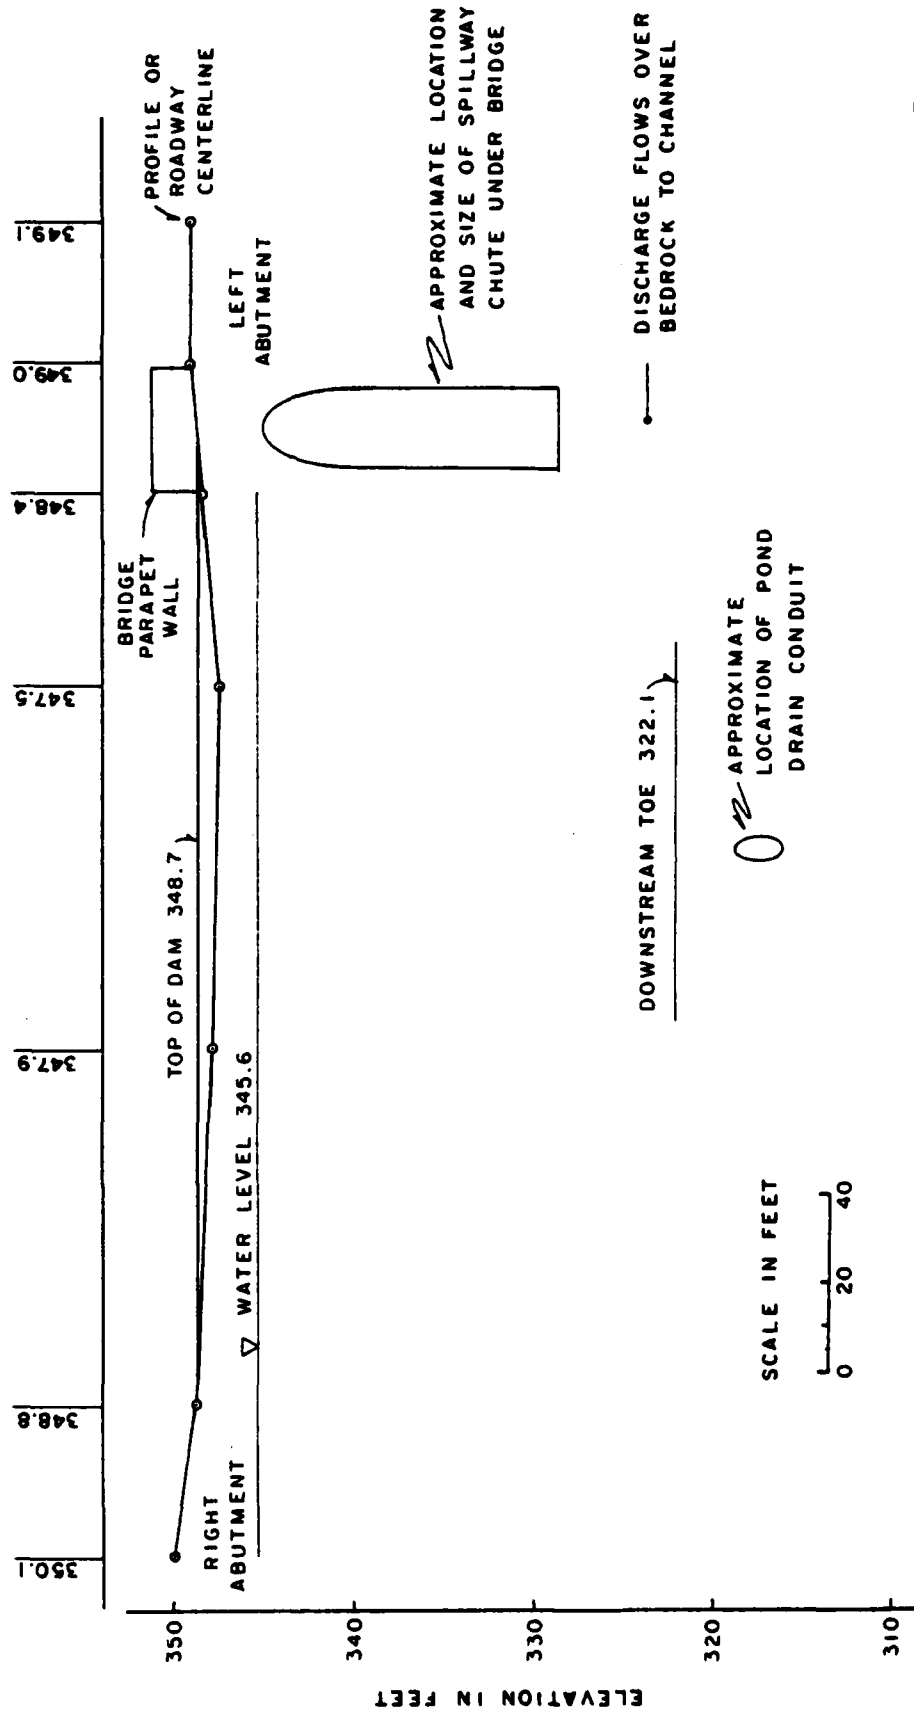
FIELD OBSERVATION PROFILE  
 SPRING MILL DAM

2. Outlet Works. The exposed portions of the masonry screen chamber, shown in Photograph 5, were inspected and appear to be in good condition. The wooden top could not be removed to inspect the interior of the chamber. The upper two intakes were exercised; the lower intake is inoperable. The pond drain conduit is gated at the upstream end and at the downstream toe. The upstream gate is nonfunctional, and flow through the pond drain is controlled at the downstream valve. A small amount of water was flowing through the pond drain conduit at the time of the inspection, as shown in Photograph 6. The original cast iron conduit has been extended by reinforced concrete pipe, and this discharges into the stream channel about 135 feet beyond the dam. Two other valves at the toe of the dam control the flow of water between the treatment plant and the reservoir and tank on top of the hill. A third valve controls the drain line from the tank. The drain line from the tank can also draw off water from upstream of the dam. A schematic diagram, as reported by the plant operator, is included on sheet 5a.
