MISCELLANEOUS PAPER SL-80-6

**CONCRETE AND ROCK TESTS, MAJOR  
REHABILITATION OF STARVED ROCK LOCK AND  
DAM, ILLINOIS WATERWAY, CHICAGO DISTRICT  
PHASE II COMPLIANCE, SCOUR DETECTION**

R. L. Stowe, B. A. Pavlov

April 1980

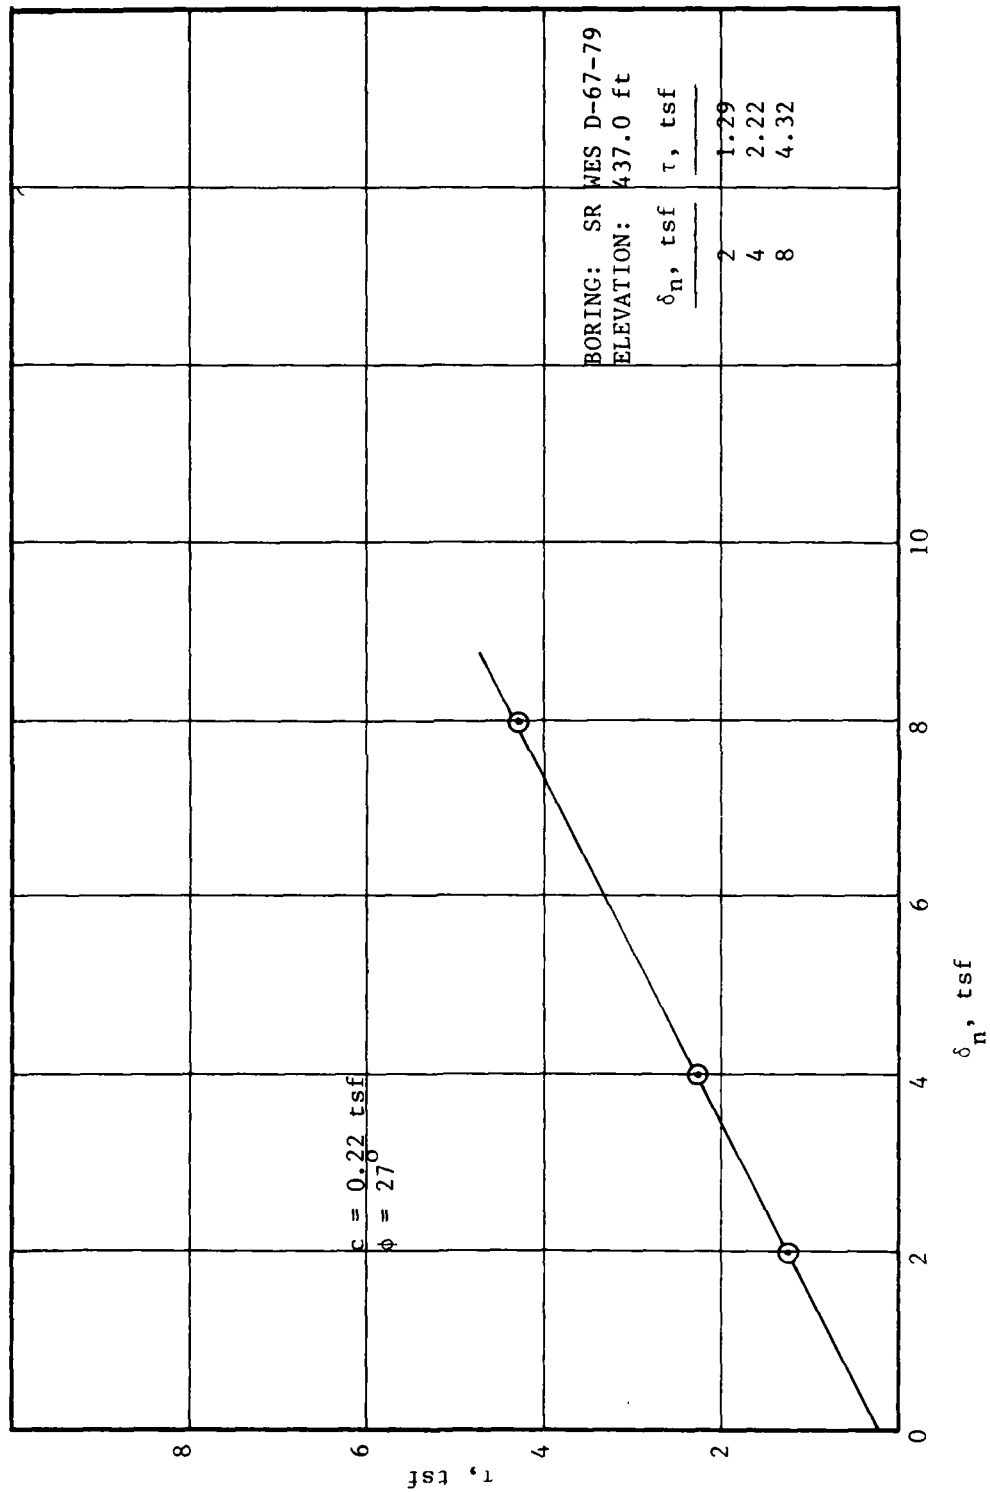
Plate 22. Direct shear of silty sand (SM), head gate dam

67. The sample was classified as a silty sand (SM). A direct shear box (1 by 3 by 3 in.), used for testing soils, was used to run direct shear tests on the sand. The normal loads used were 2, 4, and 8 tsf. A plot of the normal load versus shearing load is presented in Plate 22. The angle of friction for the sand is 27 deg with a cohesion is 0.22 tsf.
