ALPINA DAM (Inventory Number **778**)
St. Lawrence River Basin **NY**
LEWIS COUNTY,
NEW YORK.

PHASE I INSPECTION REPORT,
NATIONAL DAM SAFETY PROGRAM

Name of Dam Alpina Dam NY778

State Located New York
County Located St. Lawrence
Stream Bonaparte Creek
Date of Inspection May 2, 1979

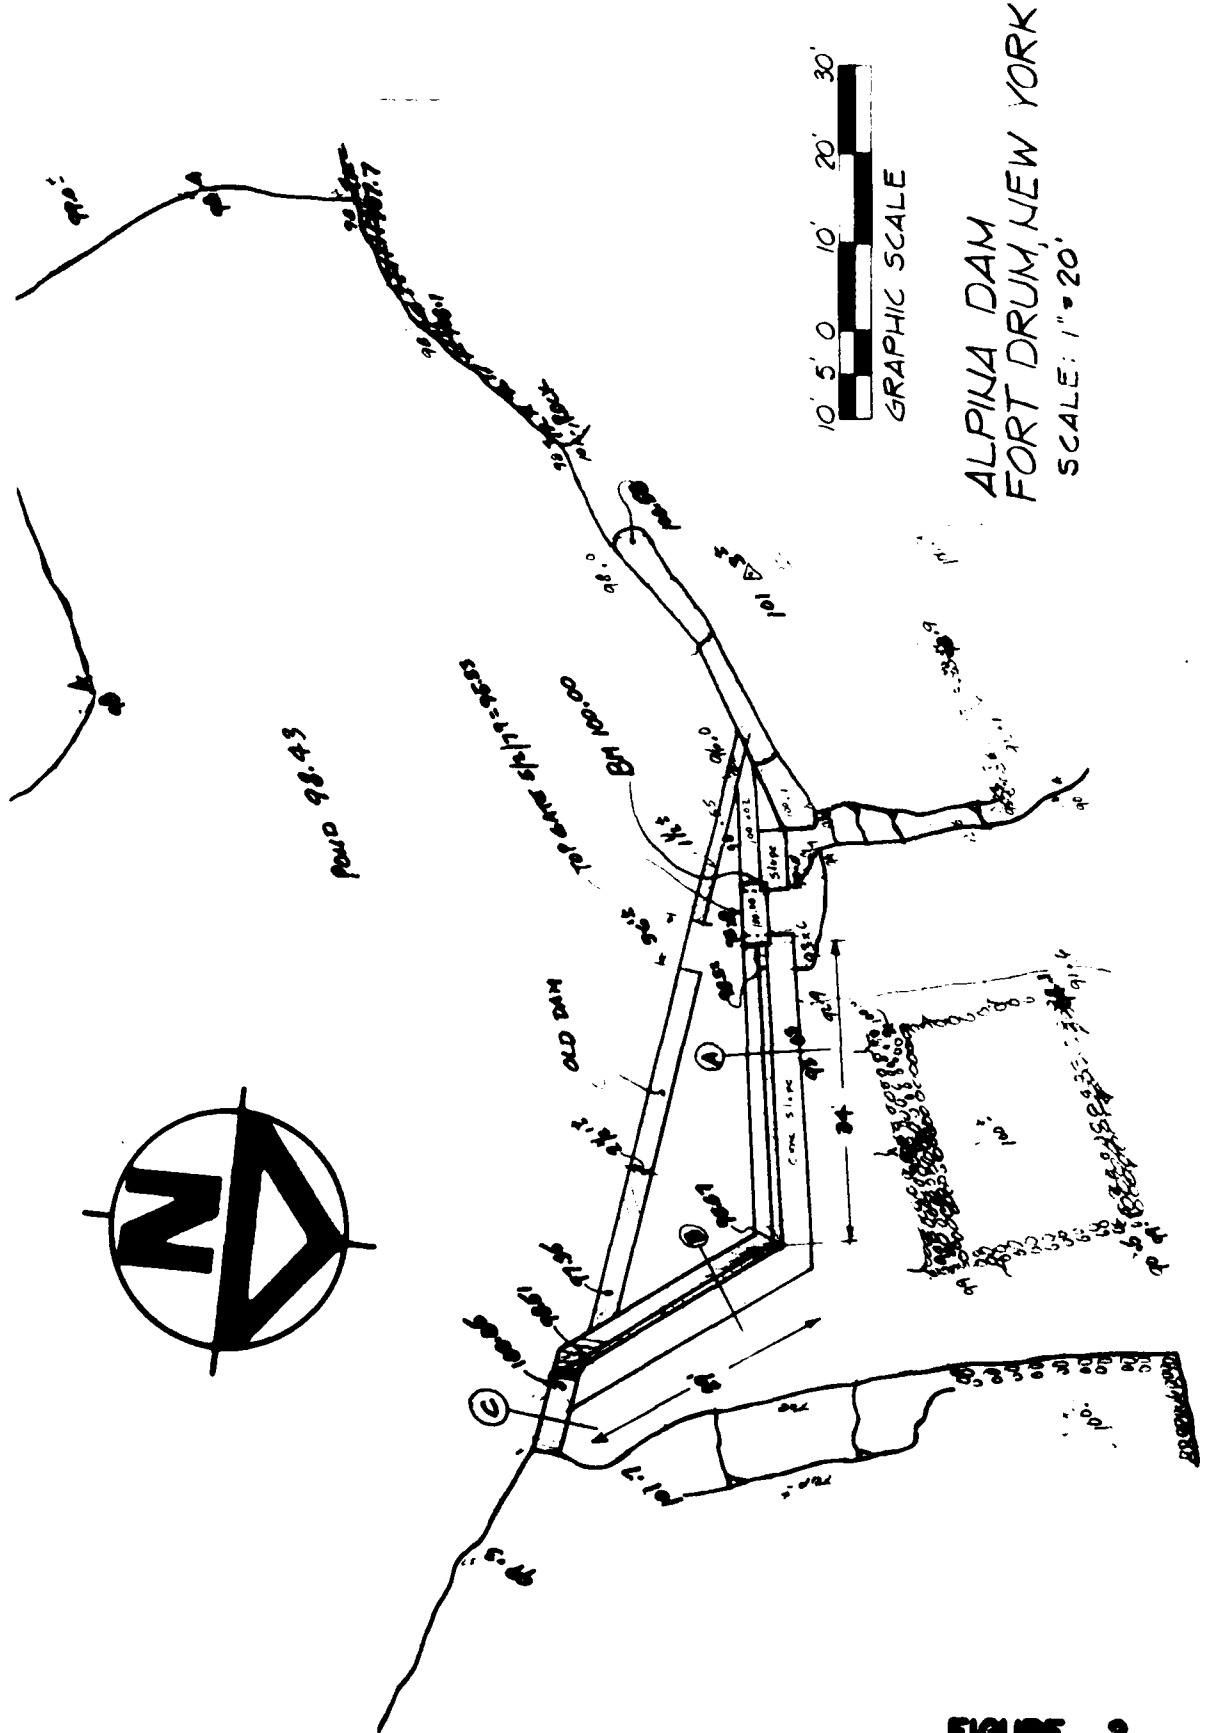
FIGURE 2

The dam and spillway system are shown in the Sketches prepared by Dale Engineering Company in Figures 2 and 3. The dam was reconstructed in 1933. The east abutment is along the alignment of the original dam. This abutment is founded on bedrock and there is no indication of seepage along the abutment or along the spillway of the dam. Near the west abutment of the dam, a small walkway crosses the control spillway. The concrete supporting this walkway is cracked near the elevation of the top of the emergency spillway. The west abutment of the dam is also founded on bedrock and meets the alignment of the old dam at the west abutment. On the west abutment, a wing wall which extends beyond the dam structure is deteriorated on the upstream side and severely undermined. The dam is in generally good structural condition except for this wing wall on the west abutment. There is no evidence of cracking nor is there evidence of seepage. There are provisions on the top of the emergency spillway for mounting flashboards, although there are no flashboards in the area of the dam.

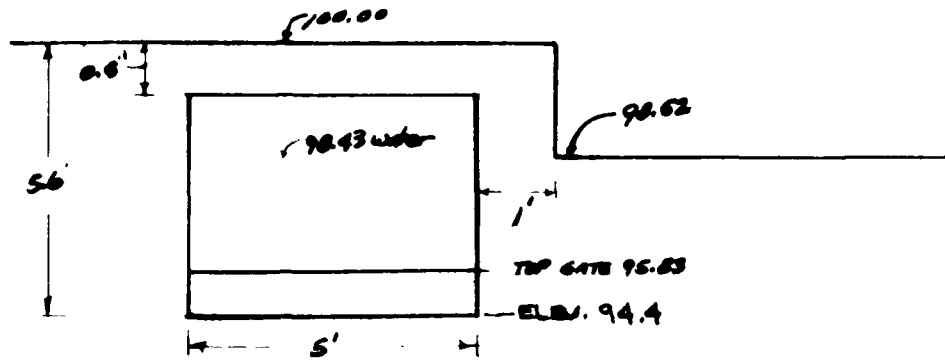
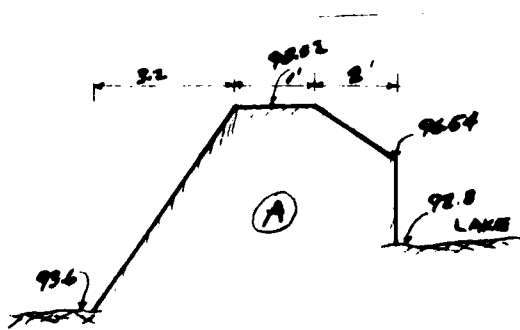
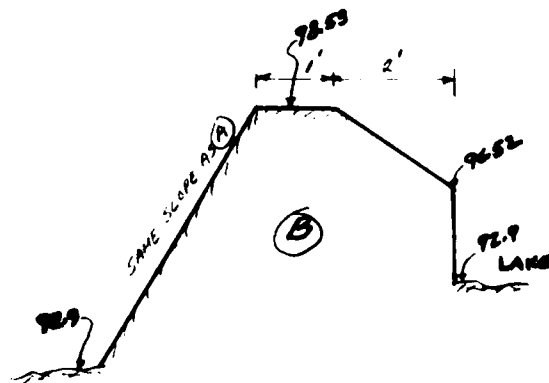
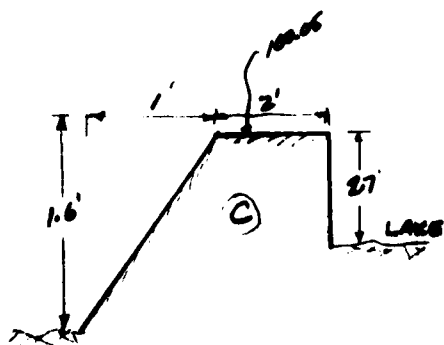
No information relating to the design and construction of the dam structure has been made available. A field survey undertaken as part of this Phase I study has provided information on dam cross-sections (Figures 2 & 3) but did not extend to determining properties of the dam's concrete and foundation rock. Stability evaluations have been performed, utilizing the obtained cross-section information to obtain an indication of the dam's performance when subject to different possible loading conditions. In these analyses, assumptions were required in regard to concrete and rock properties, the geometry of the dam, and cross-section for the assumed critical location.

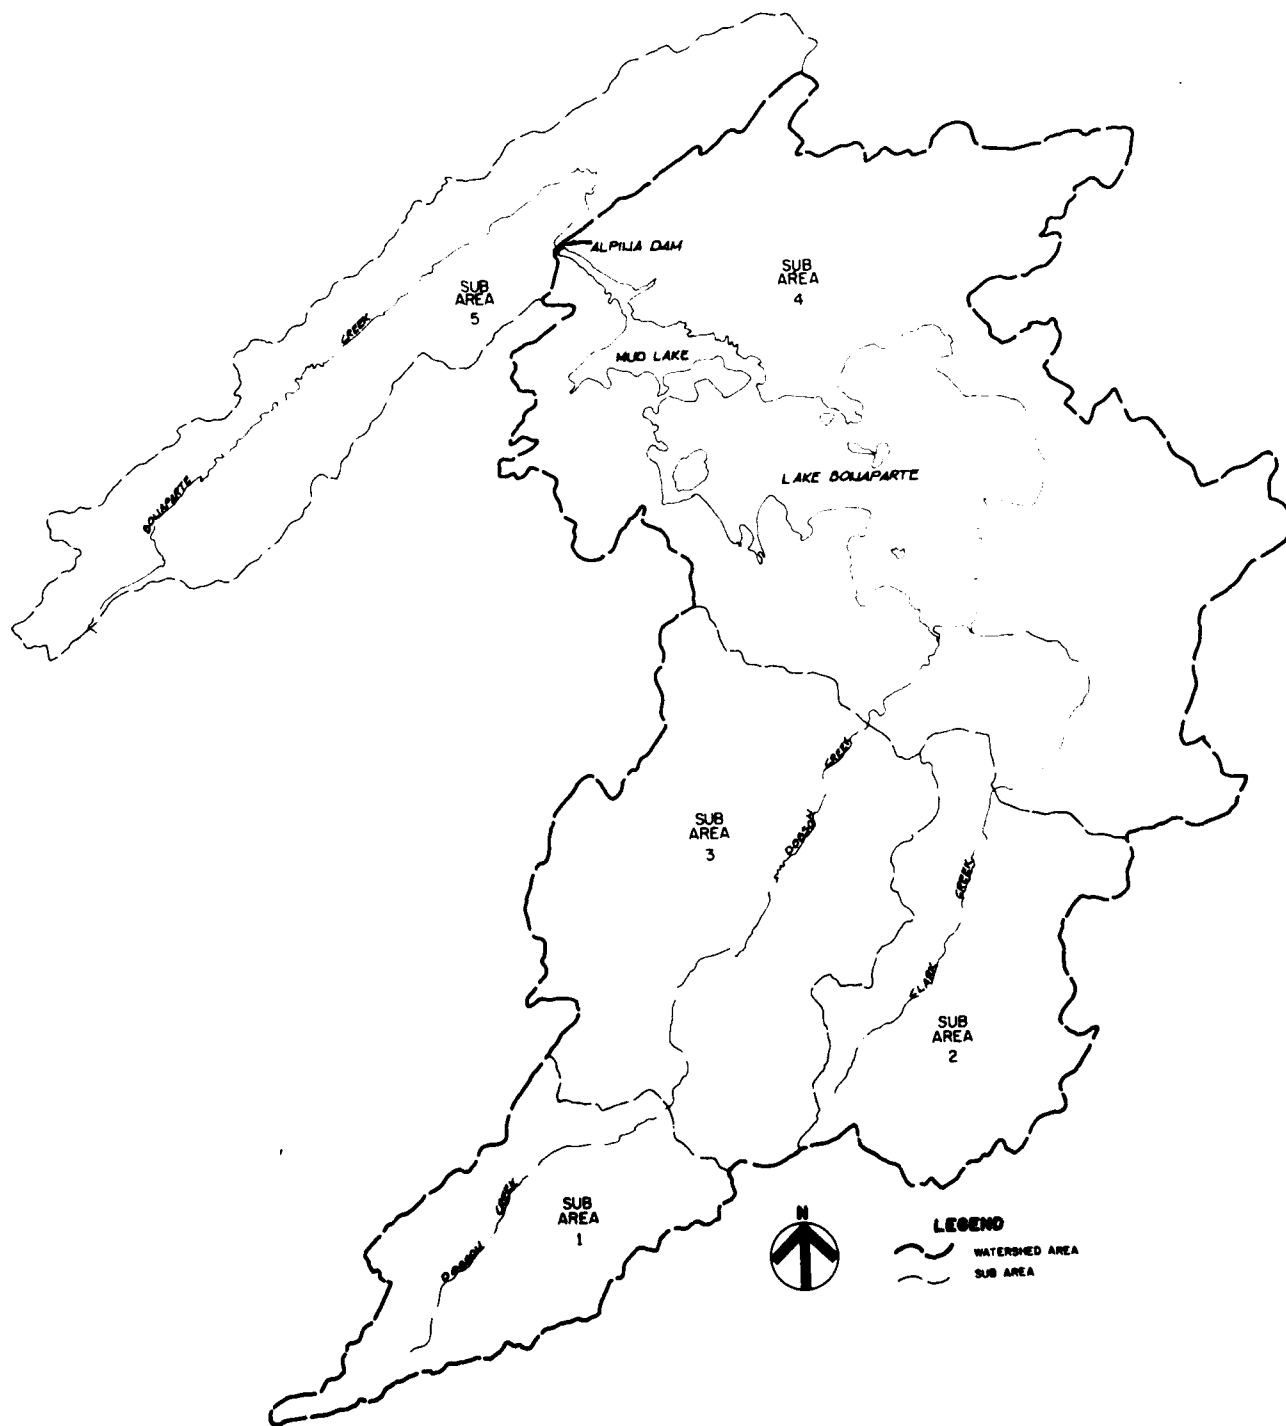
FIGURE 5

hydrograph was determined by applying the PMP to the unit hydrographs and runoff and routing to the dam sites (Figure 5). The PMF results in an inflow into the impoundment of 26,219 cfs. The 1/2 PMF inflow is 13,116. Due to the storage effect of the lake, the discharges were significantly reduced to 8,923 cfs for the Probable Maximum Flood and 2,377 for the 1/2 PMF.
