NATIONAL DAM SAFETY PROGRAM. UPPER AETNA LAKE DAM (NJ 00420), D--ETC(U)

**UPPER AETNA  
LAKE DAM  
NJ 00420**

**PHASE 1 INSPECTION REPORT  
NATIONAL DAM SAFETY PROGRAM**

**FEBRUARY 1980**

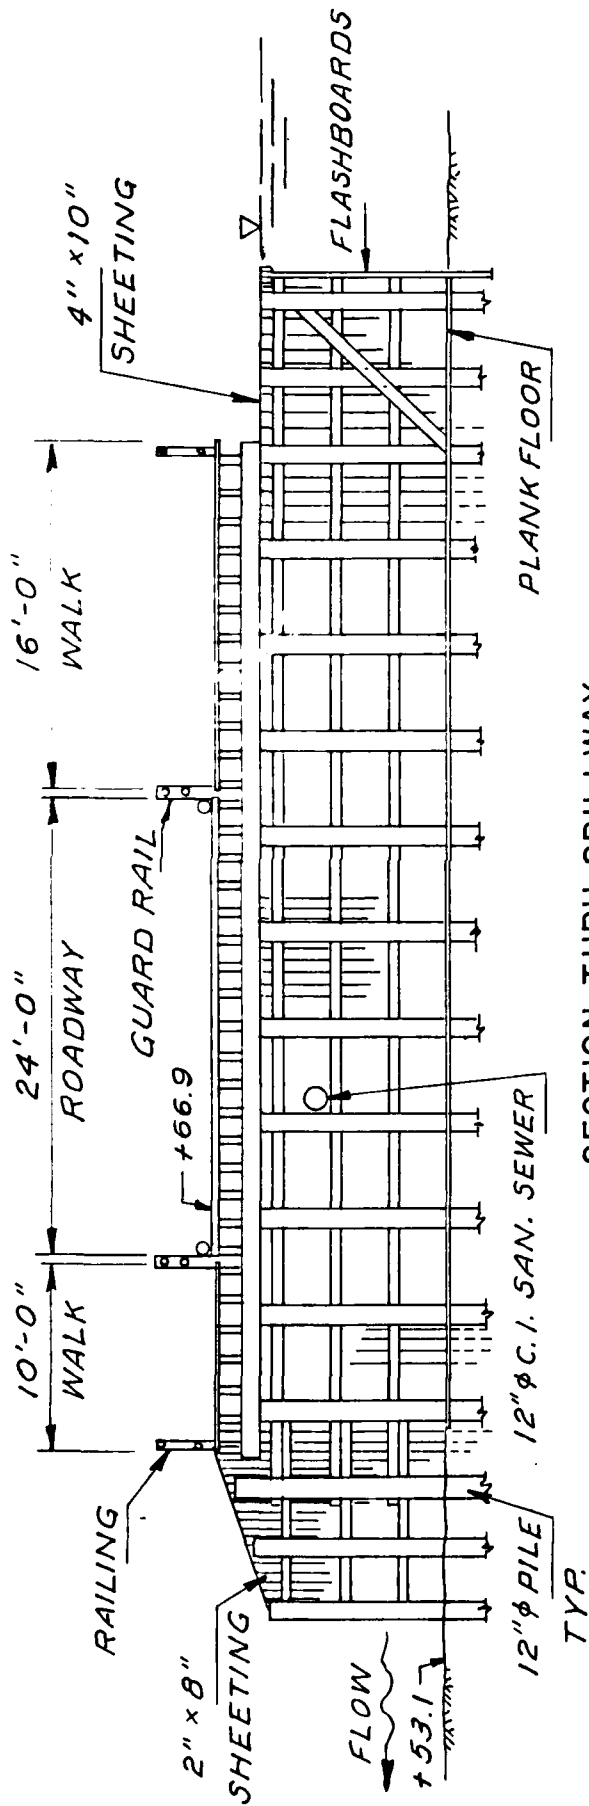
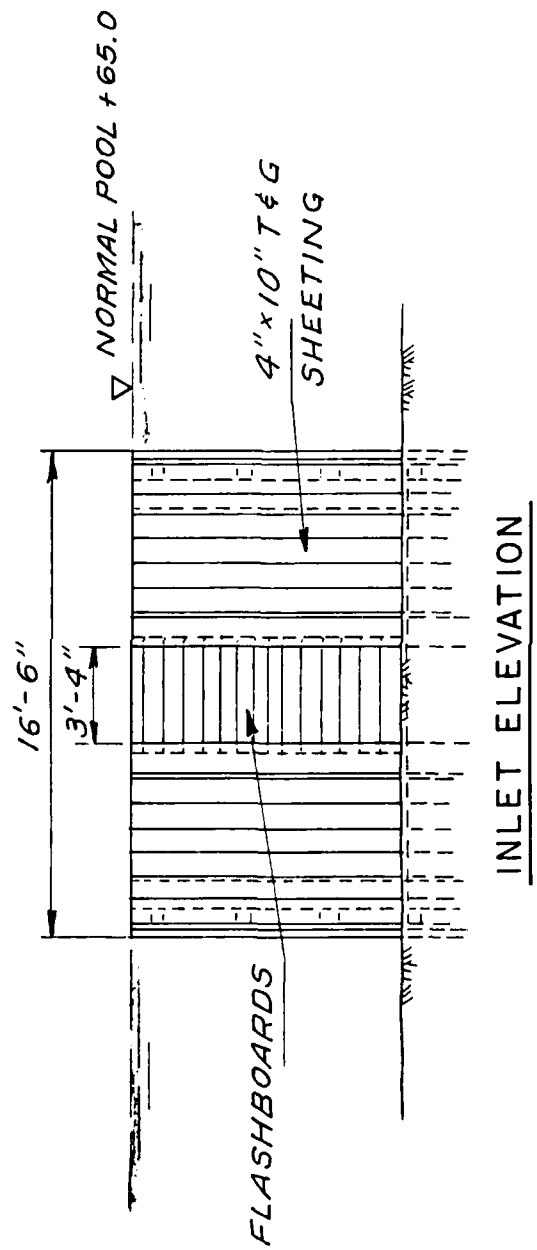
FIGURE 4

The three-sided timber box spillway which measures approximately 16' x 10' is in reasonably good condition except for some deterioration of

(2) Conduct an examination of the overall spillway structure with a view to planning the repair or replacement of selected timbers before their condition becomes critical.
