PASSAIC RIVER BASIN  
LONGHOUSE CREEK, PASSAIC COUNTY  
NEW JERSEY

**WEST MILFORD  
LAKE DAM  
NJ 00189 S**

**PHASE 1 INSPECTION REPORT  
NATIONAL DAM SAFETY PROGRAM**

**FEBRUARY 1980**

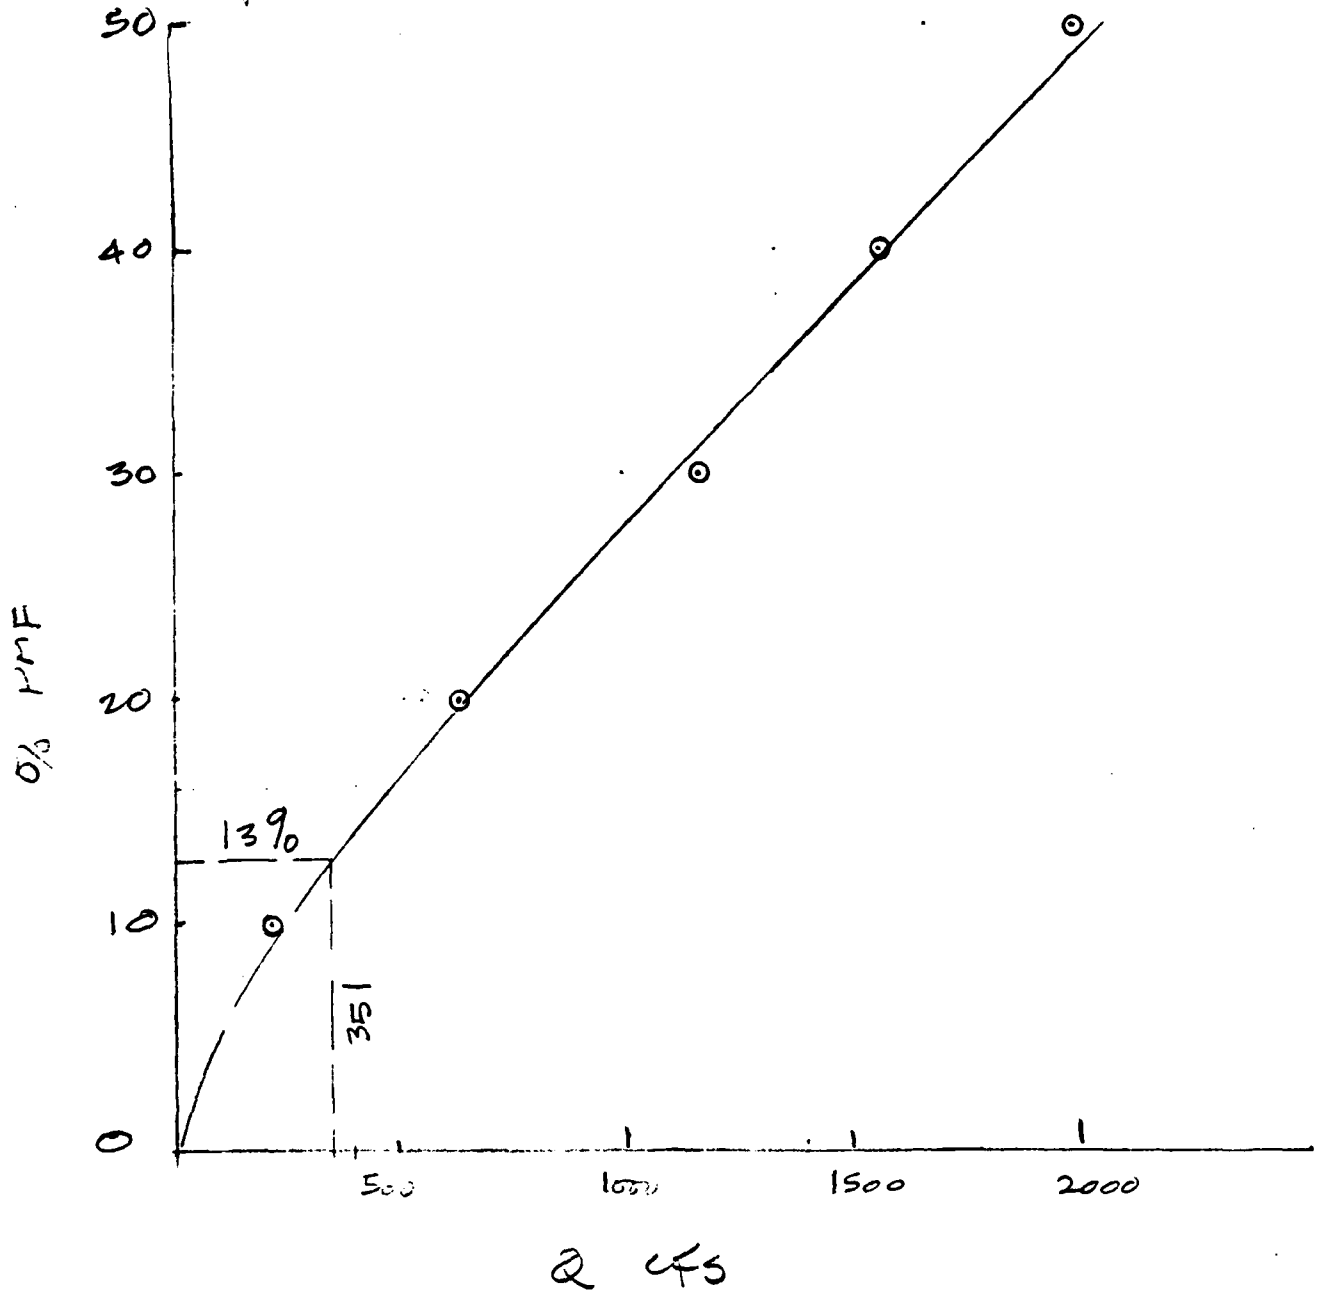
# Overtopping Potential

Overtopping of Dam occur at Ele. 689.5 with  $Q=351$  cfs  
 (~ 13% PMF)

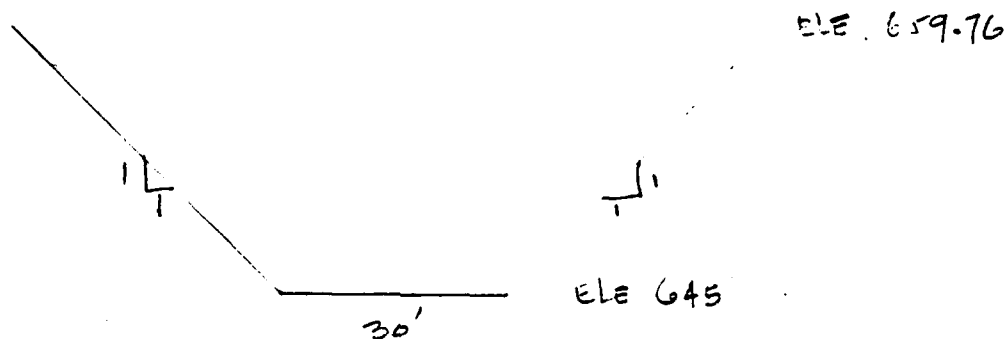
### Breach Analysis

The breach begins to develop when Lake stage reaches Elev. 659.76 @ 20% PMF with failure time = 0.5 hr.
