**DSCS II**

**BATTERY ANOMALY INVESTIGATION  
SATELLITES 9437 AND 9438**

TRW DEFENSE AND SPACE SYSTEMS GROUP  
ONE SPACE PARK  
REDONDO BEACH, CALIFORNIA 90278  
REPORT NO. 32824-AR-019-01

**FINAL REPORT**

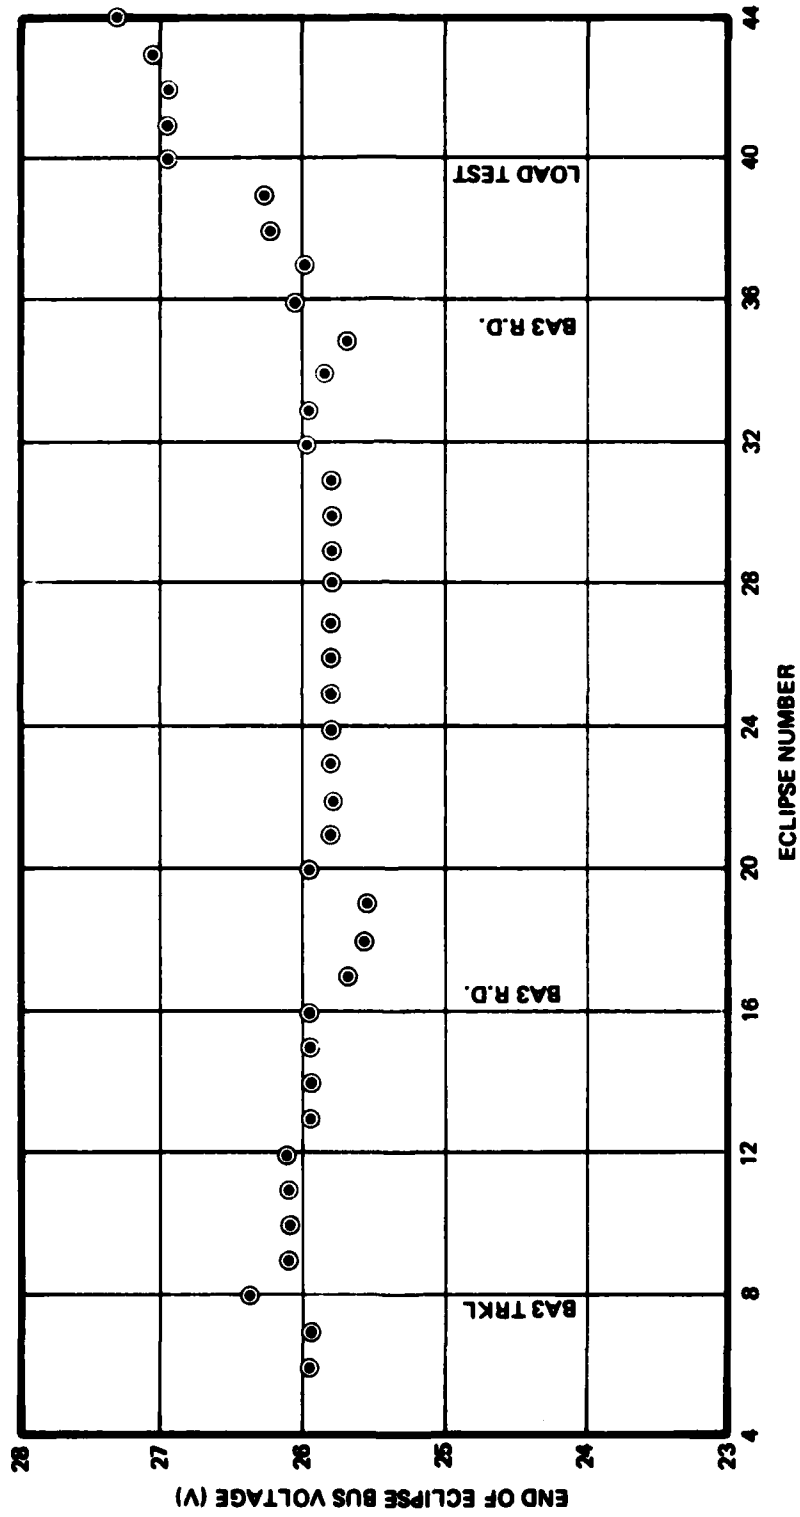
Figure 3-4. Satellite 9438 Minimum Bus Voltage, Eclipse Season Three (September 1973)

Figure 3-4 depicts the variation of end-of-eclipse bus voltage during the third eclipse season of Satellite 9438. Other than the discontinuities resulting from the attempts to recondition Battery 3, it appears that the minimum bus voltage for the season was approximately 25.6 volts.

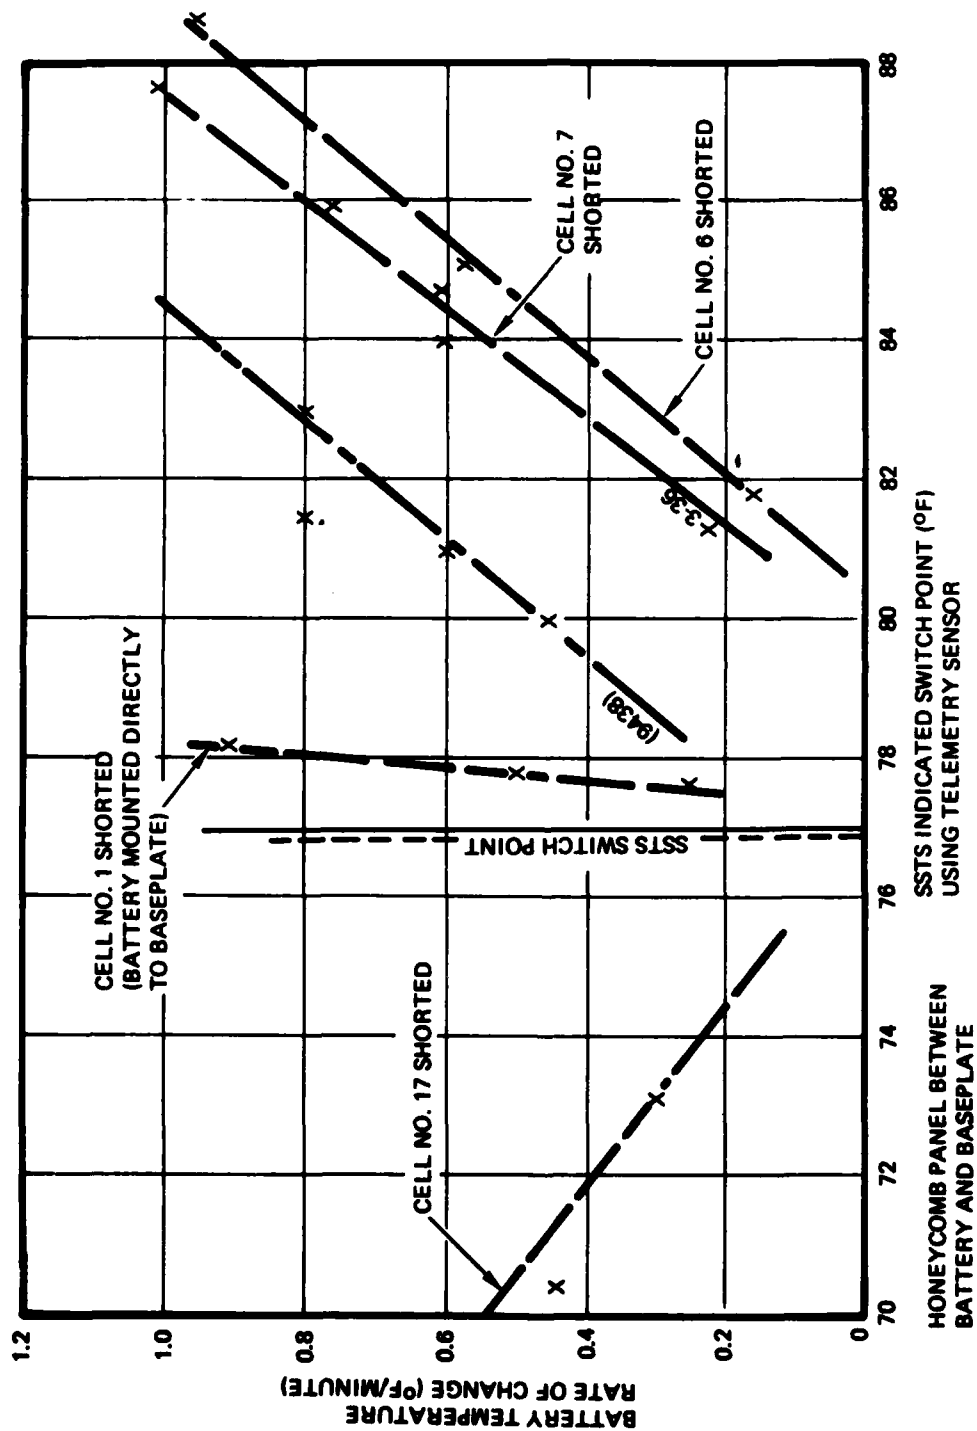
Figure 4-3. Offset of Apparent SSTS Switch Point Simulated in Test with a Battery Containing a Shorted Cell

A series of laboratory tests was conducted in which a battery containing a short-circuited cell was charged and overcharged at varying rates, so as to produce varying rates of temperature increase. Figure 4-3

shows a plot of the telemetry temperature indication at the moment of SSTS switching as a function of the rate of temperature change for several locations of short-circuited cell in the battery package. For comparison purposes a similar plot for Battery 3 of Satellite 9438 is also shown.

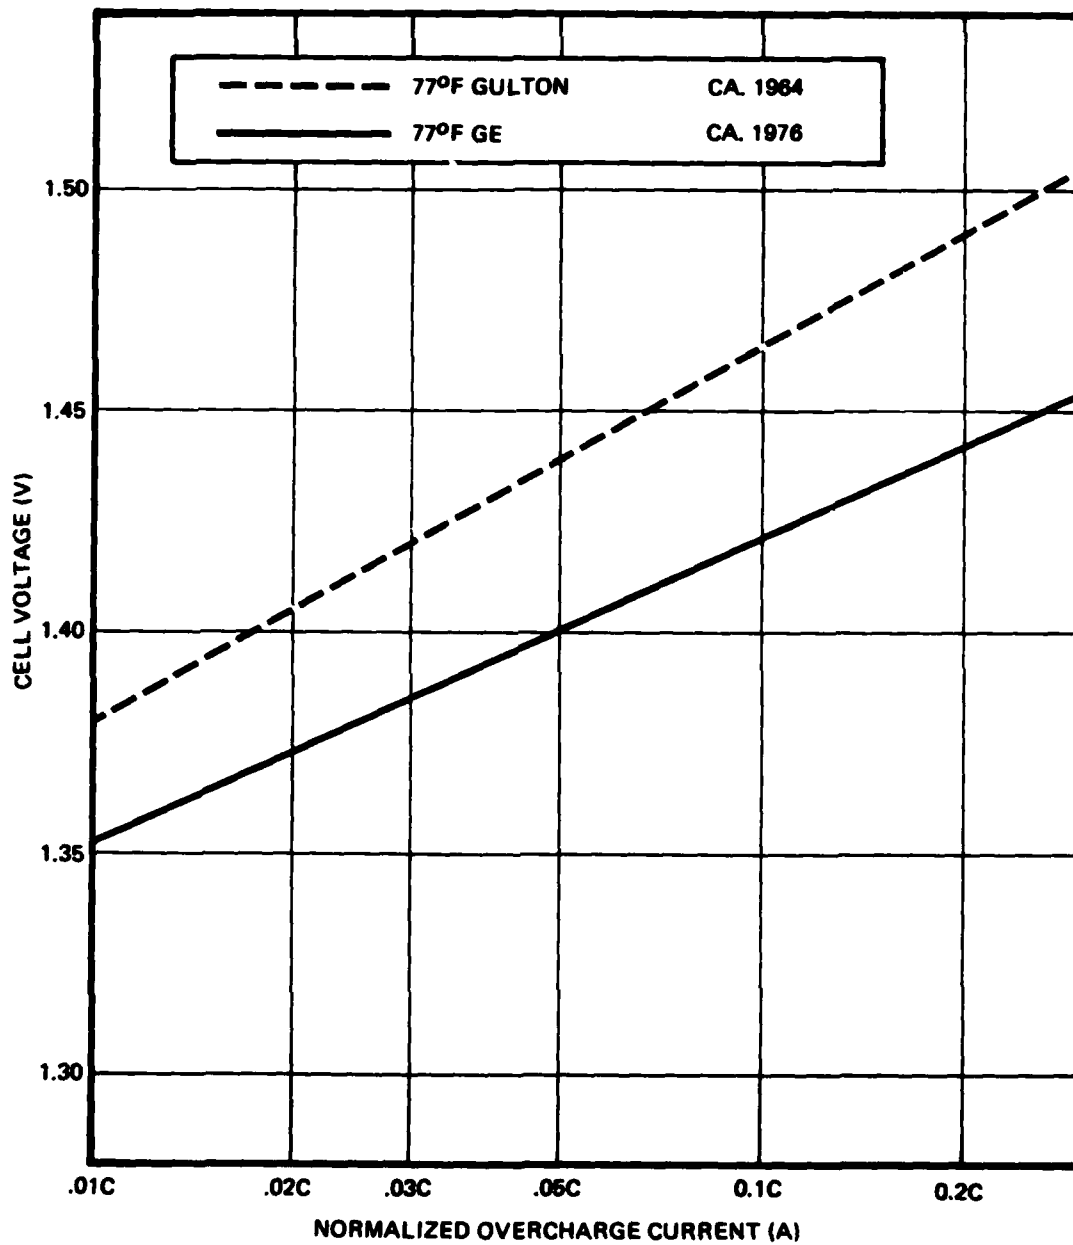
Figure 4-5. Overcharge Voltage versus Overcharge Current

The battery cells in use at the time the system was designed were manufactured by Gulton Industries, using electrodes manufactured by SAFT, France. The cells used in Satellites 9437 and 9438 were manufactured entirely by the General Electric Co. Figure 4-5 shows steady-state overcharge characteristics for Gulton cells manufactured during a period

approximately corresponding to the subsystem design and for General Electric cells manufactured during a period approximately corresponding to the purchase of Satellite 9437 and 9438 cells.

The difference between the Gulton and General Electric data (Figure 4-5) indicates that the General Electric cells will draw higher steady-state overcharge currents. The observation that Satellites 9437 and 9438 exhibited higher overcharge currents than previous satellites (containing Gulton cells) is consistent with the data.

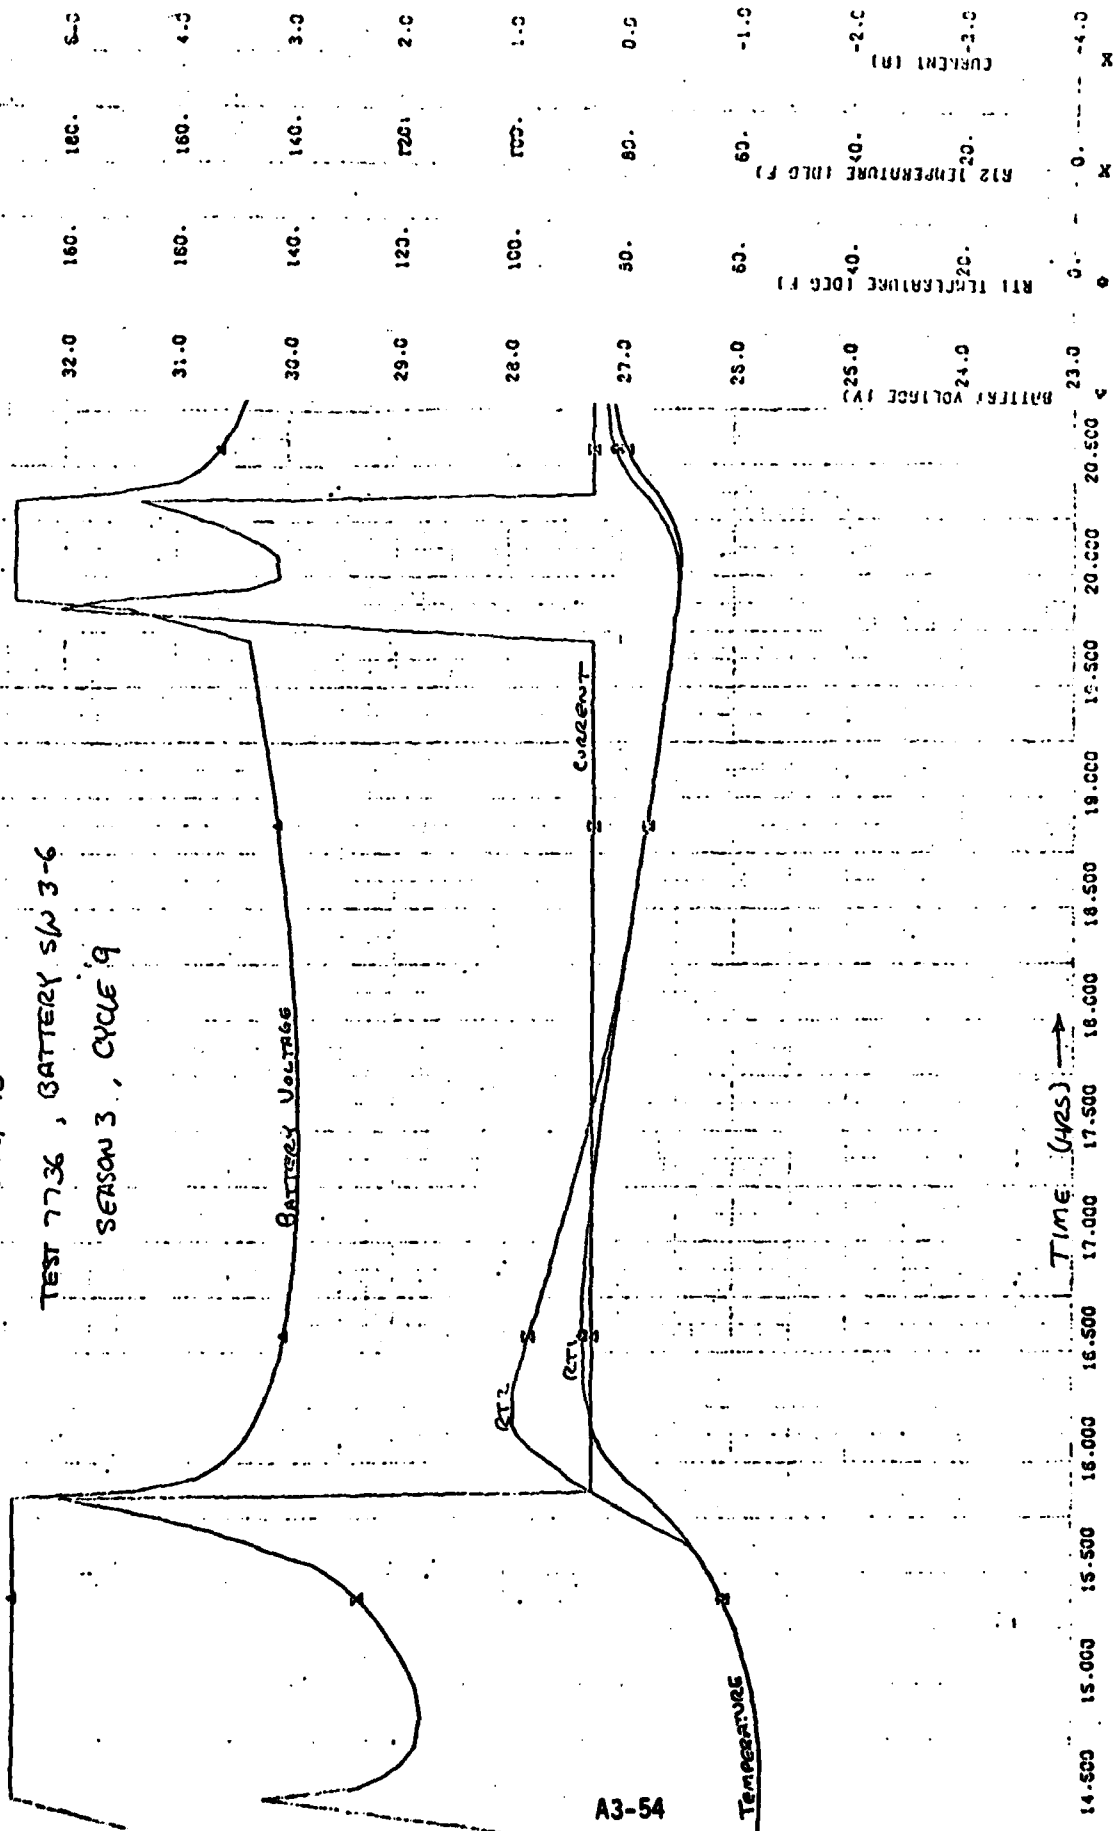
FIG 16

- 1) A battery voltage inflection occurred at 15.55 hours (Figure 16)
- 2) Temperature sensor RT2, mounted adjacent to Cell No. 6, indicated a temperature excursion starting at 15.60 hours (Figure 16).
- 3) The Cell No. 6 cell voltage dropped off its overcharge plateau prematurely at 15.55 hours (Figure 17).

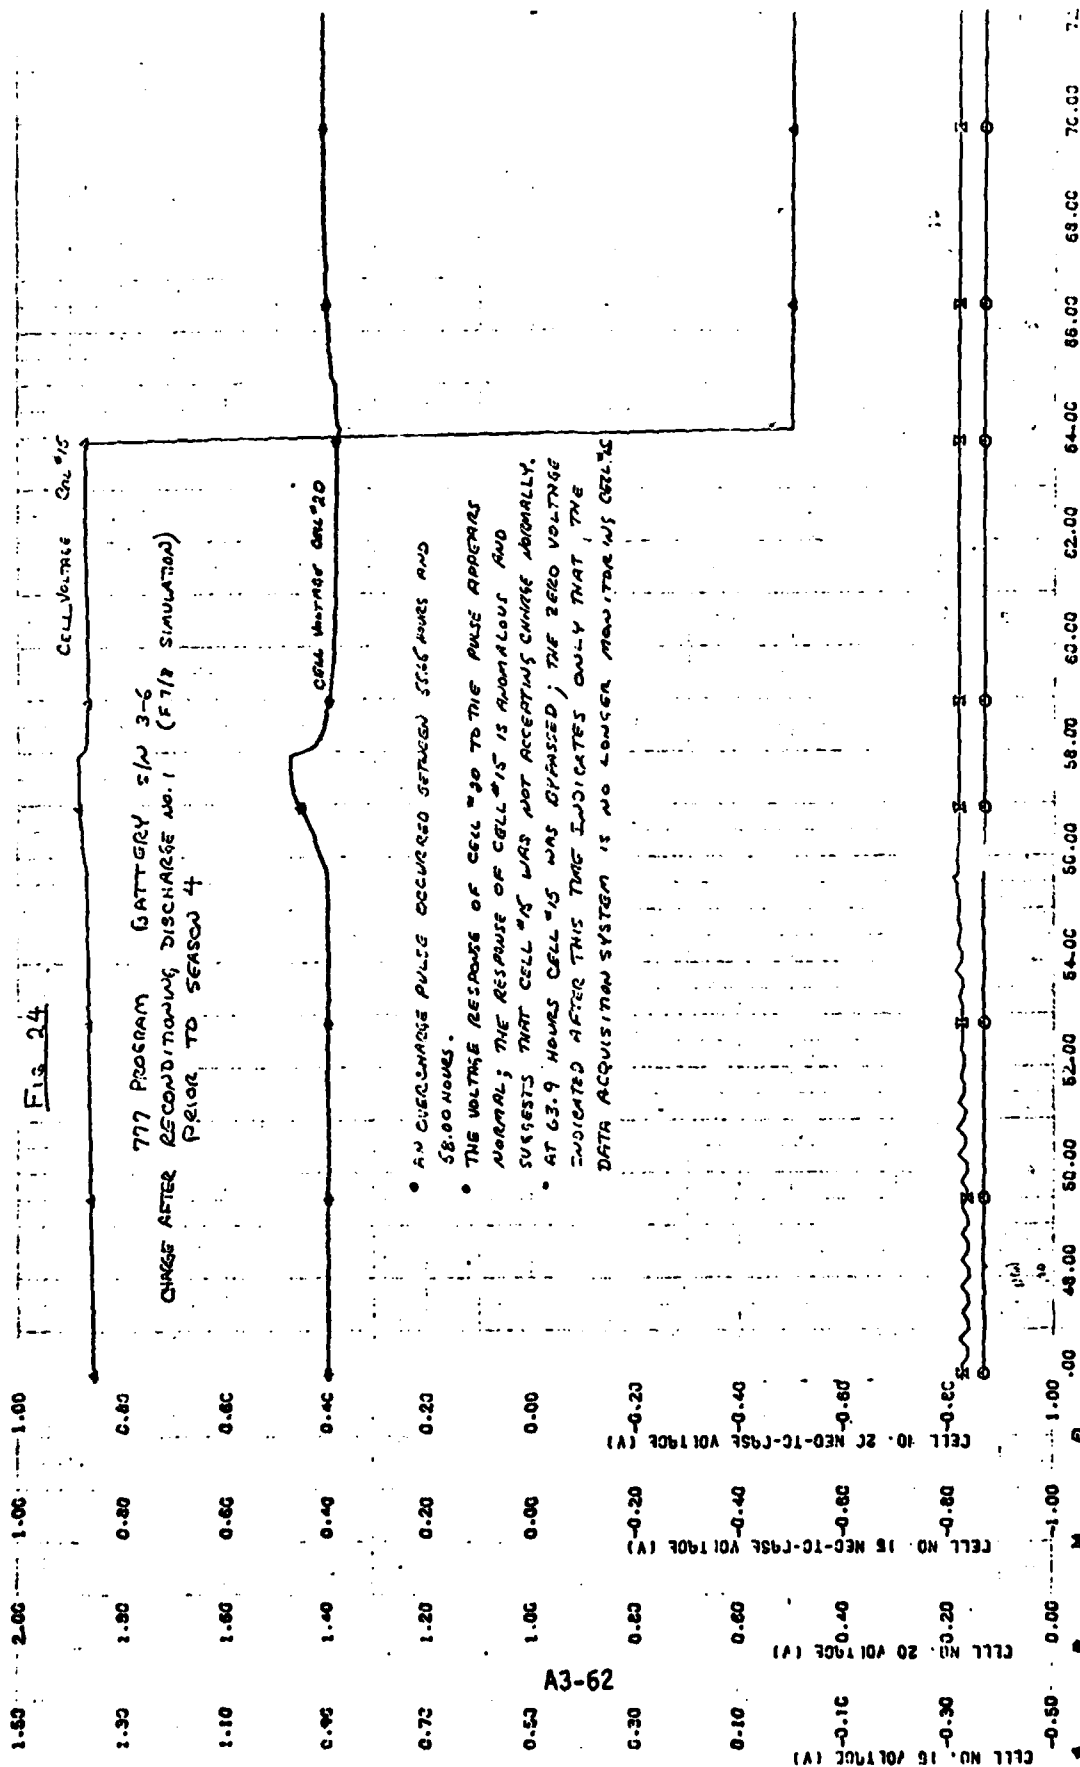
Fig. 24

An overcharge pulse occurred between 55.65 and 58.00 hours (Figures 23). The voltage responses of Cell No. 15 and a nominal cell, Cell No. 20, are presented in Figure 24. The response of Cell No. 15 is anomalous and suggests that it was not accepting charge normally.

- AN OVERCHARGE PULSE OCCURRED BETWEEN 5.50 HOURS AND 5.80 HOURS.
- THE VOLTAGE RESPONSE OF CELL #20 TO THE PULSE APPEARS NORMAL; THE RESPONSE OF CELL #15 IS ABNORMAL AND SUGGESTS THAT CELL #15 WAS NOT ACCEPTING CHARGE ABNORMALLY.
- AT 6.3.9 HOURS CELL #15 WAS BYPASSED; THE ZERO VOLTAGE INDICATED AFTER THIS TIME INDICATES ONLY THAT THE DATA ACQUISITION SYSTEM IS NO LONGER MONITORING CELL #15.

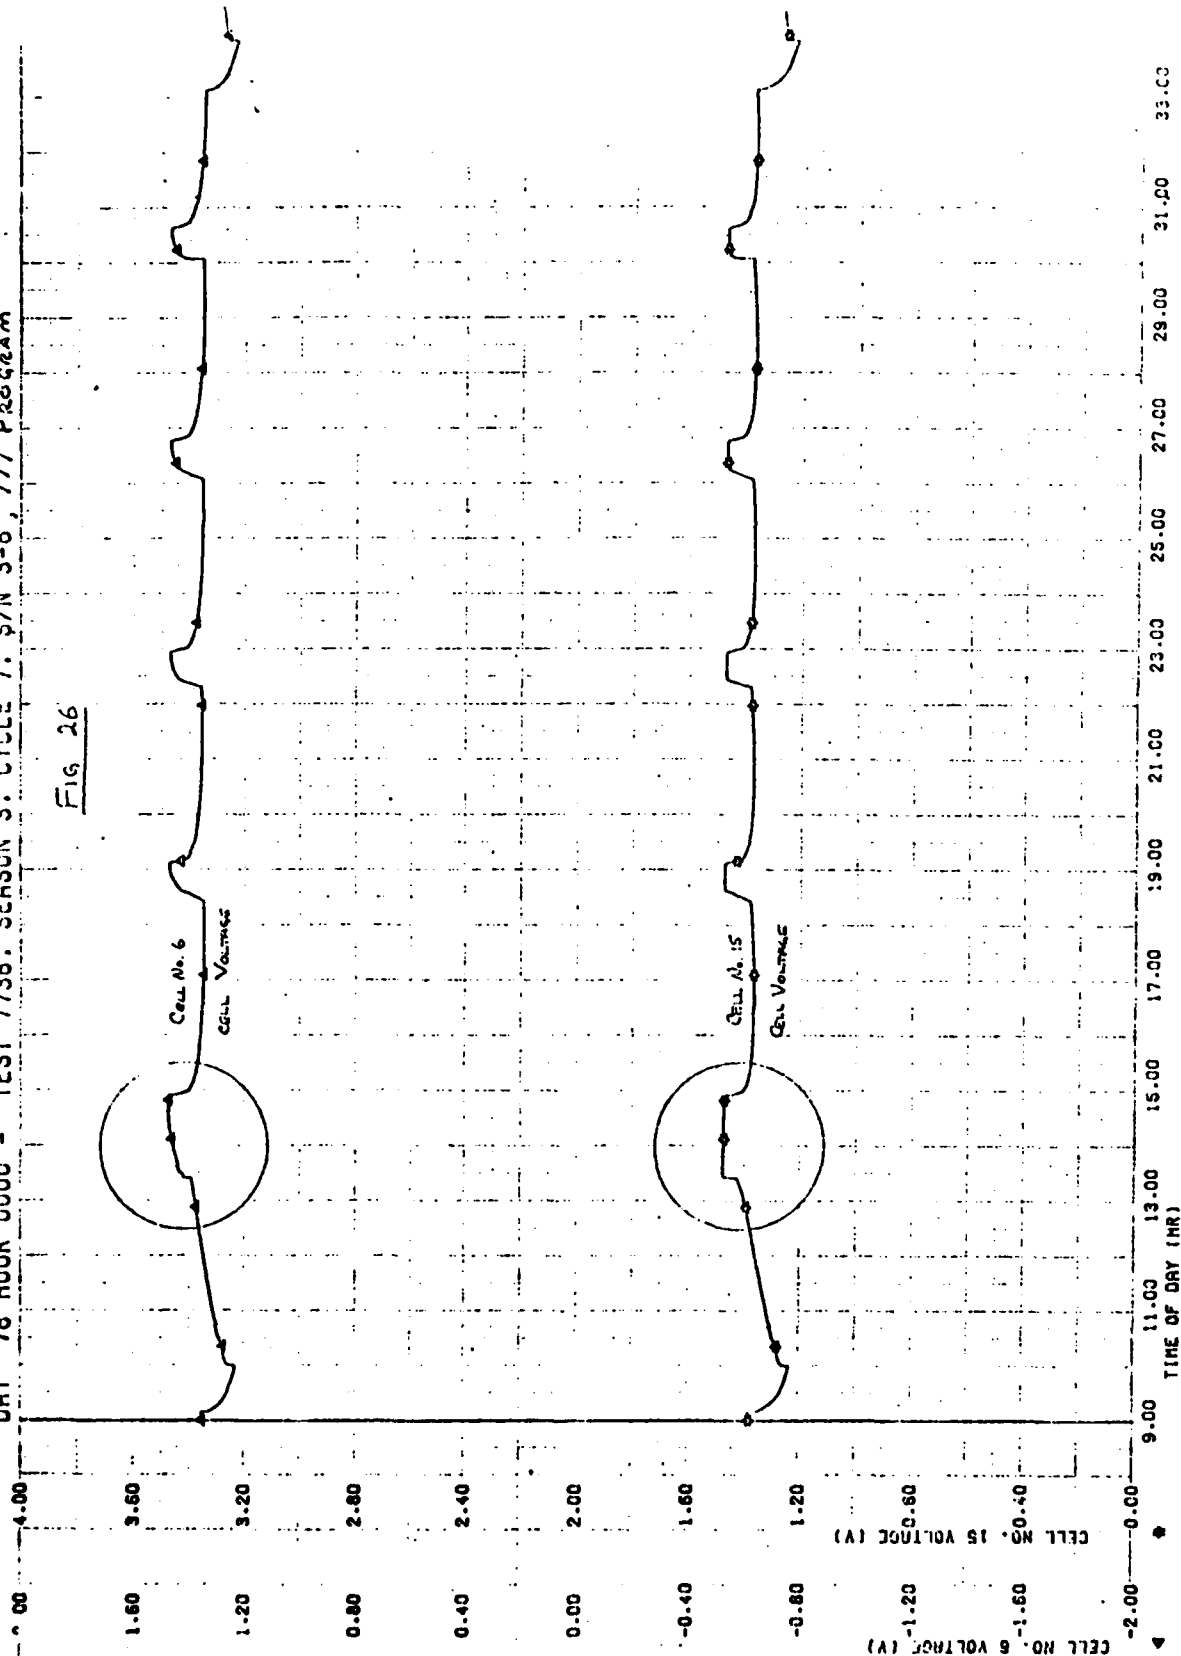
FIG 26

Figure 26 shows the voltage response waveform of Cells 6 and 15, Battery S/N 3-6, during Cycle 7 of Season 3. Cell No. 15 appears normal. Cell No. 6 exhibits the three warning signs identified above. Cell No. 6 developed a short and failed two days later during Cycle 9.

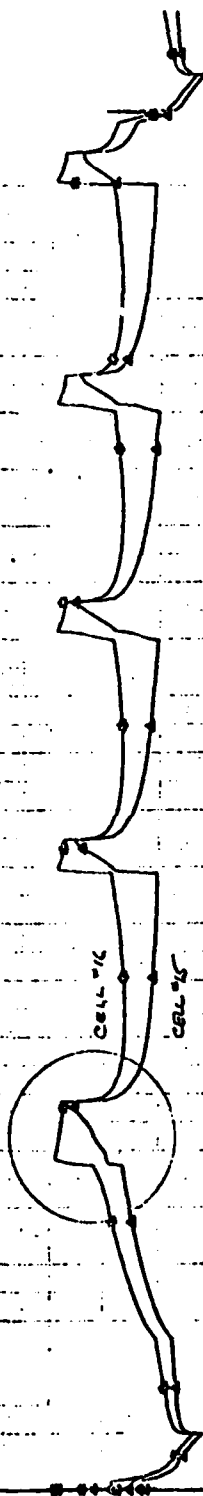
FIG. 27

Although Cell No. 15's waveform and working voltages appear normal during Cycle 7 and again during Cycle 9 its OCV decay rate was anomalous during the post-Cycle 9 stand (Paragraph 3.2 ). Figure 27 shows the voltage response waveforms of Cells 15 and 16, Battery S/N 3-6, during Cycle 33 of Season 3. Once again the three warning signs are present. Cell No. 15 developed a short and failed 14 days later during the charge following the first reconditioning discharge after completion of Season 3.

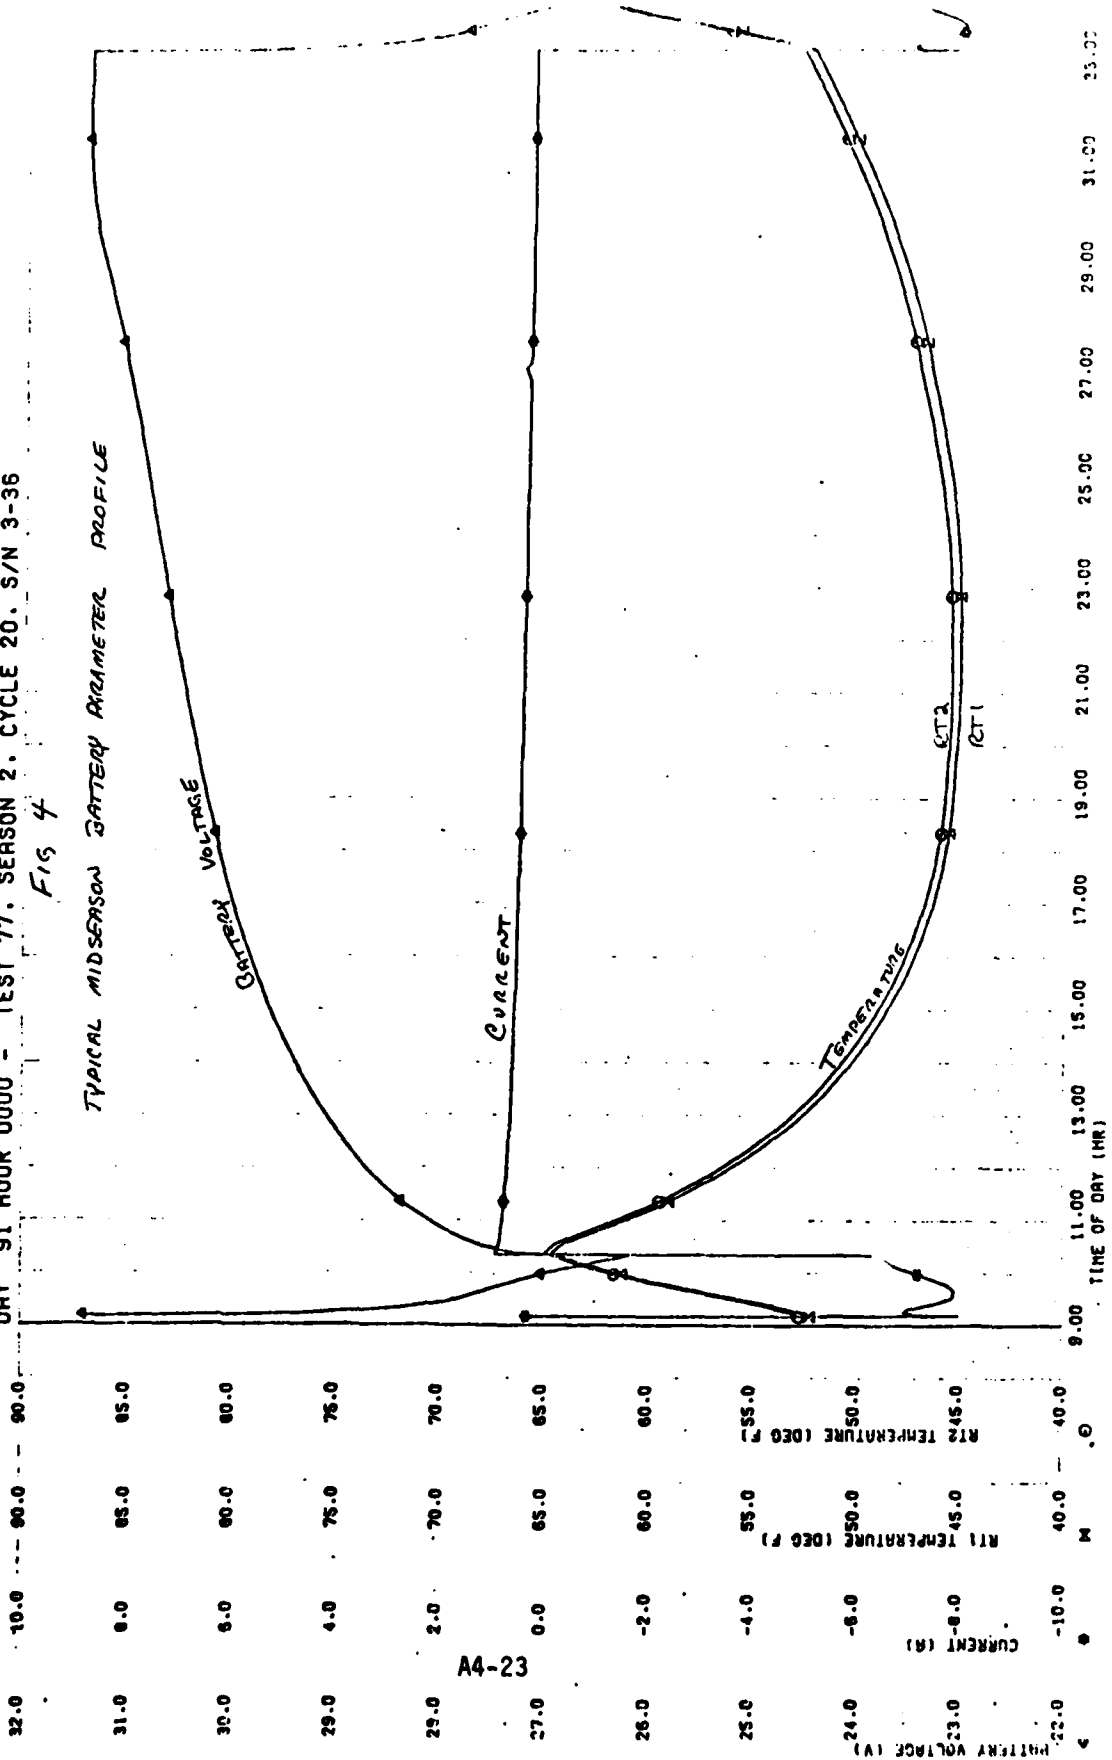
FIG 4

Figures 4 and 5 depict typical midseason voltage, current, and temperature vs. time relationships for S/N 3-36 and S/N 3-43 respectively. The parametric responses are generally similar to those observed during Season 1.

The average Preseason 3 reconditioning discharge capacity for S/N 3-36 was 0.4 Ah lower, and for S/N 3-43 0.6 Ah higher, than observed during the Preseason 2 reconditioning. This divergence may be related to the different eclipse season battery parameter profiles (Figures 4, 5) which cause S/N 3-43 to receive a great deal of overcharge and S/N 3-36 to receive very little. Large amounts of overcharge are known to increase positive capacity and insufficient overcharge can cause capacity loss. This explanation must be regarded as speculative at this point as the differences are small and only two seasons have been run.

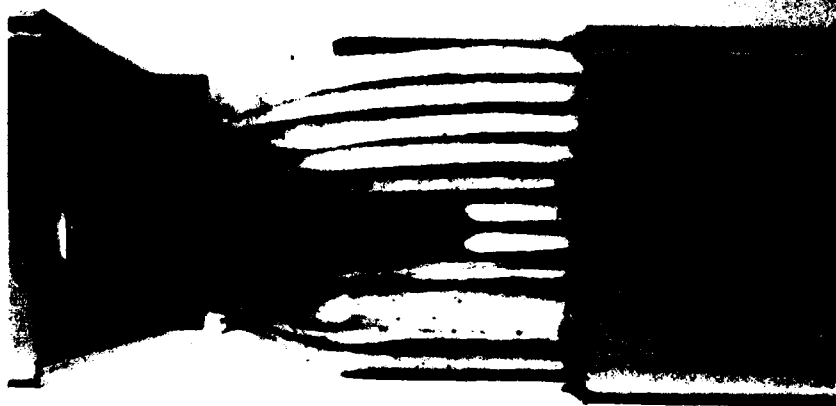
To facilitate inspection of the tab area and cutting of tabs, the plate pack (and cover) was pushed upward with respect to the remainder of the case by about one inch. Photographs of the open portion of the cell from the four sides are shown in Figures 2 through 5. Note that the separator material is not visible around two of the centermost positive plates on the positive plate tab end (Figure 4) and around four of the centermost positive plates on the negative plate tab end (Figure 5).

Figure 4. Positive terminal end view of cell  
(TRW 153394-79)

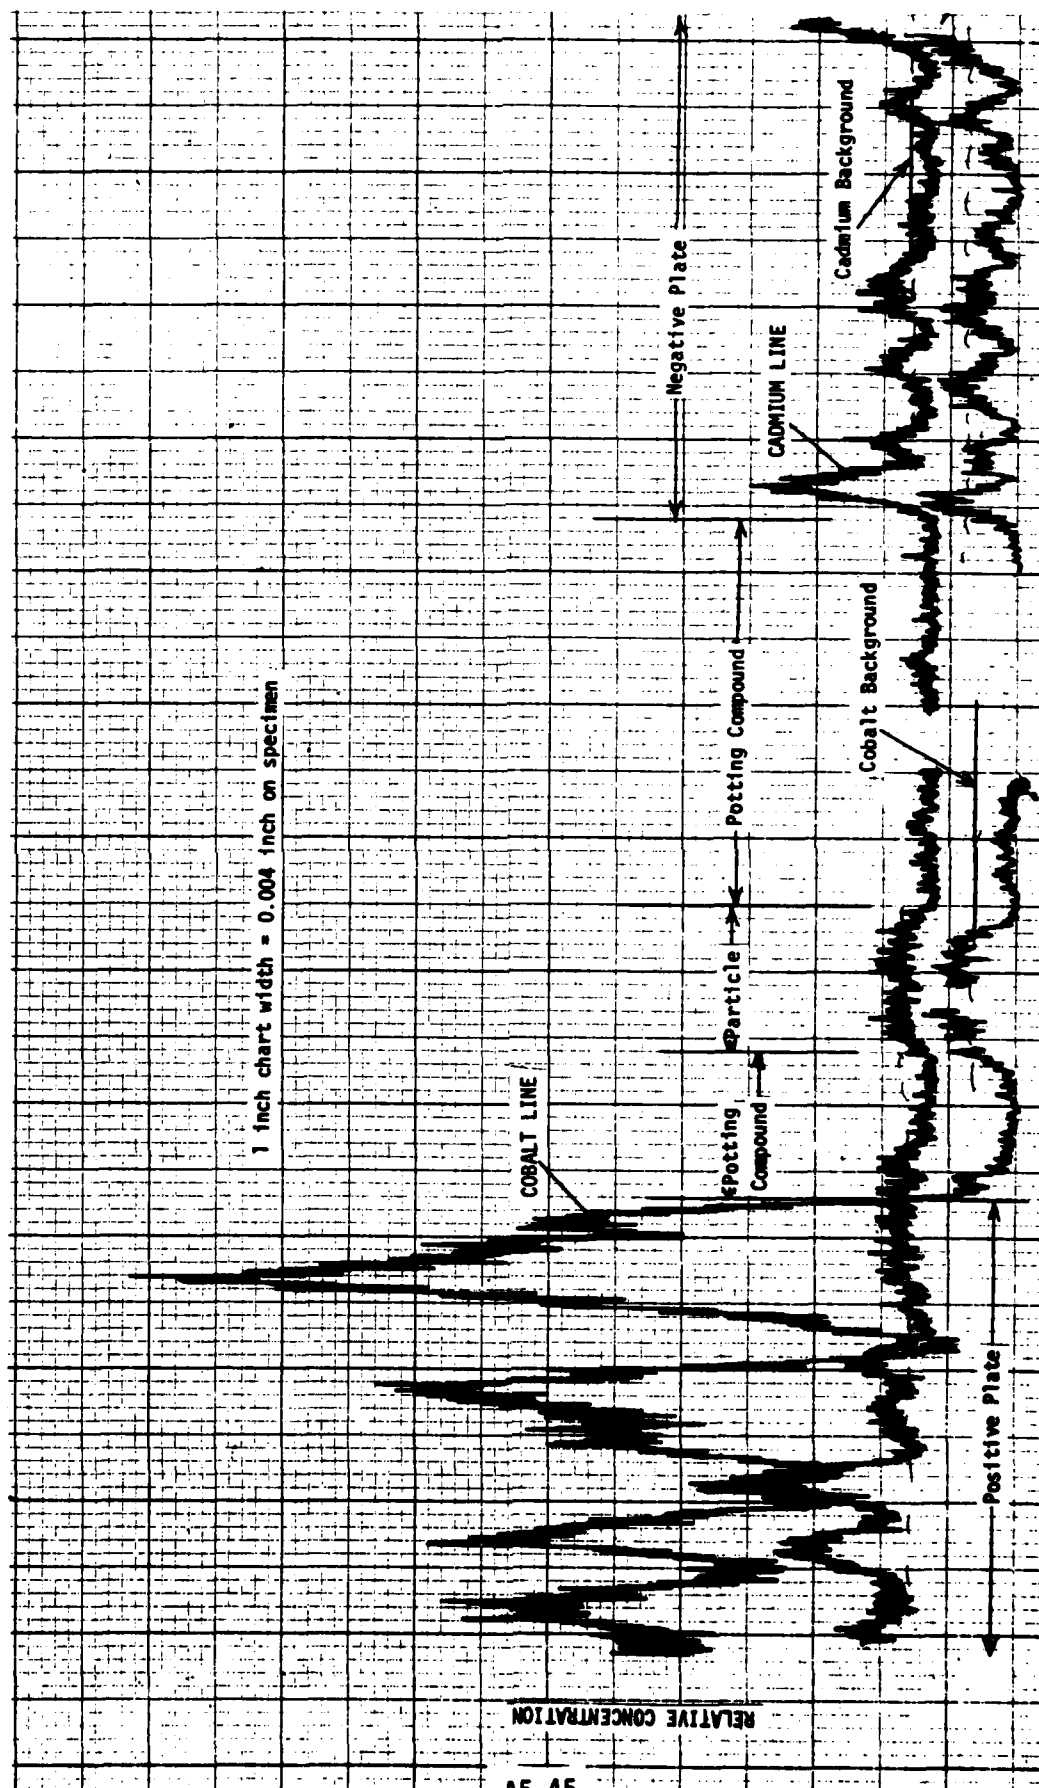
Figure 32. EMP line scan analysis for cadmium and cobalt. Section V, across the particle

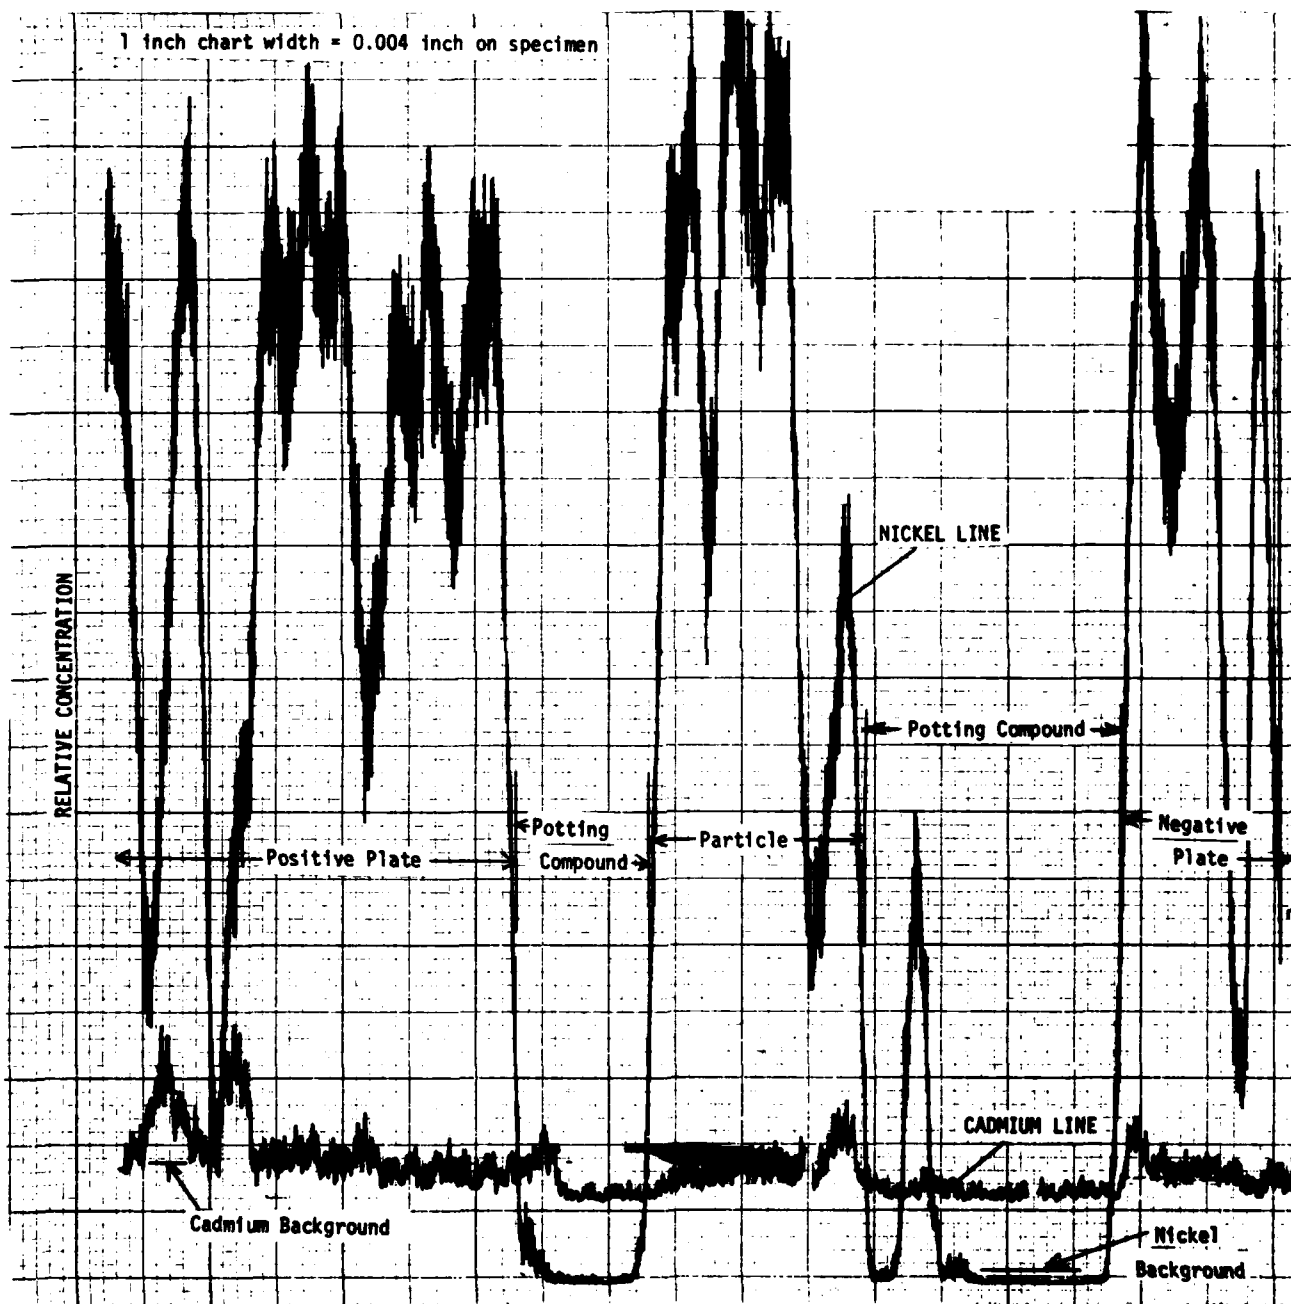
Figure 33 EMP line scan analysis for cadmium and nickel, Section V, across the particle

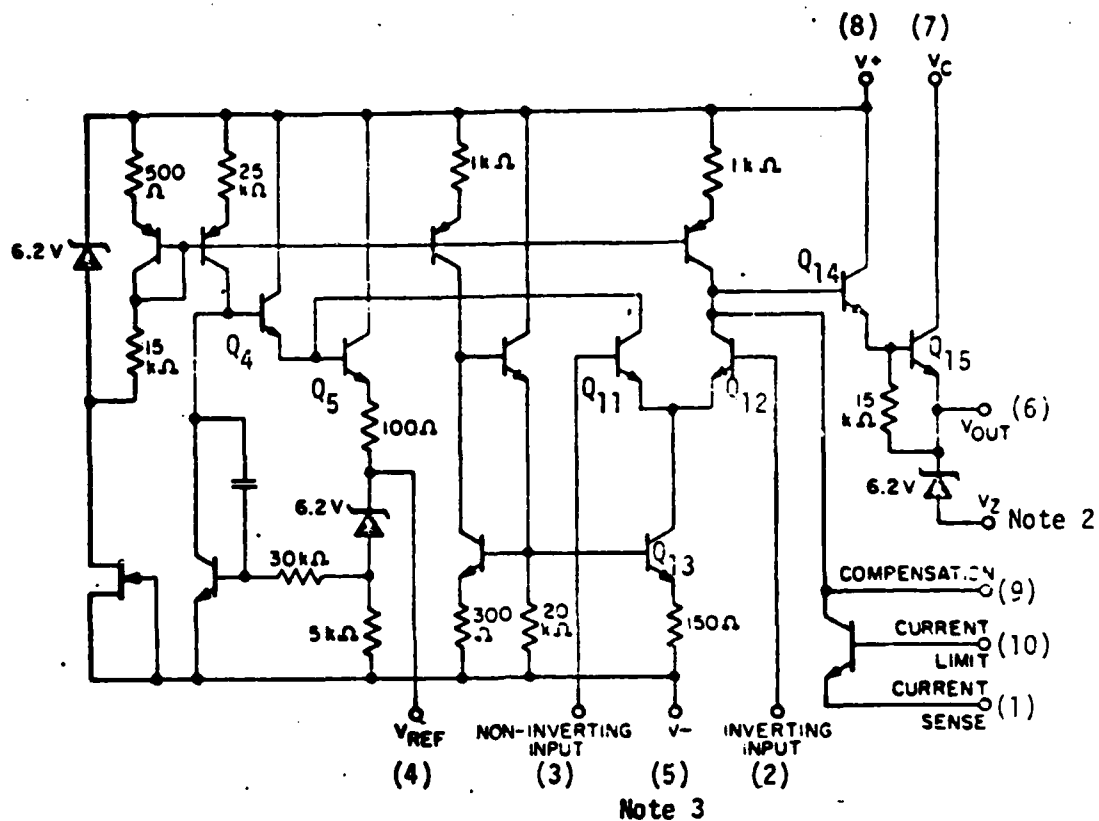
FIGURE 2. SCHEMATIC DIAGRAM

In summary, then, what we are looking for in this analysis is an electronic part failure or drift in the SSTS that could cause the set point to drift approximately 8°F high (corresponding to a  $\Delta R$  in the thermistor value of 313 ohms) and also allow the reset point to remain at its nominal value.

Operation of VR3 (Reference Figure 2) with various modes of degradation and the resulting effect on set point is tabulated in Table II. As can be seen, none of these modes can result in the observed orbital operation.

Further investigation is recommended on the relative temperature distributions on the battery under various cell failure modes (i.e., is there any way that RT1 and S6 could actually be 7-10° higher on charge than RT2). More orbital data would also be helpful.
