NDI No. PA 00482

**KENNAMETAL RESERVOIR DAM**

KENNAMETAL INC.

**PHASE I INSPECTION REPORT  
NATIONAL DAM INSPECTION PROGRAM**

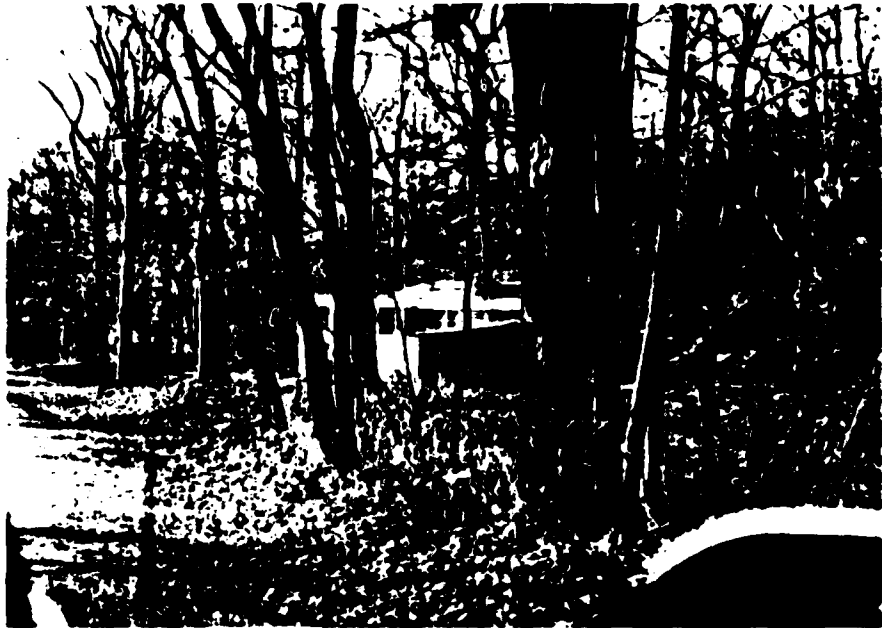
PHOTO 13. DOWNSTREAM DEVELOPMENT

- Photo 13 Downstream Development. Miller Run is located to the right of the residence.
- Photo 14 Miller Run below dam showing inhabited dwellings on floodplain.
