REYNOLDSVILLE STORAGE DAM

(NDI I.D. PA-01130
DER I.D. 33-5)

PHASE I INSPECTION REPORT
NATIONAL DAM INSPECTION PROGRAM

NAME OF DAM: Reynoldsville Storage Dam (Upper Dam)
STATE LOCATED: Pennsylvania
COUNTY LOCATED: Jefferson
STREAM: Pitchpine Run, a Tributary of Sandy Creek
SIZE CLASSIFICATION: Small
HAZARD CLASSIFICATION: High
OWNER: Borough of Reynoldsville
DATE OF INSPECTION: April 23, 1980 and April 30, 1980

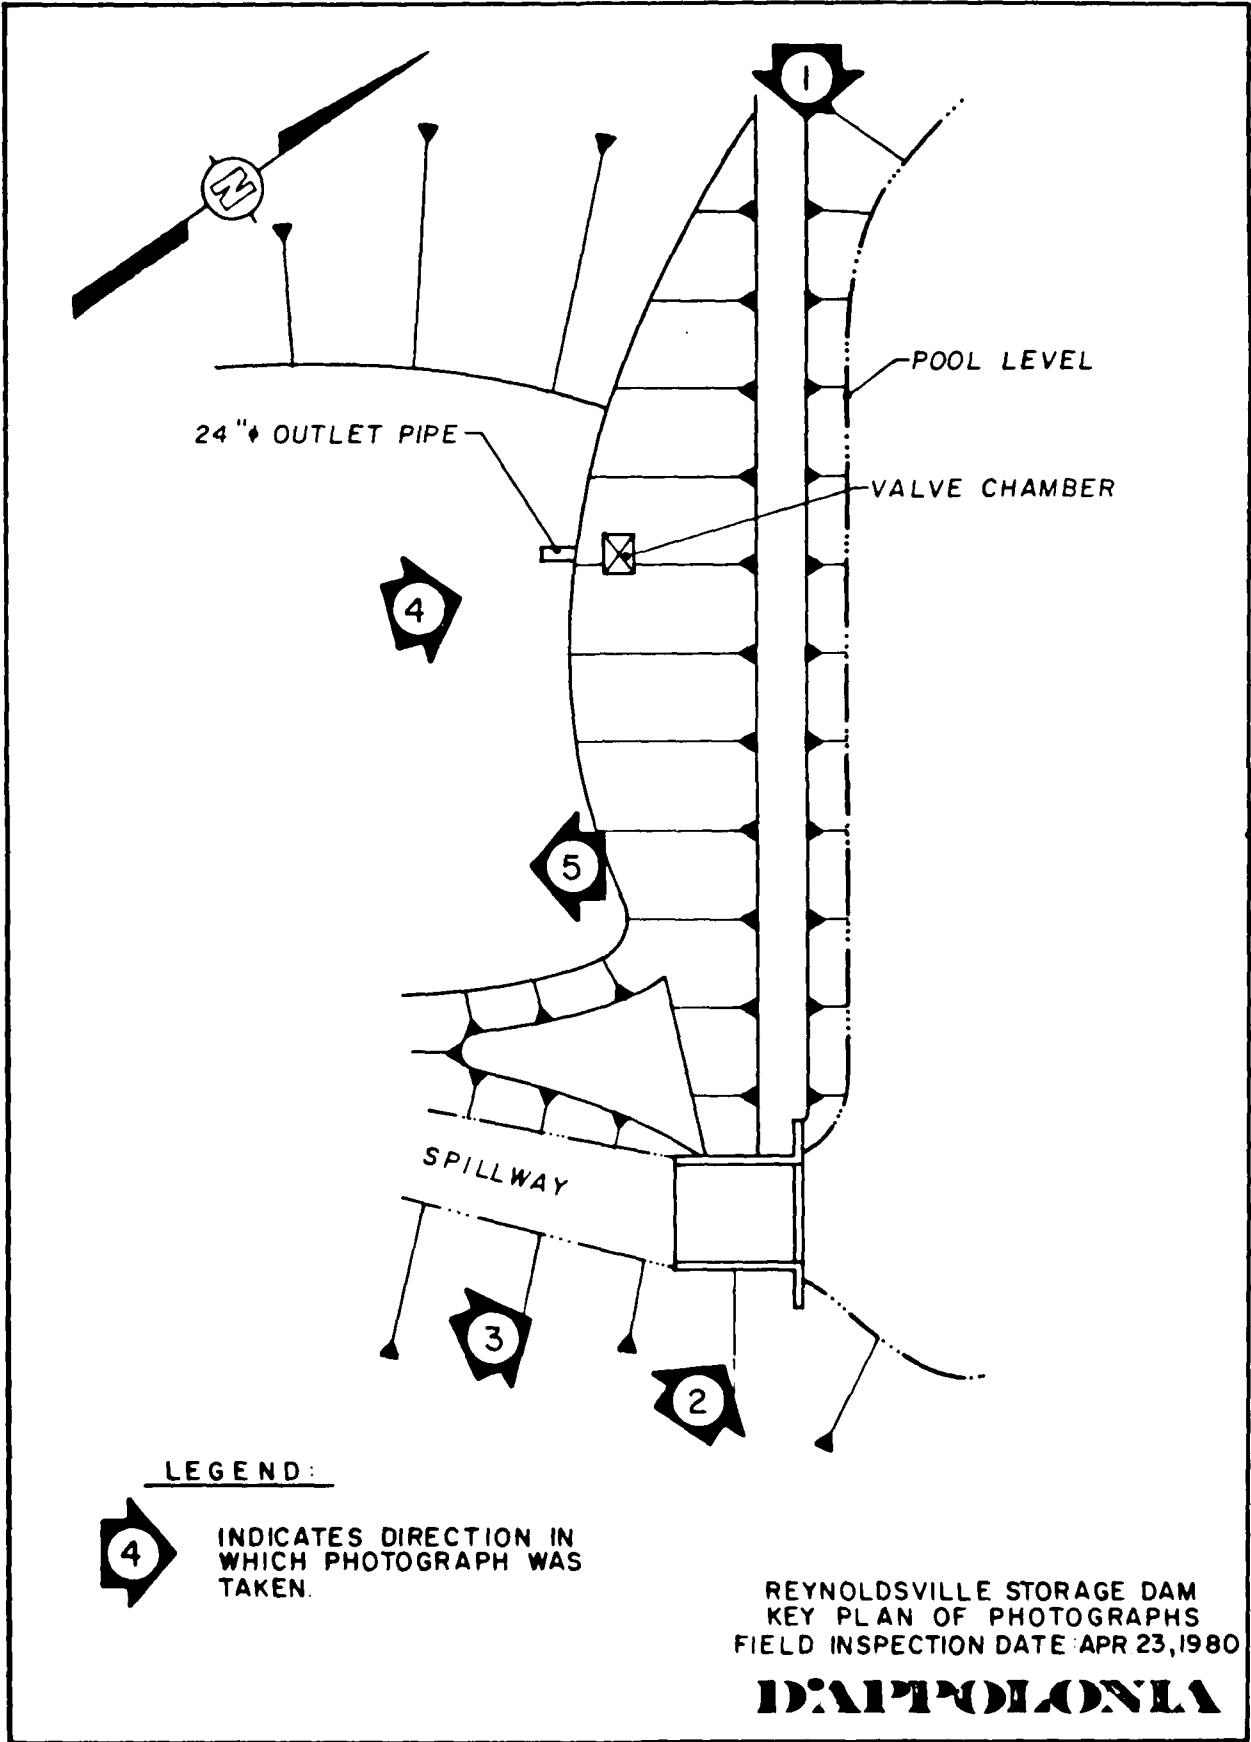
<u>PHOTOGRAPH NO.</u>	<u>DESCRIPTION</u>
1	Upstream face (looking east).
2	Spillway and dam crest (looking west).
3	Spillway (note deteriorating concrete).
4	Outlet (partially blocked).
5	Downstream reservoir (looking downstream from the crest of Storage Dam).
6	Pitchpine Run at Reynoldsville (approximately 3/4 mile downstream).
