GRACETON DAM

NDI I.D. NO: PA-00279

PHASE I INSPECTION REPORT
NATIONAL DAM INSPECTION PROGRAM

D'APPOLONIA CONSULTING ENGINEERS
DACW31-80-C-0022

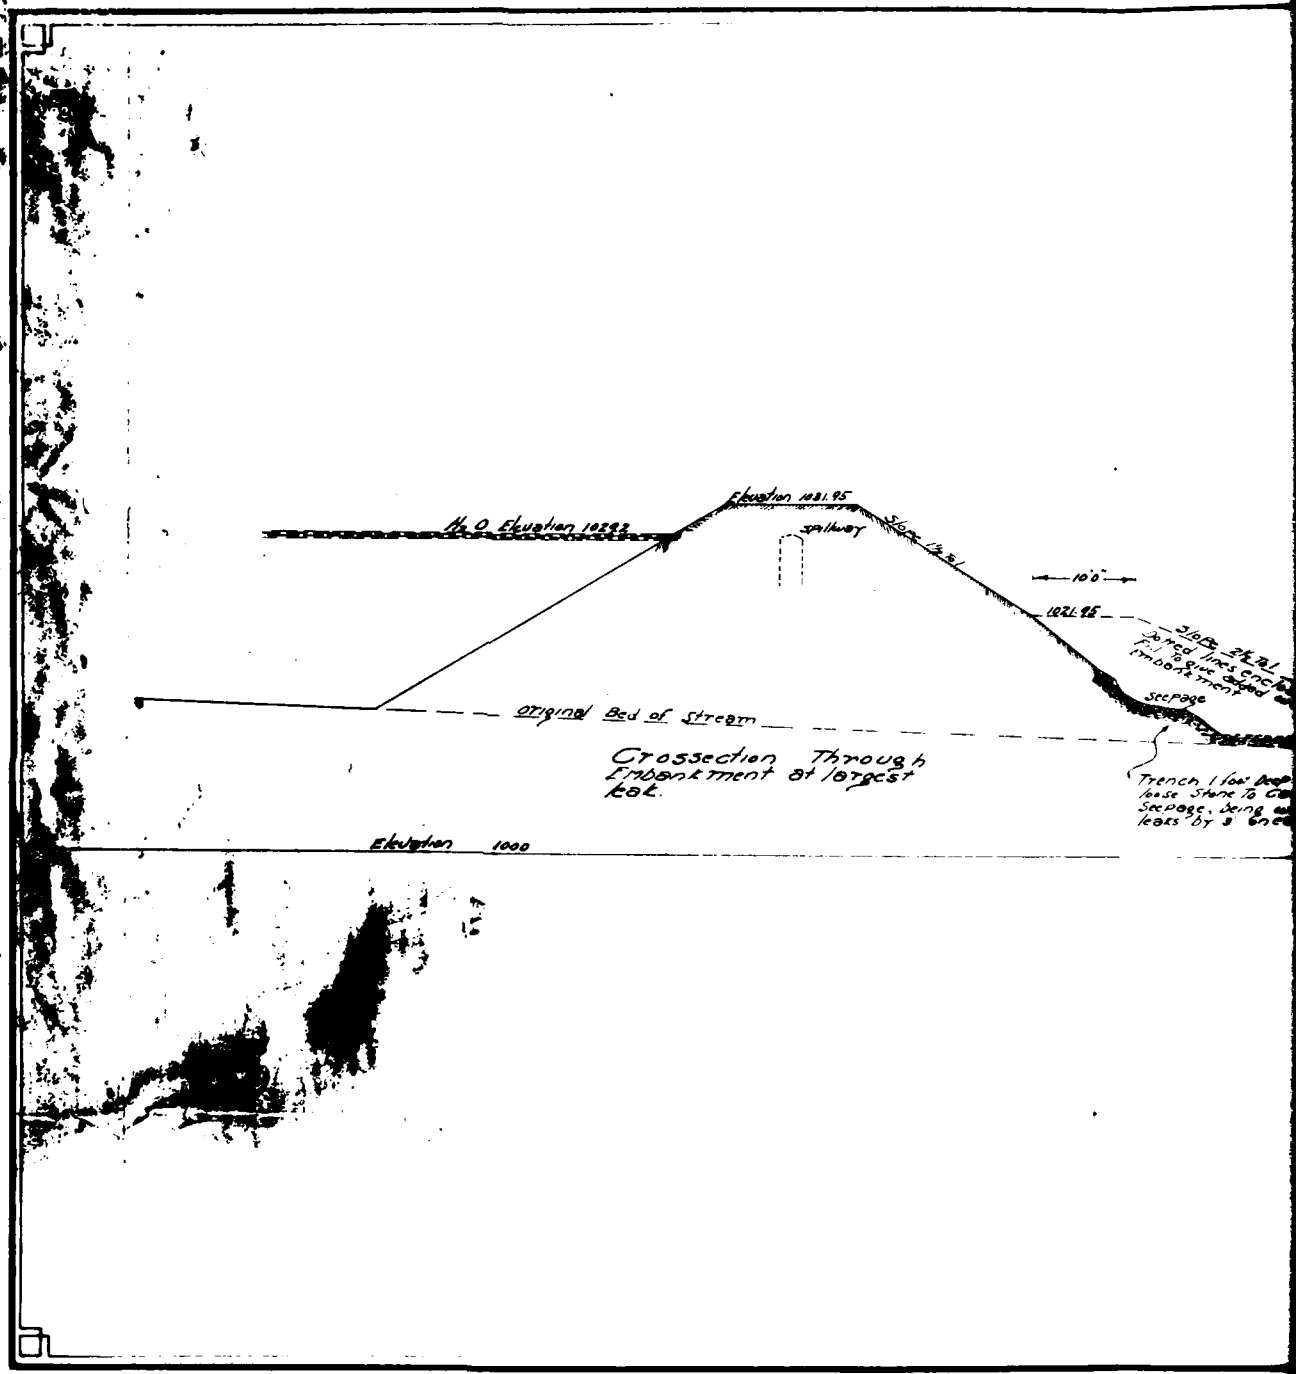
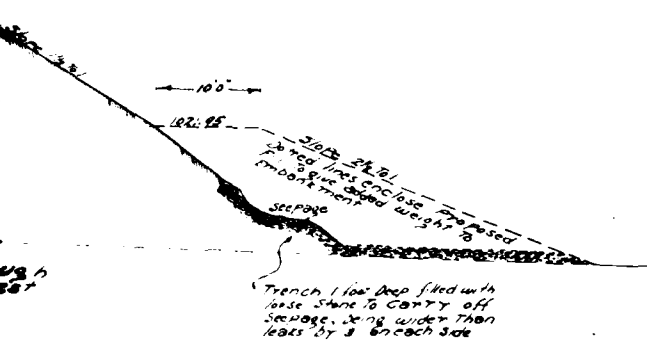
(1) Embankment. As illustrated in Plate 2, the dam appears to be a homogeneous embankment. A Commonwealth report dated June 2, 1919, indicates that the dam was designed by C. W. Knight and Sons, engineers from Rome, New York prior to 1917. The same report indicates the embankment material consisted of clay mixed with sand and gravel excavated from the reservoir area. No other information was found relative to the design of the dam.

2.2 Construction. Available records indicate the dam was constructed prior to 1917 by the original owner, The Potter Coal and Coke Company. The exact date of construction is unknown. In 1921, the downstream slope of the dam was flattened by the construction of a berm and a toe buttress to remedy a slope failure and seepage problem which existed prior to 1921.

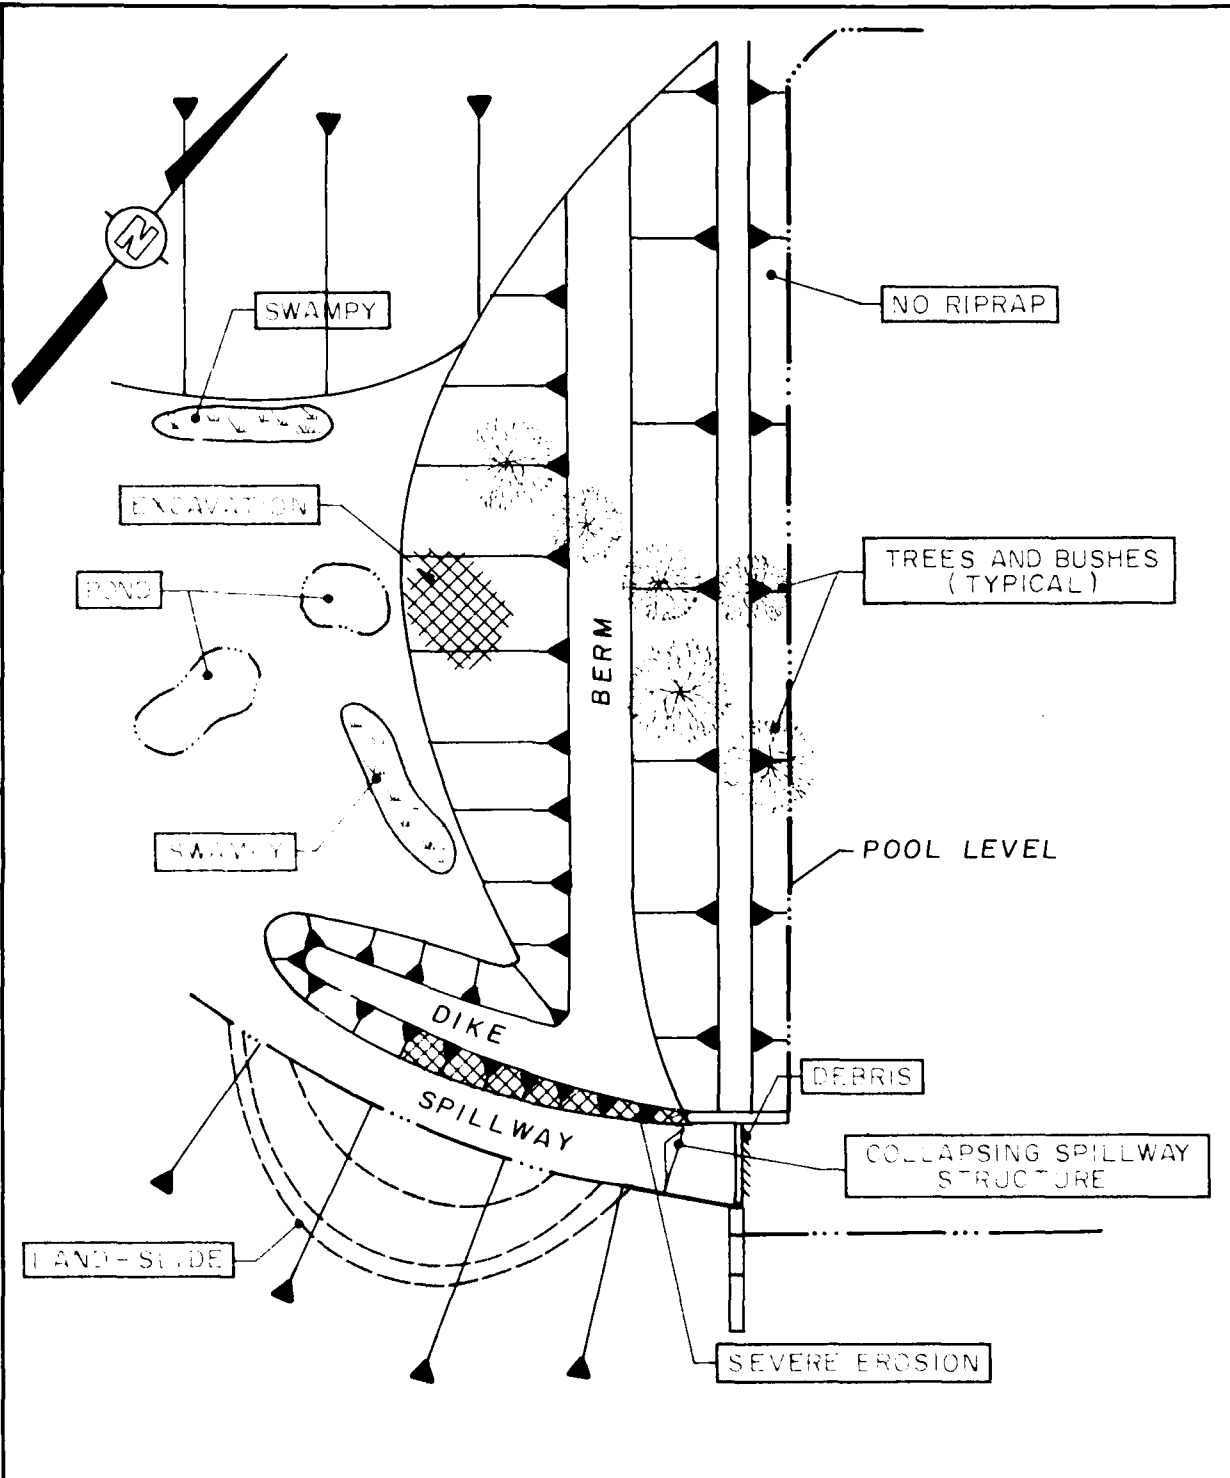
1. POOL LEVEL DATE OF INSPECTION:
0.5 FT. ABOVE SPILLWAY CREST
