POTOMAC RIVER BASIN  
TOMS CREEK, ADAMS COUNTY

PENNSYLVANIA  
NDS ID PA. 01135  
DER ID 1-86

## SECTION F DAM

### PHASE I INSPECTION REPORT NATIONAL DAM INSPECTION PROGRAM

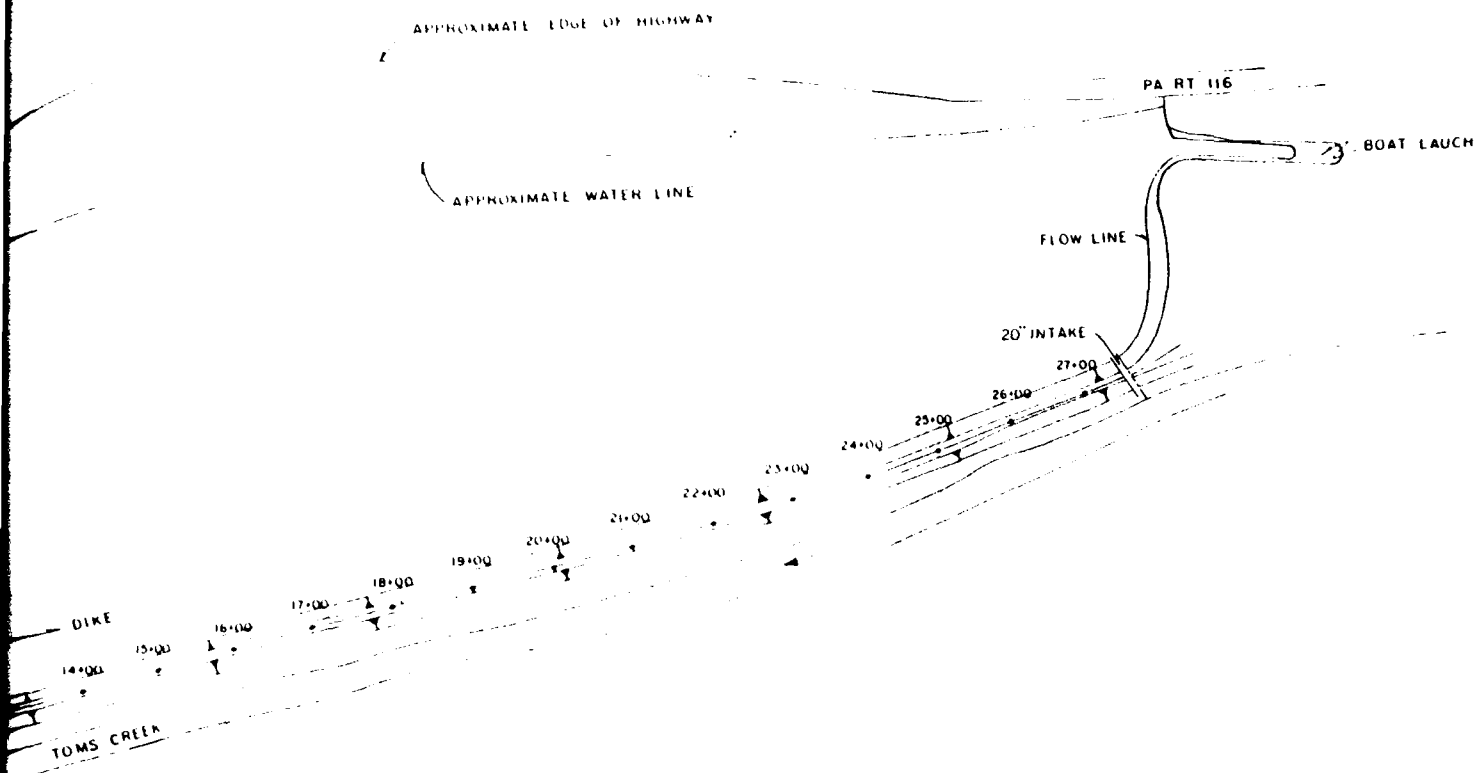
SECTION F DAM  
PLATE 2

DATA OBTAINED FROM FIELD  
INSPECTION ON APRIL 21, 1980

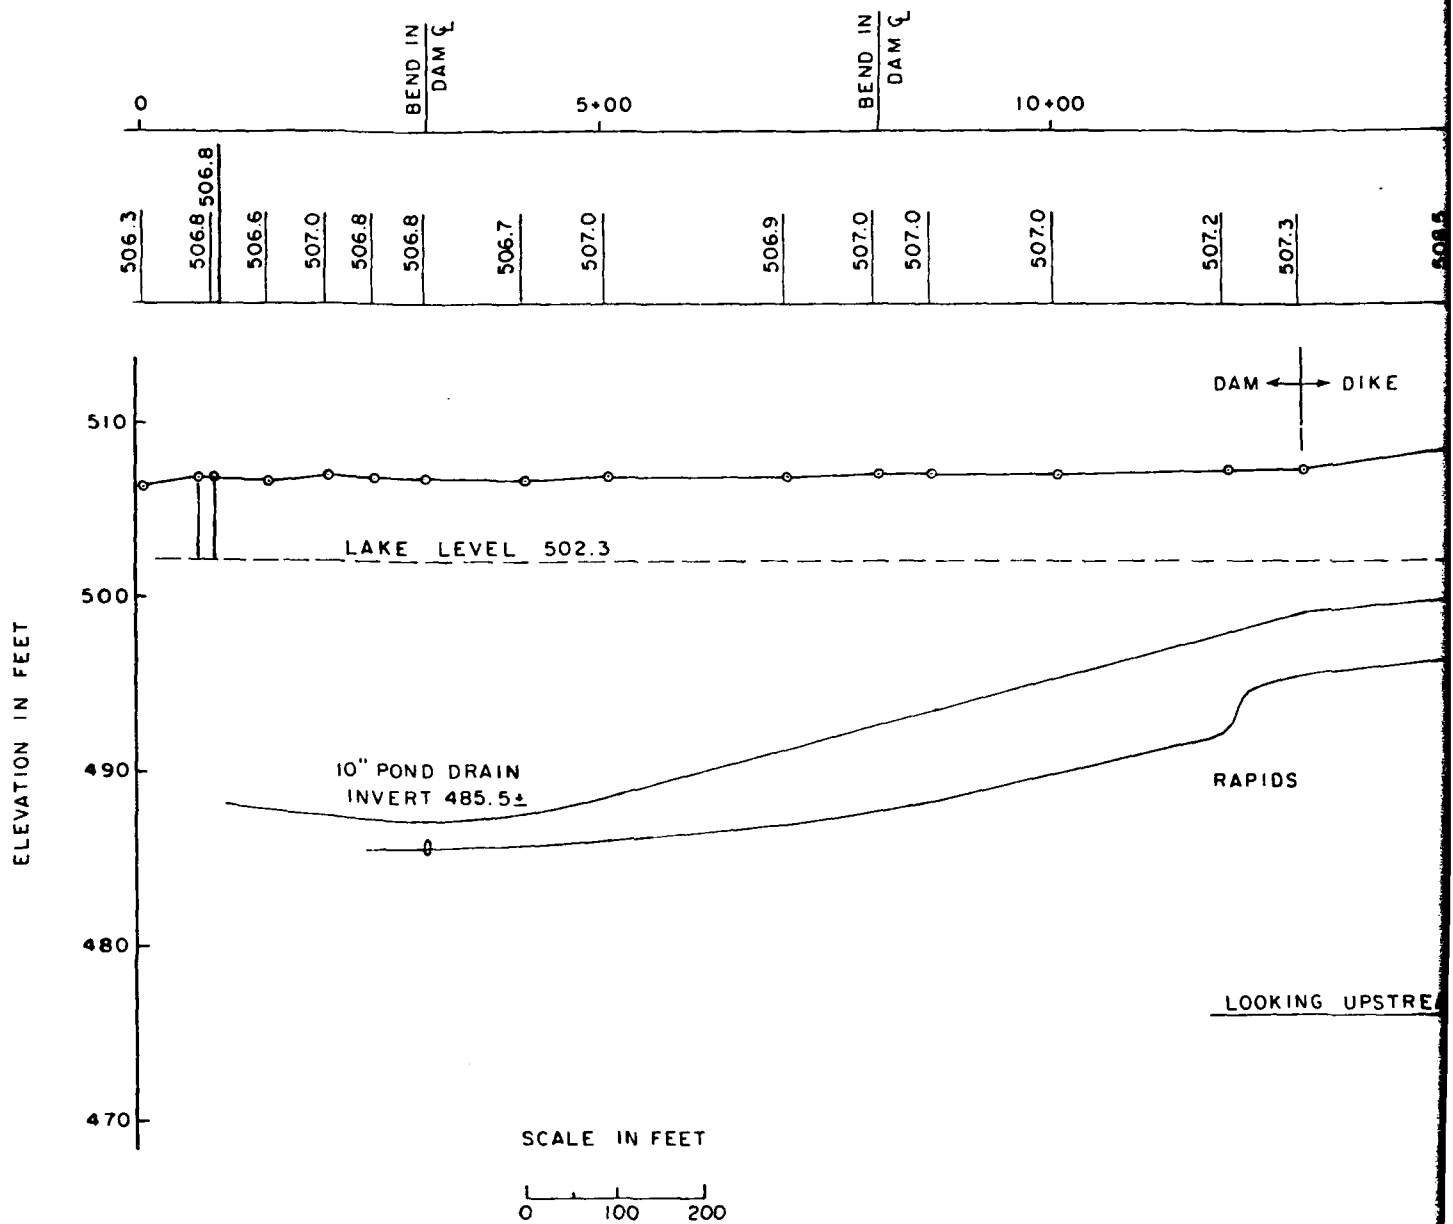
PLATE 3

b. Dam and Dike. The vertical alignment of the dam and dike was checked, and a profile is shown on Plate 3, Appendix E. No discernible horizontal displacement or bulging was noted along the crest. The crest itself is protected with grass. The grass is worn and the crest slightly rutted as a result of vehicle traffic to about Station 2+50. Shallow desiccation cracks were noted along the crest at the maximum section.

| VISUAL EXAMINATION OF | OBSERVATIONS | REMARKS OR RECOMMENDATIONS |
|---|---|---|
| VERTICAL AND HORIZONTAL ALIGNMENT OF THE CREST | <i>No discernable horizontal movement of the crest was observed. Vertical alignment was checked and is shown on Plate 3, Appendix E.</i> | |

NOTE: Crest profile shown on Plate 3, Appendix E.

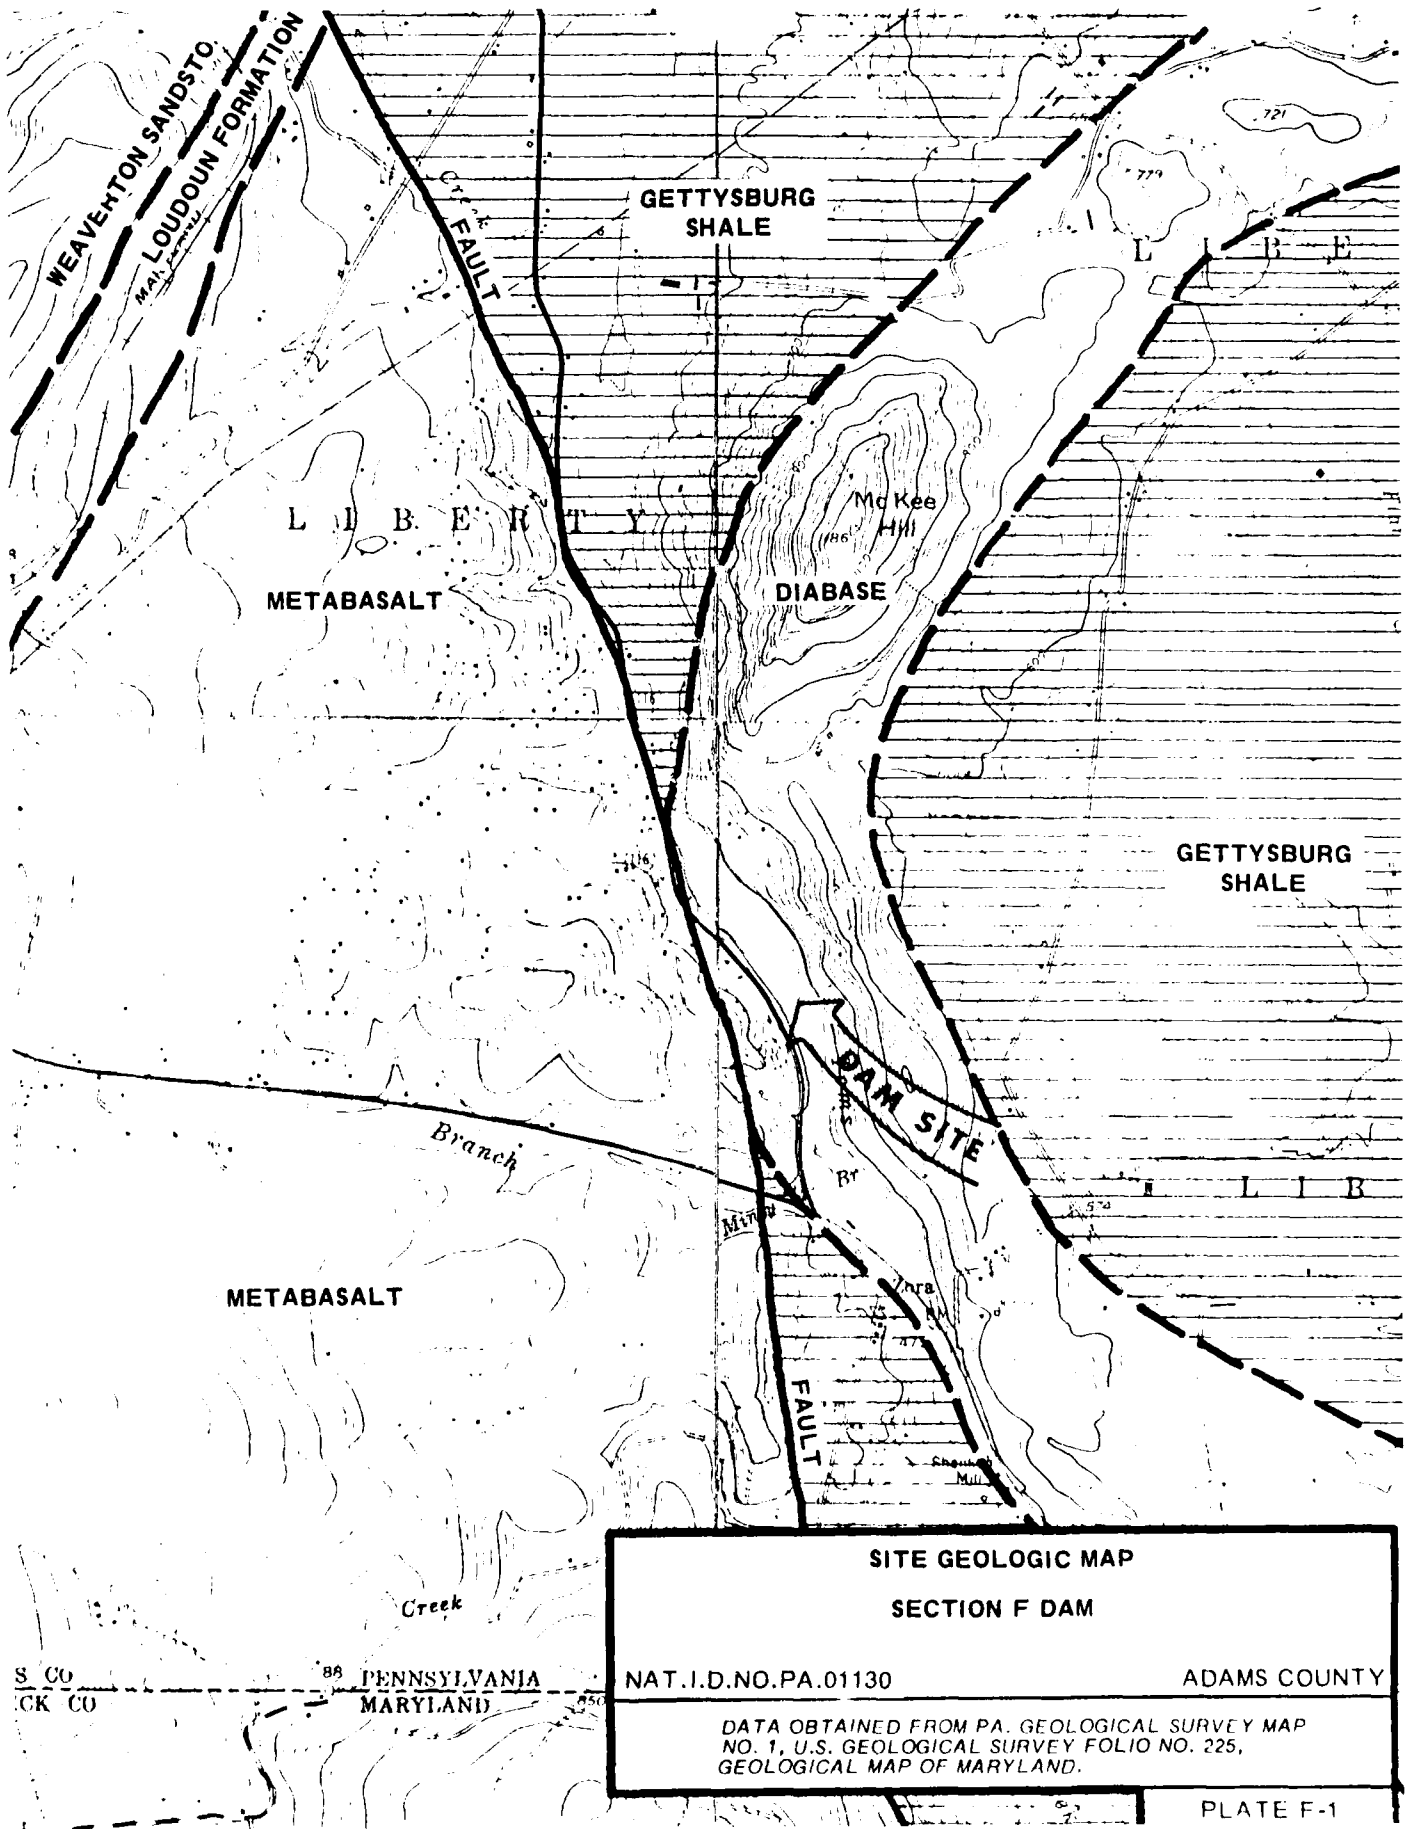
**SITE GEOLOGIC MAP**

Section F Dam is located at the boundary between the Triassic Lowland Section of the Piedmont Physiographic Province and the Blue Ridge Physiographic Province. As shown on Plate F-1, the dam is constructed upon Triassic age bedrock of igneous origin of the type diabase. The diabase has been intruded into the shale and sandstone units of the Gettysburg Formation. Rock exposures at the dam are limited to the diabase outcrop along the dam embankment in the vicinity of the rapids in Toms Creek. Here several high angle fracture sets occur, one striking northeast and the other northwest. The dipping bedrock and resistant nature of the diabase exposure has thrusts water flow in Toms Creek against the dam embankment toe and has resulted in localized intense erosion of soil adjacent to the embankment.
