**DELAWARE RIVER BASIN
OWL CREEK, SCHUYLKILL COUNTY**

**PENNSYLVANIA
NDS ID PA. 00674
DER ID 54-2**

LOWER OWL CREEK DAM

**PHASE I INSPECTION REPORT
NATIONAL DAM INSPECTION PROGRAM**

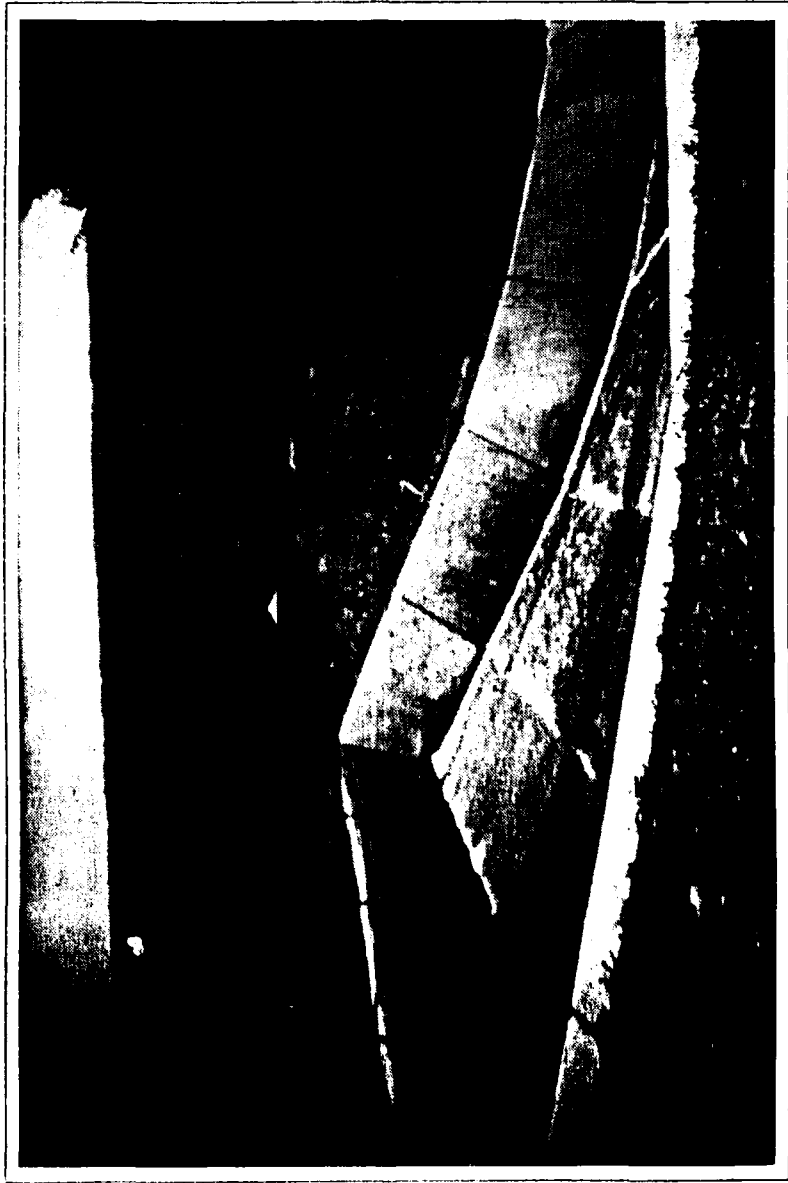
PHOTOGRAPH NO. 17

On the downstream face of the dam, there is evidence of previous minor erosion to the left of the spillway retaining wall and erosion under the steps along the side of the control house, as shown on Photograph 17. Additional minor erosion was noted in the vicinity of the chlorine tank installed on the downstream face of the dam to the right of the control house; see Photograph 16. A small minor gully was noted at the downstream toe near the left end. Two small burrows were also noted on the downstream slope. There was no evidence of seepage noted along the downstream toe of the dam. However, there were occasional patches of vegetation observed that are believed to be associated with damp to marshy soil conditions.

EROSION UNDER UPPER FLIGHT OF STEPS
SHOWN IN PHOTOGRAPH NO. 16.
