LAKE JAMIE DAM

NDI ID NO. PA-00778  
DER ID NO. 45-220

PHASE I INSPECTION REPORT  
NATIONAL DAM INSPECTION PROGRAM

JUNE 1980

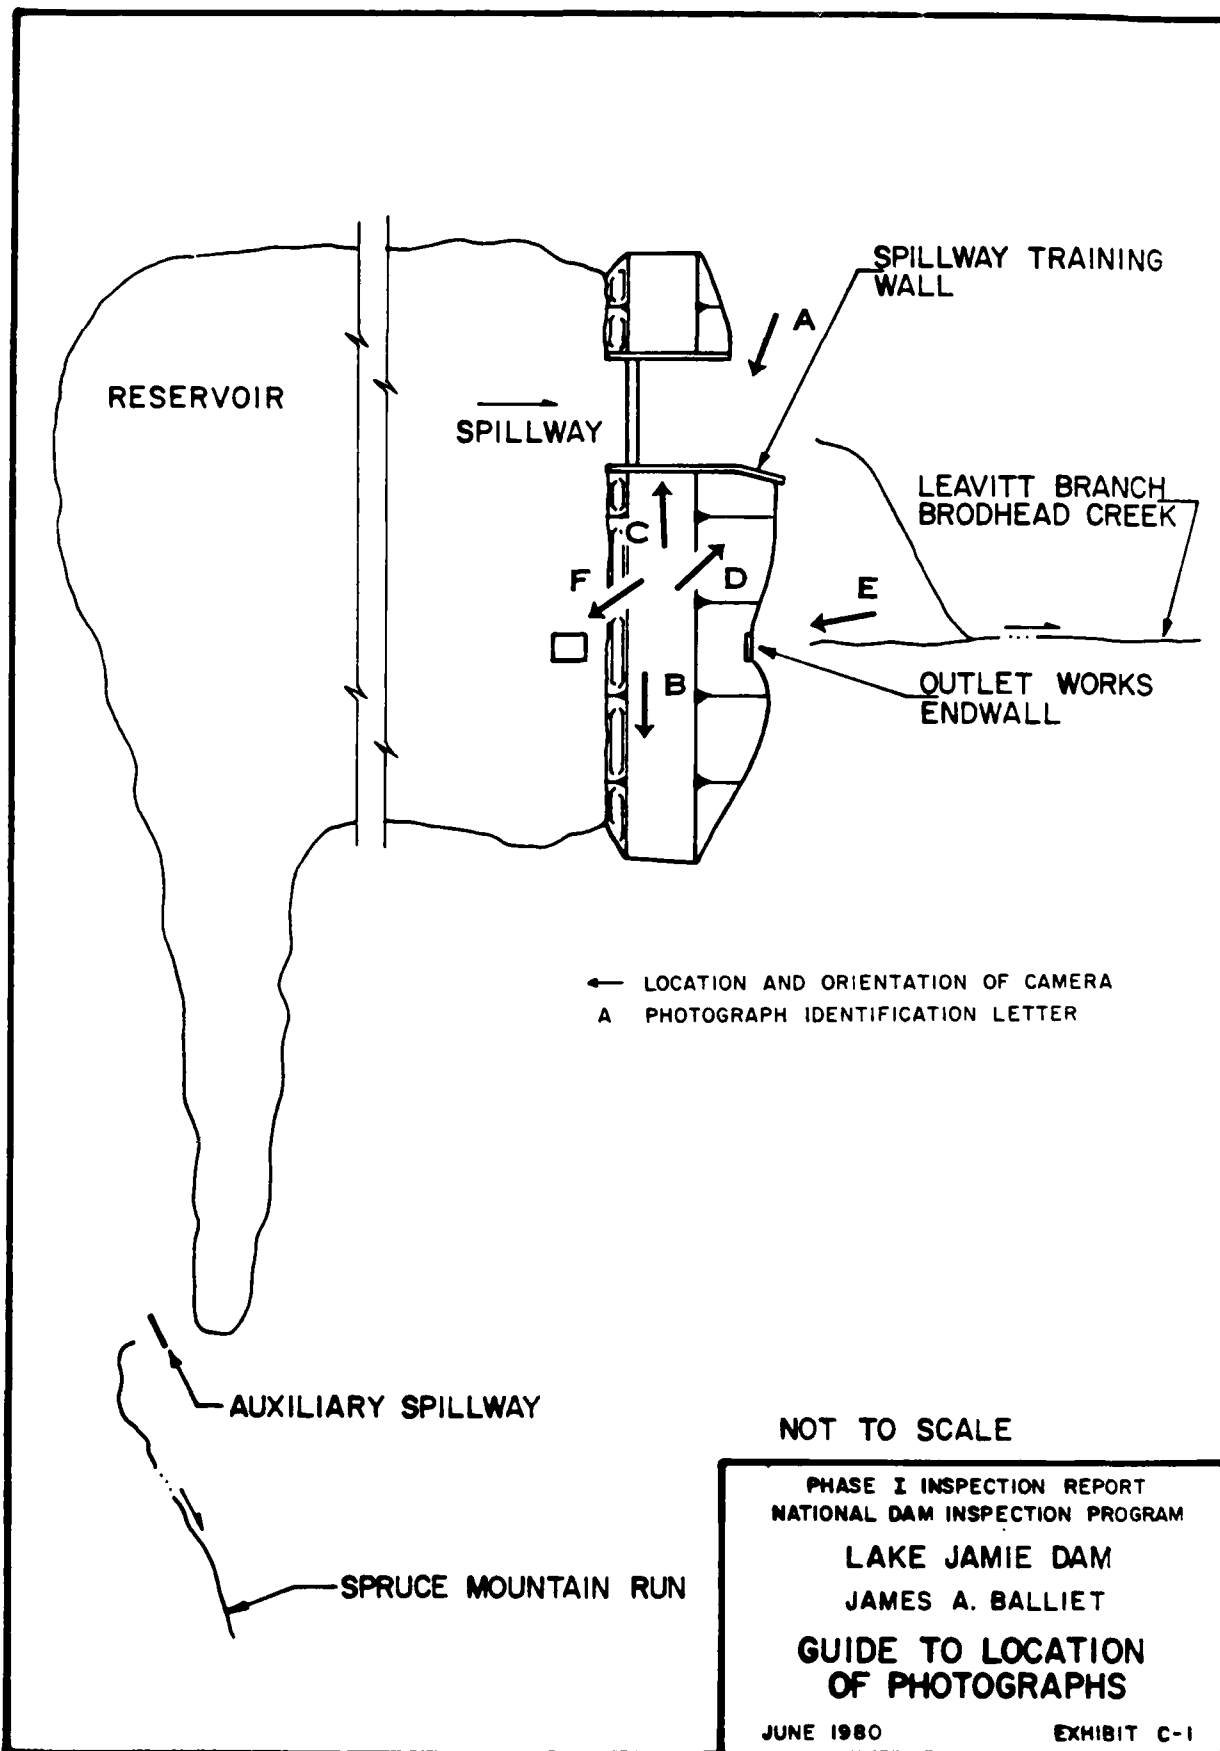
F. Outlet Works Intake Structure

The outlet works is in fair condition. Minor spalling was observed on the endwall and intake structure (Photographs E and F). The intake structure tilts toward the dam (Photograph F). The gate operating mechanism on the intake structure is rusty. The Owner stated that it has not been operated since the dam was constructed; he reported that he had been instructed shortly after the dam was built by a representative of the Commonwealth to never operate the gate. He felt that the intake structure was partially silted, which would hinder the gate operation. Therefore, he declined to attempt to operate it for the inspection team.
