BROWN'S LAKE DAM

NDI ID NO. PA-00630
DER ID NO. 45-108

PHASE I INSPECTION REPORT
NATIONAL DAM INSPECTION PROGRAM

JUNE 1980

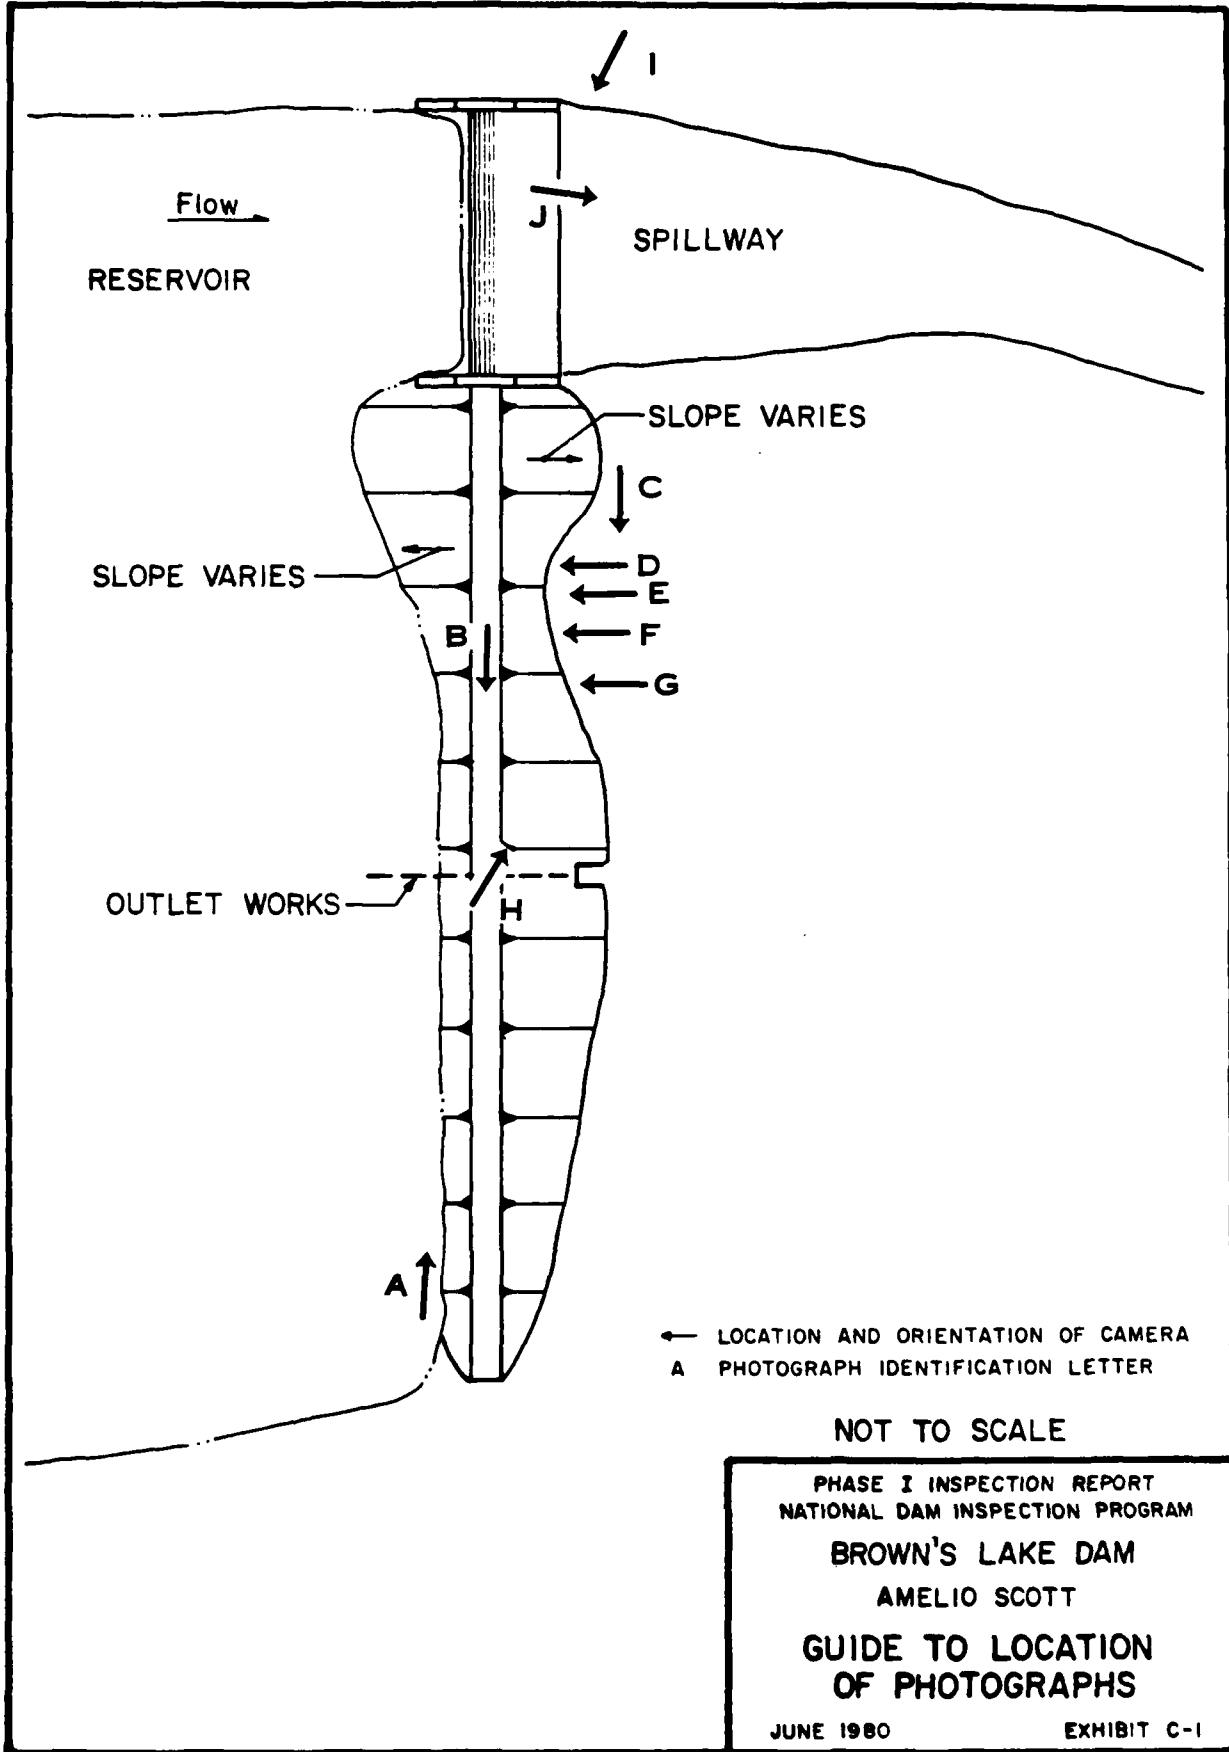
c. Appurtenant Structures. The spillway is in fair condition (Photograph I). The left abutment wall has a slight, inward tilt, two cracks, and minor spalling at its base adjacent to the spillway weir. The spillway weir is a low, triangular, concrete weir. A concrete apron extends downstream from the weir for a distance of about 10 feet. Some debris was on the spillway on the day of the inspection. The weir has two areas where the concrete has cracked and spalled. Both areas are near the right end of the weir. The right abutment wall has trees and brush growing behind it. The spillway outlet channel is an excavated earthen channel (Photograph J). It appears that the channel has been subject to retrogressive erosion.

J. Spillway Outlet Channel.
