PASSAIC RIVER BASIN  
BELCHER'S CREEK, PASSAIC COUNTY  
NEW JERSEY

**PINECLIFF LAKE DAM**  
**N J 00012**

**PHASE 1 INSPECTION REPORT**  
**NATIONAL DAM SAFETY PROGRAM**

**FEBRUARY 1980**  
**APPROVED FOR PUBLIC RELEASE;**

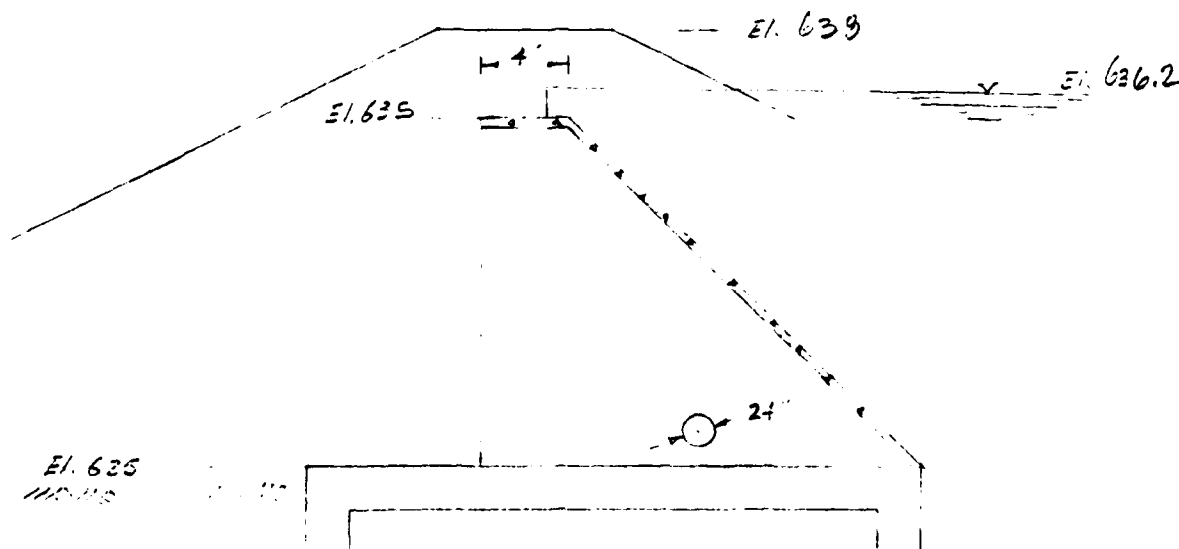
The opening between the spillway and boulders is small (approx. 0.1' x 18') and is usually plugged by debris, hence the area is not considered to be effective.

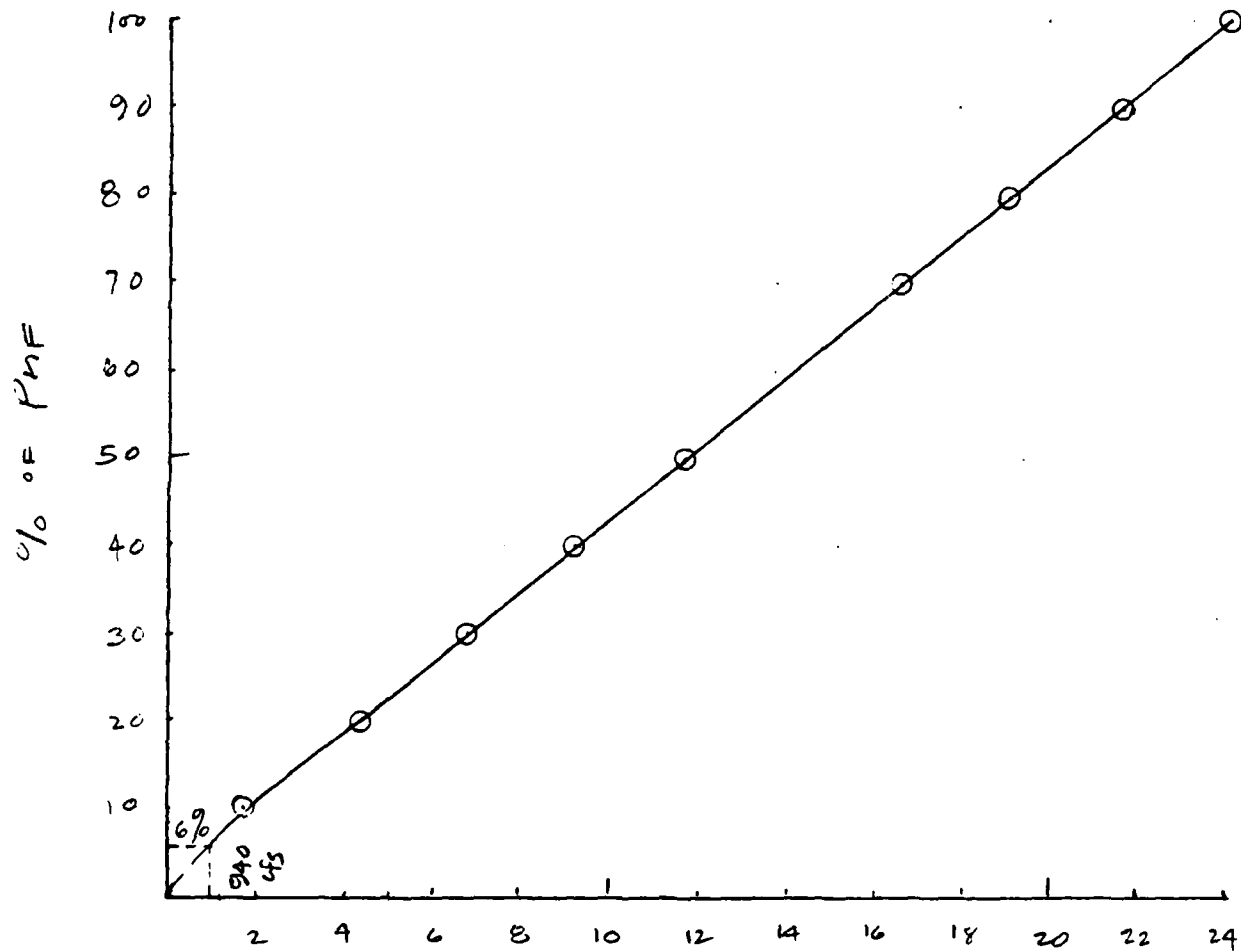
# Overtopping Potential

Overtopping of Dam occurs at ele 339.0  
with  $Q = 940 \text{ cfs}$  ( $\sim 6\% \text{ PMF}$ )
