TECHNICAL REPORT HL-80-12

## UTILIZATION OF FILTER FABRIC FOR STREAMBANK PROTECTION APPLICATIONS

Malcolm P. Keown, Elba A. Dardeau, Jr.

Hydraulics Laboratory  
U. S. Army Engineer Waterways Experiment Station  
P. O. Box 631, Vicksburg, Miss. 39180

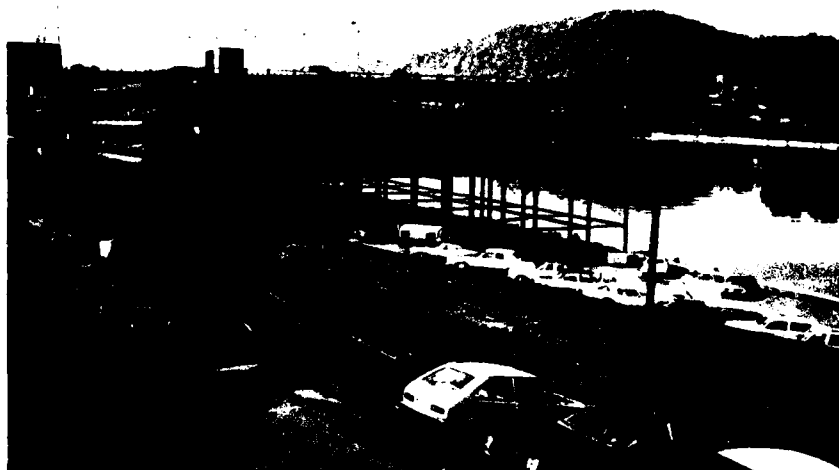
Figure 27. Wharf Parking Garage, Wheeling, W. Va.  
(22 June 1978)

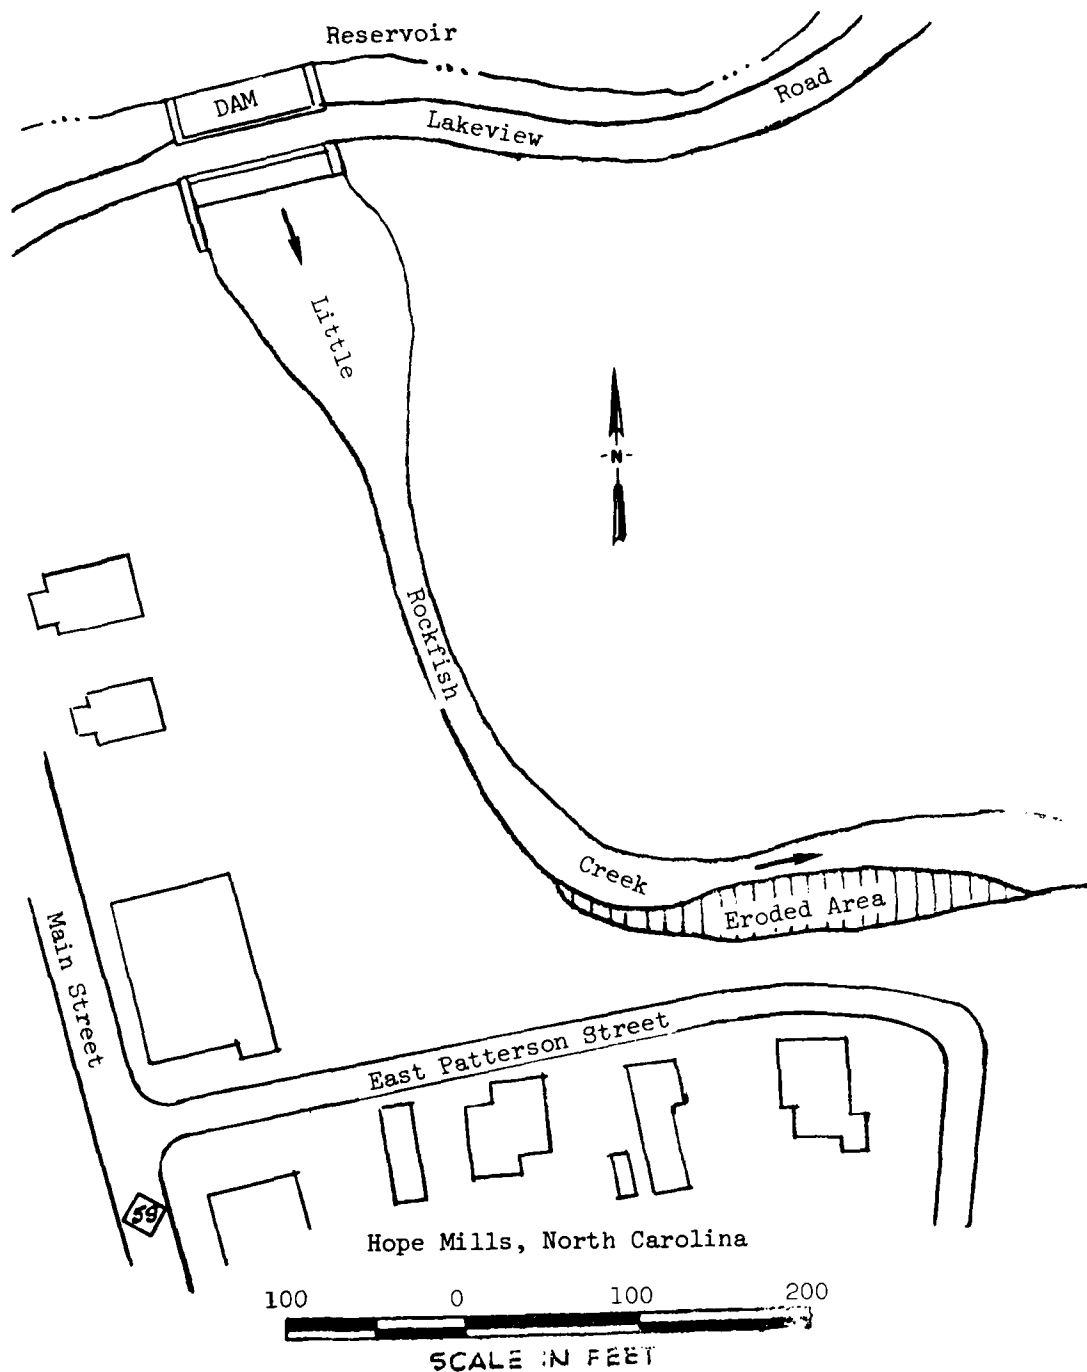
Figure 44. Location of eroded area on right bank of Little Rockfish Creek at Hope Mills, N. C. (adapted from Little Rockfish Creek, Hope Mills, N. C., General Map and Site Plan, Drawing No. RC 102-02-28, Sheet 1 of 2, SAW, 19 Sep 1975)

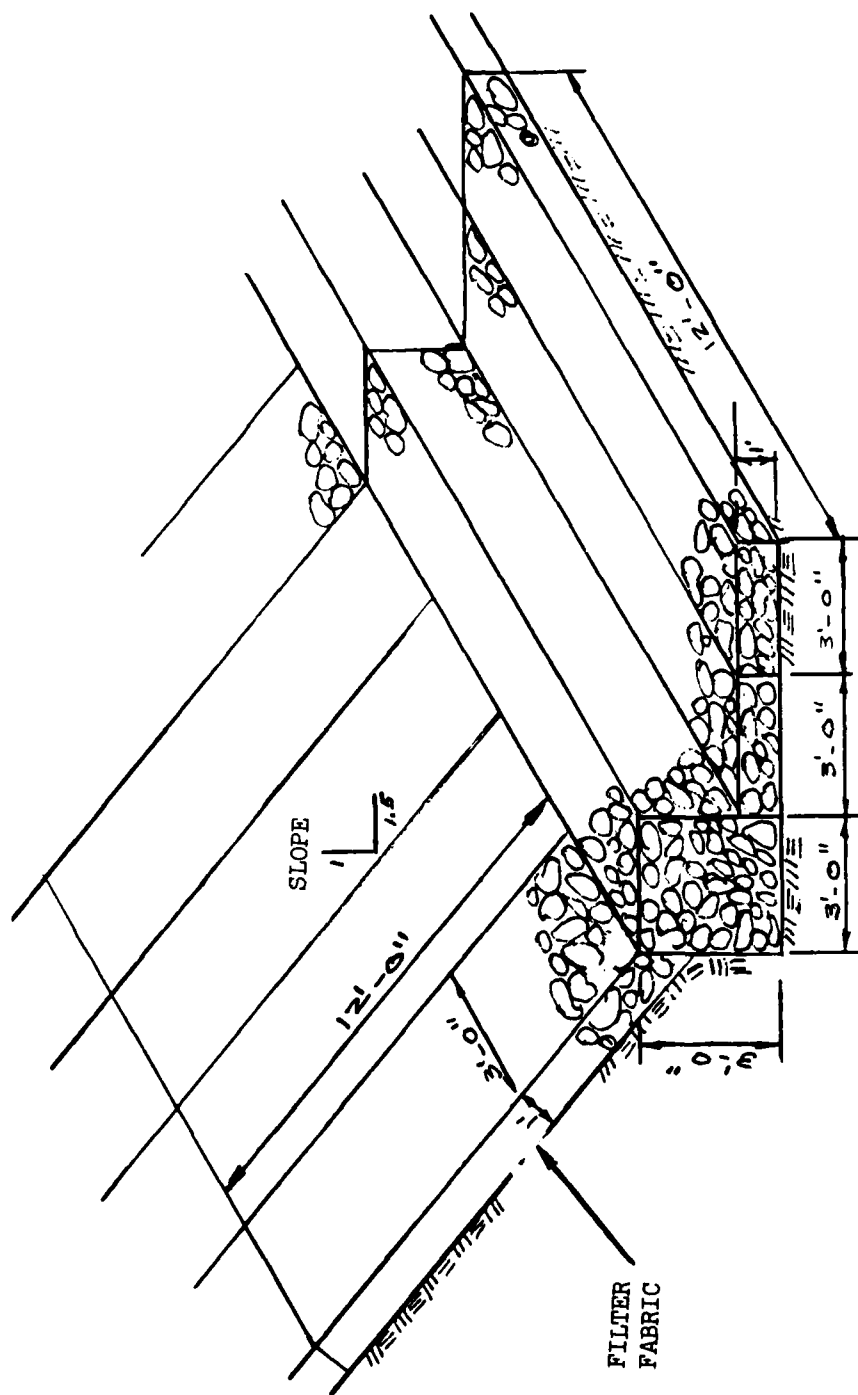
Figure 51. Typical gabion placement (adapted from Little Rockfish Creek, Hope Mills, N. C., Slope Protection, Cross Sections, Drawing No. RC 102-02-28, Sheet 2 of 2, SAW, 19 Sep 1975)

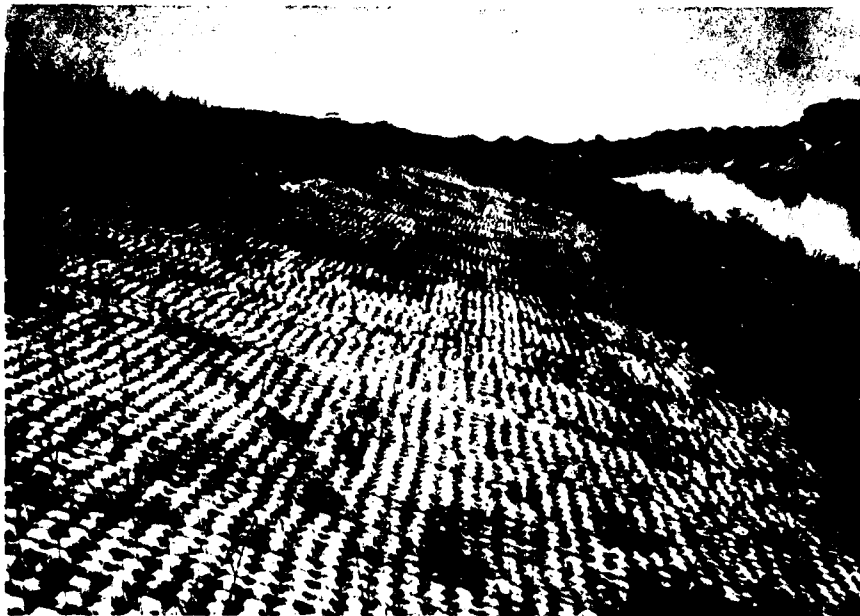
Figure 58. General downstream view of cellular block section of Morameal Revetment, La. (9 May 1978)

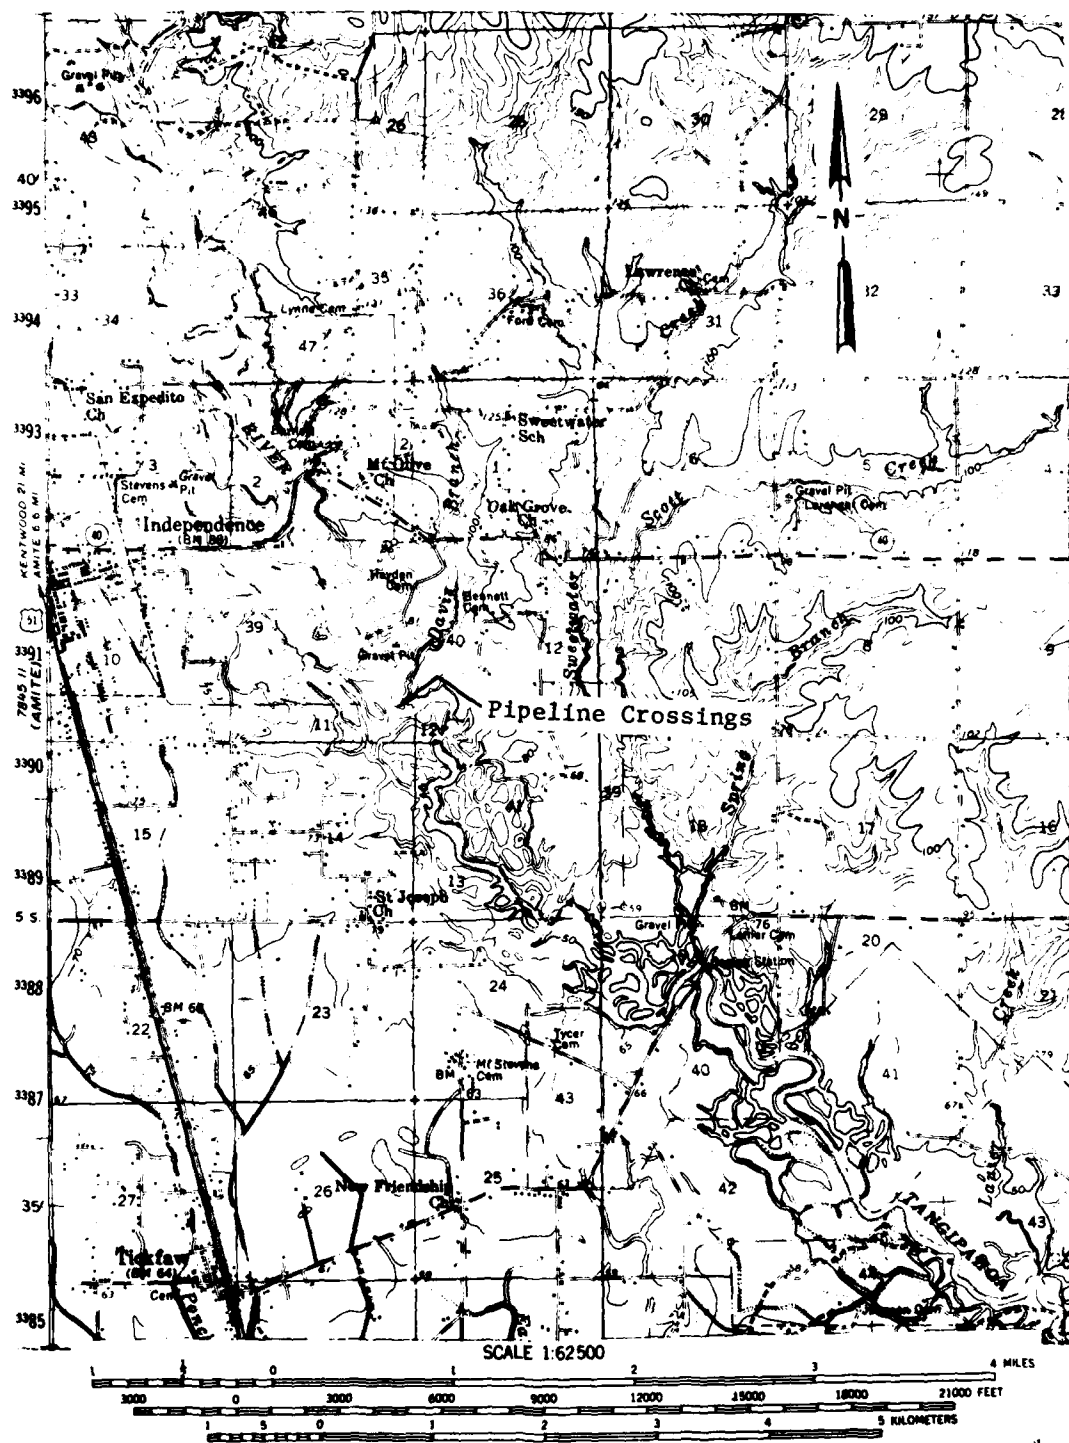
additional gas reserves that had become available since 1953. In 1969, a 30-in. loop pipeline was laid parallel to the existing 20-in. line. Both of these pipelines cross the Tangipahoa River near Independence in Tangipahoa Parish, La., at mile 38.9 (about 50 miles northwest of New Orleans; Figure 62).

Figure 62. Location of Southern Natural Gas Company's Pipeline Crossings on the Tangipahoa River near Independence, La. (Source: USGS 1:62,500 topographic quadrangle map for Hammond, La., 1959)
