DOVERSPIKE NO. 1 DAM

NDI I.D. PA-01131

PHASE I INSPECTION REPORT  
NATIONAL DAM INSPECTION PROGRAM

DEPARTMENT OF THE ARMY  
BALTIMORE DISTRICT, CORPS OF ENGINEERS  
BALTIMORE, MARYLAND 21203

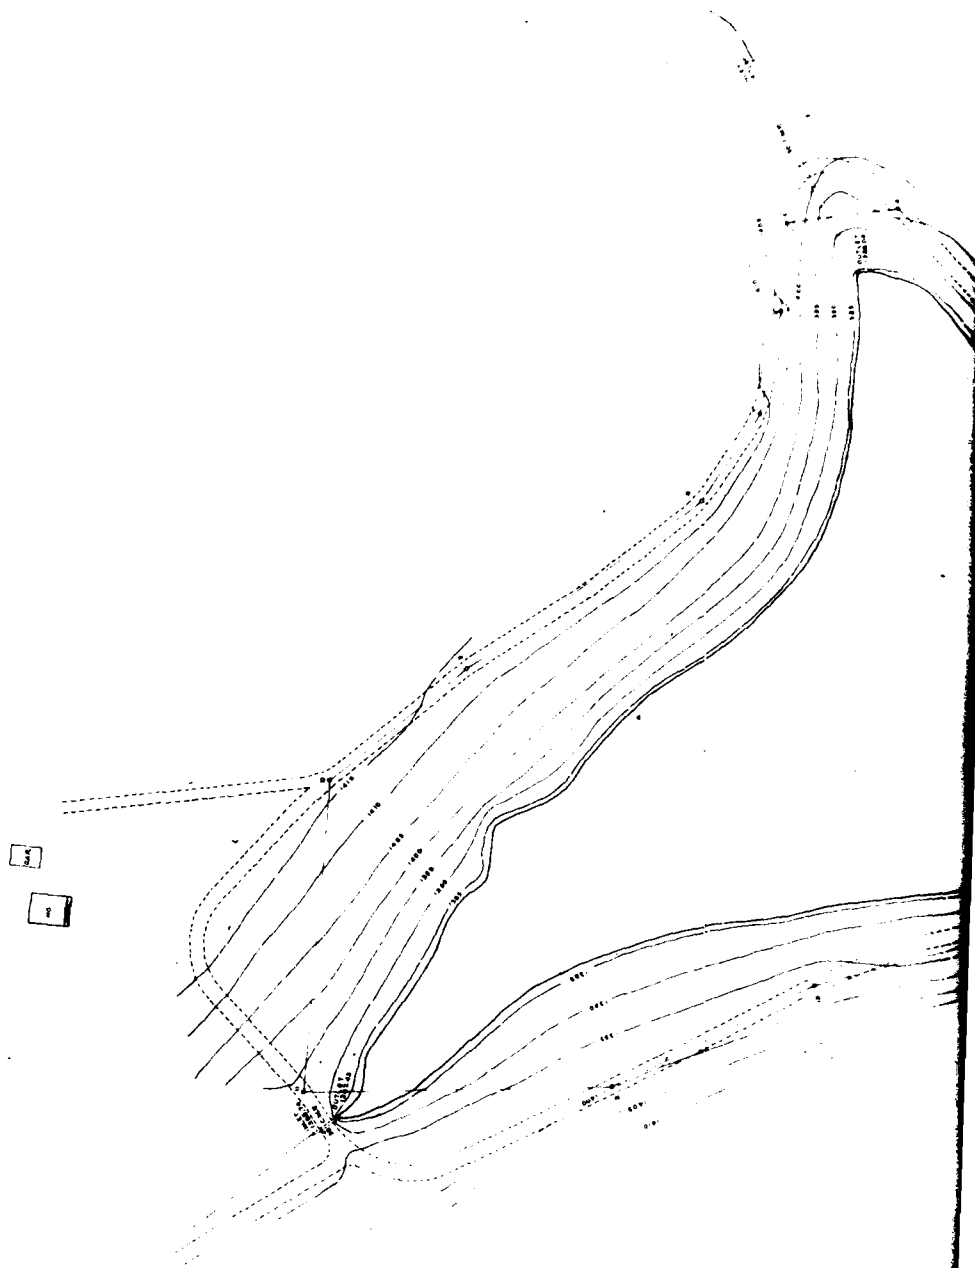
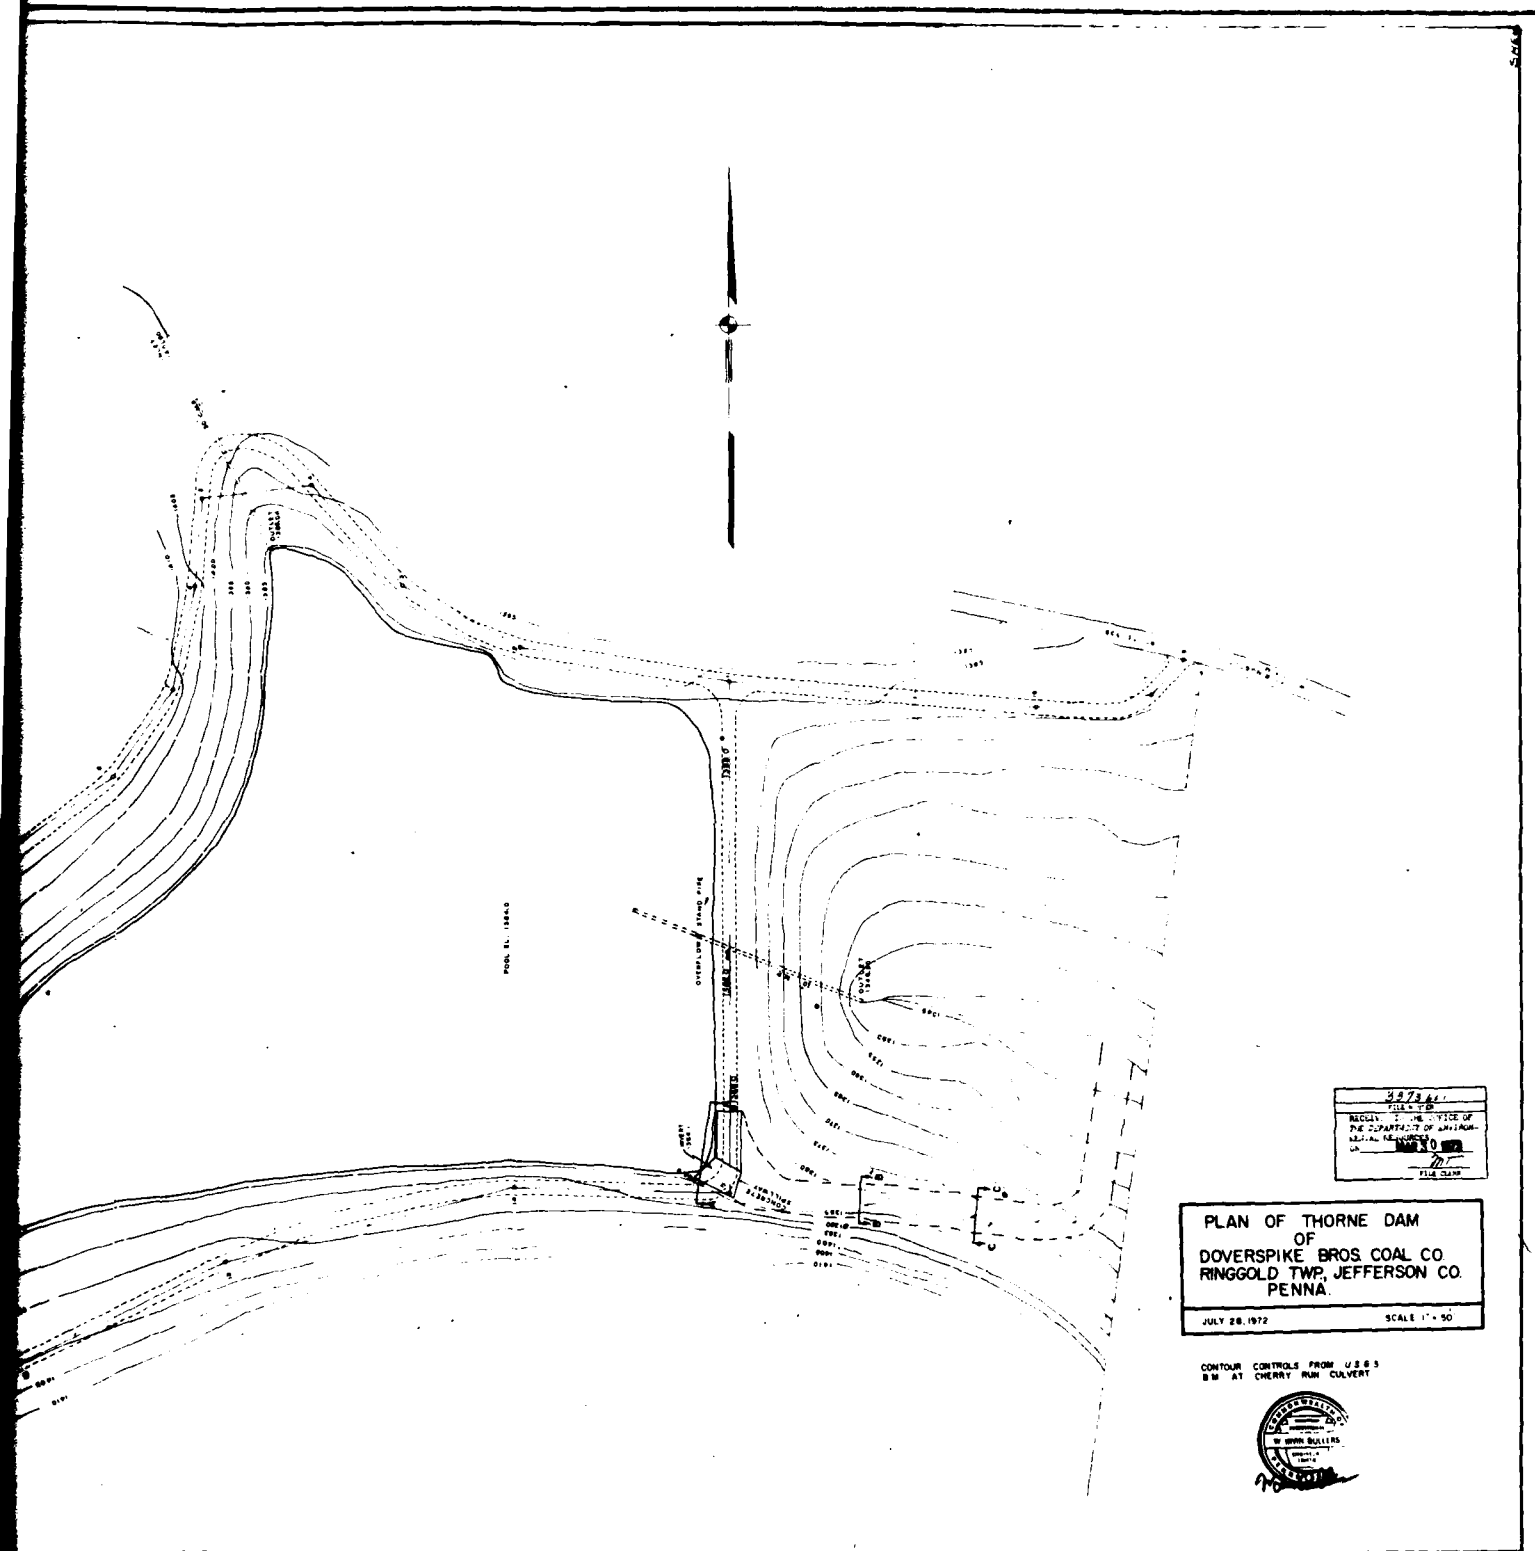
PLATE 2

(1) Embankment. Plate 2 illustrates the plan of the embankment and the appurtenant structures. As shown in Plate 3, the dam consists of a zoned earth embankment with a central impervious section with rock-fill zones upstream and downstream. The impervious section is shown to extend into a cutoff trench along the axis of the dam with a base width of 40 feet. The material of the impervious zone was described as compacted clay and shale. The available information indicates that the design of the dam was based on experience. However, an engineering investigation consisting of a subsurface investigation, materials testing, and seepage and stability analyses was conducted after the completion of the dam.

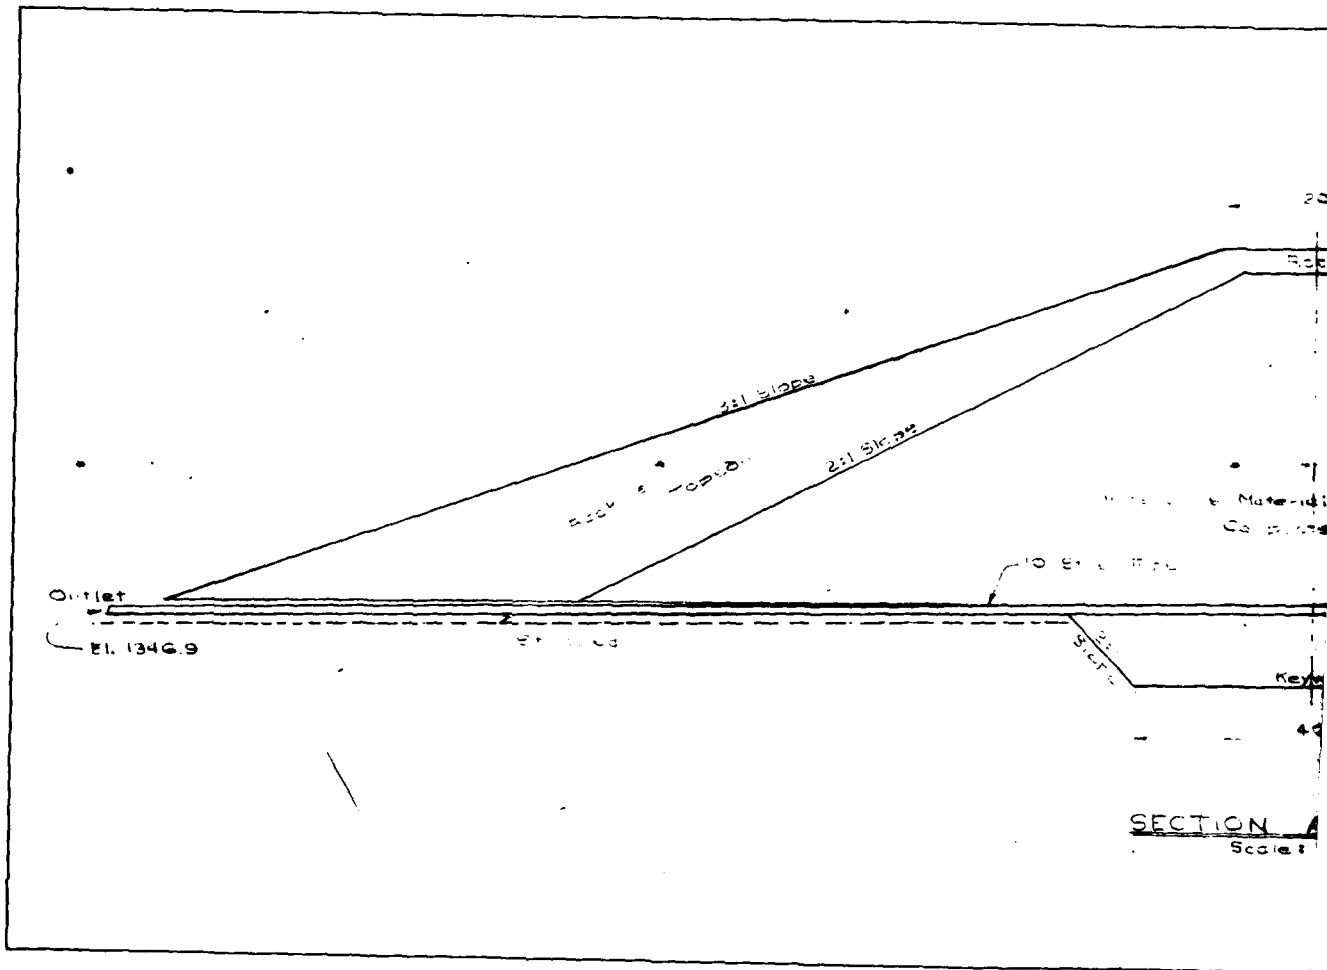
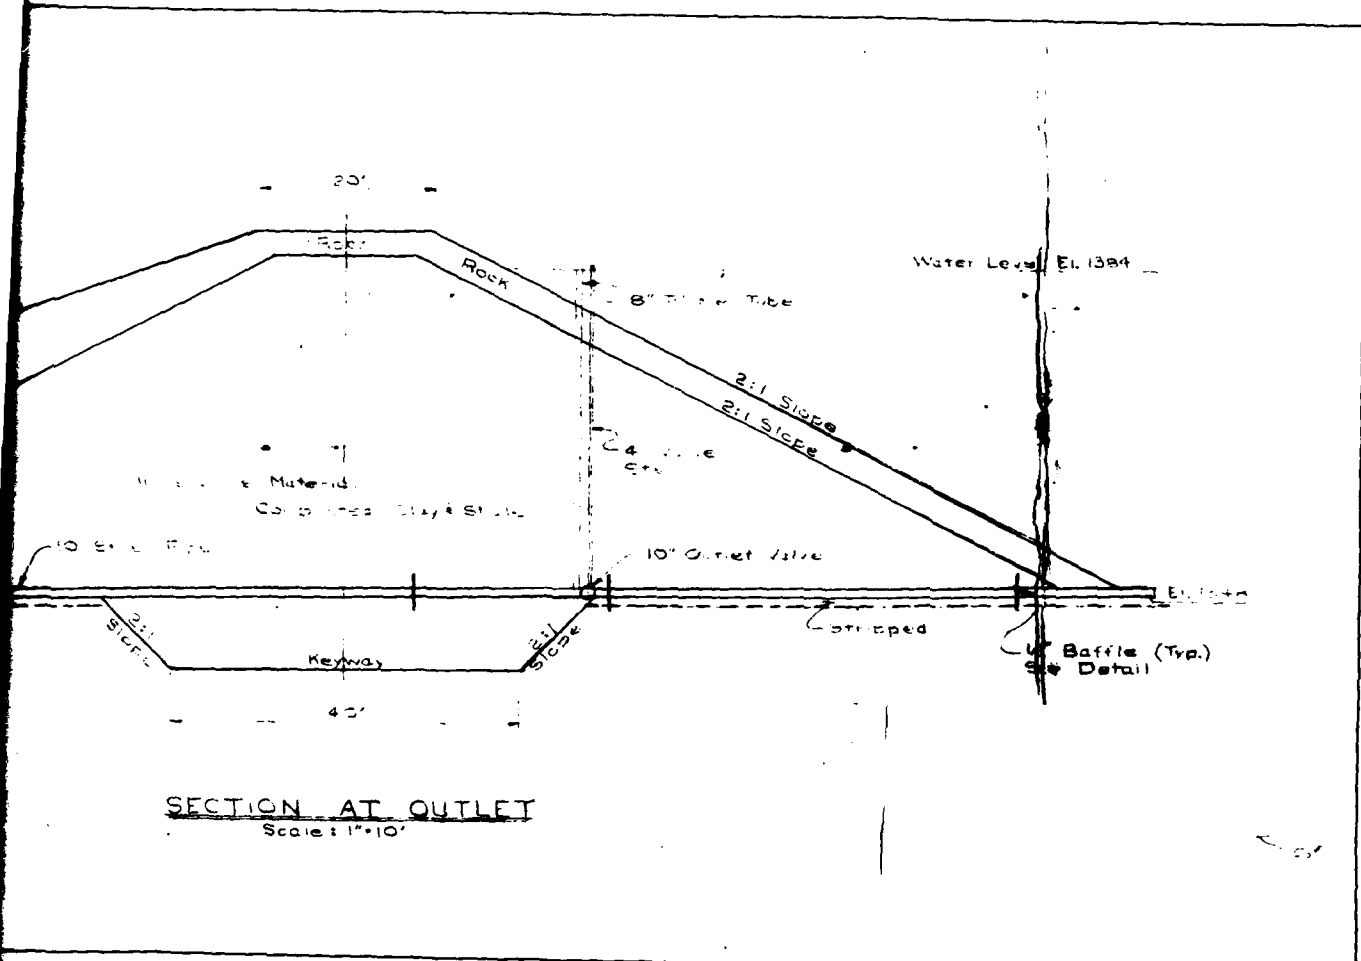
PLATE 3

(2) Appurtenant Structures. The appurtenant structures consist of a riser pipe primary spillway (combined with outlet works) and an overflow emergency spillway located near the right abutment. The typical cross section of the primary spillway and the outlet works are shown in Plate 3. The primary spillway includes an 8-inch pipe extending from the outlet pipe to the normal pool elevation. Flow entering into the riser pipe is discharged through the outlet pipe. Flow through the outlet pipe is controlled by a gate immediately upstream of the junction of the riser pipe and the outlet pipe. The stem of the outlet pipe control valve was extended through a pipe to above the normal pool elevation. The outlet pipe is shown to be equipped with three antiseepage collars located beneath the upstream slope of the embankment. The emergency spillway
