PENNSYLVANIA  
NDI No. PA 00908  
PENN DER No. 63-78

# REFUSE SETTLING BASIN

UNITED STATES STEEL CORPORATION  
RAW MATERIALS DIVISION

PHASE I INSPECTION REPORT  
NATIONAL DAM INSPECTION PROGRAM

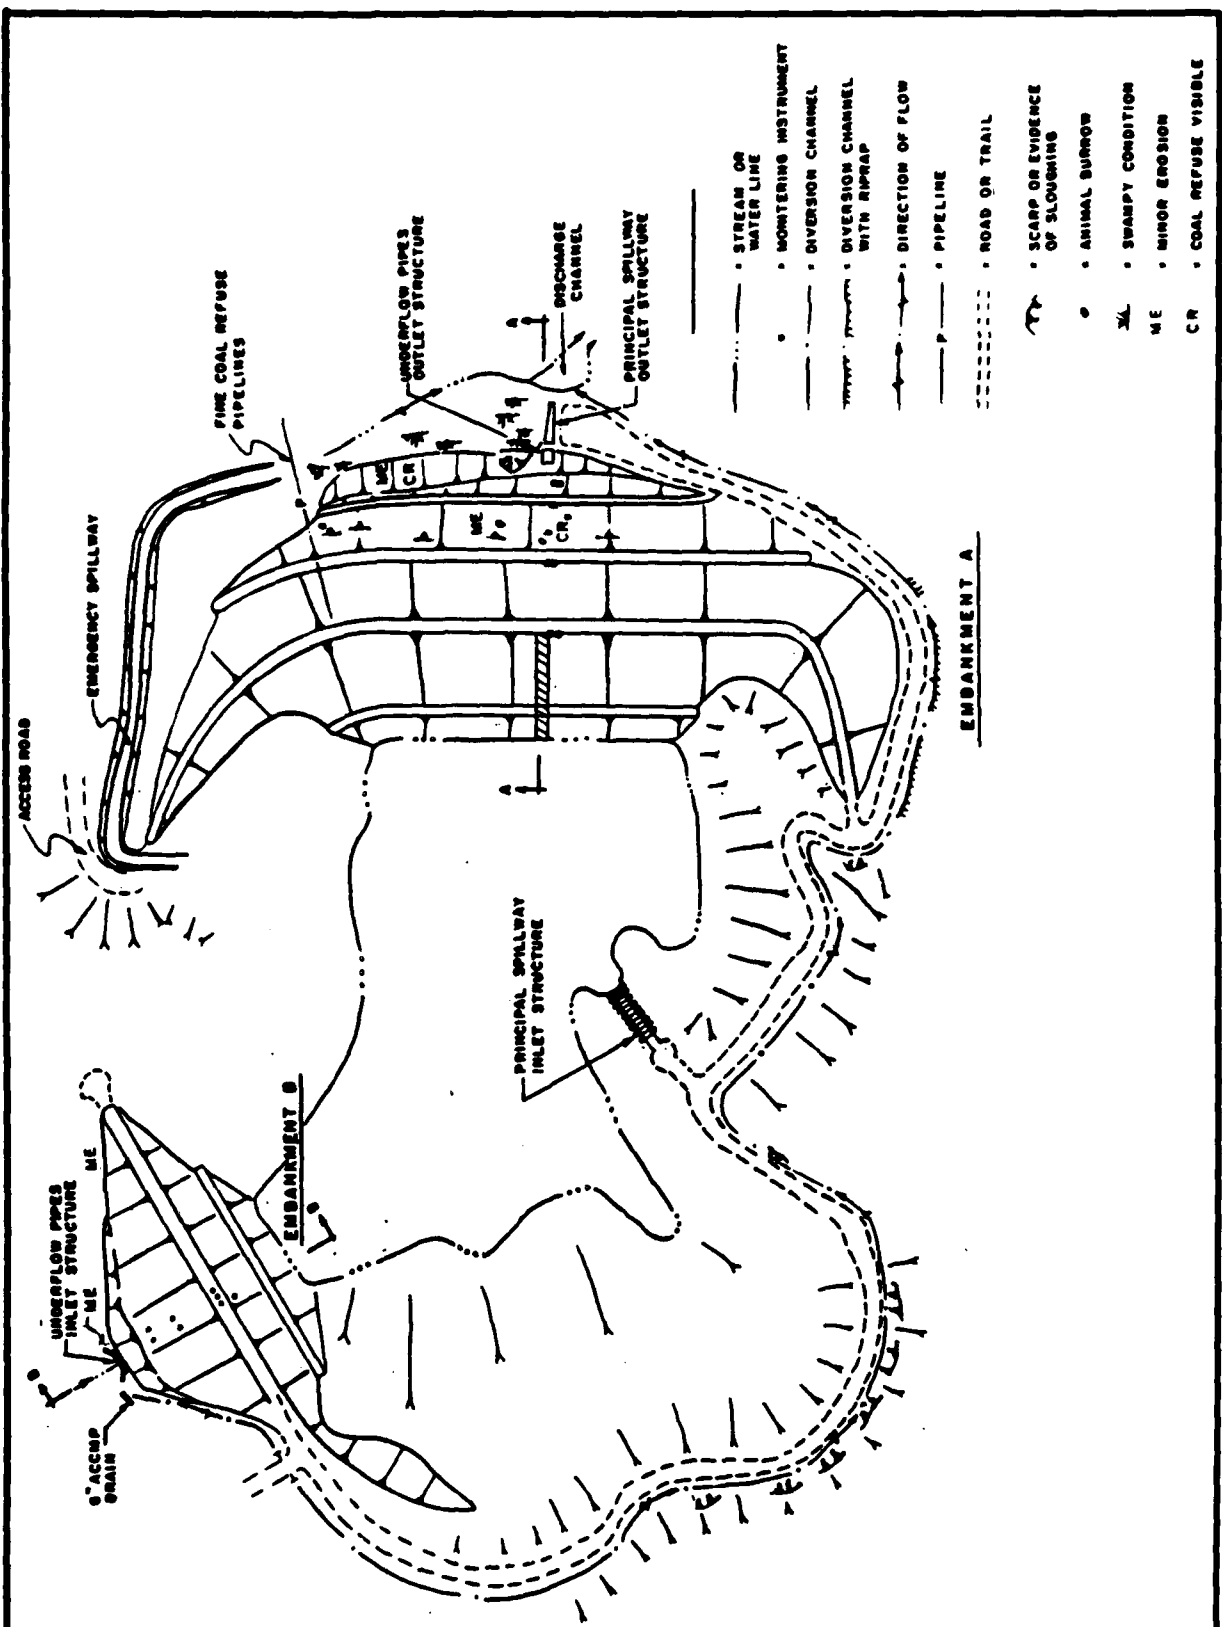
FIELD PLAN

<u>VISUAL EXAMINATION OF</u>	<u>OBSERVATIONS</u>	<u>REMARKS OR RECOMMENDATIONS</u>
<u>SLOPES</u>	<p>The reservoir slopes were observed to be generally flat to moderate and were entirely grassed both above and below the embankment crest elevation. Minor surficial sloughing was observed at several locations on steeper slopes both below and above the embankment crest elevation.</p>	
<u>INLET STREAM</u>	<p>There is no natural inlet stream to reservoir and upper watershed flows are diverted away from the impoundment by a diversion channel.</p>	
<u>SEDIMENTATION</u>	<p>Fine coal refuse (slurry) is transported to the impoundment by two steel pipes that discharge onto the upstream slope of Embankment A near the center of the dam.</p>	
<u>WATERSHED</u>	<p>The impoundment area is a disposal facility for fine coal refuse (slurry) from the Maple Creek Mine preparation plant. Consequently, considerable sediment has been impounded particularly in the area below the outfall for the slurry pipelines.</p>
