Name Of Dam: CRAB ORCHARD CREEK

Inventory Number: VA. 02102

## PHASE I INSPECTION REPORT NATIONAL DAM SAFETY PROGRAM

JULY 1980

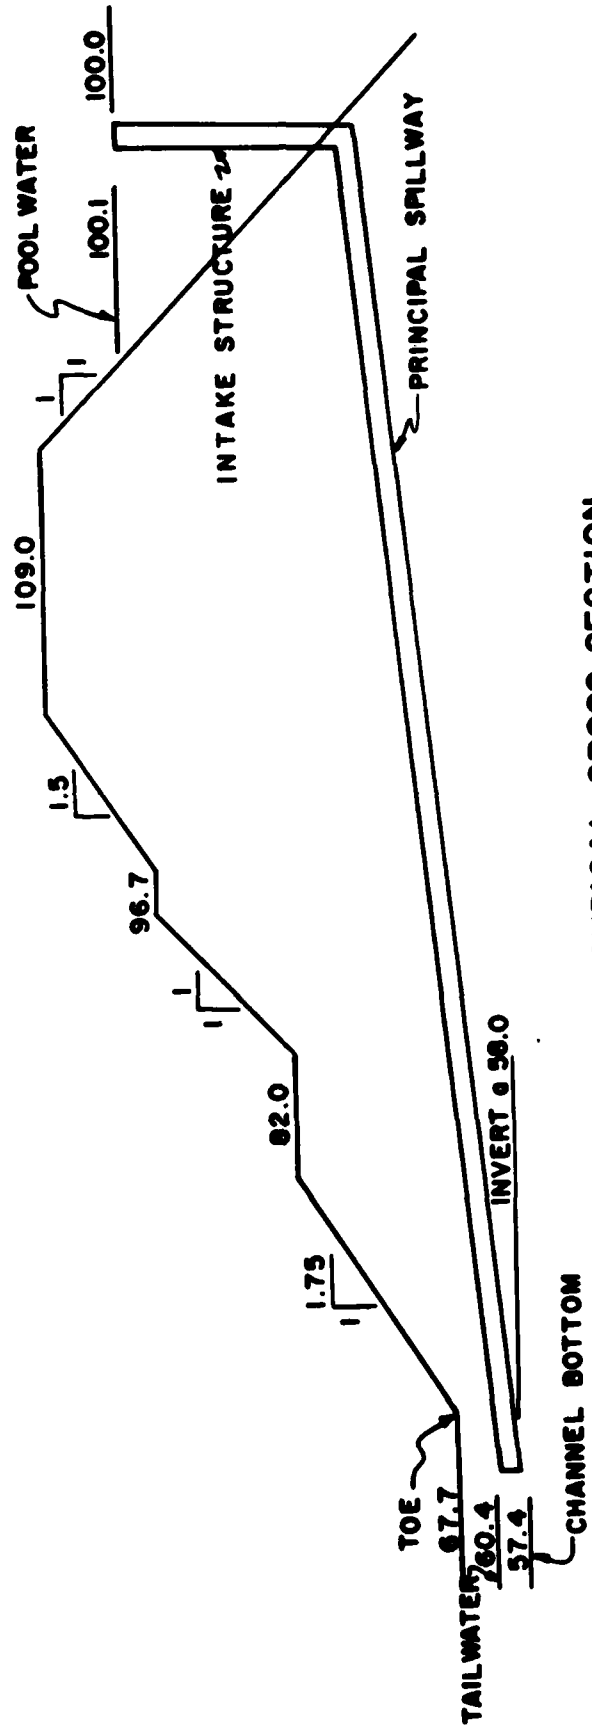
TYPICAL CROSS SECTION

- NOTE :
- 1) TOP OF DROP INLET USED AS TBM = 100.0
  - 2) CREST ELEVATION RANGES FROM 110 TO 108.
