LAKE WHETSTONE  
NDI ID NO. MD-53

PHASE I INSPECTION REPORT

NATIONAL DAM INSPECTION PROGRAM

July 1980

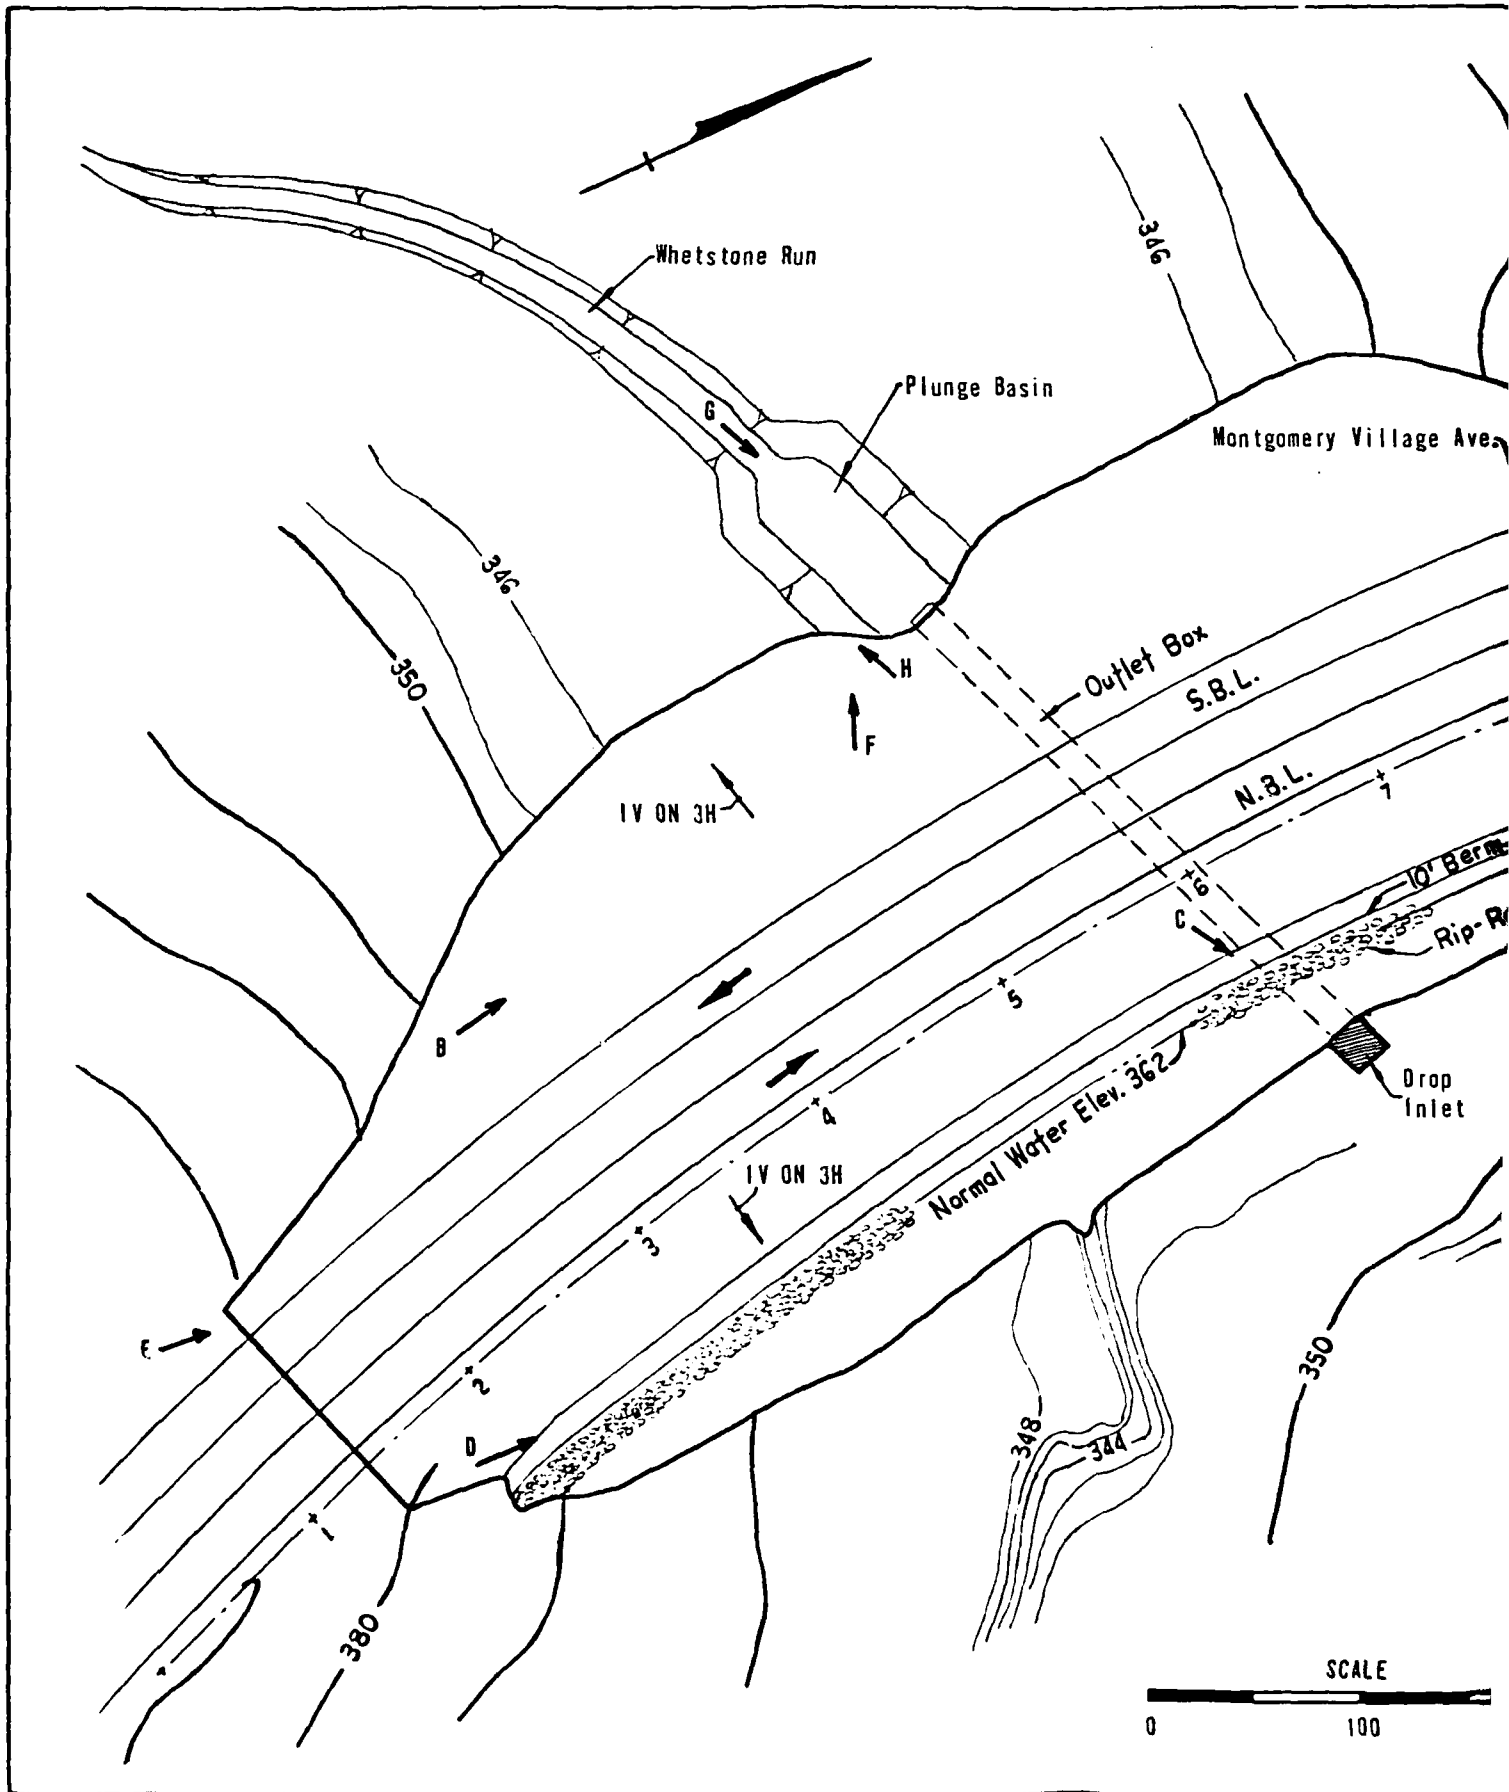
H. Erosion behind left wingwall of outlet structure

- 4.3 Maintenance and Operating Facilities. The maintenance of the operating facilities is considered fair. The north headwall and south wingwall of the outlet structure obviously need some repairs. No scheduled formal inspection program for the facilities exists.
