NEW YORK STATE DEPT OF ENVIRONMENTAL CONSERVATION ALBANY F/G 13/13  
NATIONAL DAM SAFETY PROGRAM. TIVOLI LAKE DAM (INVENTORY NUMBER --ETC--)  
SEP 80 E O'BRIEN DACW51-79-C-0001

| REPORT DOCUMENTATION PAGE | | READ INSTRUCTIONS<br>BEFORE COMPLETING FORM |
|---|---|---|
| Phase I Inspection Report<br>Tivoli Lake Dam<br>Hudson River Basin, Rockland County, New York<br>Inventory No. 052 | | 5. TYPE OF REPORT & PERIOD COVERED<br>Phase I Inspection Report<br>National Dam Safety Program |

PHASE I INSPECTION REPORT  
NATIONAL DAM SAFETY PROGRAM  
TIVOLI LAKE DAM  
I.D. NO. N.Y. 52  
D.E.C. NO. 306  
HUDSON RIVER BASIN  
ROCKLAND COUNTY, NEW YORK

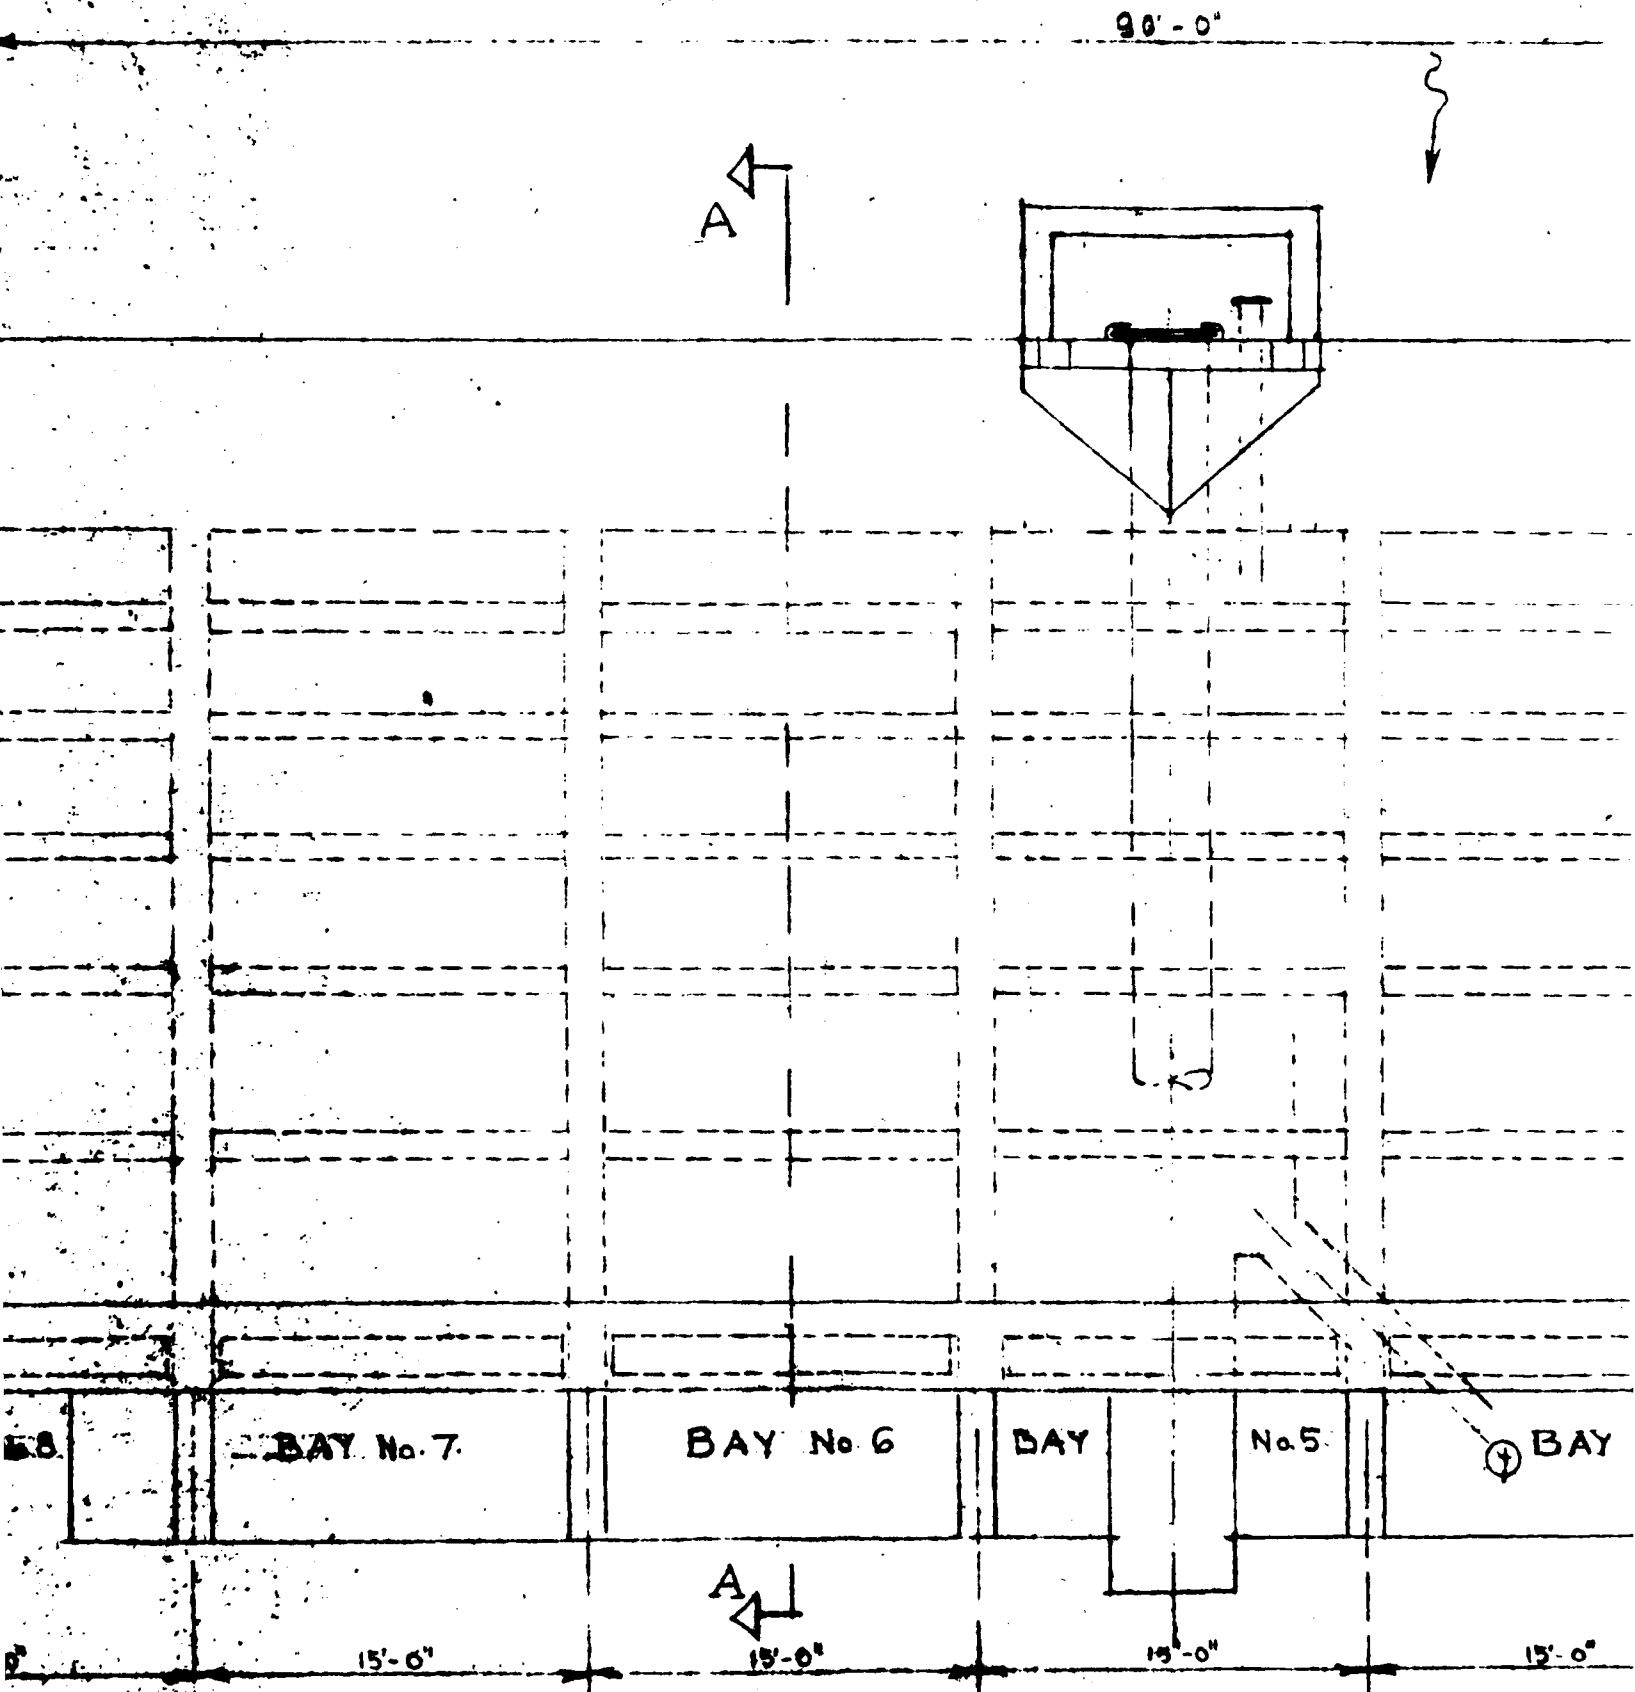
PLAN OF CRANBERRY DAM  
(FORMER TIVOLI DAM)

LOCATION OF NECESSARY CONCRETE REPAIRS.

THE INDICATED SPOTS OF NECESSARY REPAIRS DO NOT SHOW ALL THE LOCATIONS WHERE REHABILITATION MUST BE MADE. CONTRACTOR SHALL EXECUTE ALL REPAIRS WITHIN THE QUANTITIES OF THE BID LIST WHICH HE WILL FIND ON THE DAM
