LAKE SUZANNE

ROCKLAND COUNTY, NEW YORK
INVENTORY NO. N.Y. 760

PHASE I INSPECTION REPORT
NATIONAL DAM SAFETY PROGRAM

AUGUST 1980

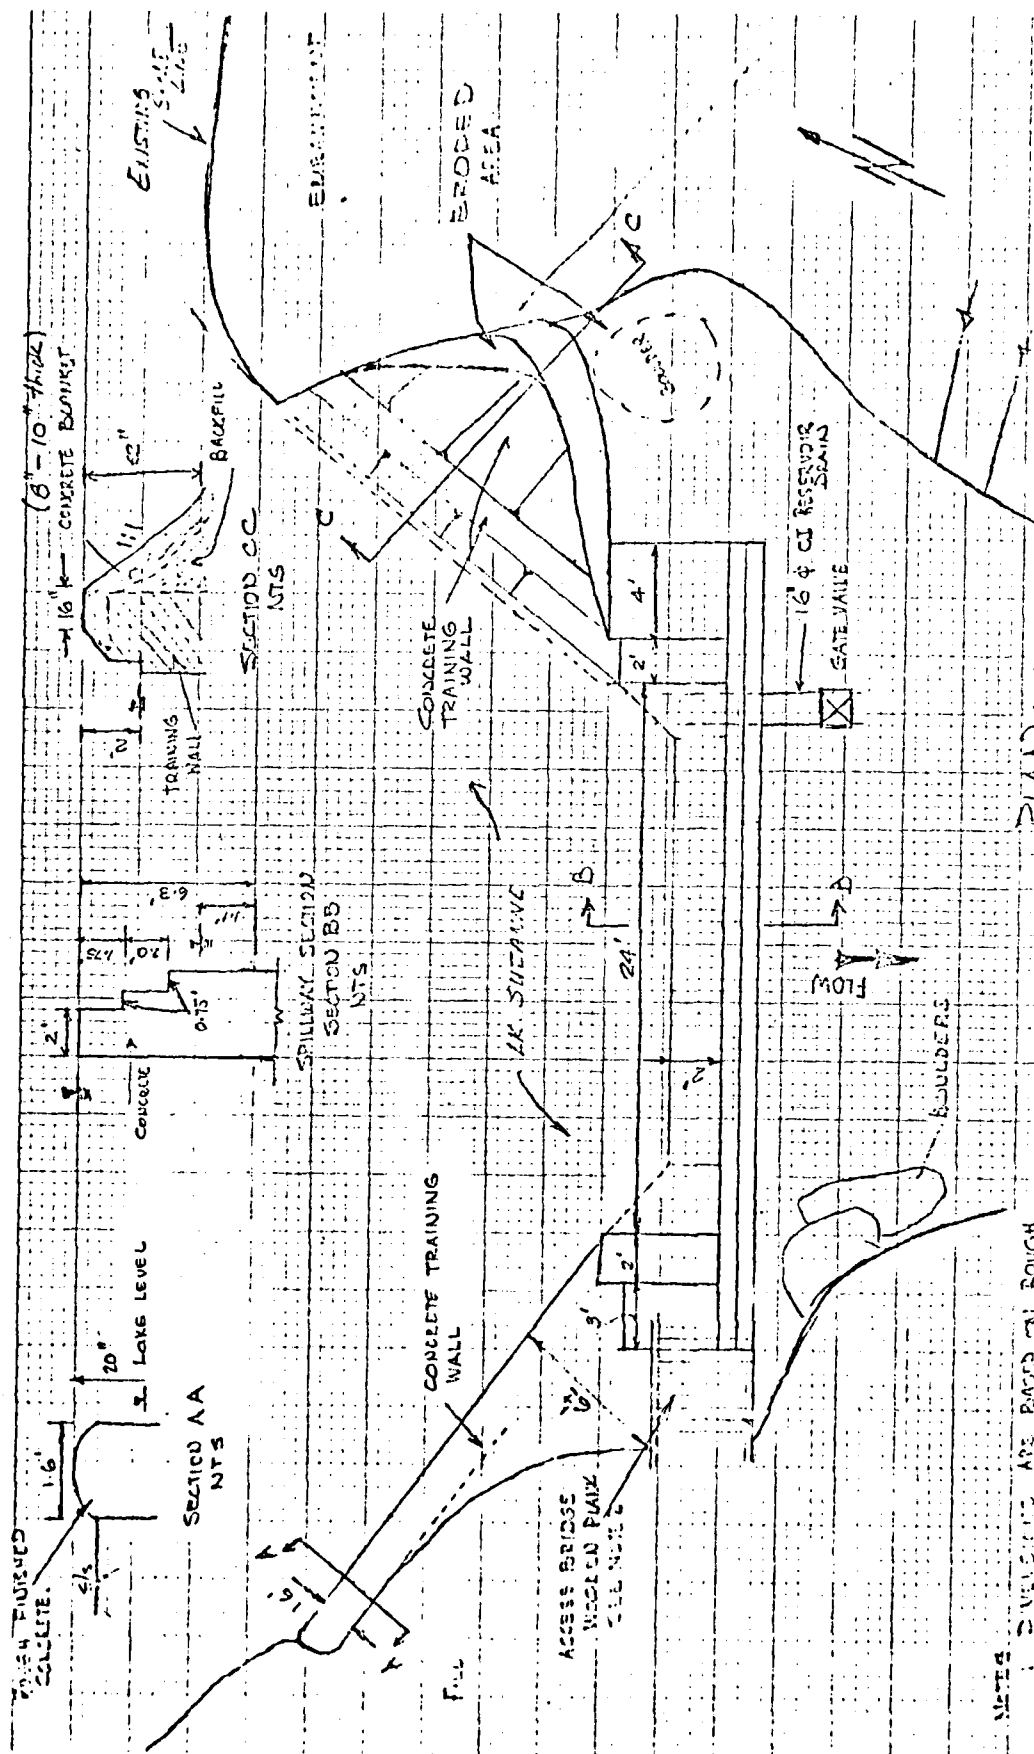
LK. SUZANNE DAM
SECTION - PLAN & SECTIONS

1. DIMENSIONS ARE BASED ON ROUGH FIELD MEASUREMENT DURING VISUAL INSPECTION.
2. ACCESS BRIDGE FROM RIGHT ABUTMENT TO EMERGENT NOT SHOWN.

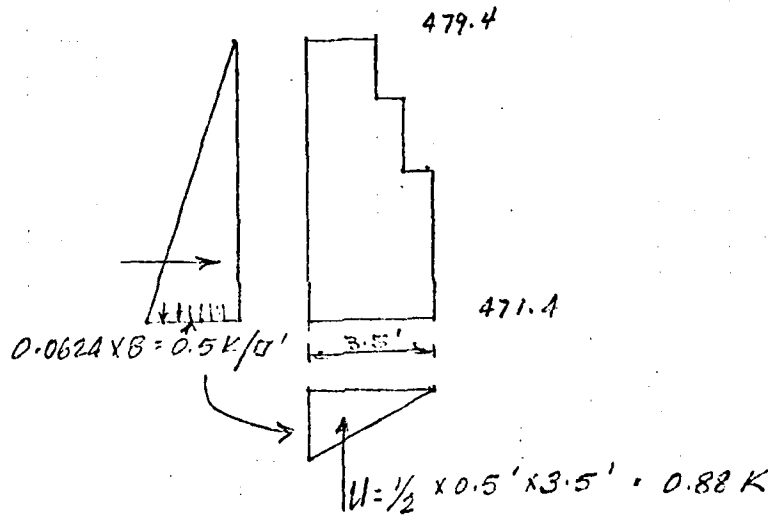
6 HYDROSTATIC FORCES

Normal loading: WL @ SPILLWAY CREST
 EL. 479.4

$$P = \frac{1}{2} \times 0.5' \times 8' = 2.0 \overset{\text{K}}{\rightarrow} \times 2.67 = 5.33 \overset{\text{KF}}{\text{}}$$

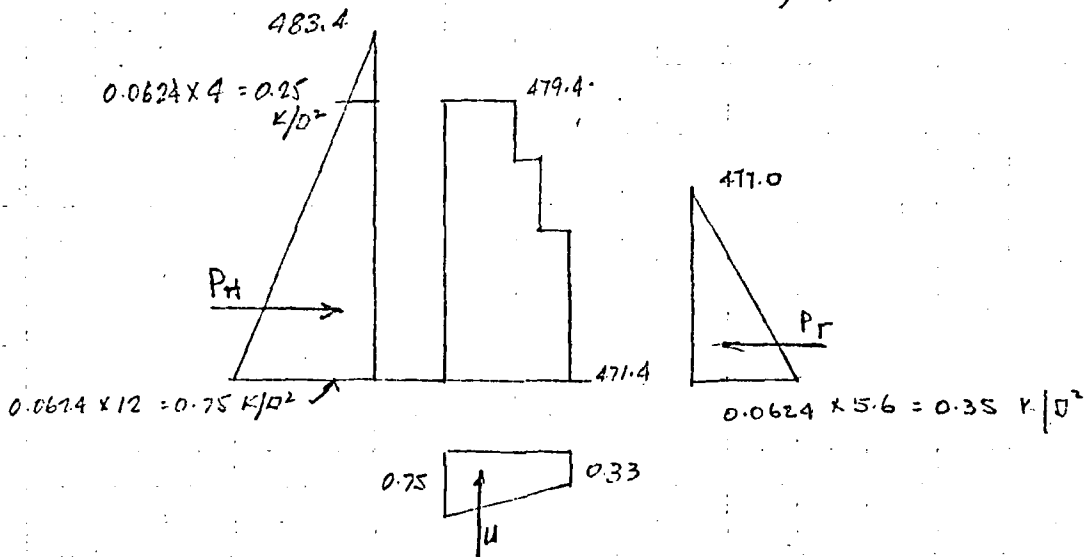
WL Equal to $\frac{1}{2}$ PMF

EI. 483.4 ; Tailwater EI. 477.0

$$P_H = \left(\frac{0.25 + 0.75}{2} \right) 8 = 4.0 \times 3.33' = 13.32 \text{ KF}$$

$$P_R = \left(\frac{1}{2} \times 0.35 \times 5.6 \right) 0.6 = 0.59 \times 1.9' = 1.12 \text{ KF} \quad 60\% \text{ TW Pressure}$$

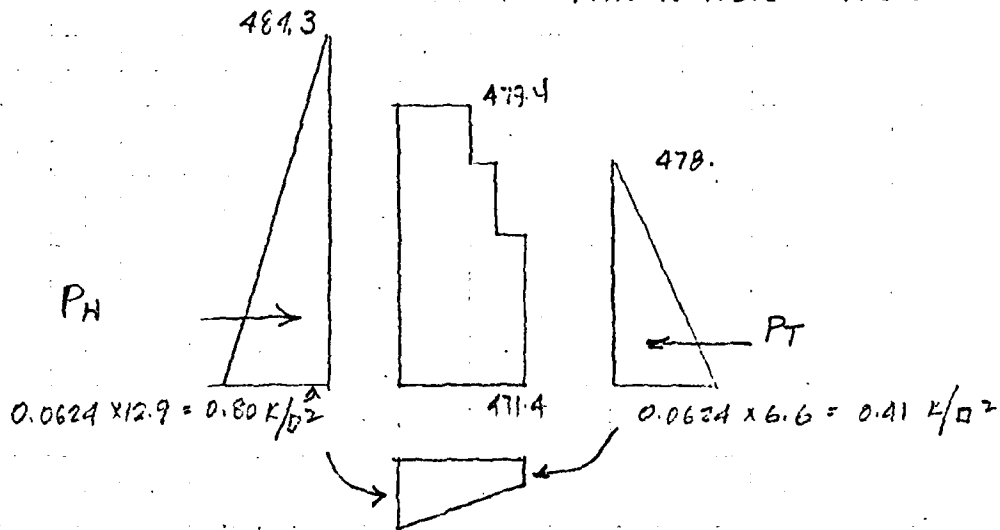
MAXIMUM LOADING

WL EQUAL TO PMF LEVEL 484.3
 TAIL WATER 478.0

$$P_H = \left(\frac{0.31 + 0.80}{2} \right) 8 = 4.44 \overset{K}{\rightarrow} \times 3.41 = 15.14$$
