| REPORT DOCUMENTATION PAGE | | READ INSTRUCTIONS<br>BEFORE COMPLETING FORM |
|---|---|---|
| 4. TITLE (and Subtitle)<br>Phase I Inspection Report<br>Palmer Falls Dam<br>Upper Hudson River Basin, Saratoga & Warren<br>Counties, NY Inventory No. 145 | | 5. TYPE OF REPORT & PERIOD COVERED<br>Phase I Inspection Report<br>National Dam Safety Program |
| 9. PERFORMING ORGANIZATION NAME AND ADDRESS<br>Stetson-Dale Engineering Company<br>Bankers Trust Building<br>Utica, NY 13501 | | 8. CONTRACT OR GRANT NUMBER(s)<br>DACW-51-79-C-0001 |

PHASE I REPORT  
NATIONAL DAM SAFETY PROGRAM

Name of Dam Palmer Falls Dam, NY145

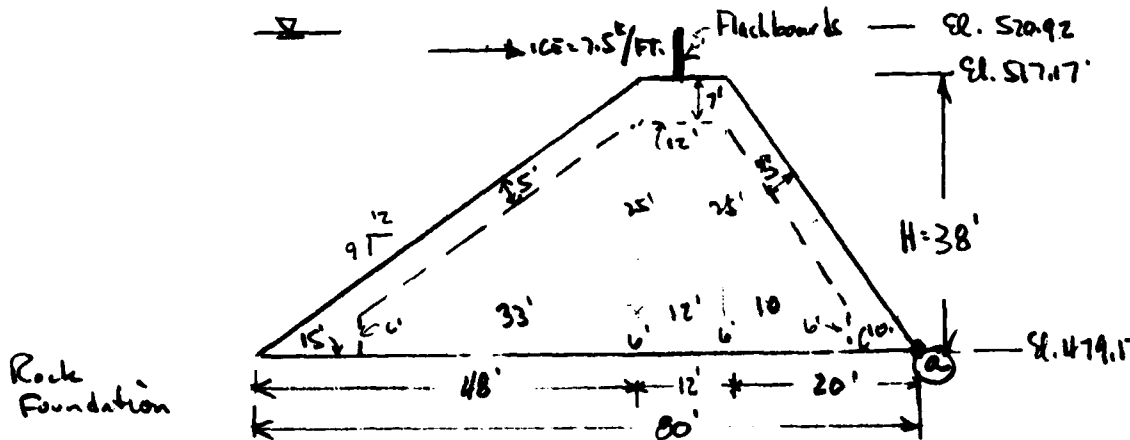
Assumed Cross-Section and Loading Conditions - Easterly Section

Note: Dam section selected at location near to maximum height (Pier 6). Upstream and downstream thickness represents weighted avg between buttresses.

Note 19' cc between buttresses, buttresses 4' wide the section of dam 19' long

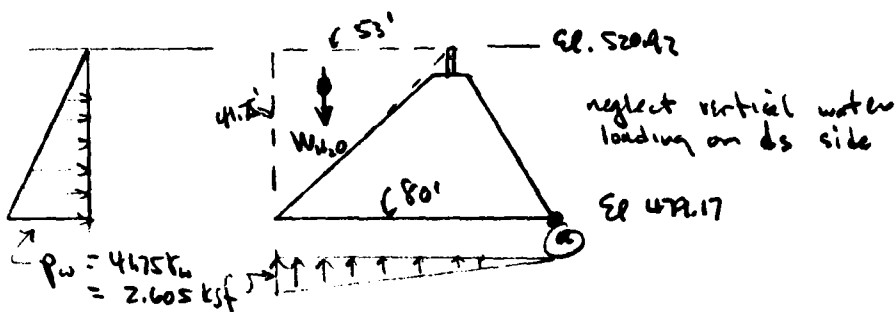
Case I: WL @ Normal Operating Level (Top of Flashboards)

overturning  
(a)  $M_a$  causing overturning due to lateral  $H_2O$  pressure =  $(H) \left( 2.605 \times \frac{41.75}{2} \times \frac{41.75}{3} \right)$   
no uplift  
(19) (757  $^k$ ) = 14,383  $^k$ /per 19'

$$\text{FS against overturning} = \frac{82,953 \text{ } ^k + (19) \left( \frac{1}{2} \times 41.75 \times 53 \times 0.0624 \right) \left( \frac{106}{3} + 27 \right)}{14,383 \text{ } ^k} = \frac{164,717}{14,383} = 11.4$$

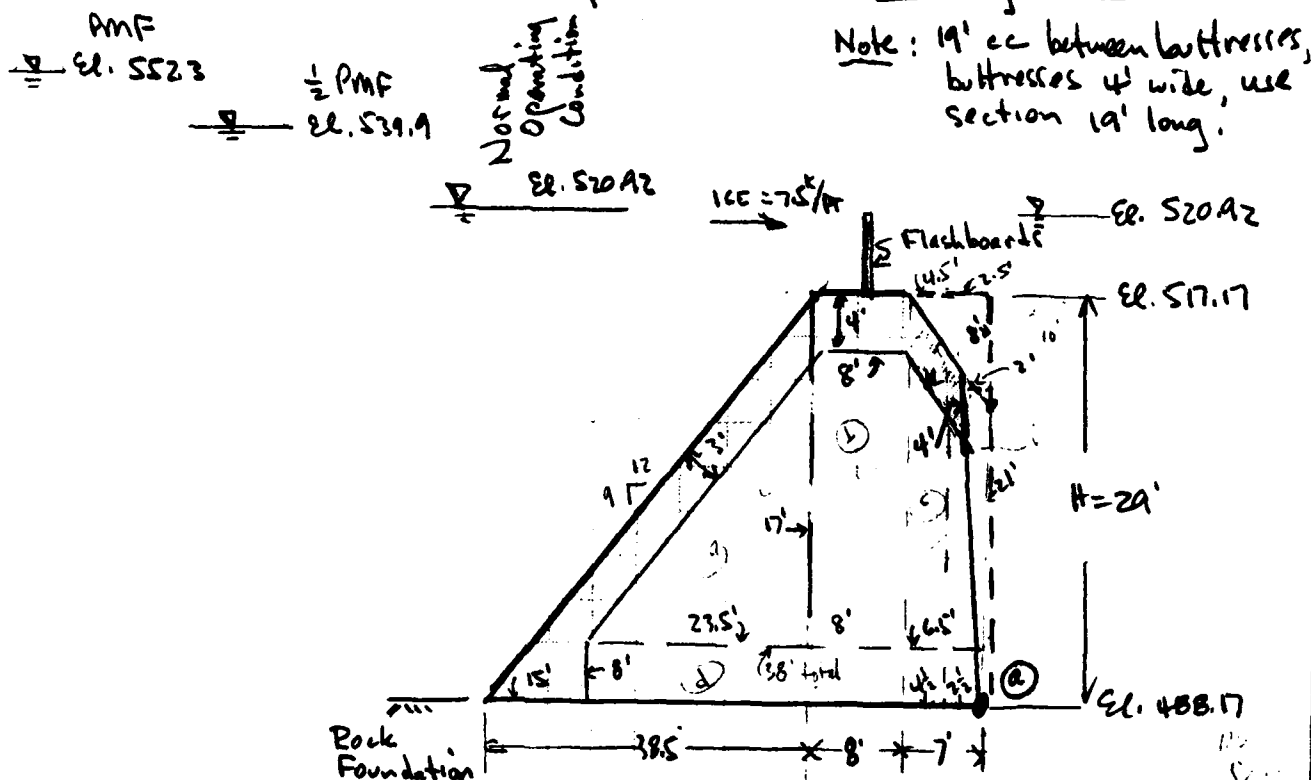
### Assumed Cross-Section and Loading Conditions - Westerly Section

$$\begin{aligned} \text{Wt. of 19' long section} &= (19 \times 15) \left[ \left( \frac{1}{2} \times 38.5 \times 29 \right) + (15 \times 29) - \left( \frac{1}{2} \times 7 \times 8 \right) - \left( \frac{1}{2} \times 2 \times 24 \right) \right] - \\ &\quad - (15 \times 15) \left[ \left( \frac{1}{2} \times 17 \times 23.5 \right) + (8 \times 17) + \left( \frac{6.5 \times 5}{2} \times \frac{17+13}{2} \right) + (37.5 \times 8) \right] = \\ &= (19 \times 15 \times 944.3) - (15 \times 15 \times 722) = 1065 \text{ K} \end{aligned}$$

$$\begin{aligned} M_a \text{ due to mass of 19' long section} &= (19 \times 15) \left[ (558.3) \left( \frac{38.5}{3} + 15 \right) + (435 \times \frac{15}{2}) - (28 \times \frac{7}{3}) - (24 \times \frac{2}{3}) \right] - \\ &\quad - (15 \times 15) \left[ (448) \left( \frac{23.5}{3} + 15 \right) + (136) (4+7) + (186) \left( \frac{4.5}{2} + 2.5 \right) + (300 \times 14) \right] = \\ &= (19 \times 15) (18723) - (15 \times 15) (12167) = 25985 \text{ K} \end{aligned}$$

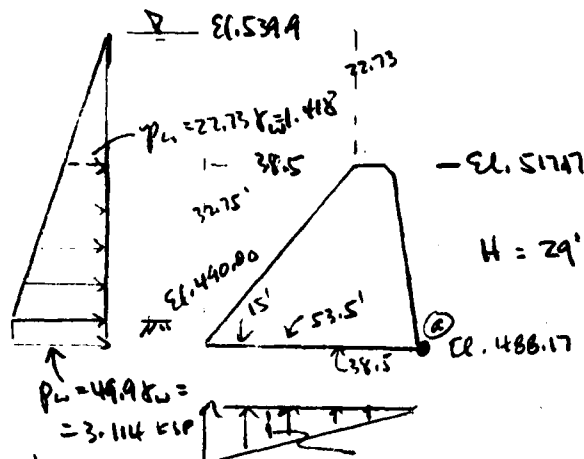
Case III. WL @  $\frac{1}{2}$  PMF Elevation, Flash boards failed

causing overturning due to horiz.  $H_2O$  pressure, normal uplift on entire plan area

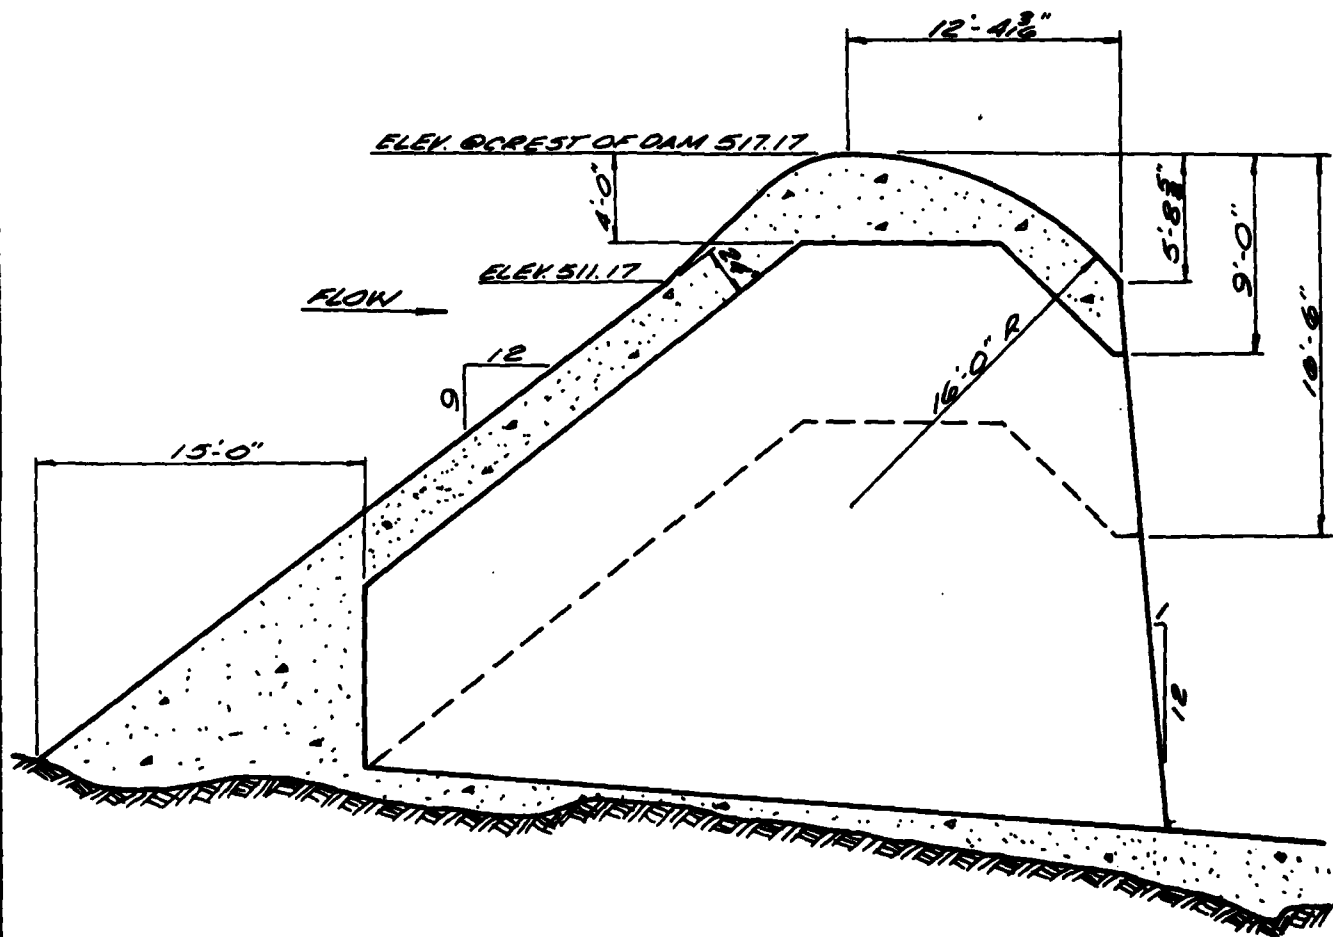
PALMER FALLS DAM  
 1/8" = 1'-0"

NOTE: - 19' ON CENTER BETWEEN  
 ARCHWAYS  
 - BUTTRESSES ARE 4' THICK
