NAVAL POSTGRADUATE SCHOOL

A-10/GAU-8 LOW ANGLE FIRINGS VERSUS
SIMULATED SOVIET TANK BATTALION
(HONEYWELL LOT NUMBER 0L78D043-016)
(ARRAY 3)
2 FEBRUARY 1979.
R.H.S. STOLFI
R.R. MCEACHIN
AUGUST 1980

Prepared for: A-10 System Program Office
Wright Patterson Air Force Base
Ohio 45433

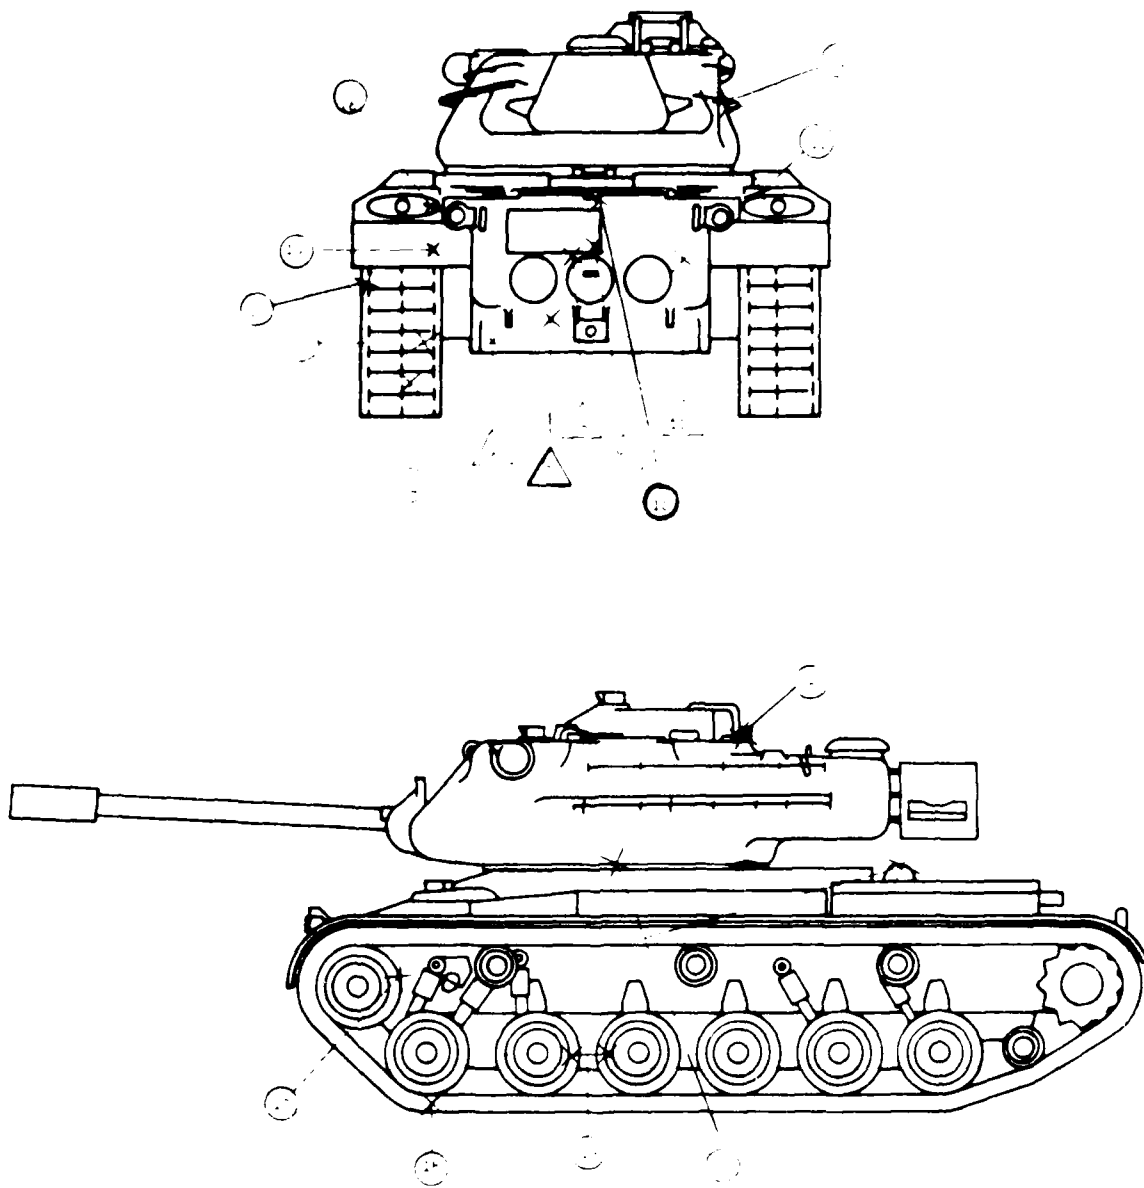
FIGURE 7. Impact Diagram, Target 2.

100% M-Kill, resulting from the following projectile impacts, shown in Figure 7:

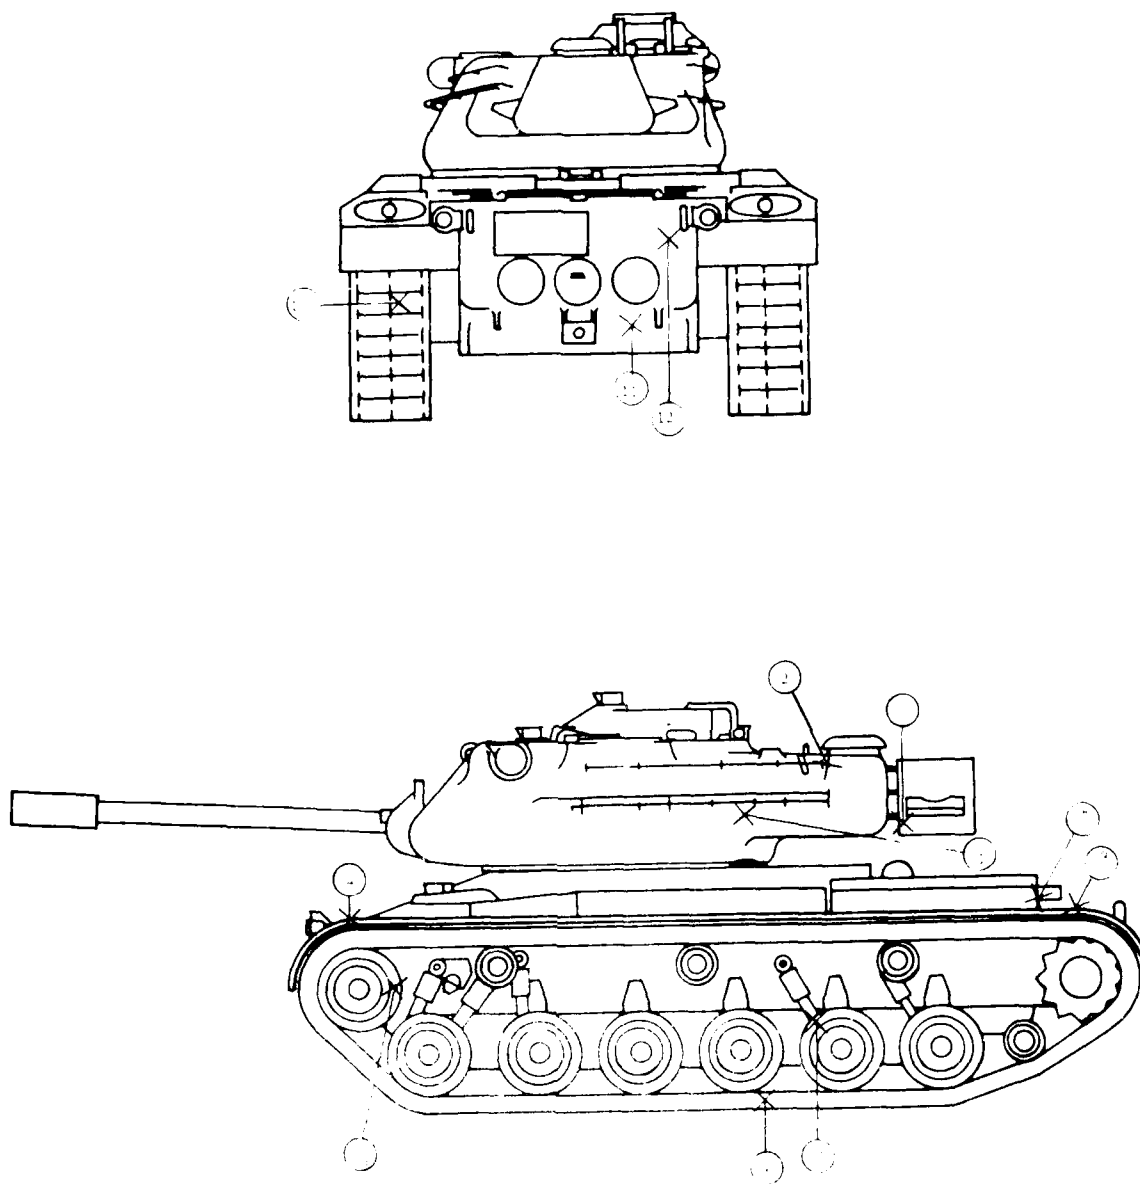
FIGURE 13. Impact Diagram, Target 4.

100% M-Kill, resulting from the following projectile impacts, shown in Figure 13:

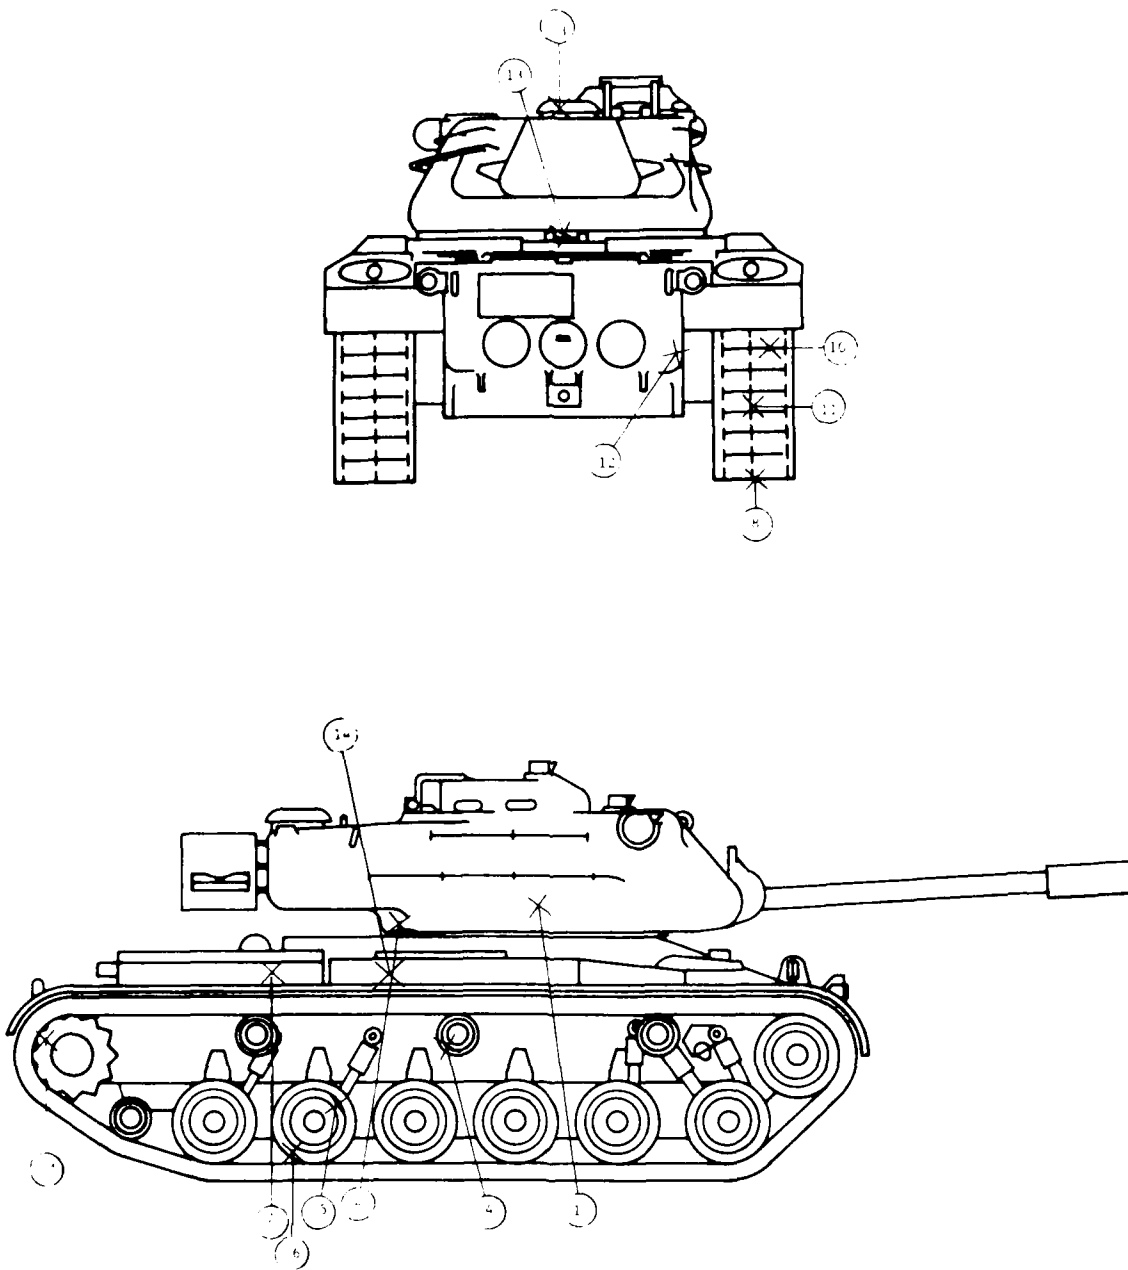
FIGURE 15. Impact Diagram, Target 7.

20% M-Kill, resulting from the following projectile impacts, shown in Figure 15:

Mobility was estimated to have been degraded by 20%, due to cumulative damage to the track and suspension system resulting from seven hits. Impact 9, shown in Figure 16, is representative of the most severe damage inflicted during this attack pass.

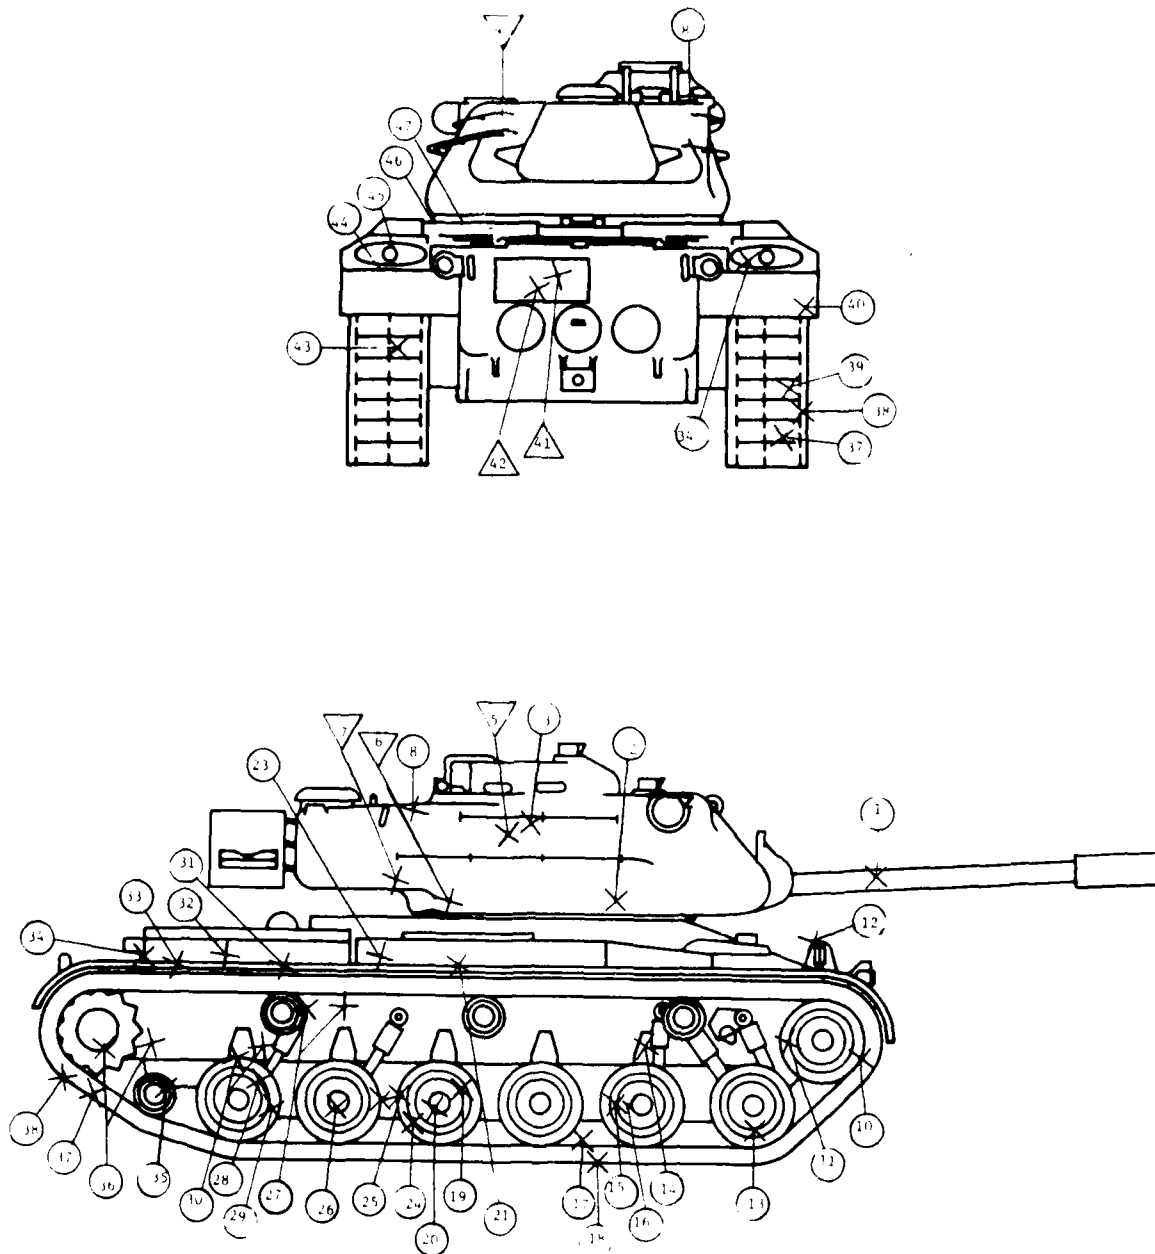
FIGURE 17. Impact Diagram, Target 17.

100% K-Kill, resulting from the following projectile impacts shown in Figure 17:

The rear hull was perforated by Impacts 41 and 42, which perforated the transmission case and severed an oil cooler line. Either of these impacts could have ignited oil in the transmission compartment.

A small fire, which could not be extinguished by the crew due to casualties, provides the best scenario for assessment of a K-Kill. The most likely place of origin of the fire is the transmission/engine compartment.

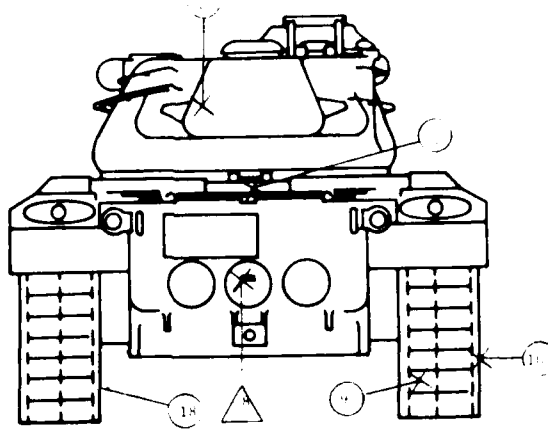
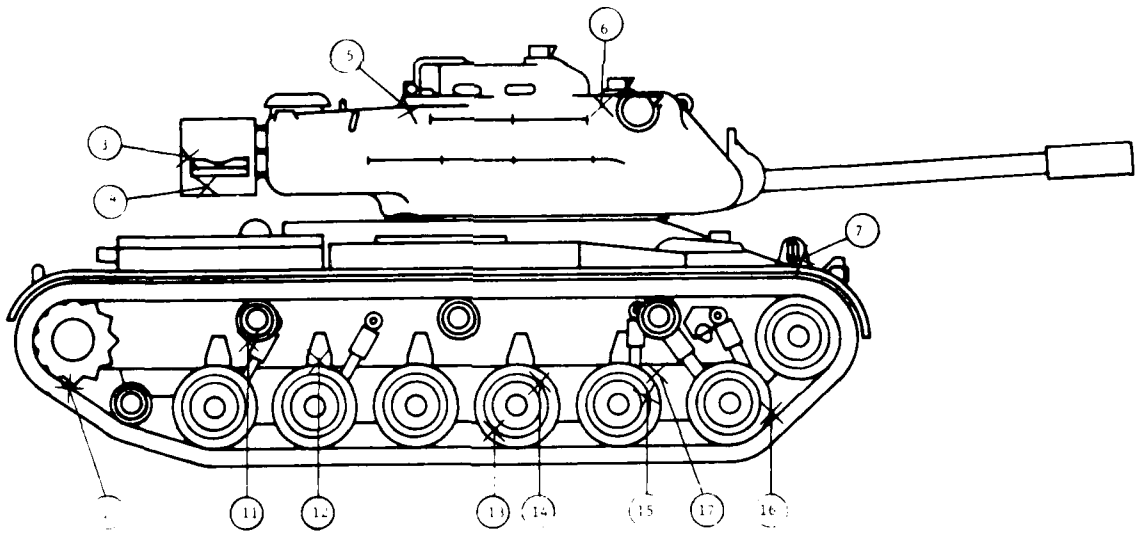
FIGURE 21. Impact Diagram, Target 19.

100% M-Kill, resulting from the following projectile impacts, shown in Figure 21:

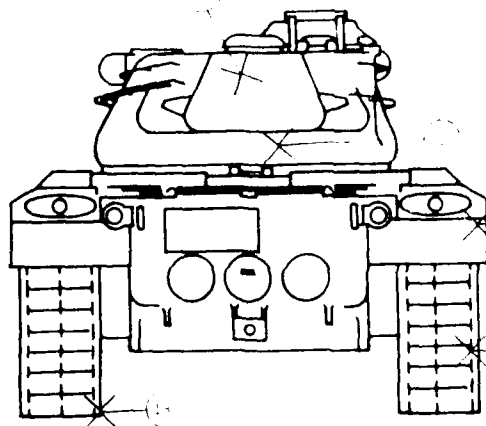
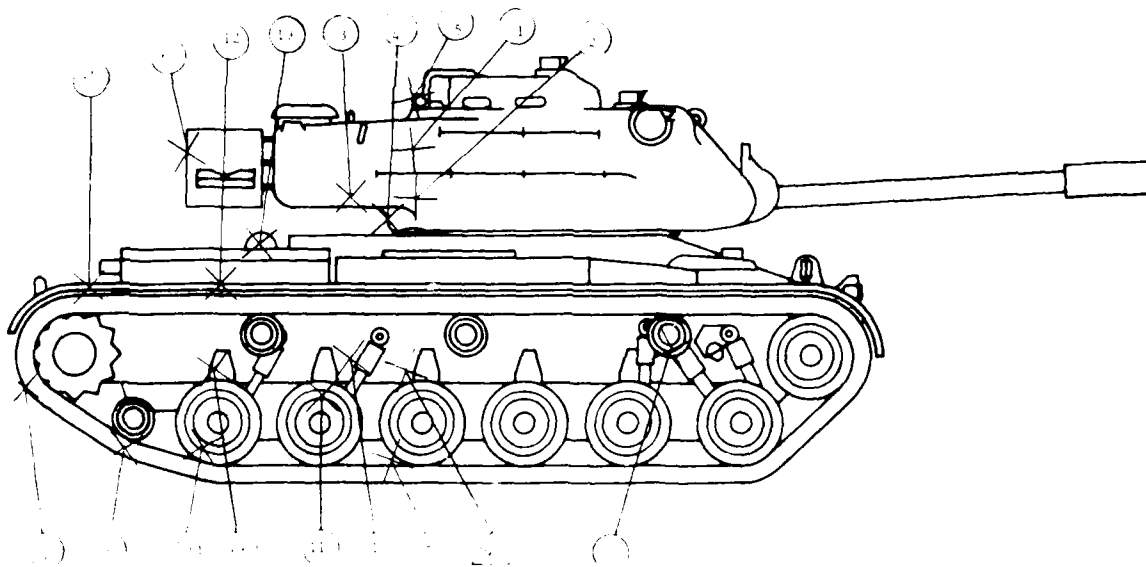
FIGURE 23. Impact Diagram, Target 20.

100% M-Kill, resulting from the following projectile impacts, shown in Figure 23:

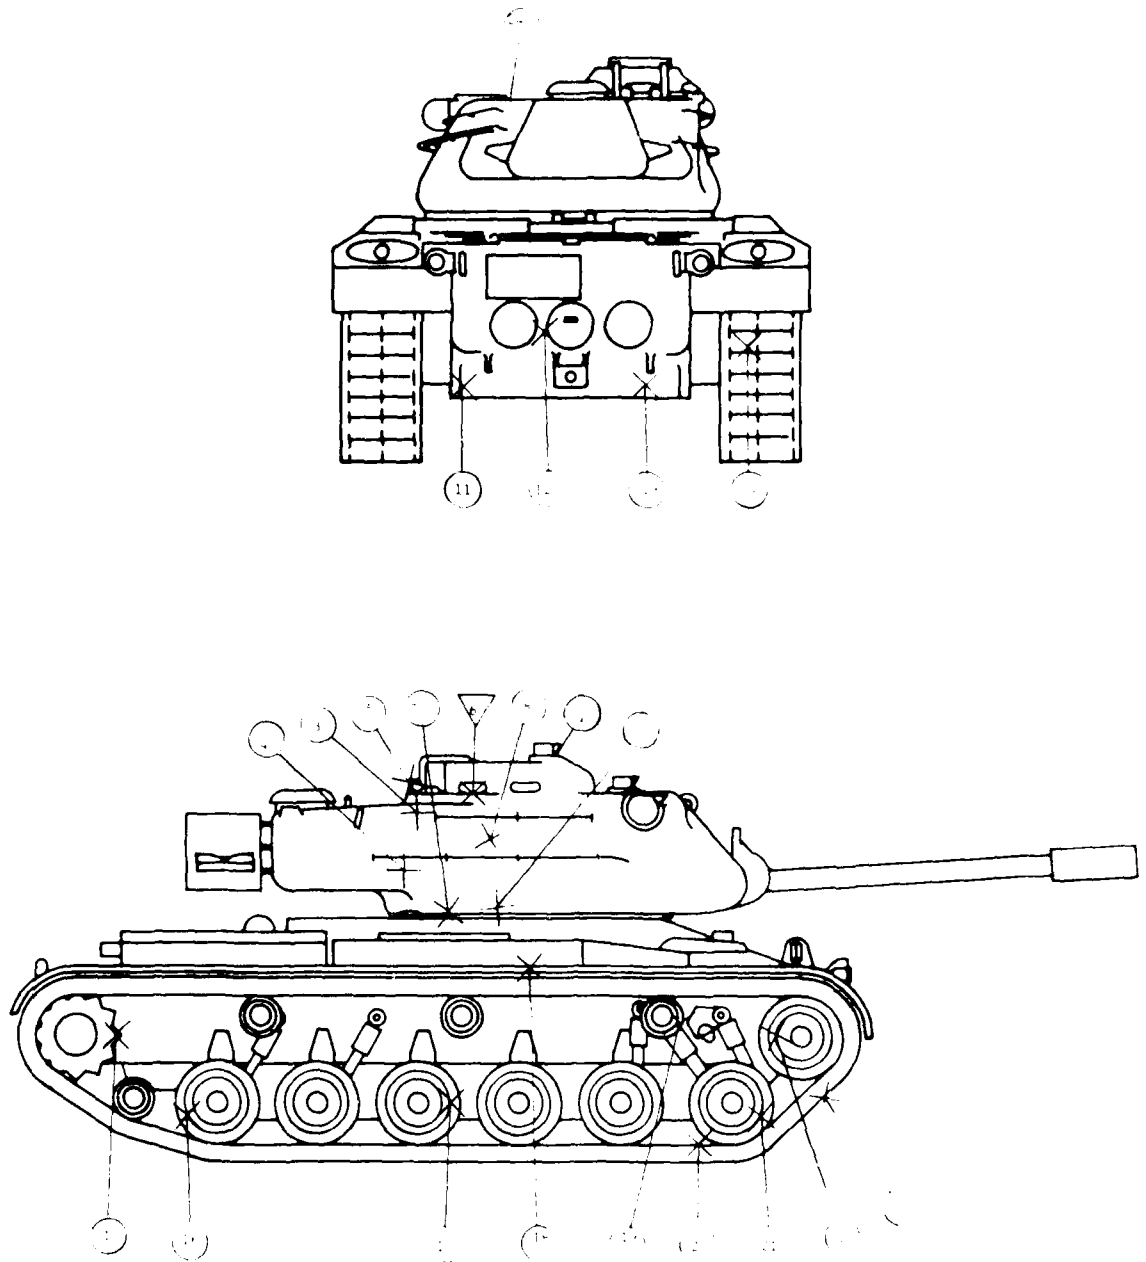
FIGURE 25. Impact Diagram, Target 21.

75% M-Kill and 100% F-Kill resulting from the following projectile impacts, shown in Figure 25:

- a. M-Kill: An overall 75% M-Kill was assessed, based primarily (65%) on crew casualties (tank commander and gunner) caused by impacts 6 and 9, shown in Figures 26 and 27, respectively, and secondarily (10%) on cumulative damage to the track and suspension system caused by three other impacts.
- b. F-Kill: 100% F-Kill was due to crew casualties from impacts 6 and 9, and to impact 7 (Figure 28) which jammed the turret, preventing it from traversing.

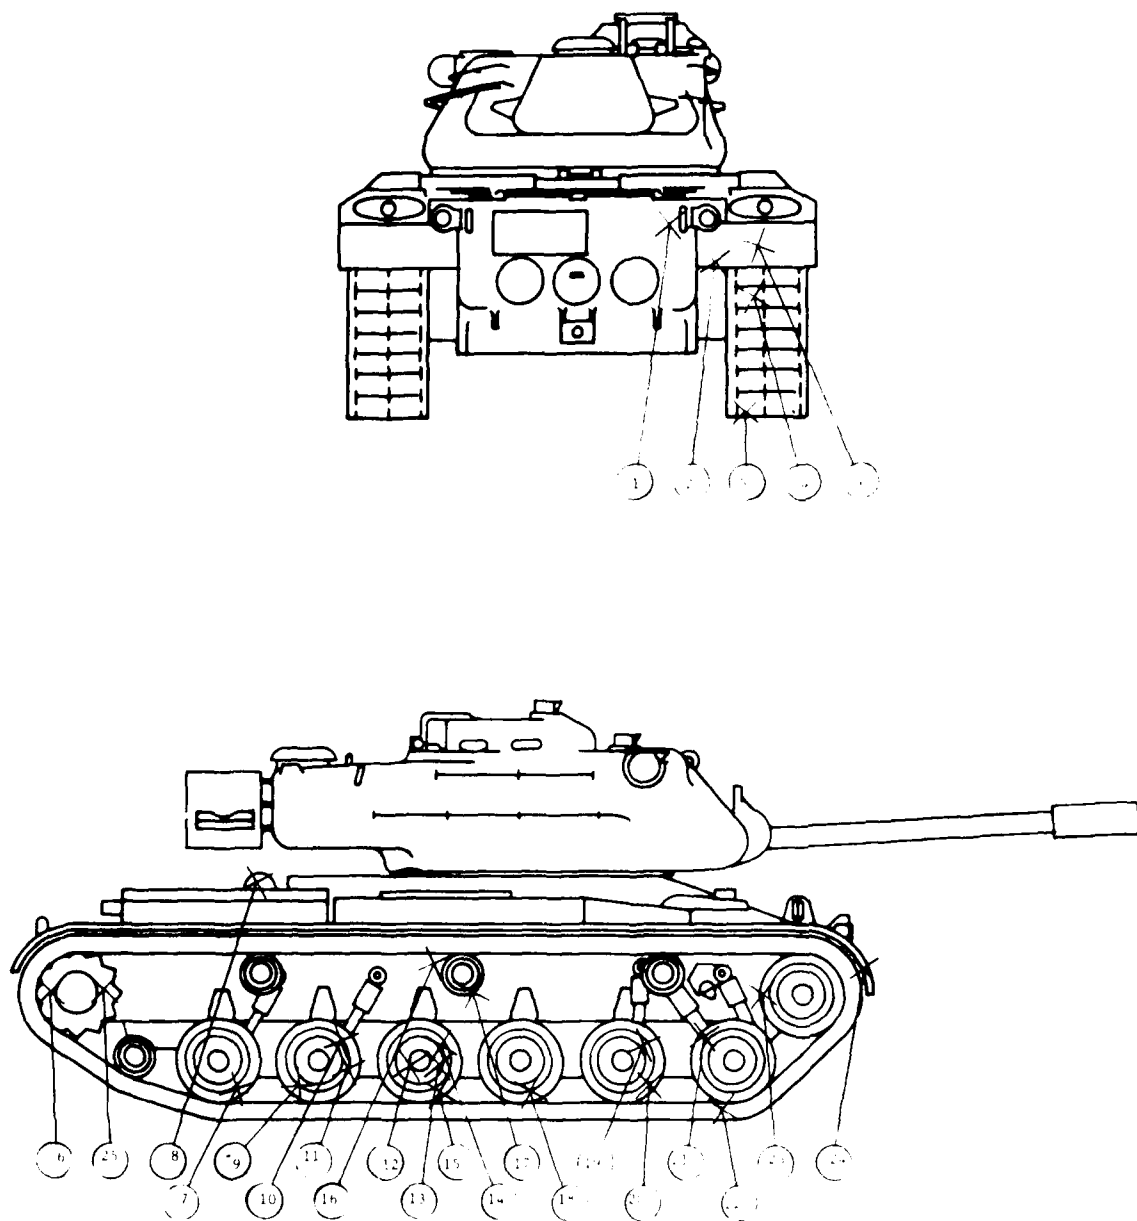
FIGURE 29. Impact Diagram, Target 22.

100% M-Kill, resulting from the following projectile impacts, shown in Figure 29:

The primary contributors to the kill were impacts 10 and 12, shown in Figures 30 and 31, respectively, which destroyed the right #4 roadwheel bearing spacer and hub, damaging the spindle; and impacts 6 and 25, shown in Figures 32 and 33, respectively, which severely damaged the right drive sprocket. Cumulative damage from four other impacts contributed to the kill.

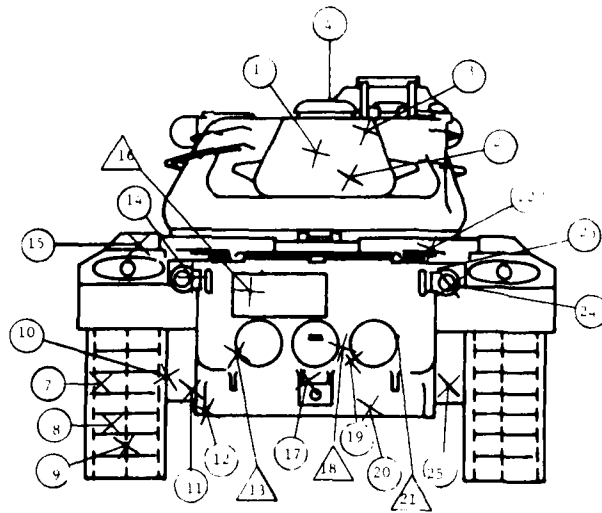
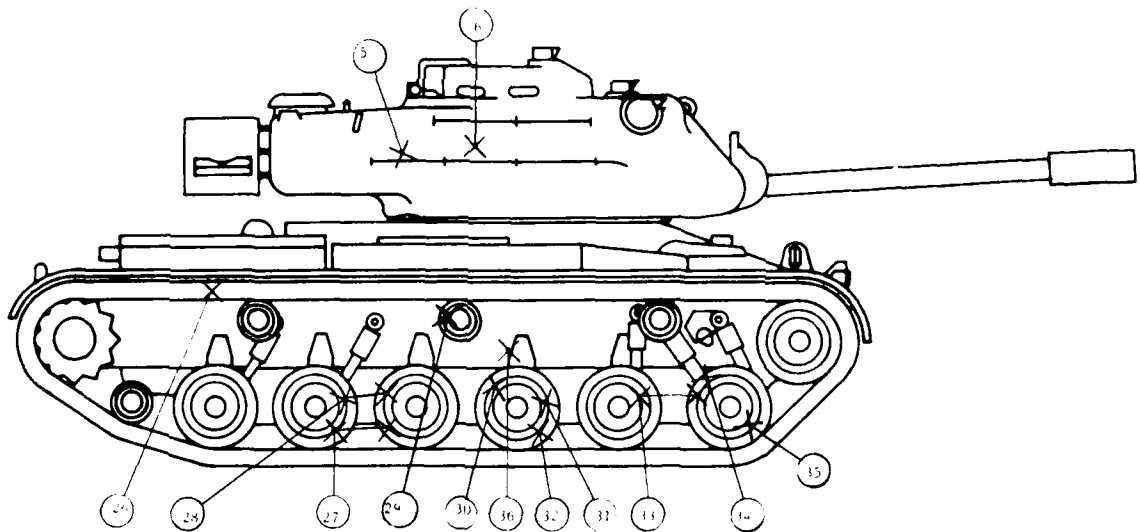
FIGURE 34. Impact Diagram, Target 23.

100% M-Kill, resulting from the following projectile impacts, shown in Figure 34:

Both final drives were damaged sufficiently to cause an M-Kill. Impacts 10 and 11, shown in Figures 38 and 39, respectively, penetrated the left final drive. Impact 25 (Figure 40) penetrated the right final drive.

Cumulative damage to the track and suspension system from 11 other impacts (numbers 7, 8, 9, 28, 29, 30, 31, 32, 34, 35, and 36 contributed to the kill).

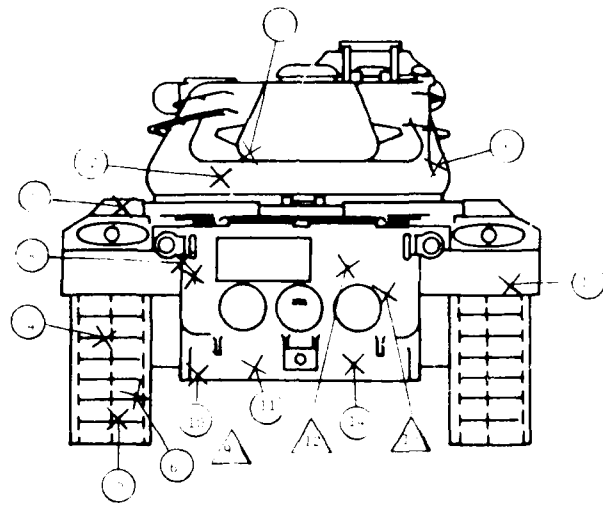
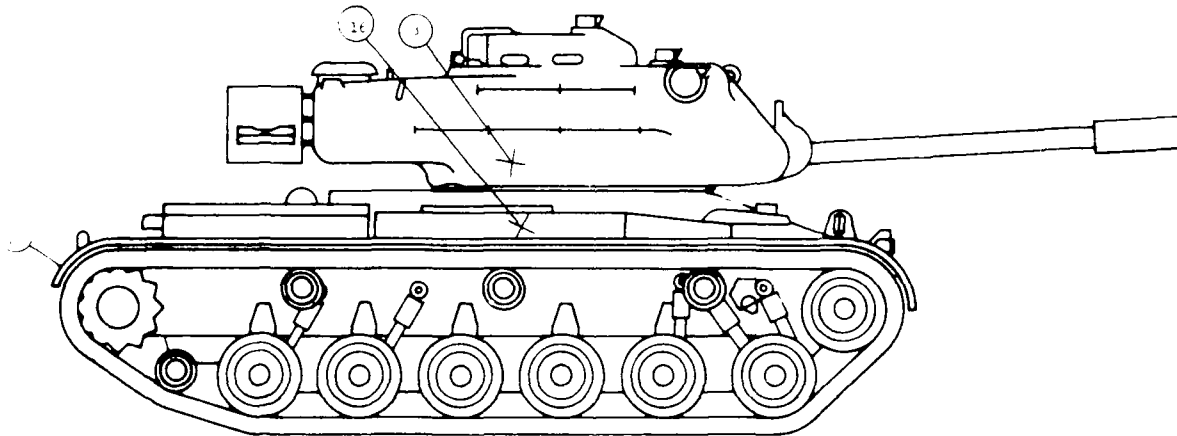
FIGURE 41. Impact Diagram, Target 26.

100% M-Kill, resulting from the following projectile impacts, shown in Figure 41:

A 100% M-Kill was assessed because of Impacts 12 and 13, shown in Figures 42 and 43, respectively, which perforated the rear hull armor and penetrated the transmission case. Two other impacts (4 and 6), which caused slight damage to the track, made a minor contribution to the kill. One other hit (Impact 9) perforated the rear hull into the transmission compartment, but the extent of the damage could not be determined.

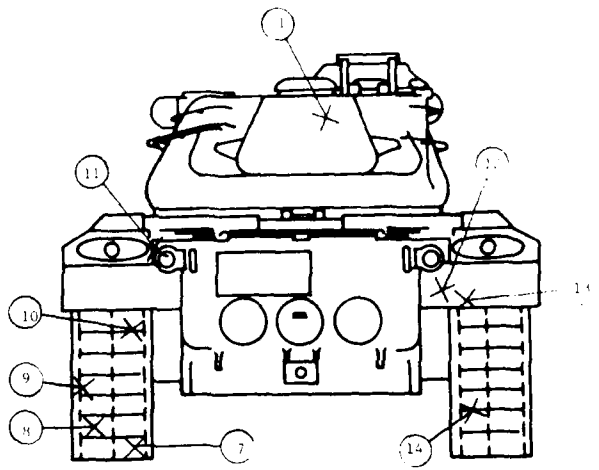
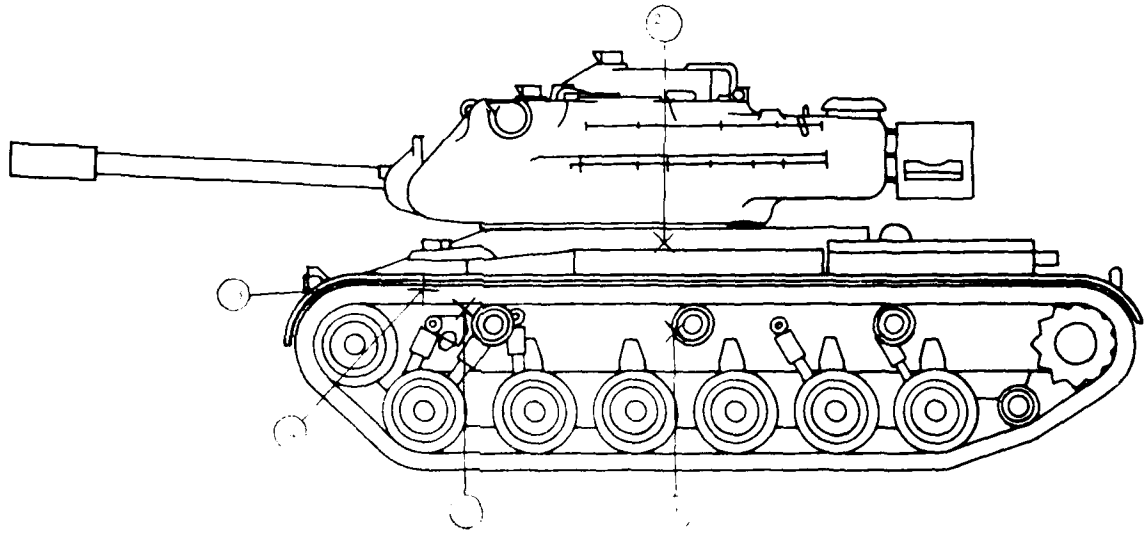
FIGURE 44. Impact Diagram, Target 27.

10% M-Kill, resulting from the following projectile impacts, shown in Figure 44:

A 10% M-Kill was assessed due to the impacts on the track and suspension system. Impact 6, shown in Figure 45, is representative of the most severe damage inflicted during this attack.

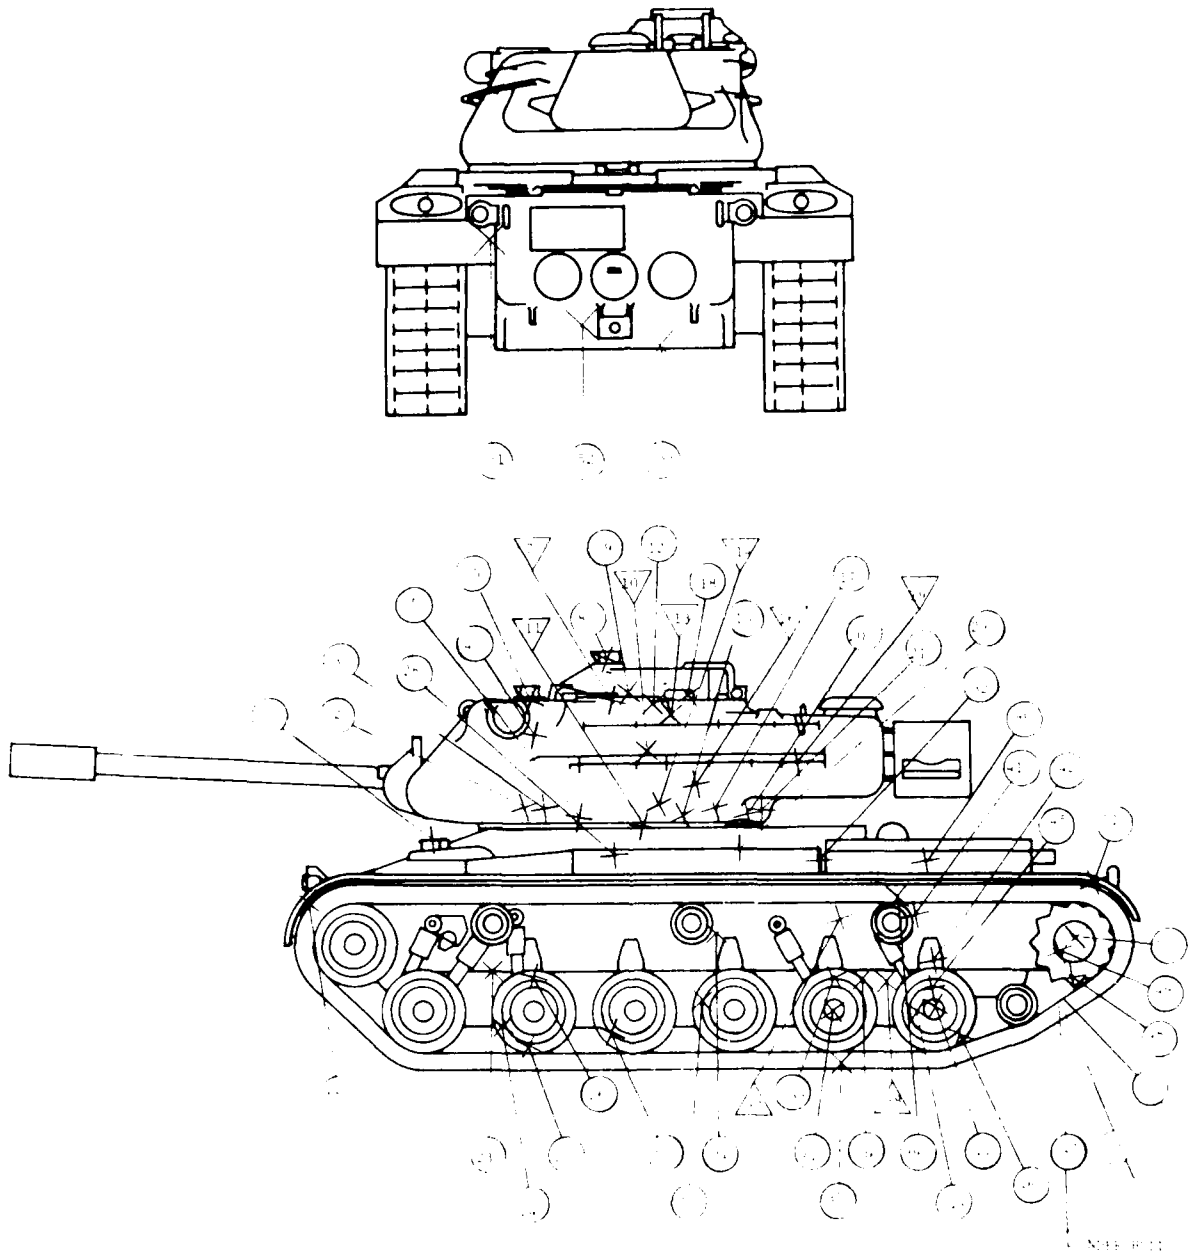
FIGURE 46. Impact Diagram, Target 28.

100% M-Kill and 95% F-Kill, resulting from the following projectile impacts, shown in Figure 46:

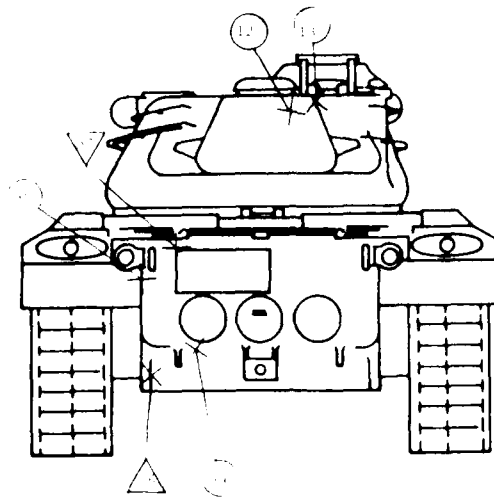
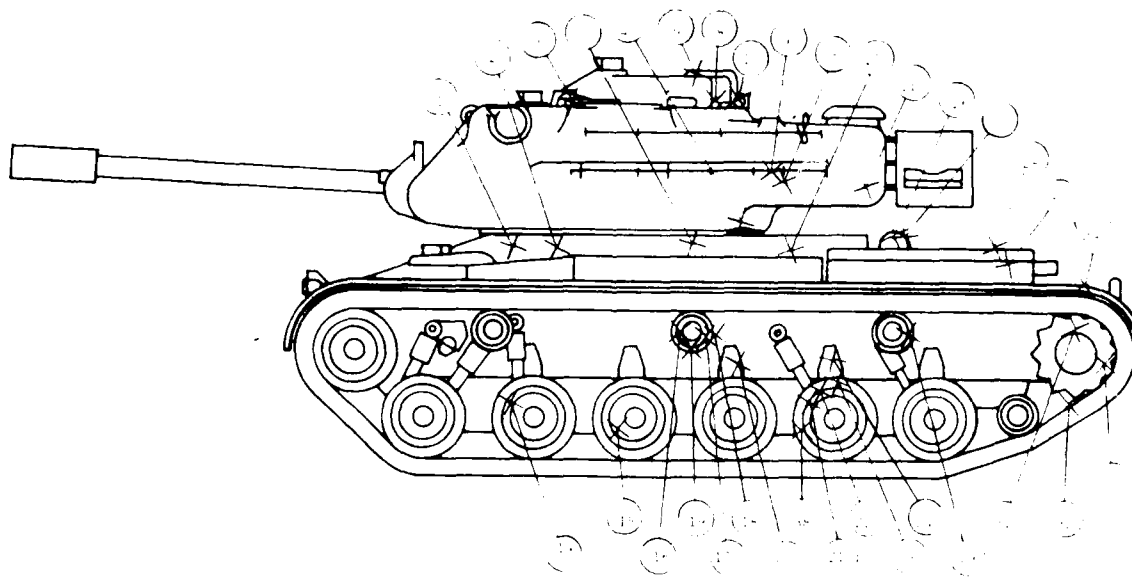
FIGURE 50. Impact Diagram, Target 29.

100% M-Kill, resulting from the following projectile impacts, shown in Figure 50:

There were three perforations into the transmission compartment, one of which (Impact 37) had no behind-the-plate effects. Either of the other two perforations was capable of causing an M-Kill. Impact 34 (Figure 51) perforated the left hull armor and severed the steering control rod. Impact 36 (Figure 52) perforated the rear hull armor and penetrated the transmission case. Cumulative damage to the track and suspension system from 14 other impacts contributed to the kill.

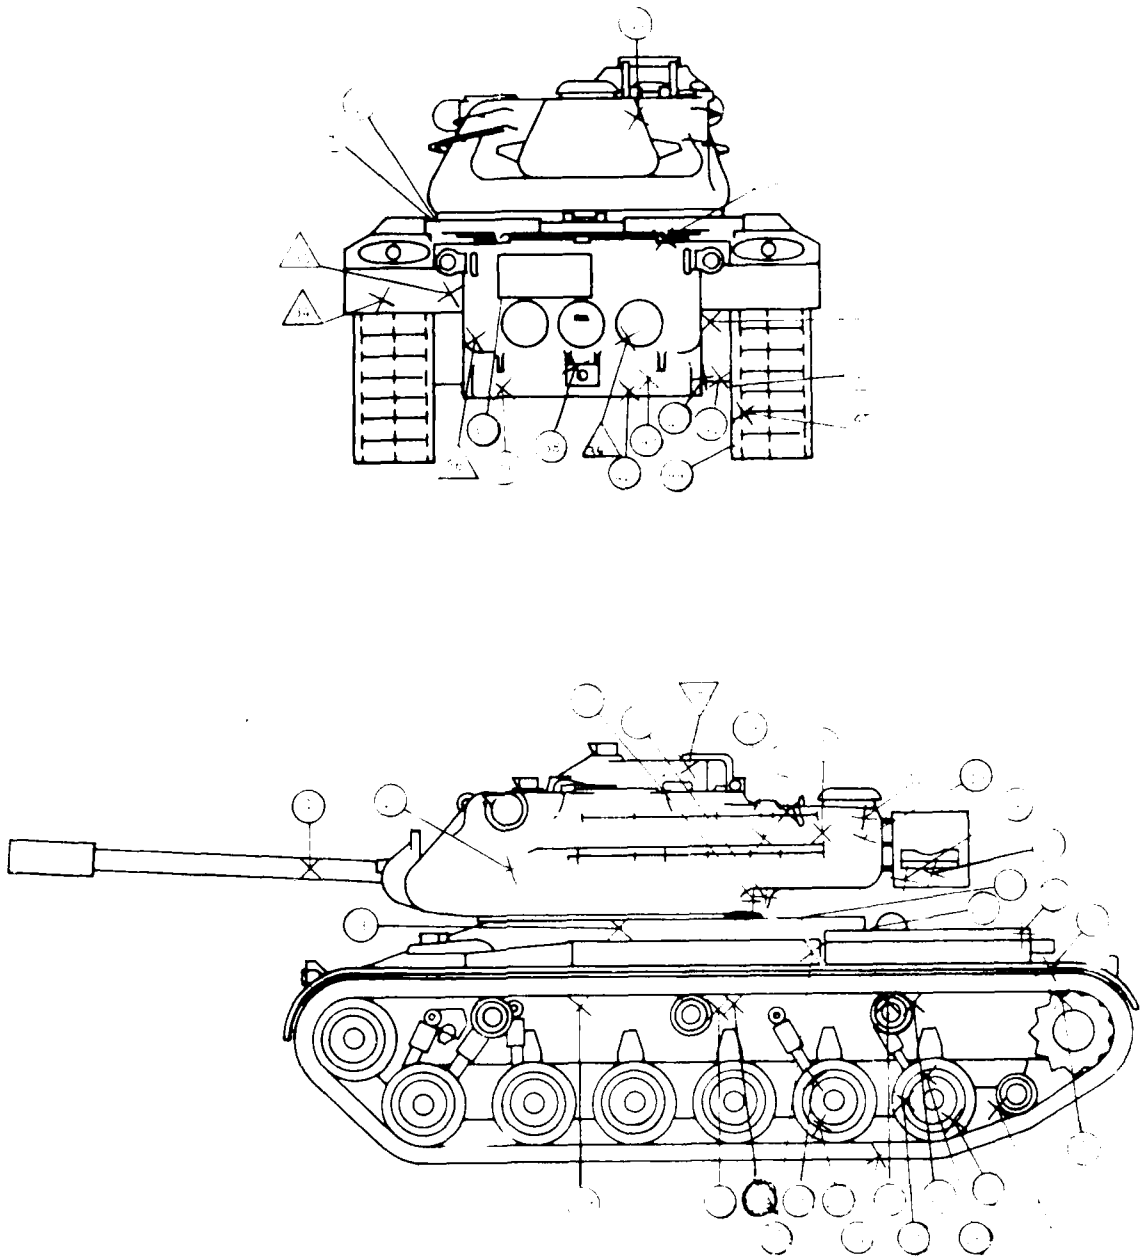
FIGURE 53. Impact Diagram, Target 30.

100% M-Kill and 100% F-Kill, resulting from the following projectile impacts, shown in Figure 53:

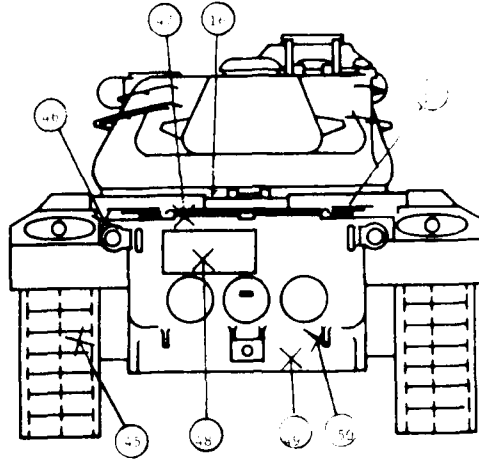
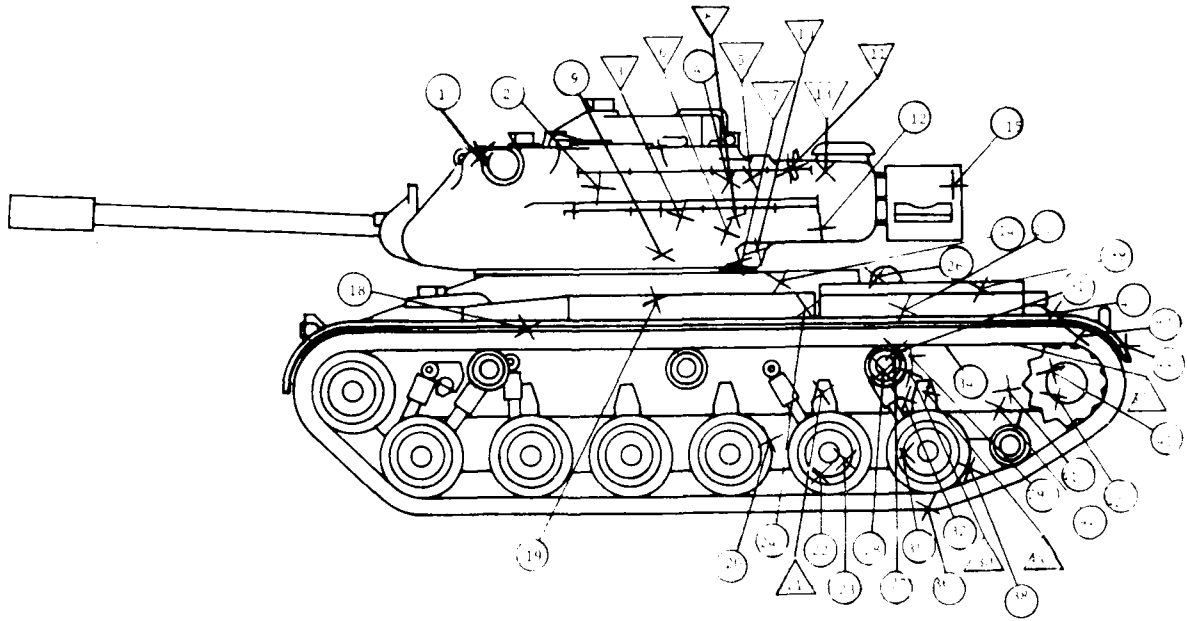
FIGURE 59. Impact Diagram, Target 31.

100% M-Kill and 100% F-Kill resulting from the following projectile impacts, shown in Figure 59:

- a. M-Kill: This target suffered three perforations which alone or together were capable of causing an M-Kill. Impacts 21 and 30, shown in Figures 60 and 61, respectively, perforated the left hull and penetrated the left fuel tank. Impact 33 (Figure 61) perforated the left hull into the engine compartment and penetrated the oil cooler space; if the cooler had been in place it would have been damaged or destroyed. One other perforation into the engine compartment had no behind-the-plate effects. Cumulative damage to the track and suspension system from 10 other impacts contributed to the kill.

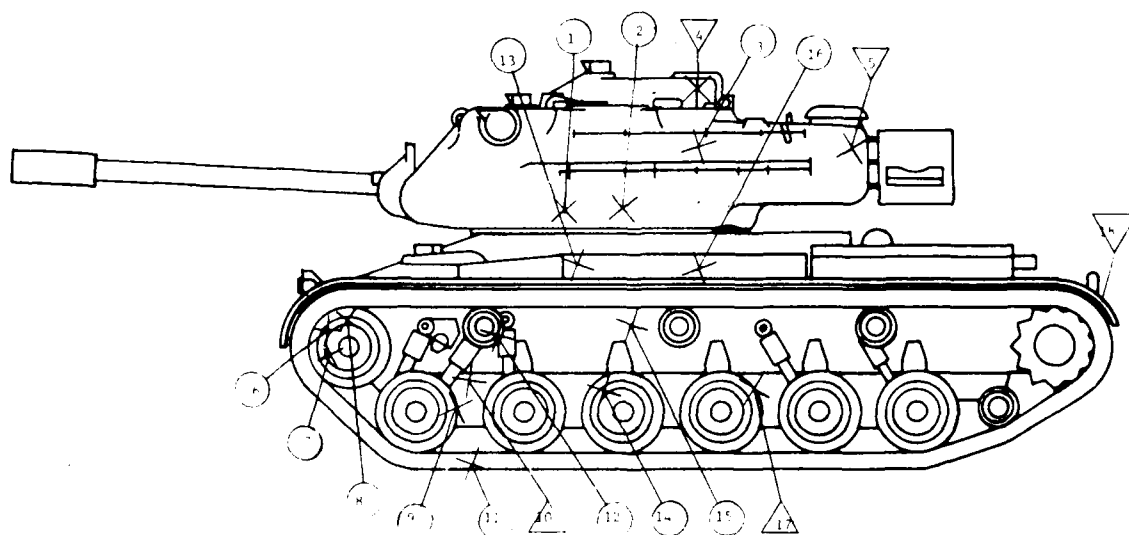
FIGURE 62. Impact Diagram, Target 32.

100% K-Kill, resulting from the following projectile impacts, shown in Figure 62:

Tank 32 was observed to be burning immediately after the attack; the fire probably was caused by Impact 17 (Figure 63) which perforated the left hull and penetrated the left fuel tank. The tank suffered three other perforations (Impacts 4, 5, and 10), which probably caused casualties to the tank commander, gunner, loader and driver. One other perforation (Impact 18) perforated the rear hull armor and penetrated the transmission case, but made no apparent contribution to the catastrophic kill. In the judgement of the Combat Damage Assessment Team, the simultaneous outbreak of a major fire and occurrence of four casualties would have prevented the crew from effectively controlling the fire.

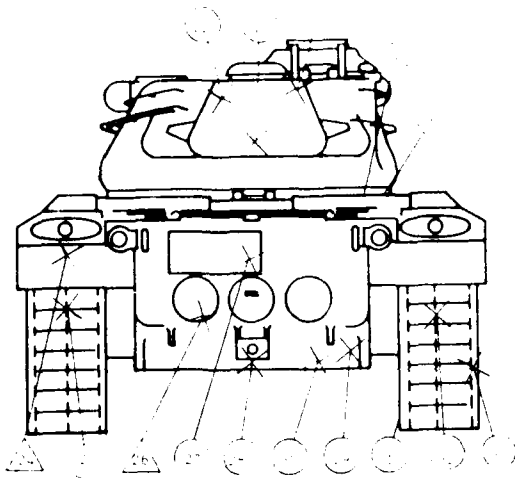
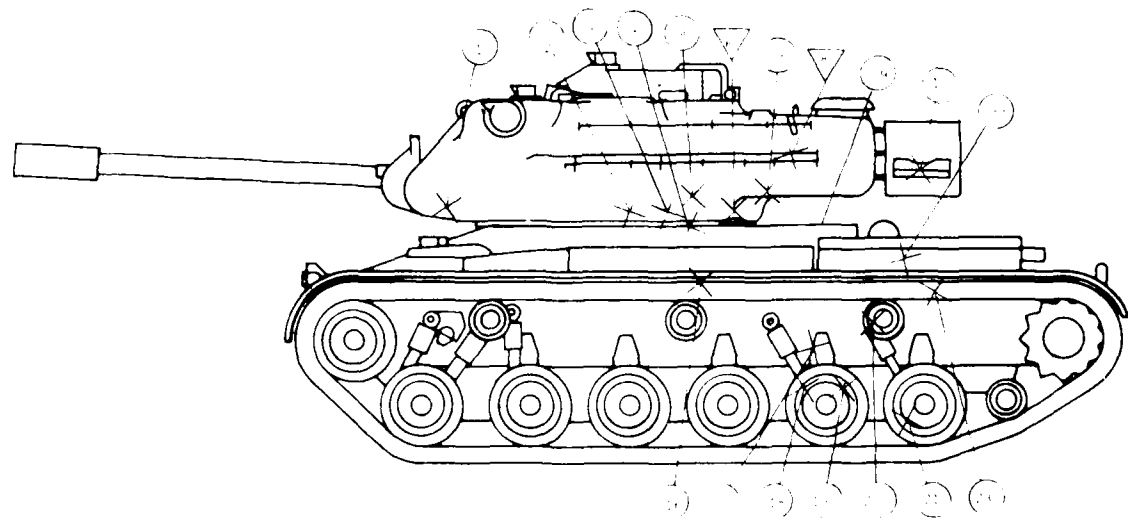
FIGURE 64. Impact Diagram, Target 33.

100% M-Kill and 95% F-Kill resulting from the following projectile impacts, shown in Figure 64:

- a. M-Kill: This target suffered 4 perforations, two of which were independently capable of causing an M-Kill. Impact 24 perforated the left hull and severed an oil cooler line. Impact 26, shown in Figure 65 and 66, respectively, perforated the rear brake adjust access door and penetrated the transmission case. Cumulative damage to the track and suspension system from 5 other impacts contributed to the kill.
- b. F-Kill: A 95% F-Kill was assessed based solely on crew casualties (tank commander and gunner - Figures 67 and 68) resulting from Impacts 6 and 8 which perforated the left side of the turret.

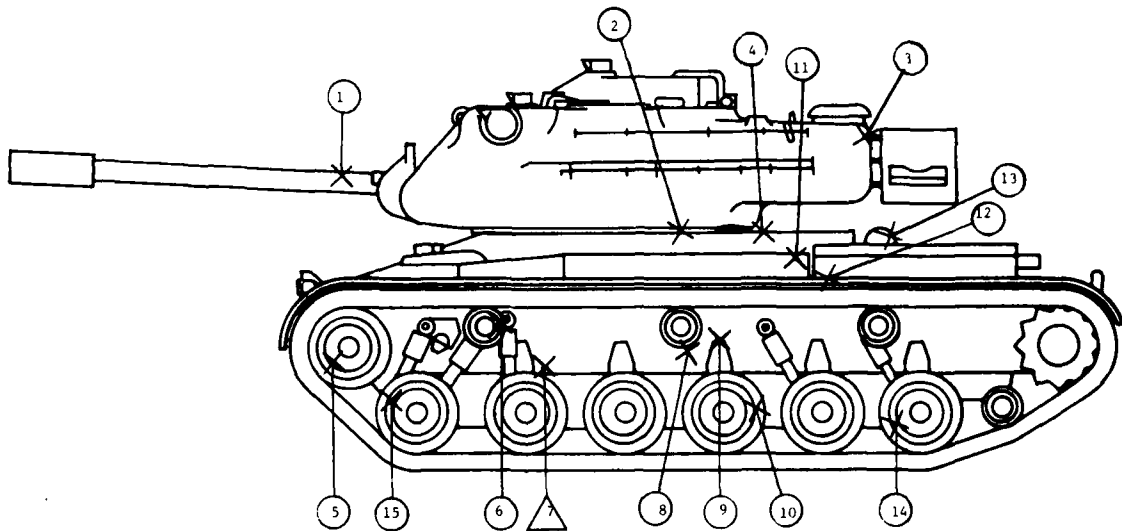
FIGURE 69. Impact Diagram, Target 34.

100% F-Kill, resulting from the following projectile impacts, shown in Figure 69:

NOTE: Roadwheels number 4 and 5 were hit on the right hand side of the tank (Impact number 16), and are not shown in this view.

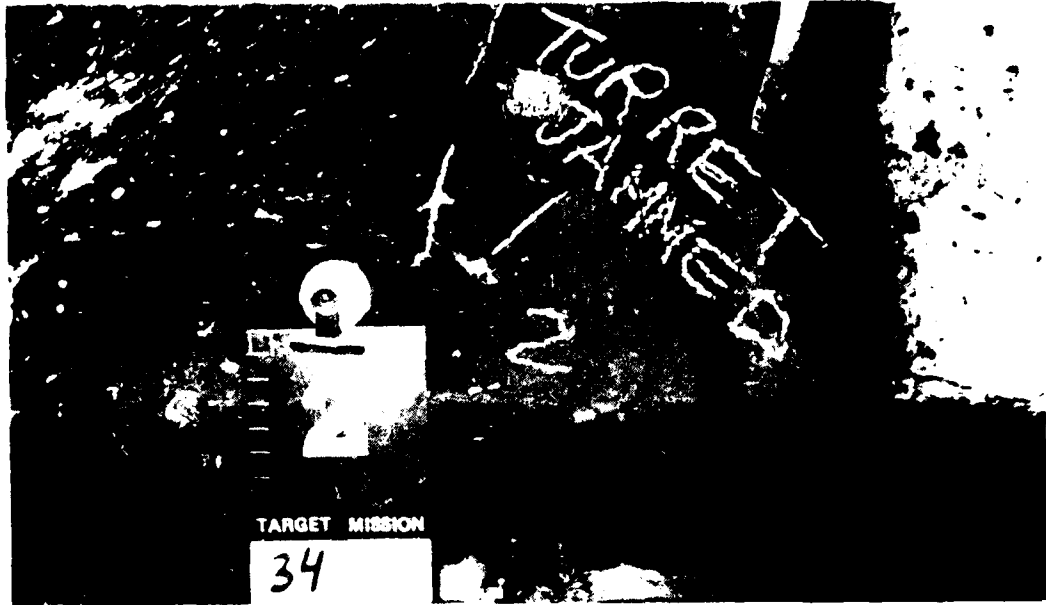
Impact 2 (Figure 70) hit between the turret and hull, bulging the armor on the inside, and jammed the turret so that it would not traverse. The perforation, shown in Figure 71, Impact 7, penetrated into the bulkhead ammunition stowage rack and into the adjacent stowage box, but did not impact any of the stowed ammunition.

FIGURE 70. Impact Two, Target 34, Penetration of Turret Ring between Hull and Turret, Armor Bulged, Turret Jammed.

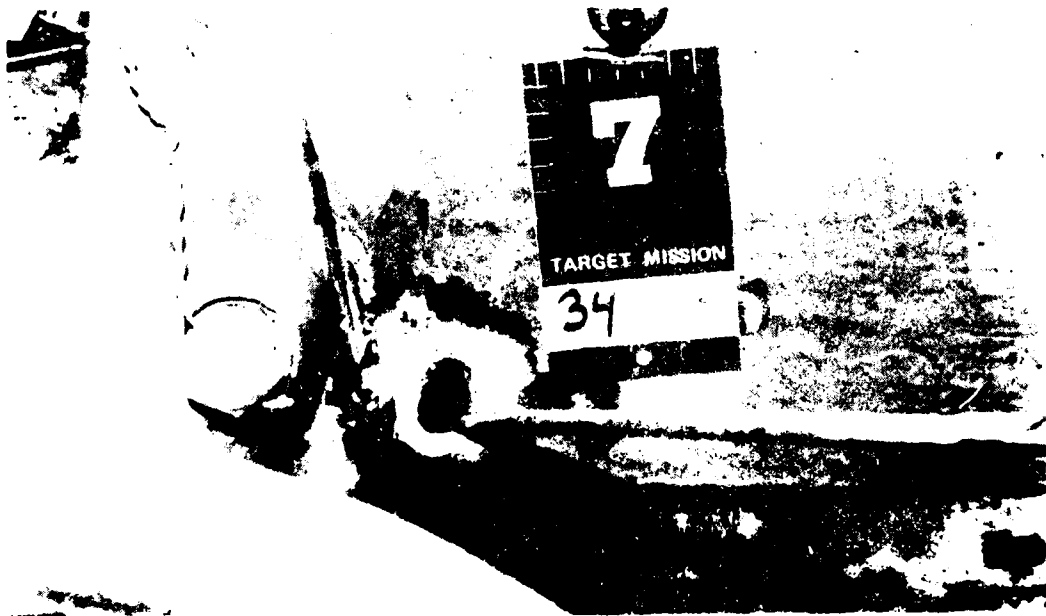
FIGURE 71. Impact Seven, Target 34, Penetration of the Left Hull Armor in the Stowage Area.
