NAVAL POSTGRADUATE SCHOOL

A-10/GAU-8 LOW ANGLE FIRINGS VERSUS
SIMULATED SOVIET TANK BATTALION
(HONEYWELL LOT NUMBER 0L78D043-016)
(ARRAY 3)
2 FEBRUARY 1979.
R.H.S. STOLFI
R.R. MCEACHIN
AUGUST 1980

Prepared for: A-10 System Program Office
Wright Patterson Air Force Base
Ohio 45433

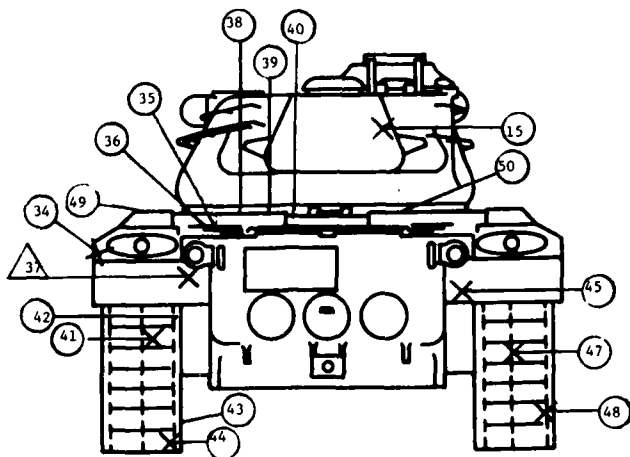
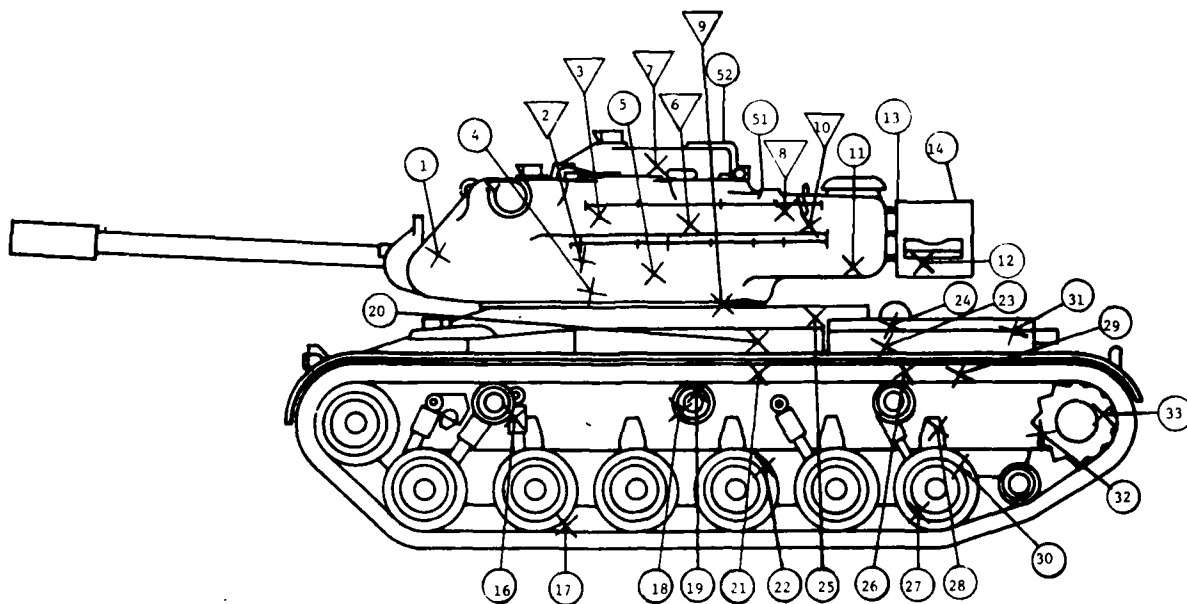
FIGURE 72. Impact Diagram, Target 35.

100% M-Kill and 100% F-Kill, resulting from the following projectile impacts, shown in Figure 72:

a. M-Kill: 100% M-Kill was due to crew casualties, shown in Figures 73, 74, and 75. It was caused by perforations into the fighting compartment from Impacts 2, 3, 6, 7, 8, and 10, and by cumulative damage to the track and suspension system from twelve other impacts. One other perforation (Impact 37) into the transmission compartment had no behind-the-plate effects.

IMPACTS 38, 39 and 40 ON EXTENDED FUEL TANK BRACKET

NOTE: The number 46 was not used in identifying hits.

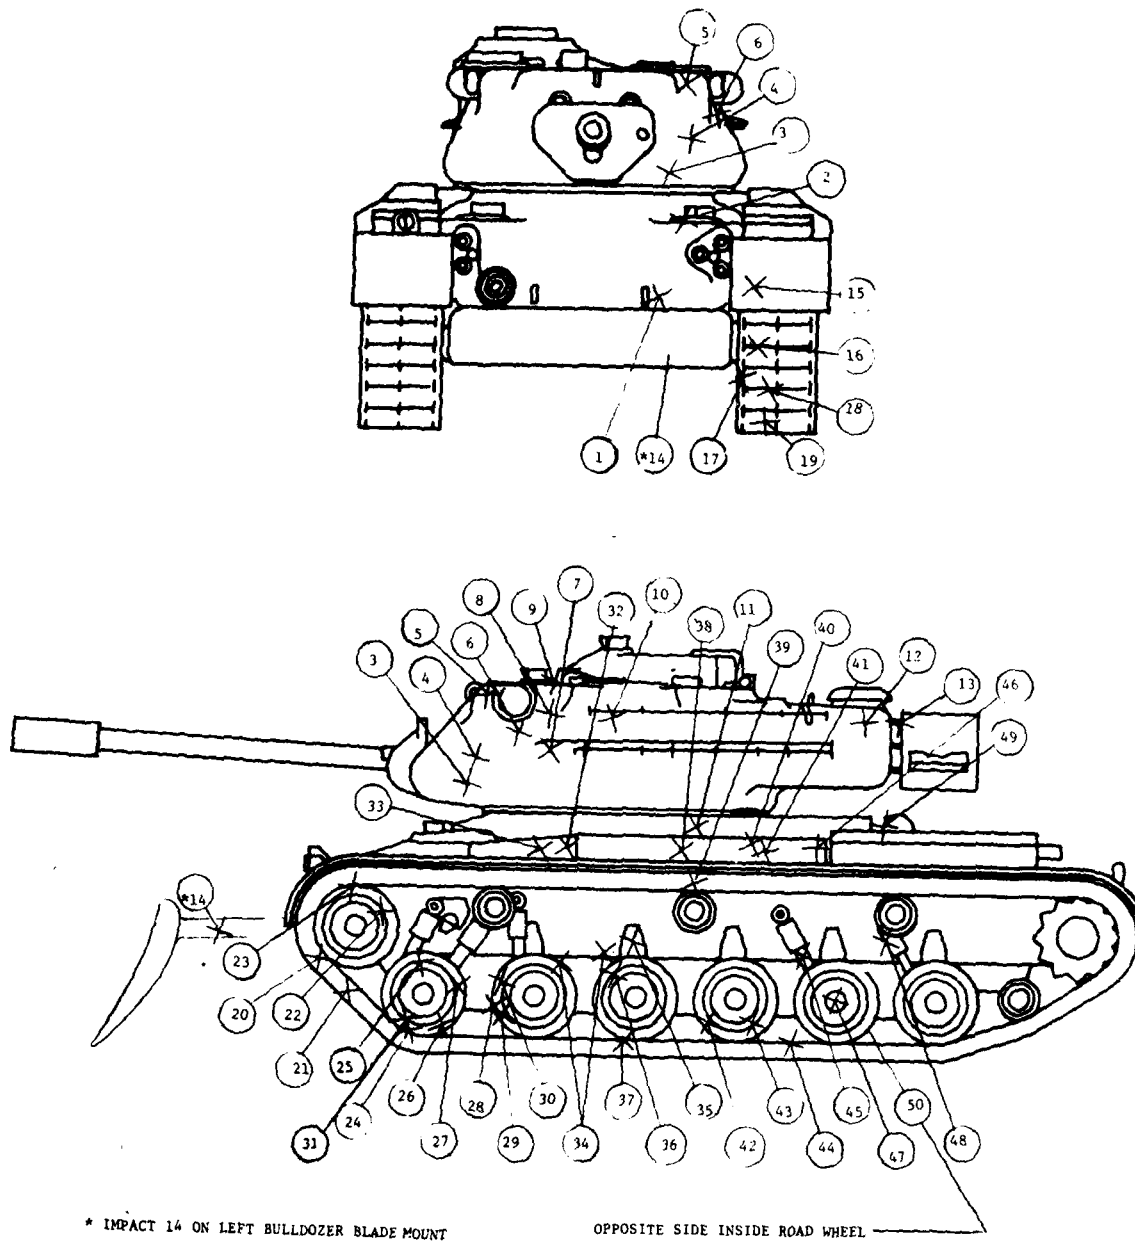
FIGURE 77. Impact Diagram, Target 36.

100% M-Kill, resulting from the following projectile impacts, shown in Figure 77:

Major damage to the track and suspension system was caused by Impact 30 (Figure 78), which destroyed the left #2 roadwheel hub and bearings; Impact 31 (Figure 79), which destroyed the left #1 track support roller hub; and Impact 47 (Figure 80), which destroyed the left #5 roadwheel hub and bearings; and by twenty-two other impacts, which inflicted a high level of cumulative damage to the track and suspension system.

* IMPACT 14 ON LEFT BULLDOZER BLADE MOUNT

OPPOSITE SIDE INSIDE ROAD WHEEL

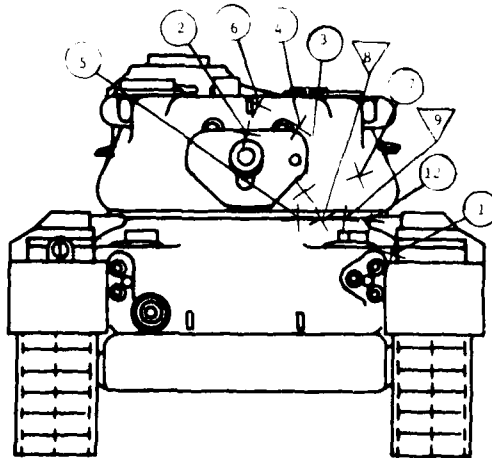
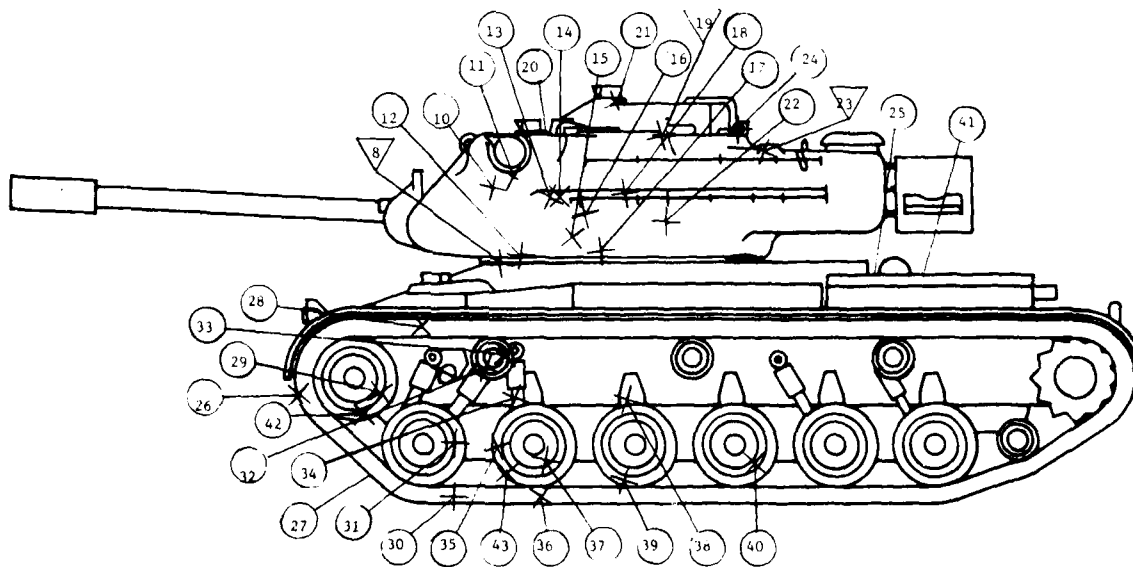
FIGURE 81. Impact Diagram, Target 37.

80% M-Kill and 100% F-Kill resulting from the following projectile impacts, shown in Figure 81:

- a. M-Kill: Mobility was estimated to have been degraded 80% by crew casualties and cumulative damage to the track and suspension system. The crew casualties resulted from impacts 9 and 19, and the cumulative track and suspension damage from 13 other impacts including 27, 29, 20, 31, 32, 33, 34, 35, 36, 37, 38, 39, and 40.

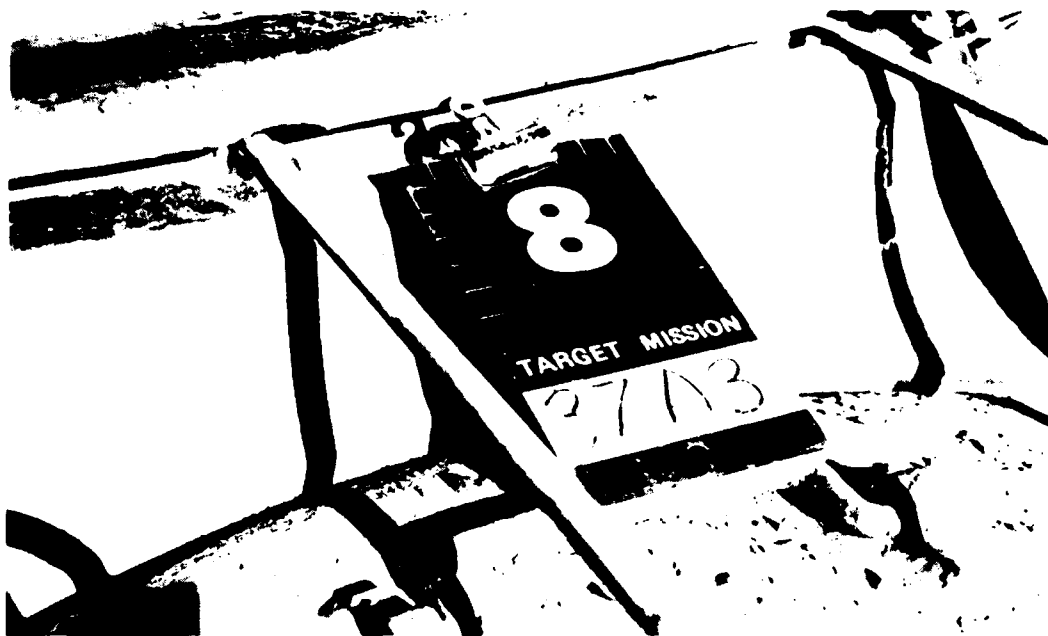
- b. F-Kill: A 100% F-Kill was assessed because of Impact 8, (Figure 82), which perforated the turret ring and jammed the turret; Impact 9 (Figure 83), which perforated the turret ring, jammed the turret, ignited propellant in an ammunition round in the ready rack, and wounded two crewmen (gunner and loader - Figures 84 and 85) and Impact 19, which perforated the lip of the loaders hatch, contributing to the loader casualty. One other perforation (Impact 23) of the antenna base aperture made no contribution to the kill. Two additional hits (Impacts 5 and 12) in the turret ring may have contributed to the jammed turret.

FIGURE 82. Impact Eight, Target 37, Perforations of Turret Ring which Jammed Turret.

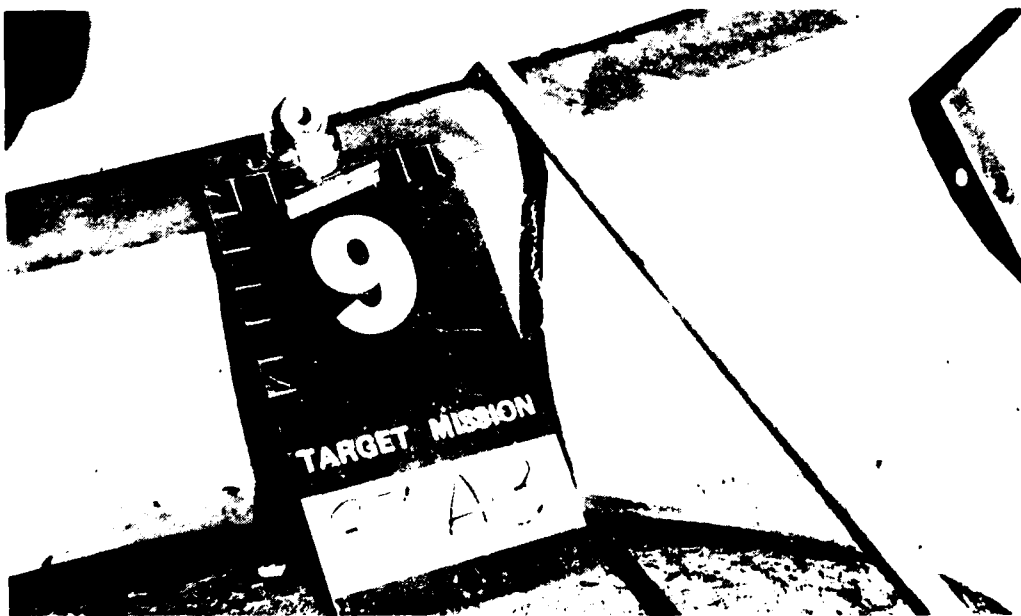
FIGURE 83. Impact Nine, Target 37, Perforations of Turret Ring which Jammed Turret.

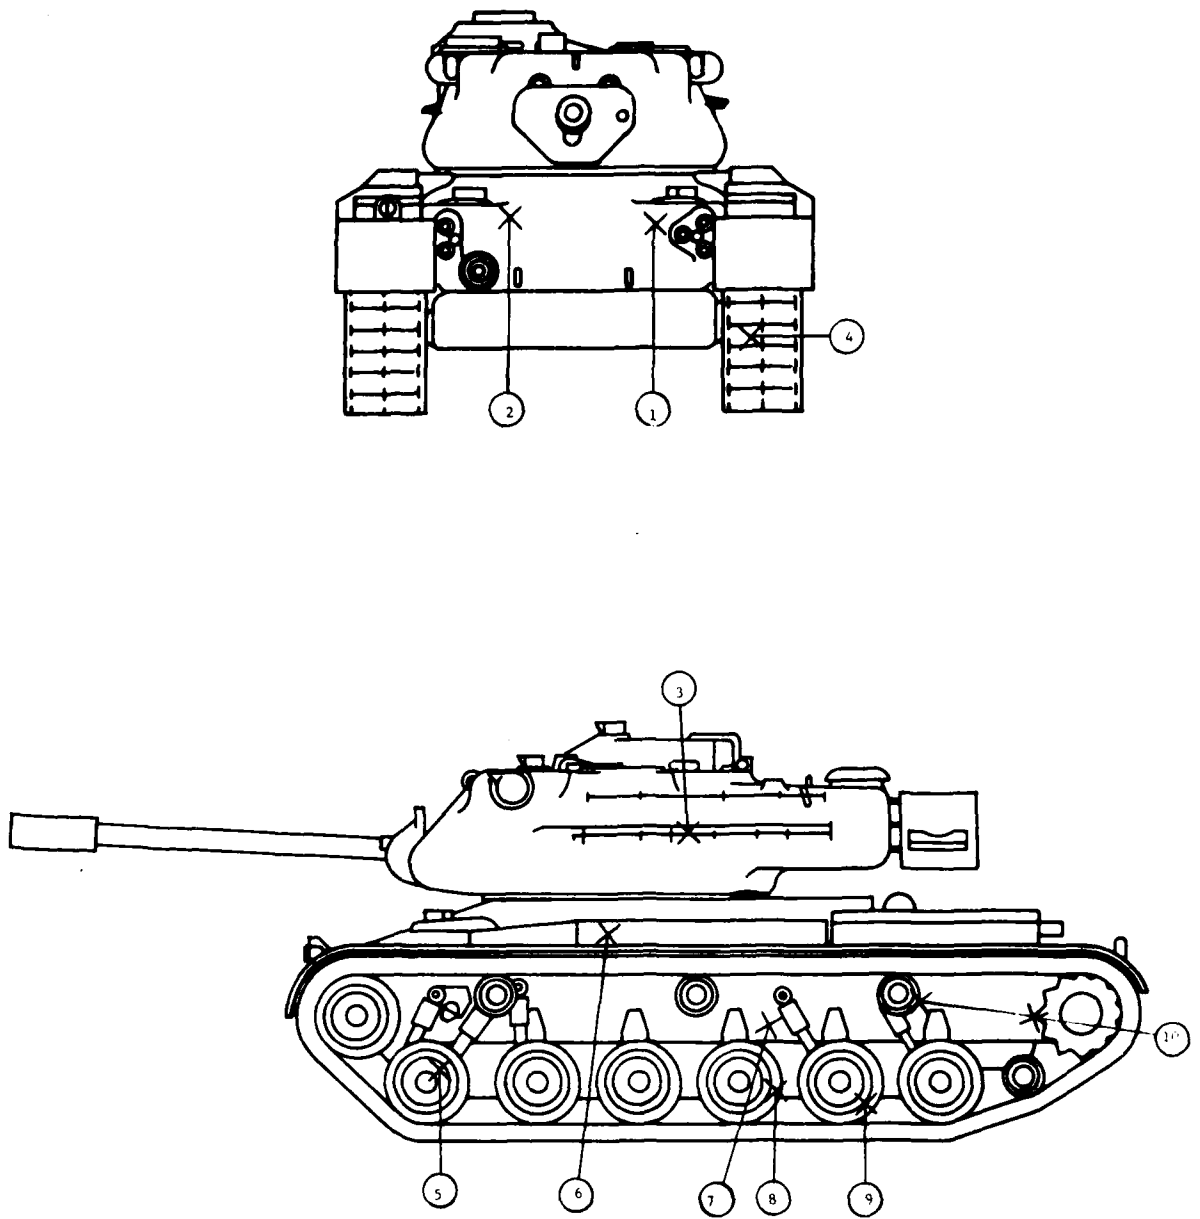
FIGURE 86. Impact Diagram, Target 38.

100% interdiction M-Kill, resulting from the following projectile impacts, shown in Figure 86:

A 100% interdiction type M-Kill after 5km travel was assessed due to impact 10 (Figure 87), which penetrated the left final drive, causing an oil leak (Figure 88) and possibly projectile and/or fragment damage to the gears. Minor track and suspension damage from 4 other impacts contributed to the kill.

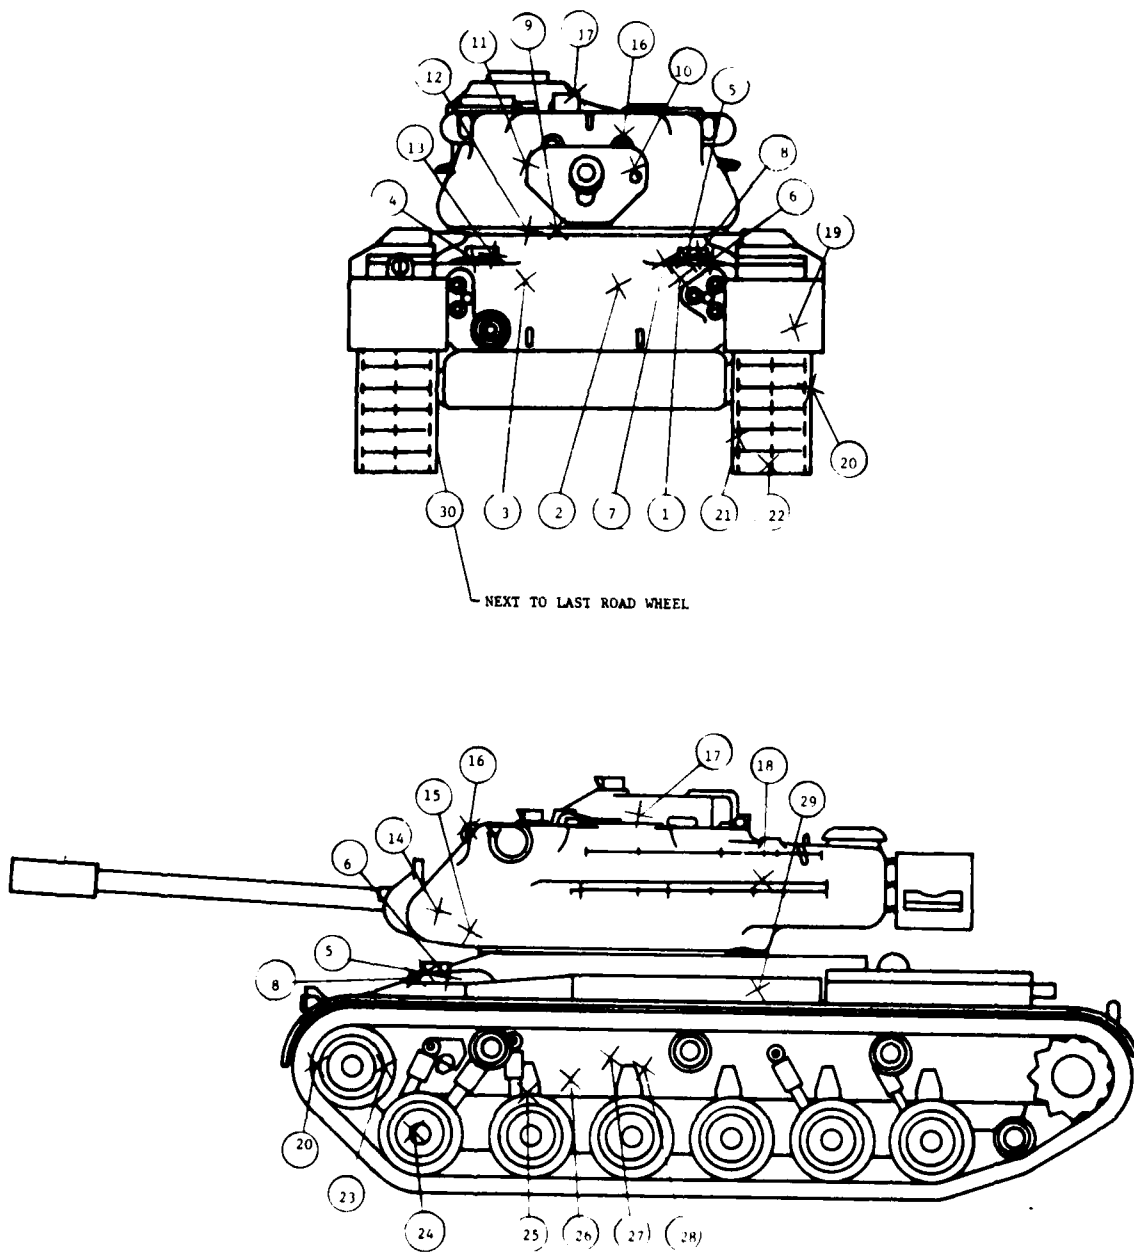
FIGURE 89. Impact Diagram, Target 39.

100% interdiction M-Kill and 50% F-Kill, resulting from the following projectile impacts, shown in Figure 89:

- a. M-Kill: A 100% interdiction type M-Kill after 5km travel was assessed because of Impact 24 (Figure 90), which destroyed the left #1 roadwheel hub, and because of cumulative damage to the track and suspension system resulting from 5 other impacts.
- b. F-Kill: The F-Kill was attributed solely to crew casualties. The tank commander was assessed a casualty from glass fragments because of Impact 17, shown in Figure 91, which shattered a vision block in his cupola.

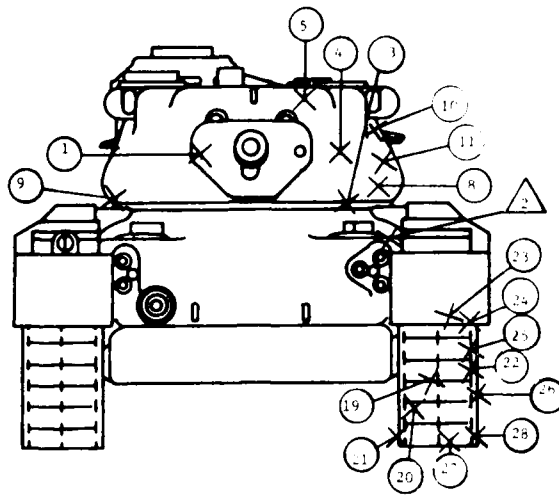
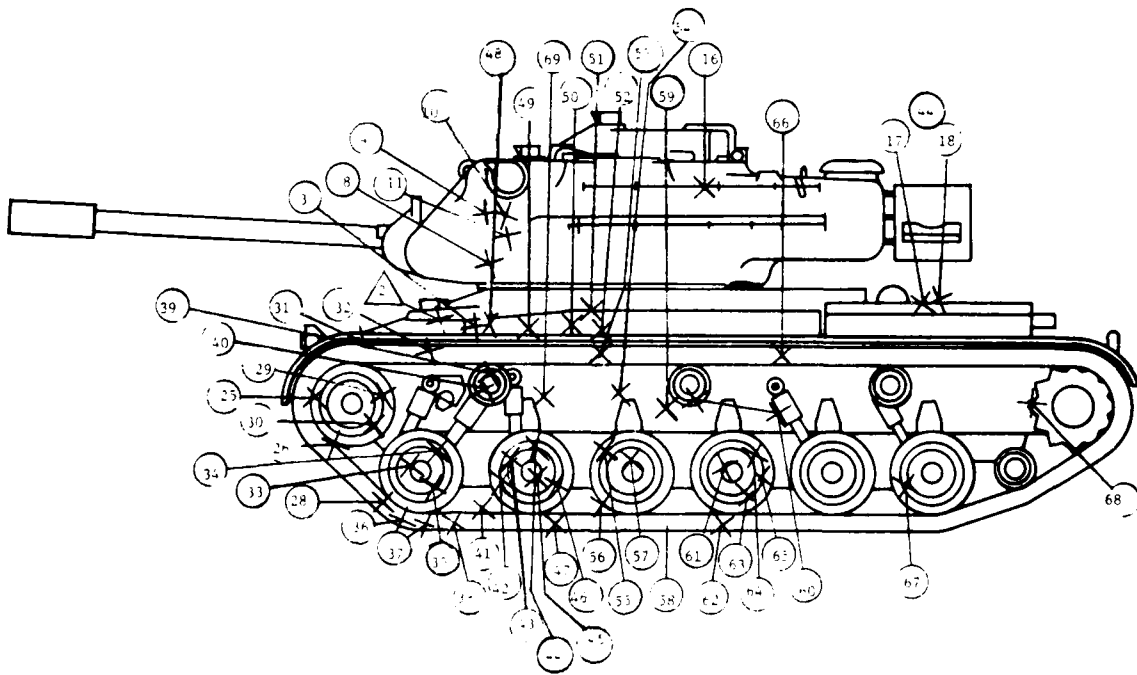
FIGURE 92. Impact Diagram, Front and Side, Target 40.

100% M-Kill, and 100% F-Kill, resulting from the following projectile impacts, shown in Figures 92 and 93:

- a. M-Kill: Impact 2, shown in Figure 94, perforated the driver's hatch cover, causing the driver to become a casualty (Figure 95). Impact 33 destroyed the left #1 roadwheel hub, shown in Figure 96. Impacts 42 and 45 destroyed the left #2 roadwheel hub, shown in Figure 97. Impact 57 destroyed the left #3 roadwheel hub, shown in Figure 98. Impact 61 destroyed the left #4 roadwheel hub, shown in Figure 99. Impact 68 penetrated the left final drive, shown in Figure 100. Impacts 39 and 40 destroyed the left #1 track support roller, shown in Figures 101 and 102. Cumulative damage to the track and suspension system from 19 other impacts contributed to the kill.

NOTE: Impacts 69, 70 and 71 not shown.

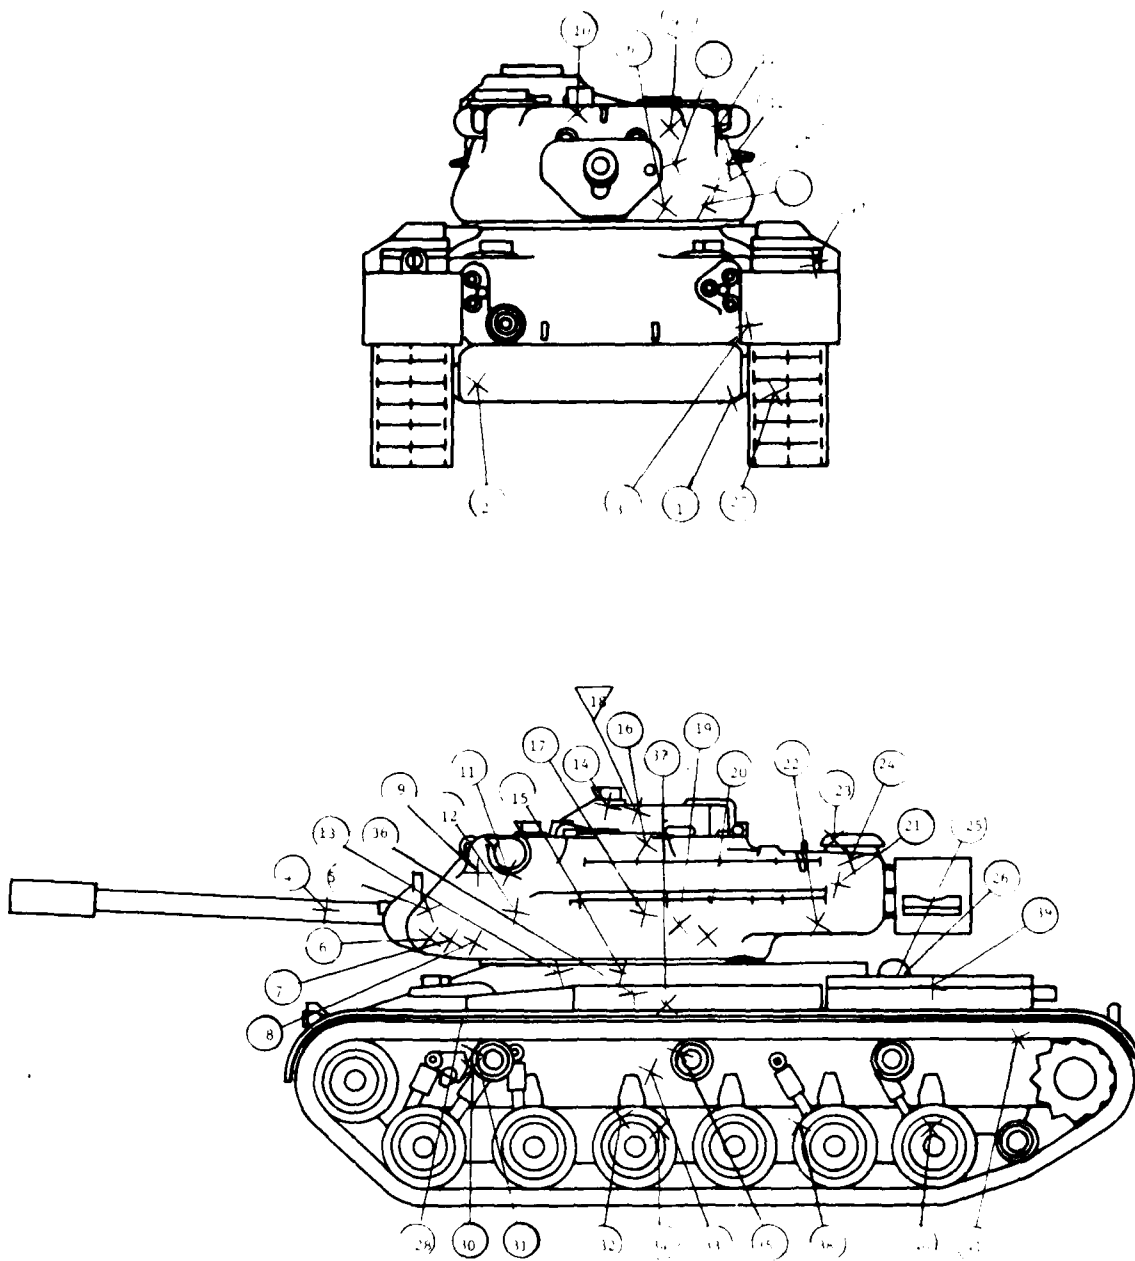
FIGURE 106. Impact Diagram, Target 41.

65% M-Kill, and 95% F-Kill, resulting from the following projectile impacts, shown in Figure 106:

- a. M-Kill: Mobility was estimated to have been degraded by 65% due to crew casualties caused by Impact 18. Minor damage to the track and suspension system, caused by Impacts 27, 30, and 32, also made a contribution to the kill.
- b. F-Kill: A 95% F-Kill was assessed for Impact 18, shown in Figure 107, which perforated the commander's cupola into the fighting compartment and caused commander and gunner casualties. Impact 11, which destroyed the range finder blister, also made a significant contribution to the kill.

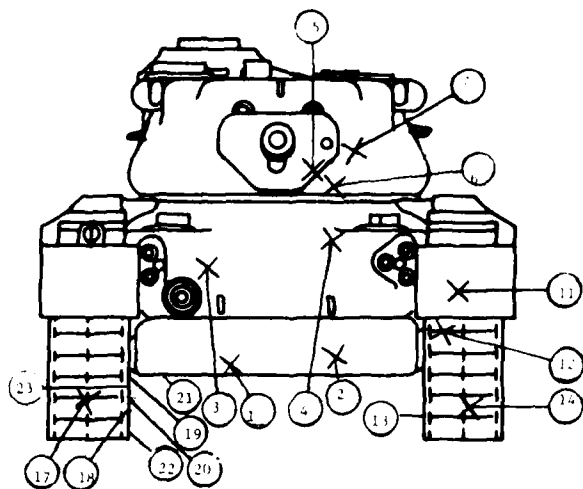
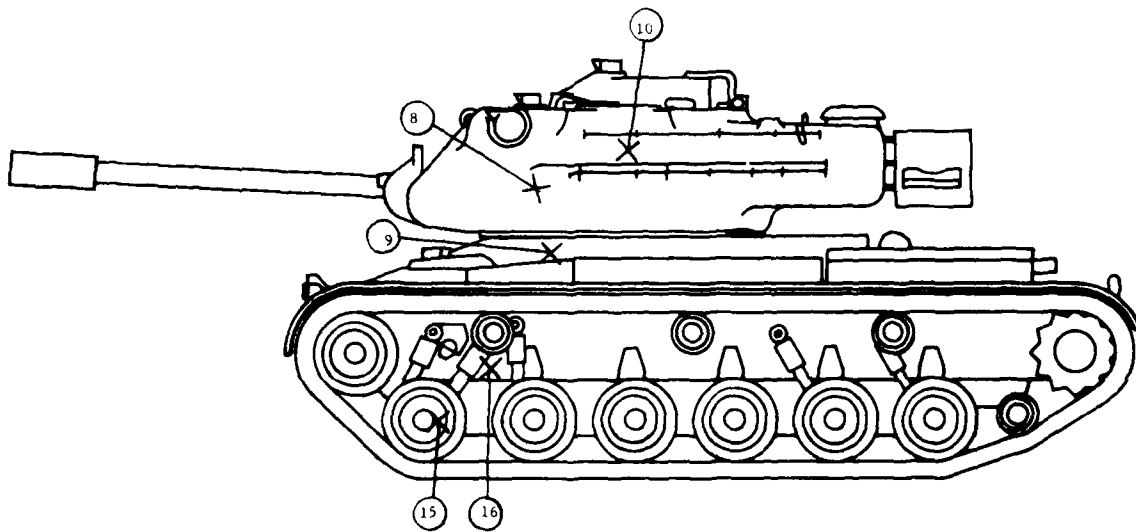
FIGURE 108. Impact Diagram, Target 42.

100% interdiction M-Kill, resulting from the following projectile impacts, shown in Figure 108:

A 100% interdiction type M-Kill, after an estimated 2000 meters travel, was assessed for Impacts 17 and 18, shown in Figures 109 and 110, respectively, which destroyed two (2) end connectors on opposite ends of the same track pins, leaving only the track center guide to hold the track together. Cumulative damage to the track and suspension system by 5 other impacts contributed to the kill.

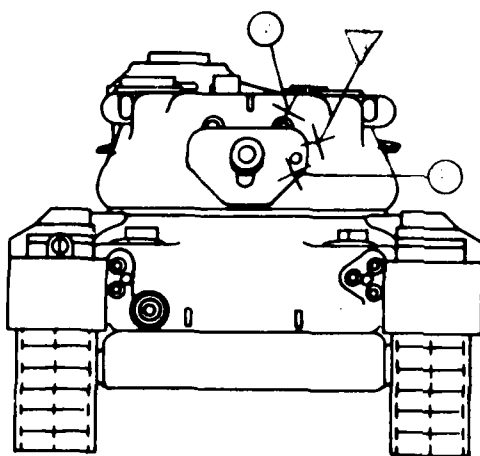
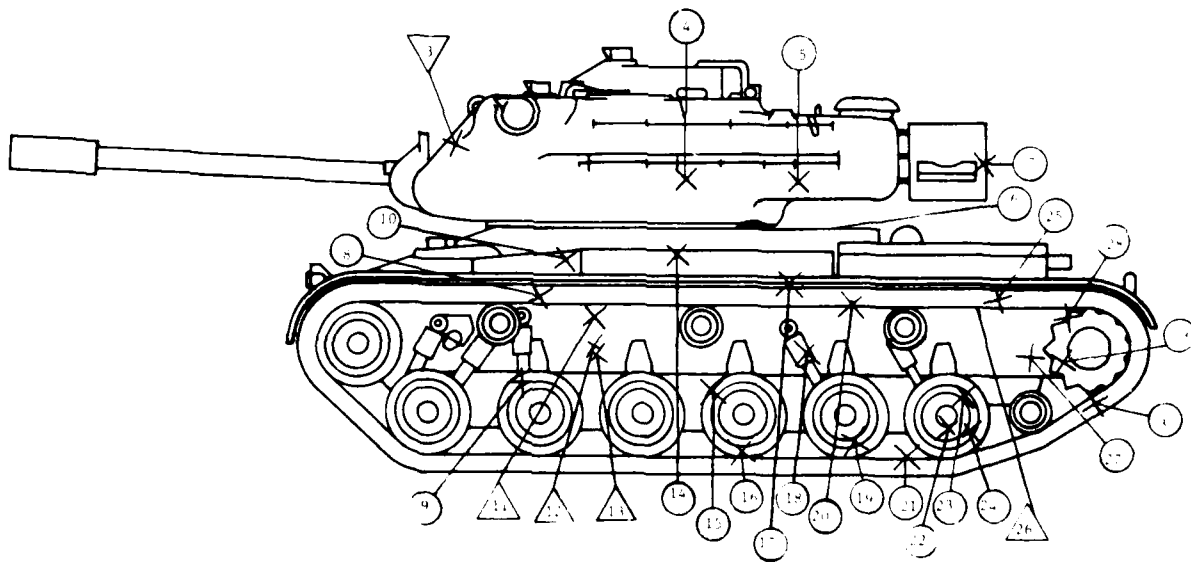
FIGURE 111. Impact Diagram, Target 43.

100% M-Kill and 100% F-Kill, resulting from the following projectile impacts, shown in Figure 111:

- a. M-Kill: Impacts 25 and 28 penetrated the left final drive, shown in Figures 112 and 113, respectively. Impact 22 destroyed the left #6 roadwheel hub (Figure 114). Cumulative damage to the track and suspension system, resulting from 10 other impacts, contributed to the kill.
- b. F-Kill: Impact 3 (Figure 115) perforated the left front turret, severed the recoil cylinder/replenisher flexible hose, and wounded the tank commander and gunner (figures 116 and 117). Four (4) other perforations of the hull had little or no behind-the-plate effects.

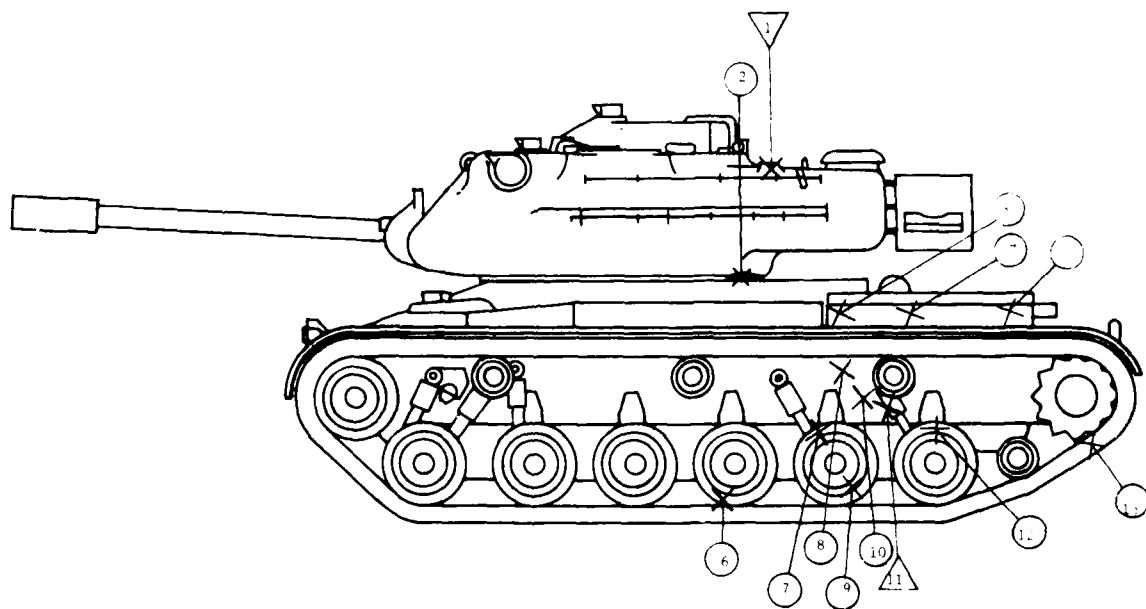
FIGURE 118. Impact Diagram, Target 44.

100% M-Kill, and 95% F-Kill, resulting from the following projectile impacts, shown in Figure 118:

- a. M-Kill: Impact 11 (Figure 119) perforated the left hull and penetrated the oil cooler area; if the oil cooler had been in place, it would have been damaged or destroyed. Impact 12 ruptured the left final drive causing an oil leak. One other impact on the track destroyed one track center guide, making a minor contribution to the kill.
- b. F-Kill: Impact 1 (Figure 120) perforated the left top of the turret and caused casualties to two (2) crewmen (tank commander and gunner). No mechanical damage that would contribute to an F-Kill was observed.

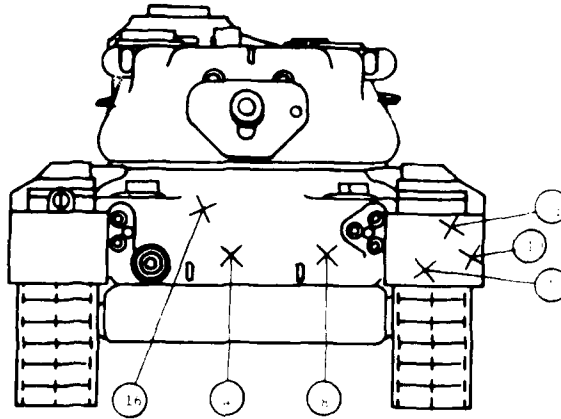
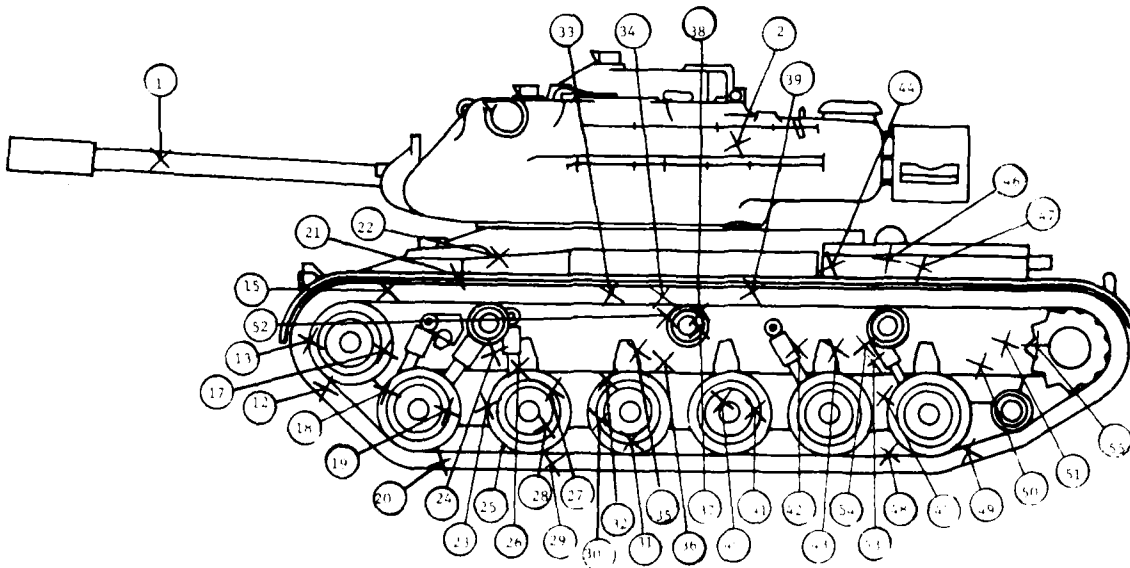
FIGURE 121. Impact Diagram, Target 45.

100% M-Kill and 10% F-Kill, resulting from the following projectile impacts, shown in Figure 121:

- a. M-Kill: Impact 28 damaged the hub of the left #2 road-wheel, causing a breach of the seal assembly. Impact 40 (Figure 122) destroyed the left #4 roadwheel hub. Impacts 37 and 38, shown in Figures 123 and 124, respectively, destroyed the left #2 track support roller. Cumulative damage to the track and suspension system from 15 other impacts contributed to the kill.
- b. F-Kill: Impact 1 (Figure 125) penetrated one wall of the gun tube, degrading firepower by an estimated 10%.

IMPACTS 3, 4, 5, 6, 7, and 14 ON BULLDOZER BLADE BRACKETS

NOTE: Not shown in the impact distribution drawing above, but recorded in firing results are hits number 3, 5, 6, 7 and 14 on bulldozer blade, and its mounting bracketry and actuating hydraulic cylinder.
