ESL-TR-80-42

## SMALL CRATER EXPEDIENT REPAIR TEST

KENNETH J. KNOX  
ENGINEERING RESEARCH DIVISION

AUGUST 1980

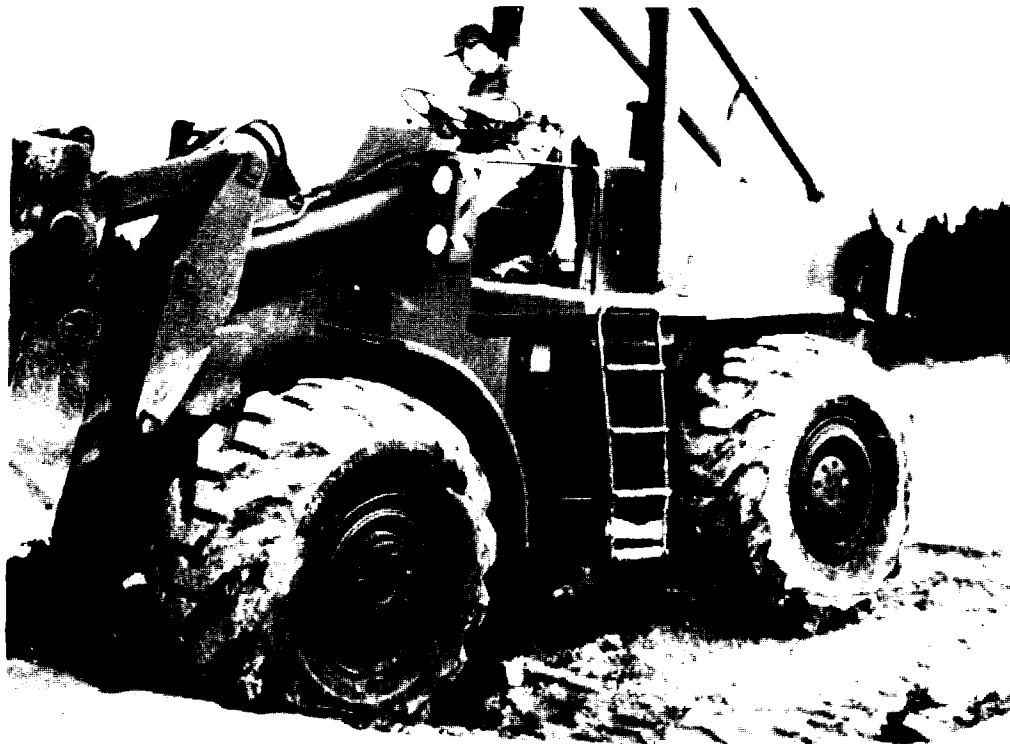
Figure 21. Compacting Debris Backfill with the Loader

plan was to build a working platform with crushed limestone on top of the clay backfill, and then compact the clay using the loader tires to the required 24-inch depth as shown in Figure 21. However, the clay failed to significantly compact under the loader tire loads. This resulted in a debris backfill that was approximately 15 inches from the surface and poorly compacted. The repair team OIC reported seeing voids in the backfill as a result of insufficient compaction of the clay chunks.

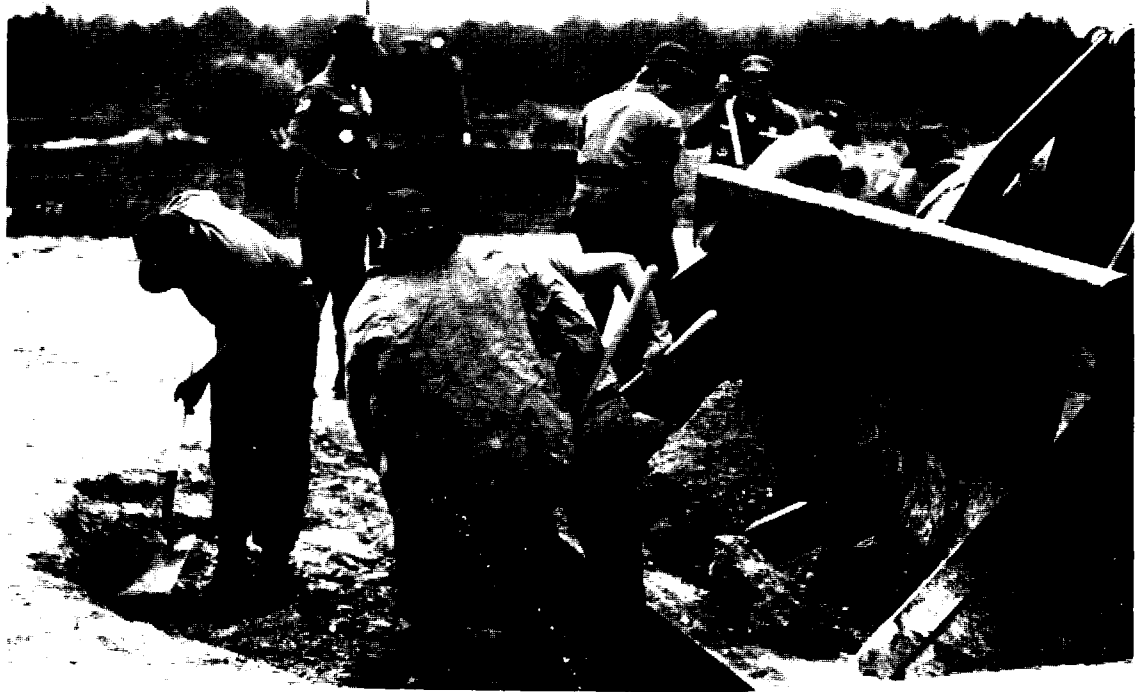
Figure 22. Cleaning the Debris Around the Crater Edges

Another significant problem in the debris backfill phase of the repair was the removal of debris along the edges of the crater. The size of the bucket on the loader precluded effective edge cleaning, requiring a large amount of handwork along the crater perimeter (Figure 22). This problem was seen throughout the Small Crater Test.

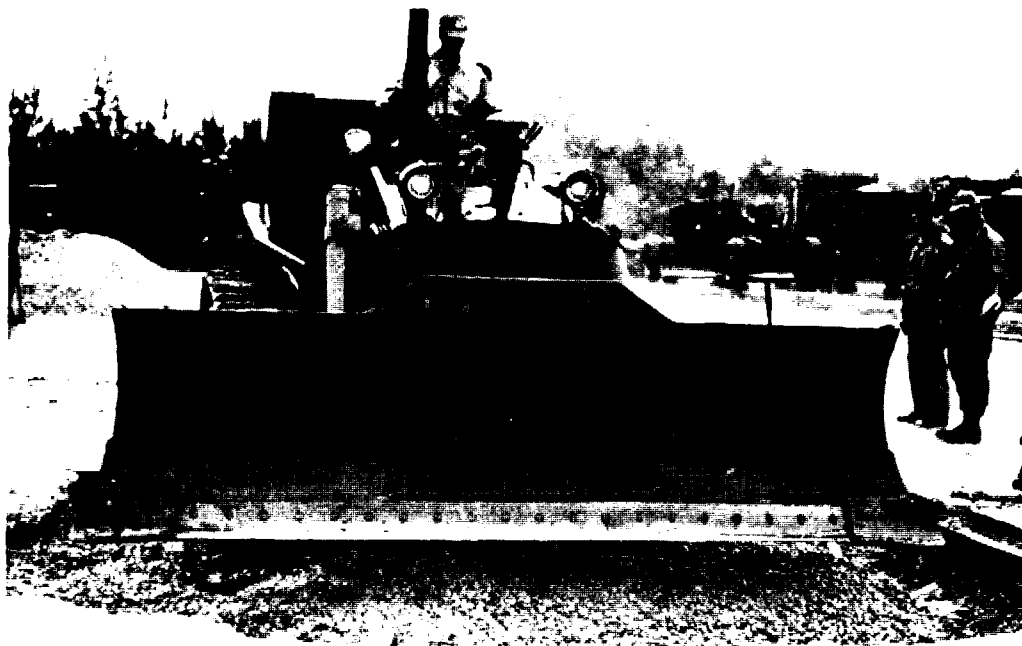
Figure 24. The Dozer Inside a Small Crater

The dozer blade was found too large for the crater, as shown in Figure 24. The blade only contacted the pavement at two points, and the dozer was unable to be positioned properly for removing the pavement due to its large size relative to the crater (the dozer was almost as big as the crater and moved awkwardly inside the crater). Also, the dozer was not operating at its full power, as mentioned in Section II. The loader, with either the bucket or forks, lacked sufficient power and weight to remove the pavement. Only the ripper tooth was able to achieve any success in removing pavement (Figure 25). The ripper was able to chip away the pavement in one- to two-foot chunks, a very inefficient and time-consuming process. The current BDR kits do not have any rapid and efficient means for removing upheaved pavement from small craters.

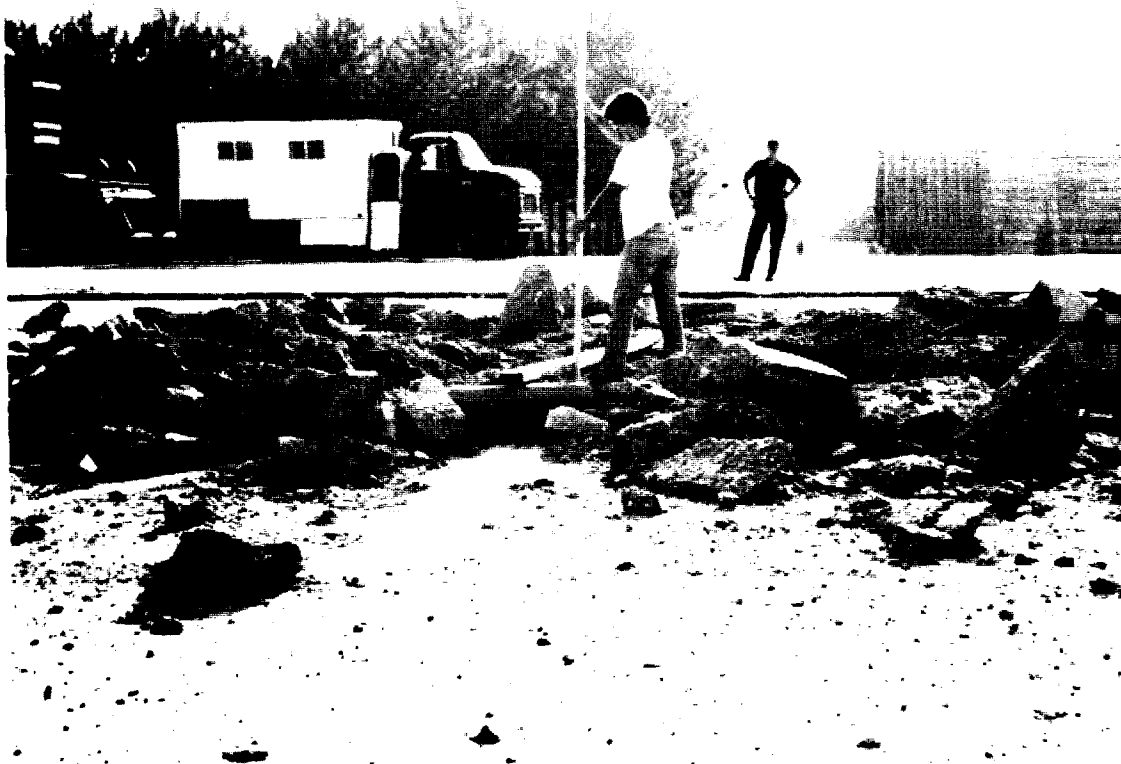
Figure 38. Crater 2

and for removal of the shattered pavement around the crater. However, due to its large physical size relative to the crater and its lack of power, the dozer proved very inefficient and was dismissed after seven minutes. Additional time was also lost due to difficulty in obtaining sufficient debris to fill the crater to the desired depth. The loader operator had immediately cleared the larger pavement slabs and some of the debris to the side of the runway upon arrival at the crater site. Thus, the loader operator ran out of material to push back into the crater and had to go to the pavement edge to get additional debris to backfill the crater. The loader operator was also forced to use some of the berm along the pavement edge in order to avoid placing the large concrete slabs into the crater. As discussed in the subsection on the crushed limestone repair, it would probably be wise to specify a minimum depth for the 2-inch stone and allow the repair team OIC/NCOIC to determine the most expedient method of filling the crater.

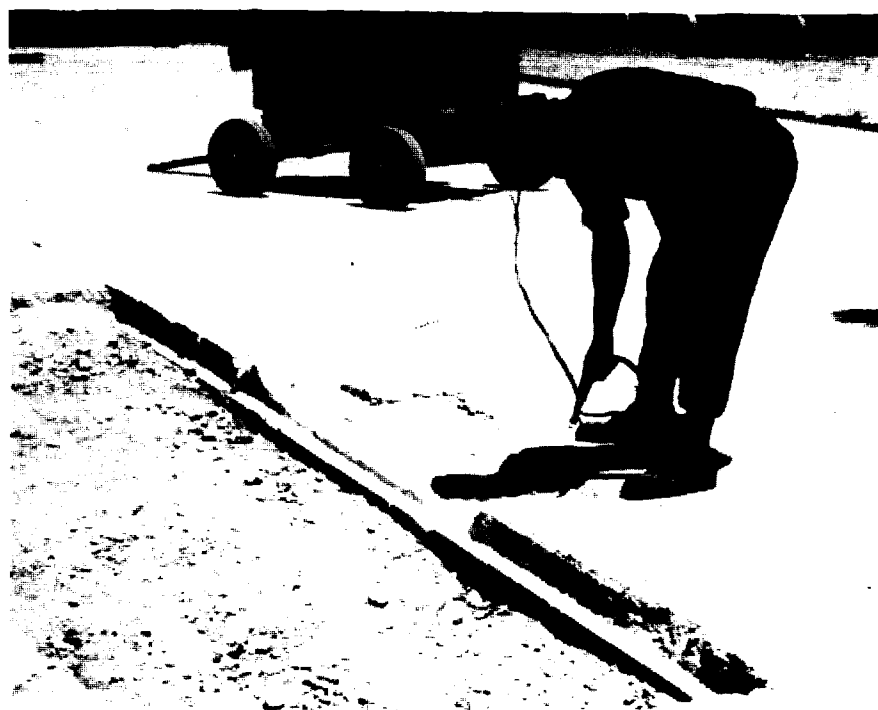
Figure 43. Cleaning the Pavement Edges With the Air Compressor

The next activity on the critical path was to clean all loose debris from the edges of the pavement. This was accomplished by using an air compressor on the south and east sides of the crater (Figure 43) and brooms on the north and west sides. Two methods were used to determine if one method of cleaning the edges was superior to the other, either in terms of the actual cleaning, actual performance under trafficking, or speed. It was found that while both methods of cleaning performed comparably under trafficking, the air compressor was preferred for its faster and more thorough cleaning. Also, two of the three brooms broke while sweeping the crater edges.

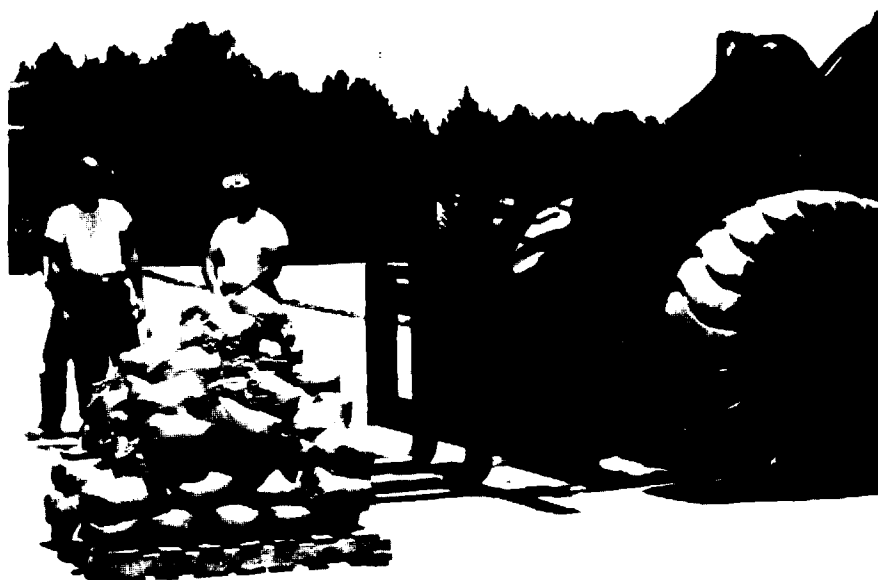
Figure 44. Pallet of Silikal®

While the crater edges were being cleaned, the forklift began unloading the pallets of polymer material from the lowboy. As can be seen in Figure 44, the bags of Silikal® polymer-mortar were stacked unbound on the pallets. This presented a problem to the forklift operator, as bags of the powder kept falling off the pallet during handling. An improved packaging method would be required if this type of repair is adopted for use by the Air Force.

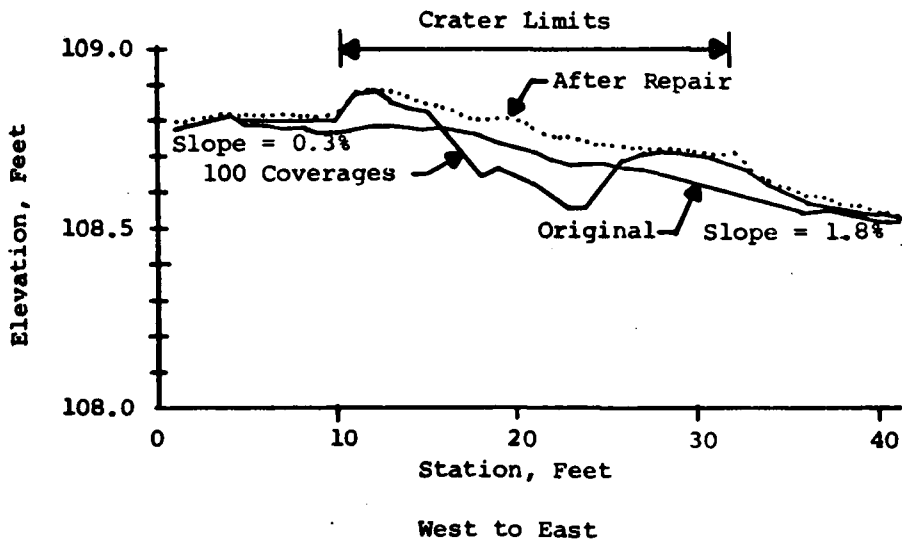
After Repair: Maximum Upheaval = 1.7"      100 Coverages: Maximum Upheaval = 1.5"  
Maximum Sag = 1.0"      Maximum Sag = 2.2"
