TECHNICAL REPORT GL-81-2

# 15 MILE ROAD/EDISON CORRIDOR SEWER TUNNEL FAILURE STUDY DETROIT AREA, MICHIGAN

January 1981

Final Report

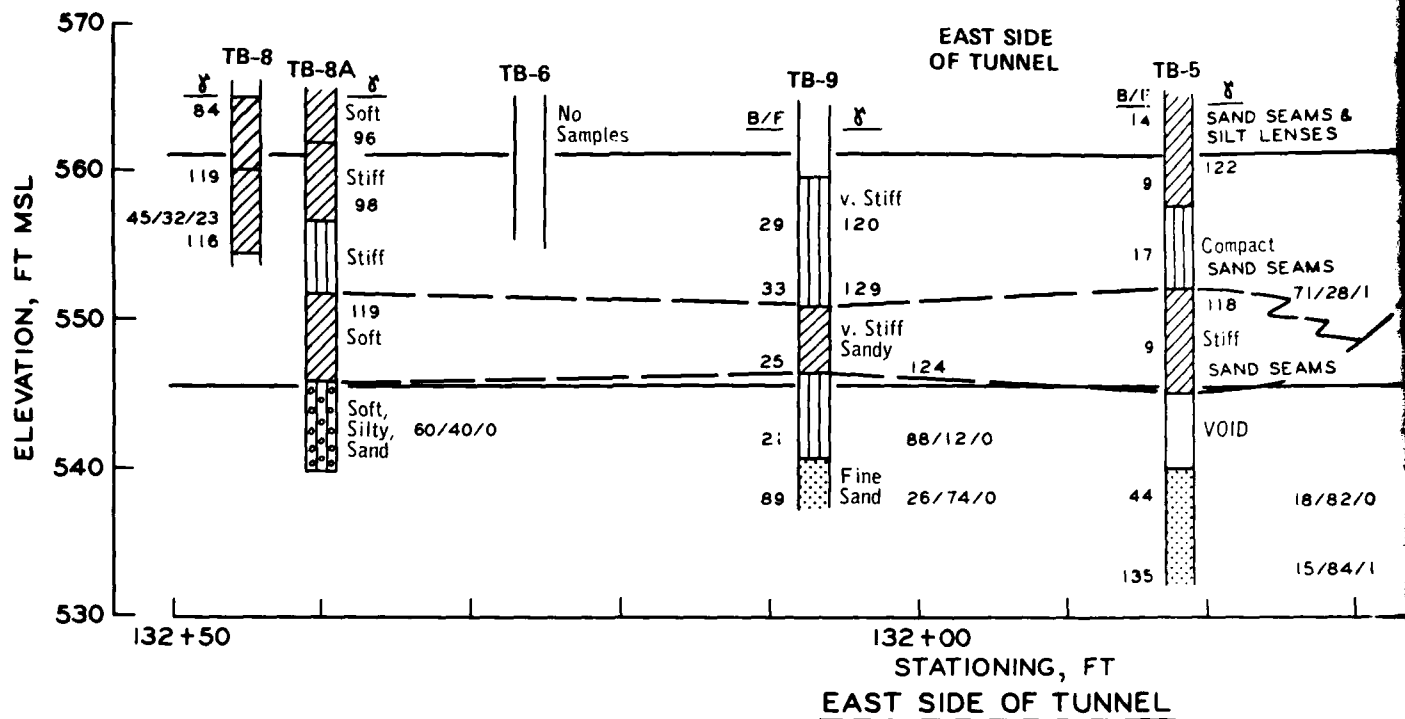
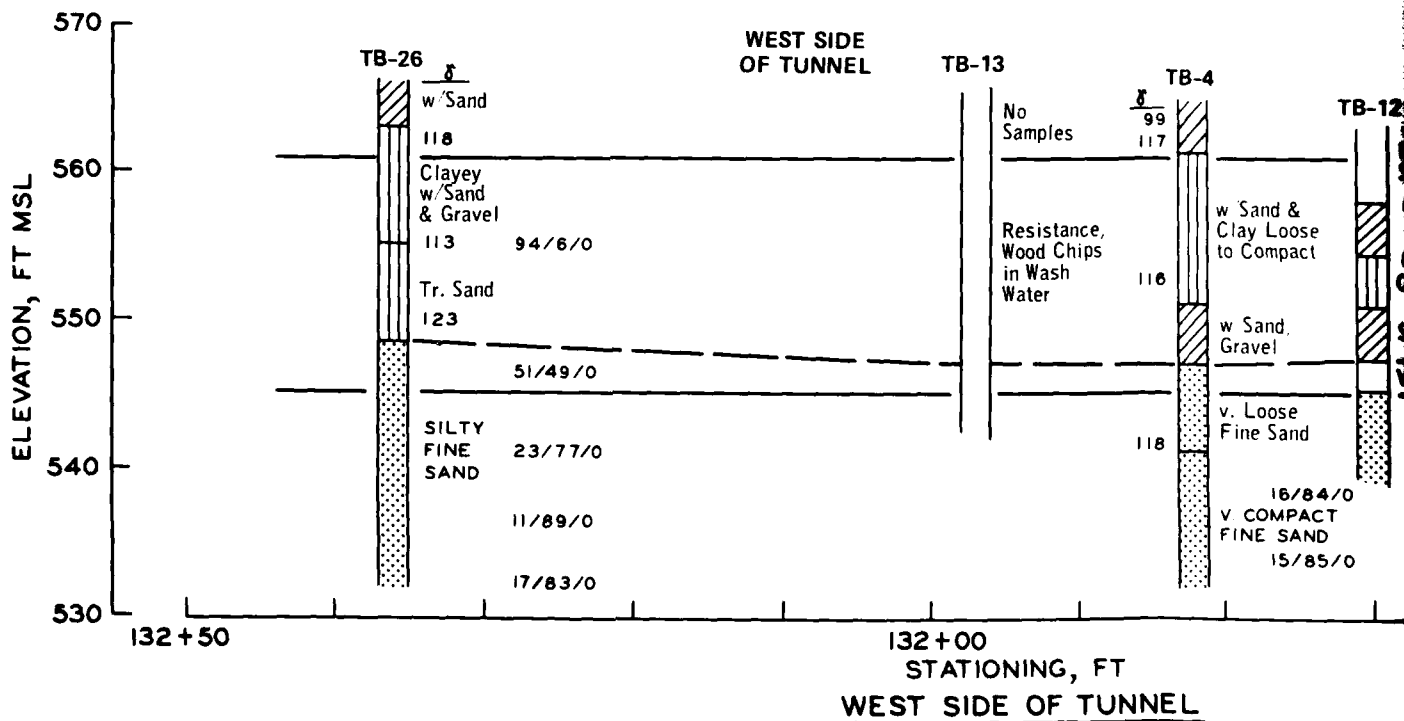
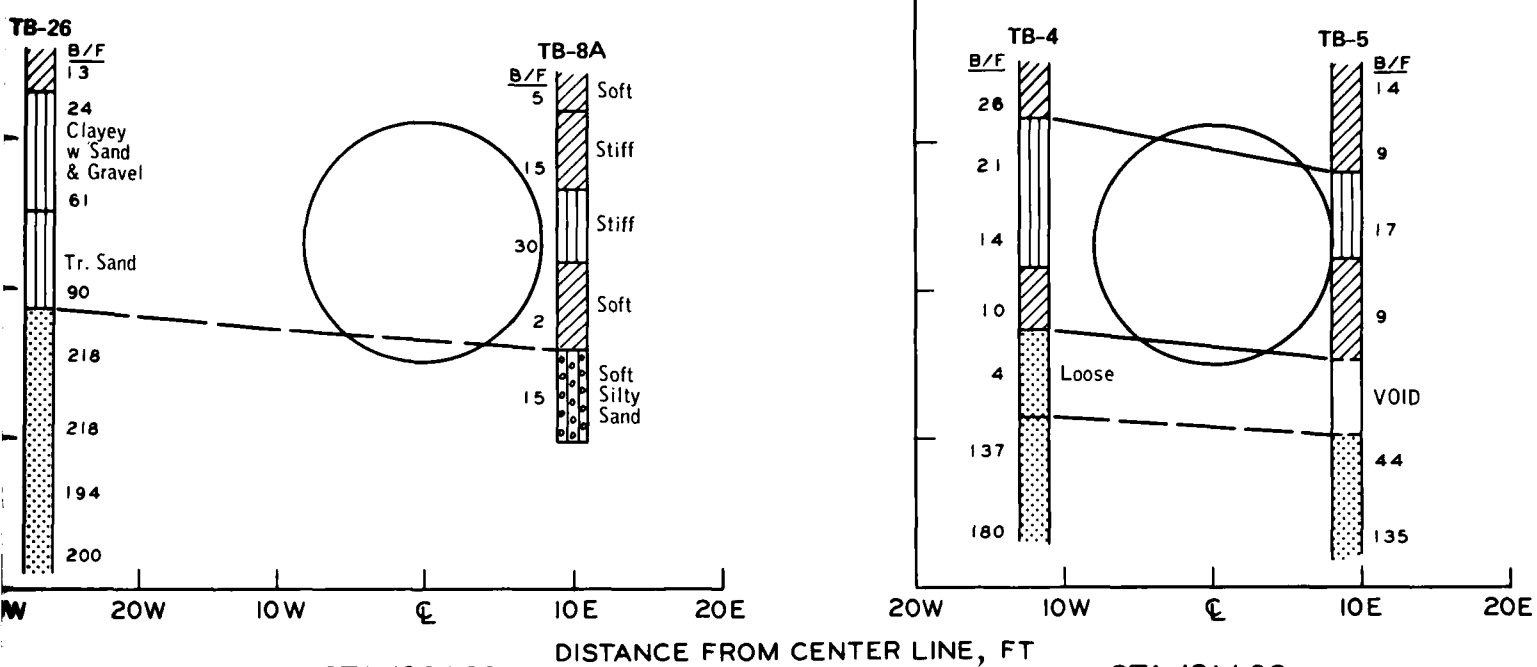
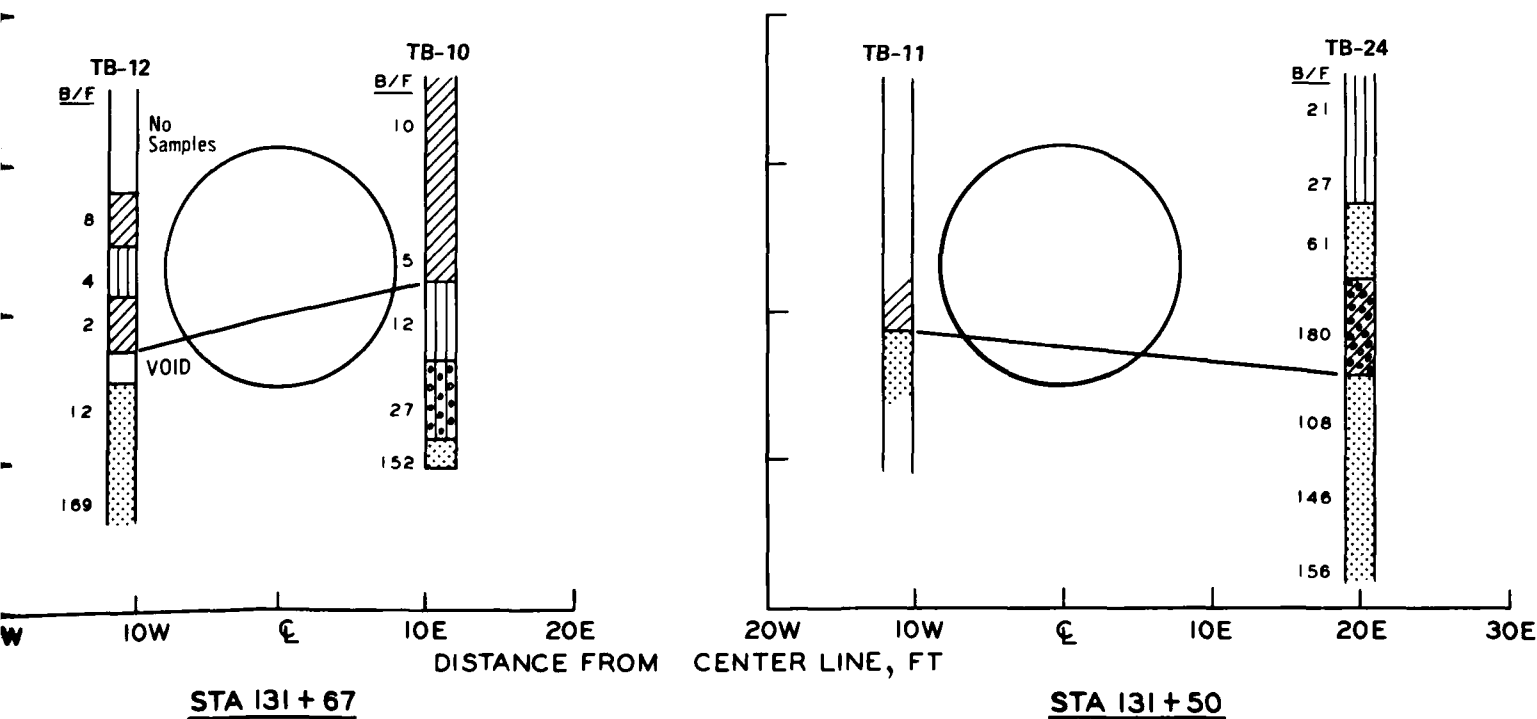
Figure 14. Profiles and sections in Distressed Area 1, 15 Mile Road/Edison Corridor Tunnel Failure Study

- d. Distressed Area 1. Detailed 1 to 1 profiles and sections constructed from logs of the closely spaced TB borings made in early February 1980 on either side of the tunnel, in the central portion of Distressed Area 1 are shown in Figure 14. The tunnel profile and sections are for the as-built location before distress. Silty sand, silt, and fine sand exist along the base of the tunnel; clay and silt strata exist above the sand. The material excavated during mining in this segment noted considerable sand along with clay, sandy clay, stones and rocks (Table 7). Borings TB-4 and 8A show loose sand and soft clay strata. Voids were also found adjacent to the invert in TB-5 and TB-12. The sections show the variable stratification on either side of the tunnel. Lines connecting similar strata indicate orientation of silt, clay, and sand around the tunnel periphery, before distress. The density values from split spoon samples are shown on the profiles in Figure 14. Although split spoon samples are considered disturbed samples, the dry densities (excluding the effects of water content) provide a relative measure or index of in situ conditions. Low density values are indicated for the soft to stiff clay above the crown at Sta 132+40 (TB-8 and TB-8A) and in the silt layer at Sta 131+40 (TB-12). Dry densities for other strata range from 113 to 129 pcf. These values are within the range for samples from other locations as shown in Figure 15. It should be noted from Figure 15 that there is a wide range in dry densities at the tunnel site. Thus, low density values may be a result of the natural variation in the complex stratification. Gradation data shown in Figure 14a indicates that the beach sand unit along the base of the tunnel is primarily a silty sand. The sand content increases with depth. Very low blow counts of 2 to 15 (compared to blow counts of 33 to 83 in preconstruction borings C-224 and C-176, Figure 9) can be noted close to the tunnel in Figure 14b. Final collapse of the tunnel crown at Sta 131+80 occurred during the time the TB borings were being drilled

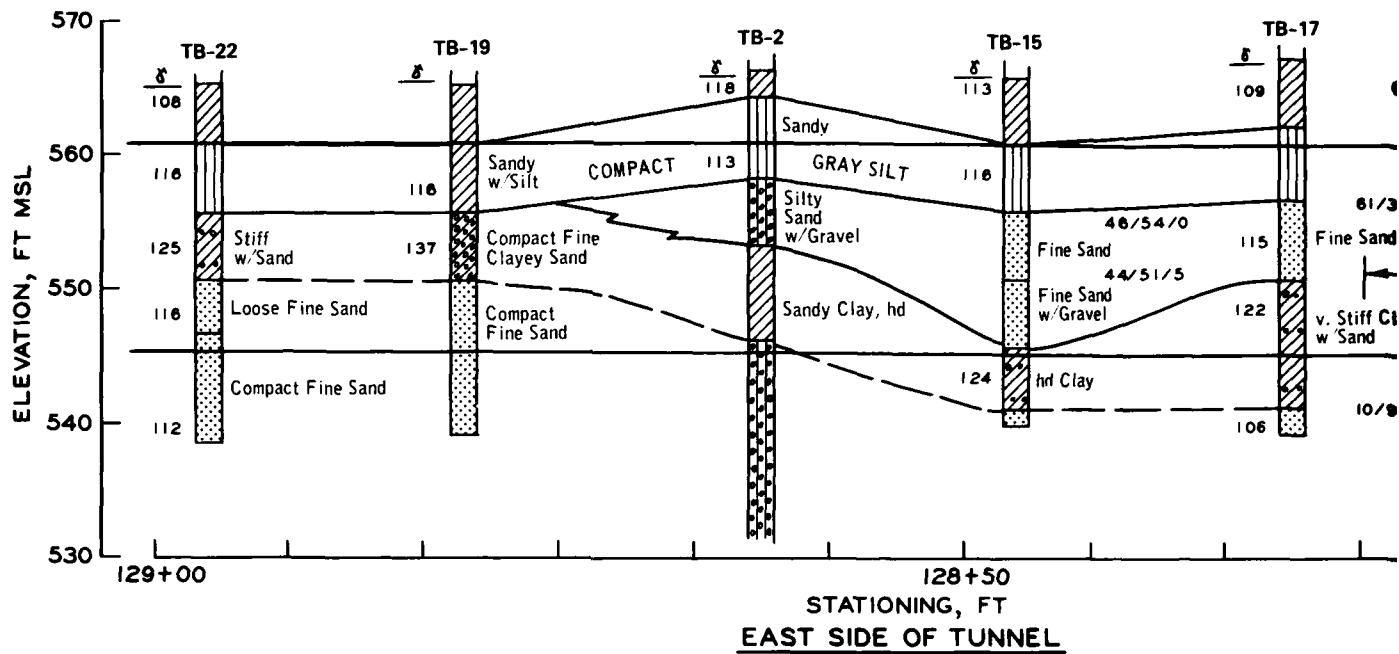
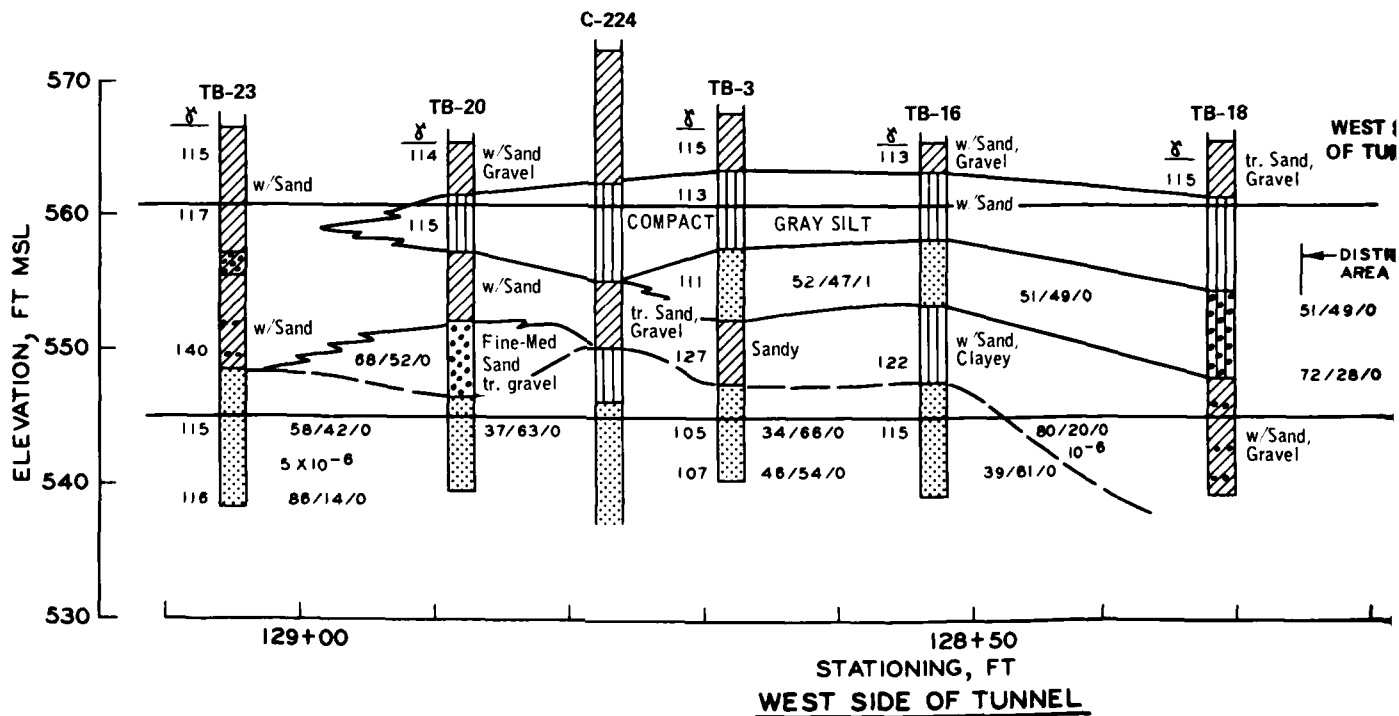
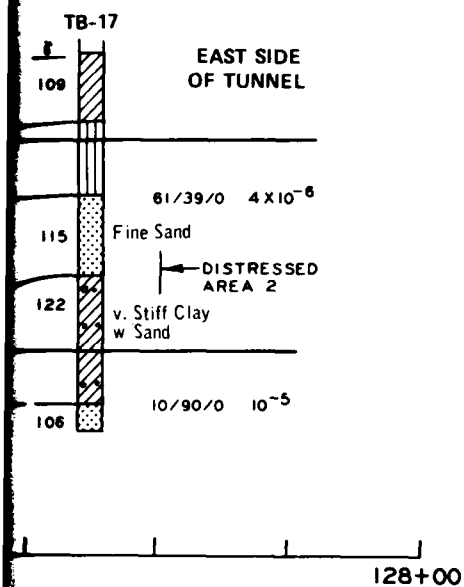
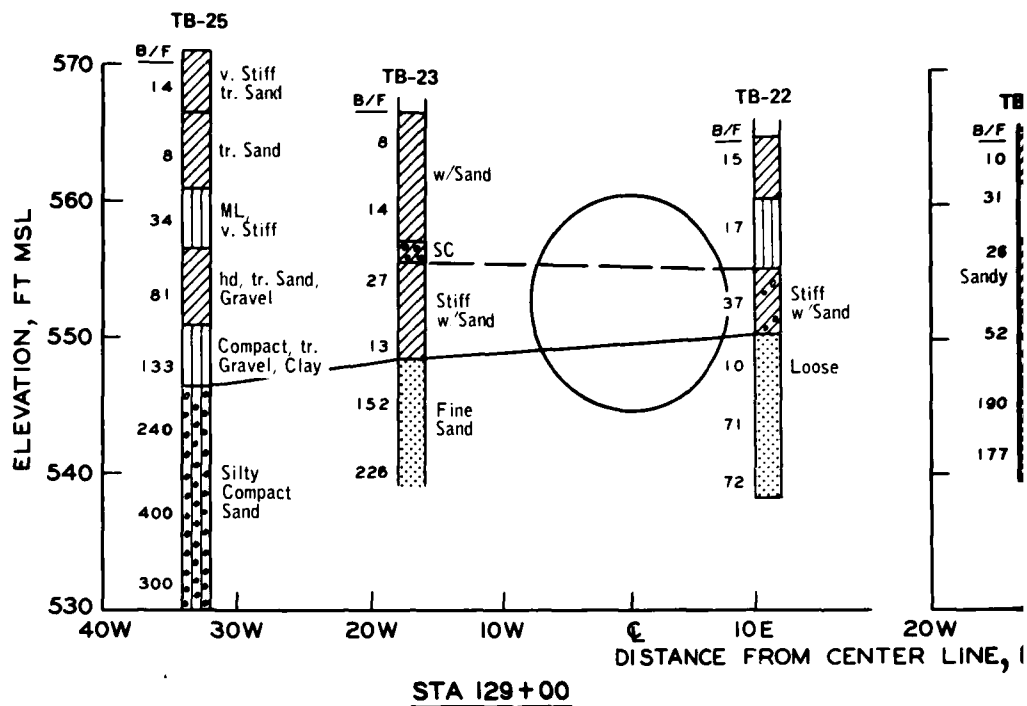
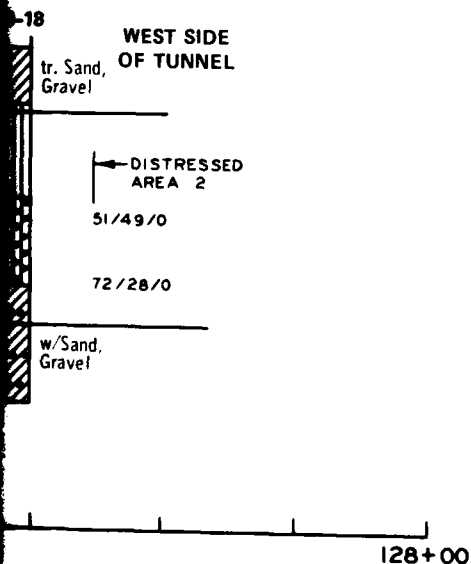
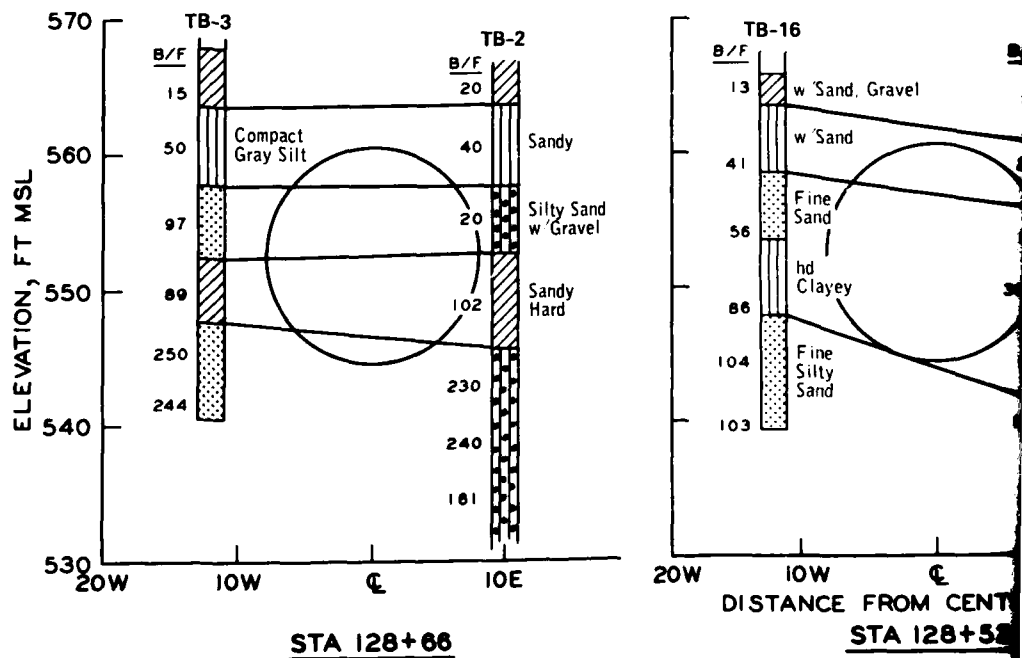
Figure 17. Profiles and sections along nondistressed tunnel segment between Distressed Areas 1 and 2, 15 Mile Road/Edison Corridor Tunnel Failure Study

- e. Nondistressed section between Distressed Areas 1 and 2. Between Distressed Areas 1 and 2, the beach sand unit grades from interbedded silt and fine sand to fine sand along the tunnel invert and then dips to elevation 531 (Figure 13, borings WES-3 to TB-17) some 5 ft below the tunnel invert, at the north end of Distressed Area 2. Clay and silt strata occur above the beach sand. The 1 to 1 profiles and sections for closely spaced TB borings (extending 72 ft north of Distressed Area 2) in Figure 17 show gradational but relatively continuous clays, silt, and sand strata, respectively, above the beach sand. The gradation data for strata shown as sand and silty sand in Figure 17 indicates considerable sandy silt lenses. The permeability of three sandy silt samples from TB borings (Figure 17) was  $10^{-6}$  cm/sec and  $10^{-5}$  cm/sec for one sample of silty sand. During excavation (as the tunneling progressed south), soils were noted as hard sandy clay to hard clay with sandy spots, stones and rock. The material changed at Sta 128+76 to sand with traces of clay and pebbles to large stones (Table 7). As shown in Figure 17, some samples of clay above the crown and of sand at the base of the tunnel had low dry densities of 105 to 109 pcf (TB-3, TB-22, and TB-17). Other dry densities in the clay, silt, and sand strata ranged from 111 to 118 pcf and from 122 to 140 pcf in the stiff to

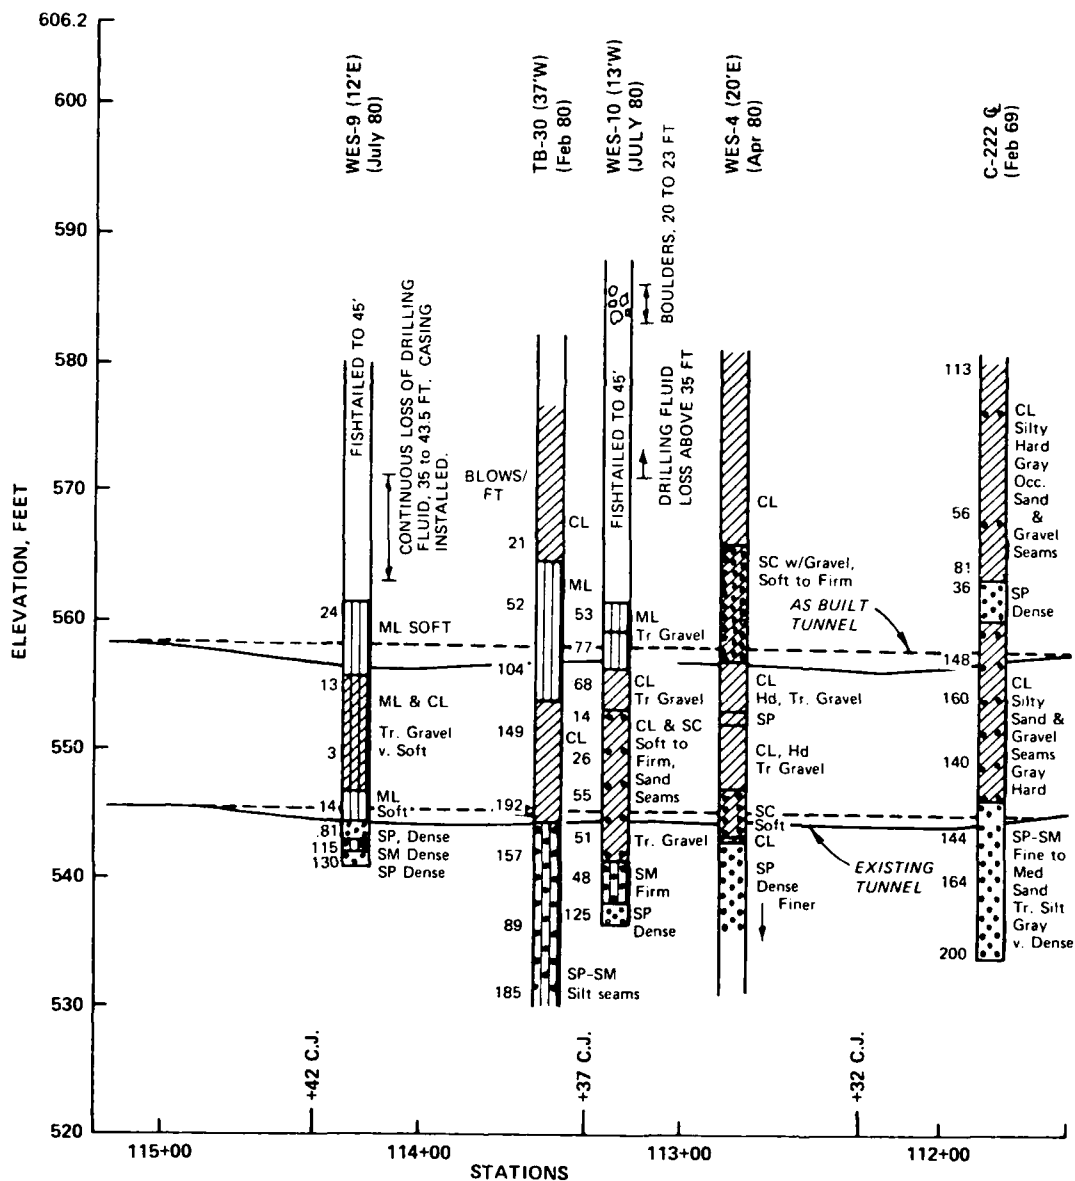
sand with much gravel (boring WES-4) are prevalent. A detailed section along this segment shown in Figure 18 indicates the sand and silt layers and prevalent sand seams. Both the as-built and after distress tunnel profiles are shown. Boring WES-9 and WES-10 adjacent to the tunnel sides lost considerable drilling fluid down to elevations 570 and 563. Drilling fluid from WES-9 was found entering the tunnel the day following completion of the boring. Very low blow counts were indicative of the soft to very soft soil conditions found in boring WES-9. Boring WES-10 indicated relatively low blow counts to a depth of 8 ft below the tunnel. The higher blow counts in boring TB-30 can be explained by the fact that this boring was 24 ft further west of the tunnel than boring WES-10, and soils at TB-30 were probably less affected by the tunnel distress. Both borings TB-30 and WES-4 indicated relatively high dry densities (Figure 15) which compare with those for samples from the preconstruction boring C-222. As discussed subsequently (para 61 g), the sand layers and seams are water bearing. Notes on tunnel excavation materials along this segment included "sand on bottom" (115+41 to 115+11), "sand seams in bottom" (114+66 to 114+36), "sand layer in face at springline" (113+71 to 113+31), "sandy bottom and top" (113+31 to 111) and traces of sand indicative of sand lenses from Stas 114+86 to 114+66 and 113+11 to 112+76. Seepage water was also noted from 113+11 to 112+76.

Figure 18. Stratification and soil conditions, Distressed Area 3

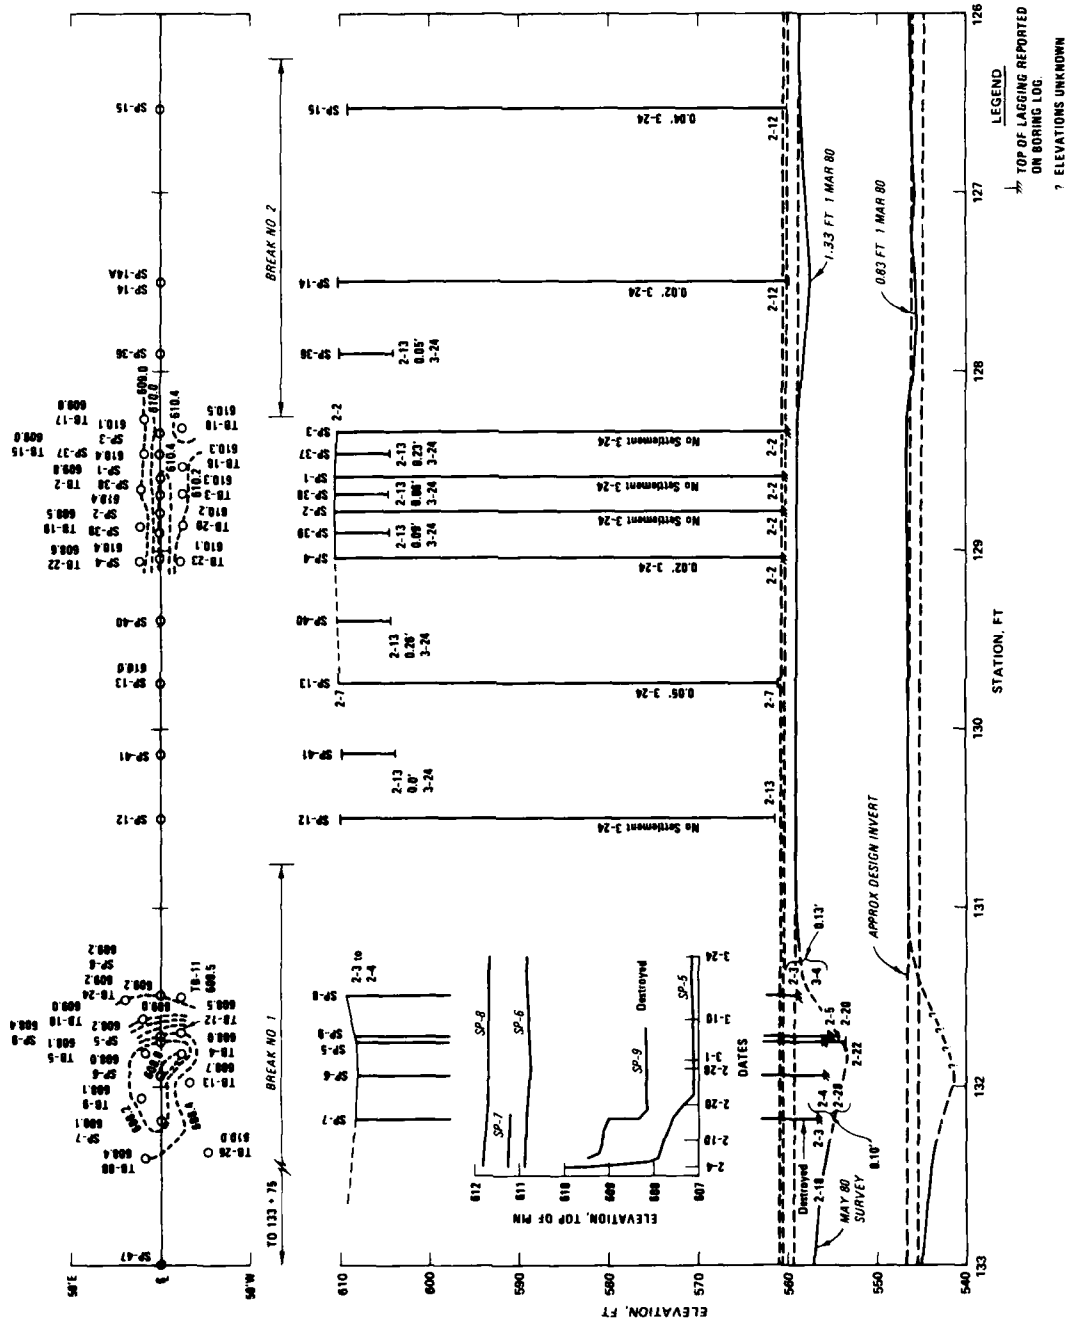
- b. Tunnel crown collapse, Distressed Area 1. In Distressed Area 1, some TB borings and grouting were completed before and others after the first settlement pin readings as summarized in Table 9. A summary of settlement pin data is shown for Distressed Areas 1 and 2 in Figure 19. The as-built and deformed tunnel profiles are shown in the figure for correlation with settlement pin data. When installed, pins 5 through 9 showed that the crown had sagged about 5 ft. Pins 5 and 9 indicated further movement totaling 1 to 3 ft from 5 February 1980 to 20 February 1980 (plot of elevation versus date in Figure 19). Table 9 shows that significant grout was injected in TB-4, TB-12, TB-5, and TB-10 on 2 February 1980 through 5 February 1980 before settlement readings. After initial pin readings, grout was injected in TB-11, TB-8A, and TB-6 on 6 February 1980 with 50 cu ft taken in TB-11 and 150 cu ft in TB-6. After completion of the TB borings on 8 February 1980 and grouting on 6 February 1980, pins 5 and 9 showed an additional downward movement of the crown. Based on this sequence of events, it is possible that further fall-in of the crown and worsening of distress could have been due, in part, to the boring and grouting operations.

Figure 19. Settlement pin observations, Distressed Areas 1 and 2, 15 Mile Road/Edison Corridor Tunnel Failure Study

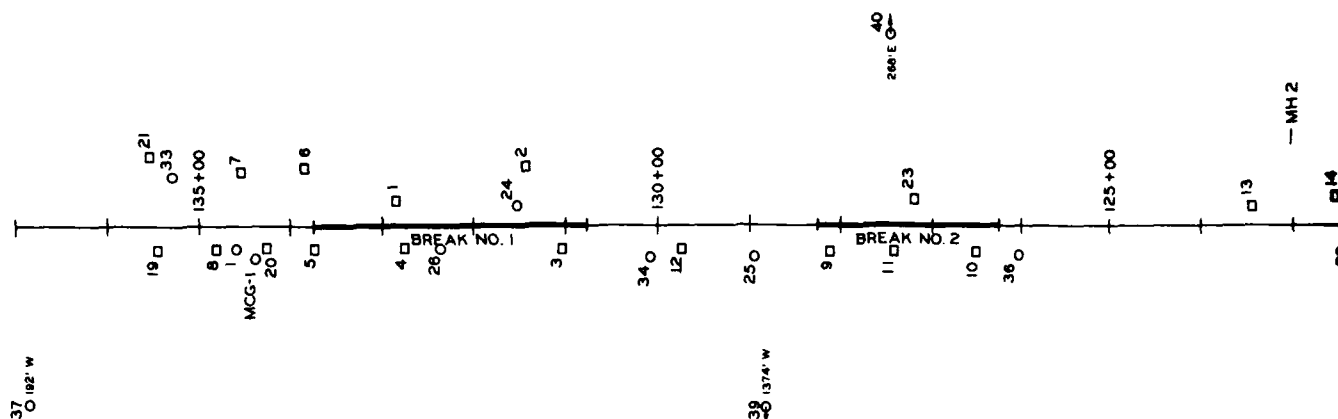
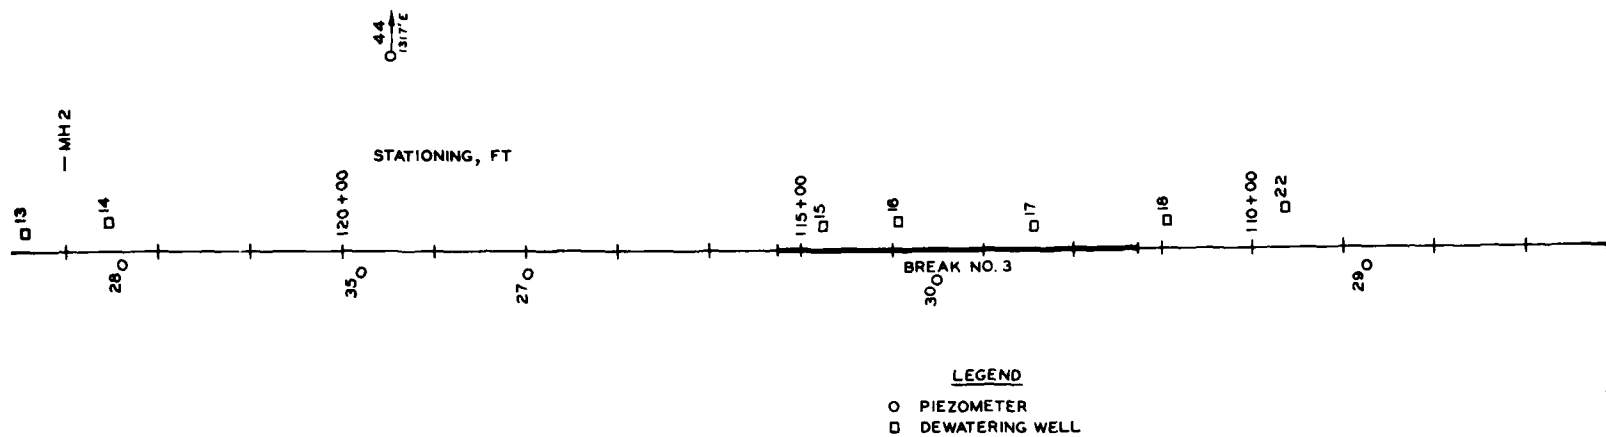
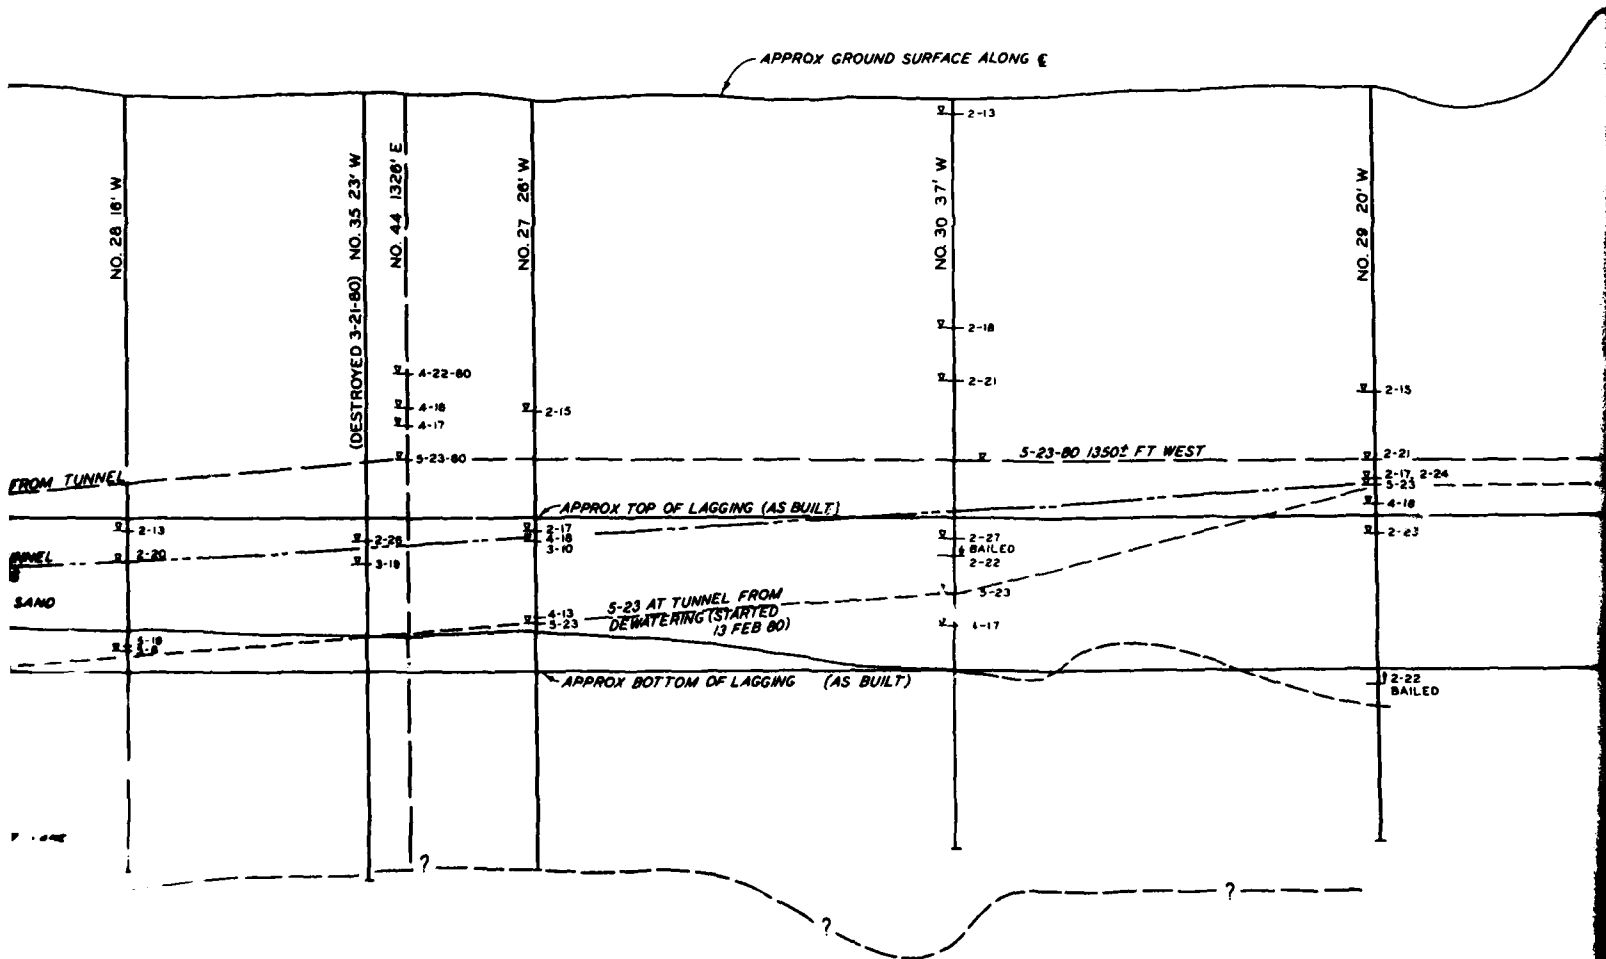
Figure 21. Su  
15 Mile Road/

- (3) Groundwater levels. Three water profiles are shown on Figure 21. The upper profile is for conditions 192 to 1400 ft away from the tunnel after stabilization of piezometer levels in the sand which were not significantly influenced by dewatering. The second profile is for piezometers near the tunnel before the effects of dewatering. The third and lowest profile is along the tunnel after dewatering had its maximum effect. The two lower profiles slope upward to the south where they tie into the profile unaffected by dewatering. This trend indicates increased stratification of clays and water bearing sands to the south, as indicated by borings in Distressed Area 3 (Figure 18). The trend is supported by the fact that the five wells from Sta 115 south could not pull the water level as far down as wells north of Sta 122 (Figure 21). The water profiles before dewatering along the tunnel and at a distance of 1300 ft to 1400 ft from the tunnel dip down in the vicinity of Distressed Area 2. The reason is unclear but could be caused by a southwesterly seepage trend since the beach sand appears to slope to the southeast (based on the top of beach sand at elevations 560 in boring A-34 on Schoenherr Rd east of the site and elevation 530 in boring C-26 on Maple Rd to the west). Also the dip in the top of the beach sand at Sta 128 could indicate a buried channel with more permeable strata below elevation 540.

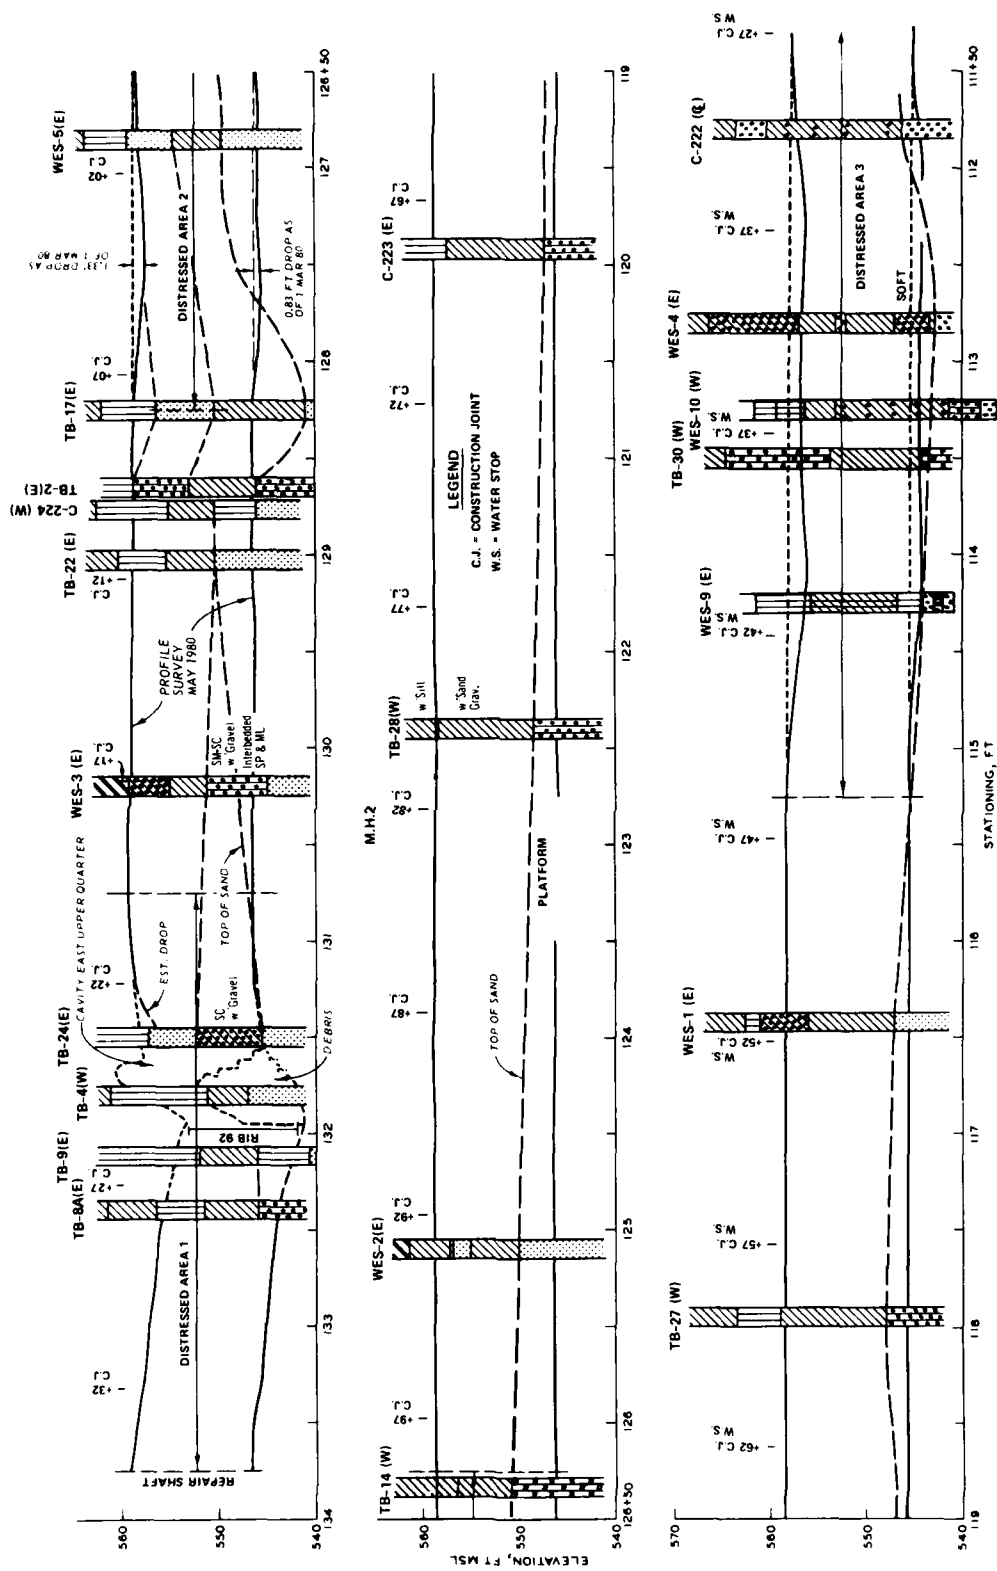
Figure 23. Summary of distressed tunnel profile and soil stratification, 15 Mile Road/Edison Corridor Tunnel Failure Study

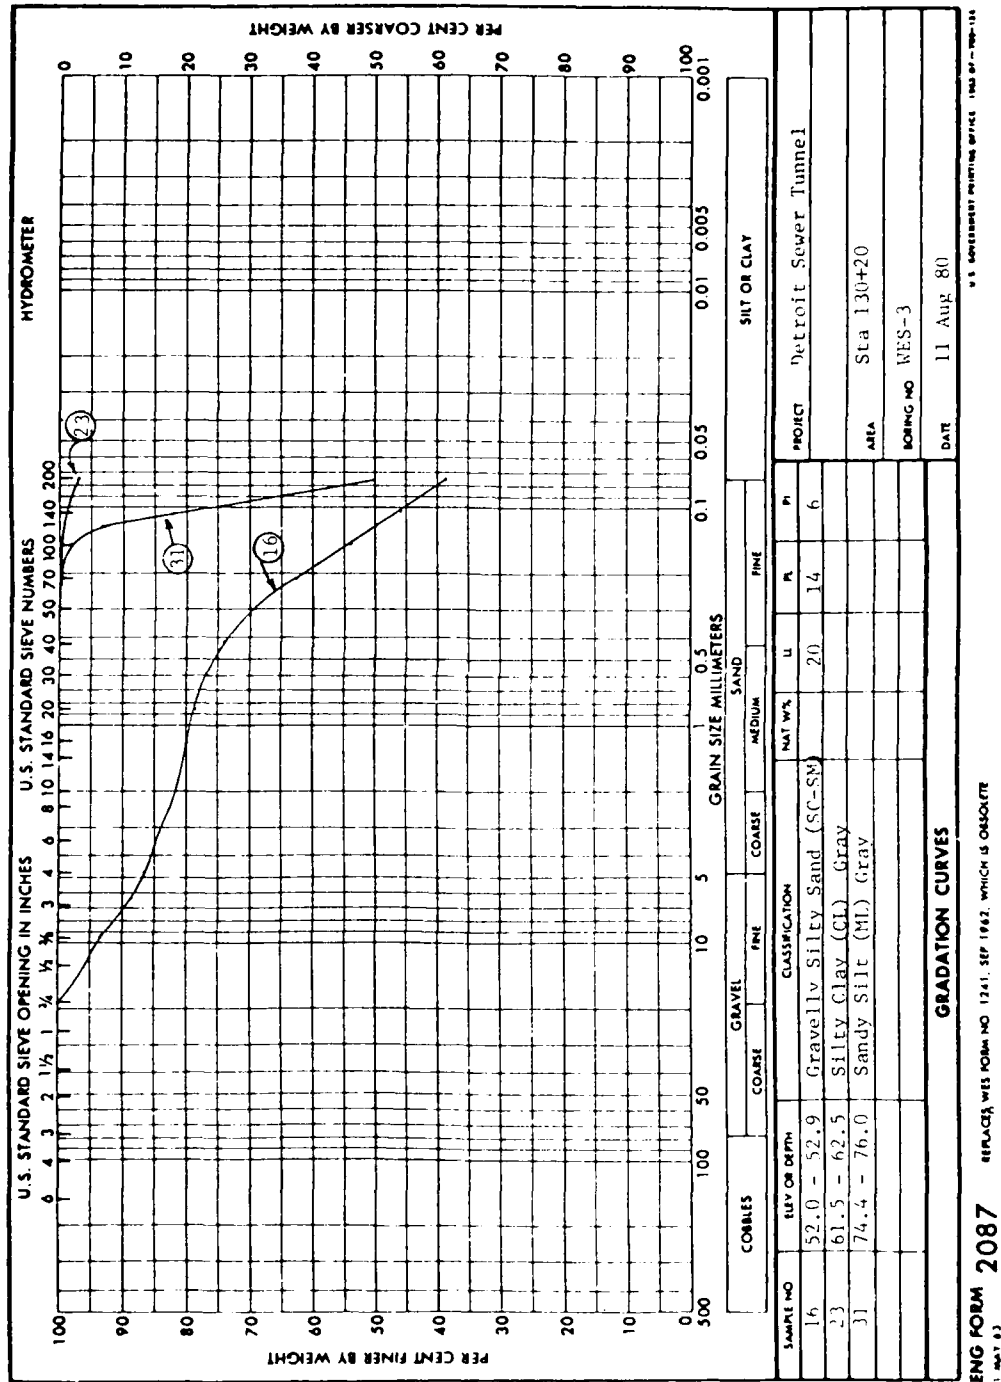
Figure 31. Gradation of samples from boring WES-3, 15 Mile Road/Edison Corridor Tunnel Failure Study

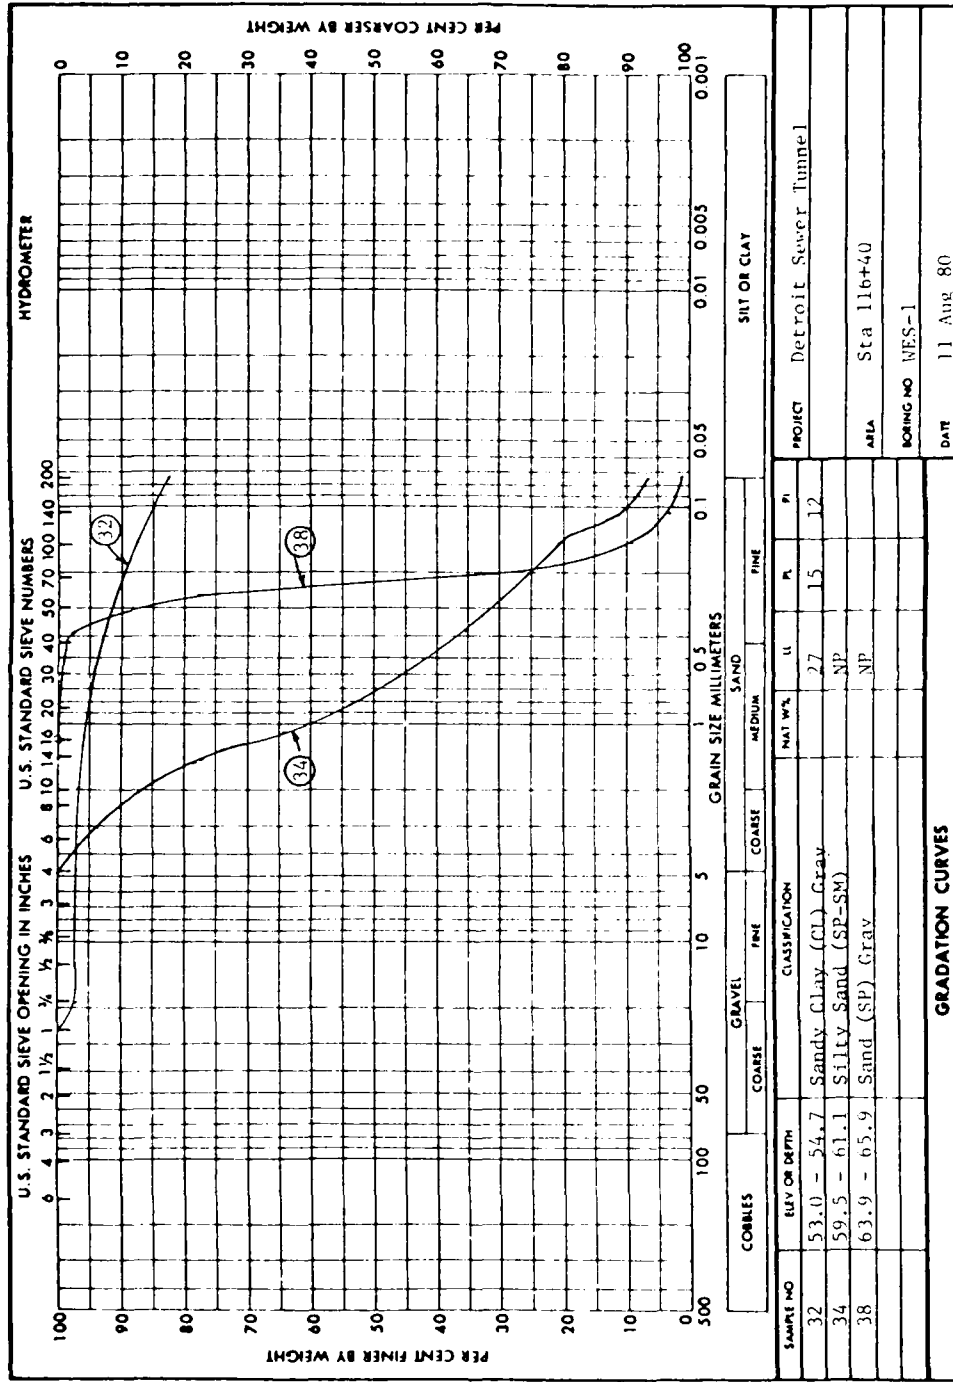
Figure 30. Gradation of samples from boring WES-1, 15 Mile Road/Edison Corridor Tunnel Failure Study

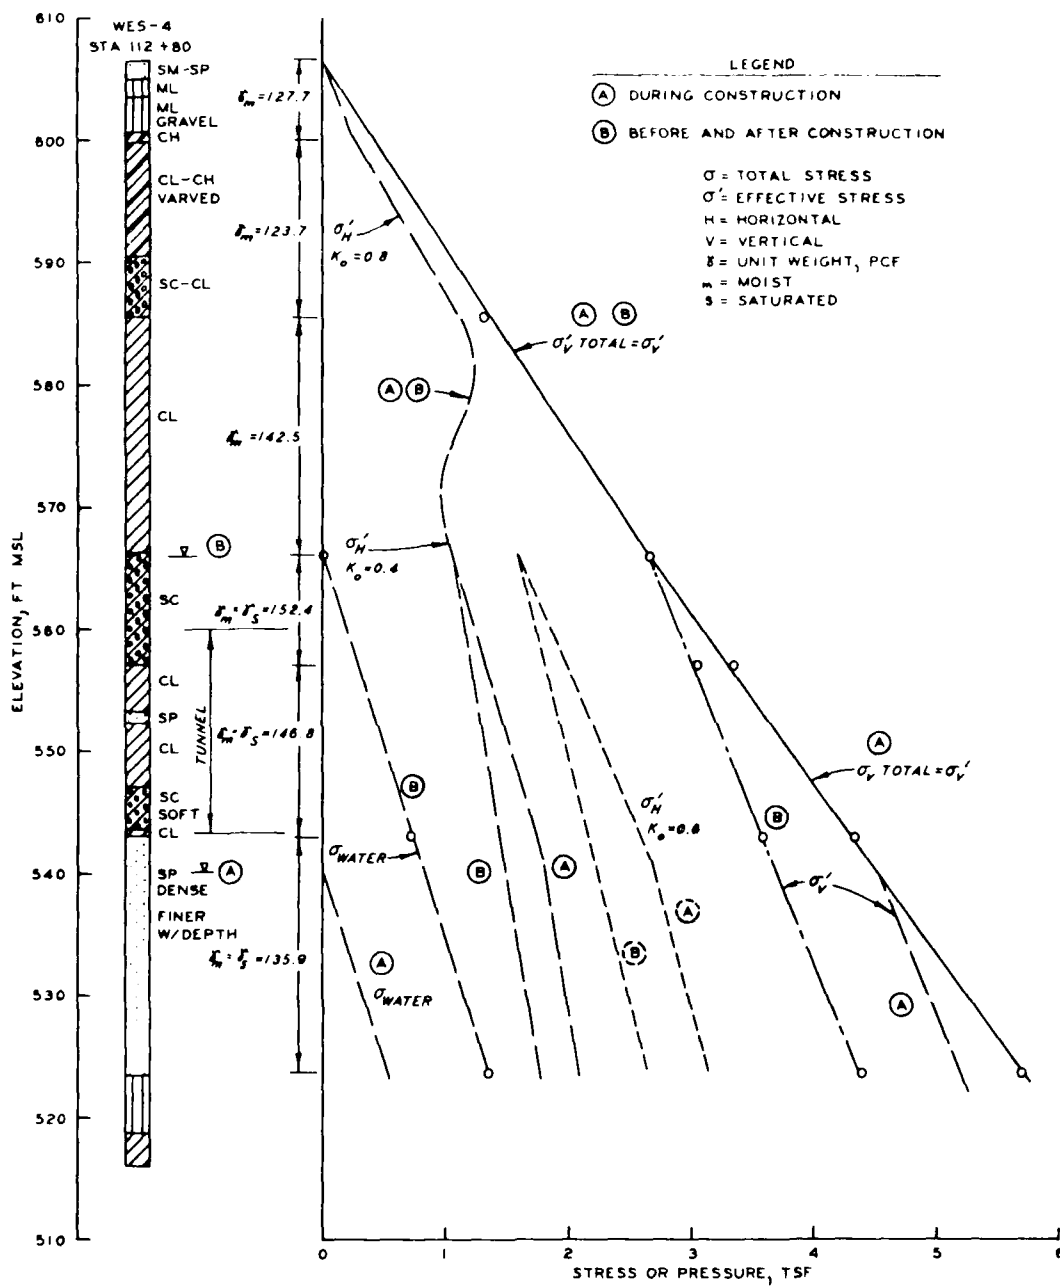
Figure 41. Estimated in situ soil stresses, Sta 112+80

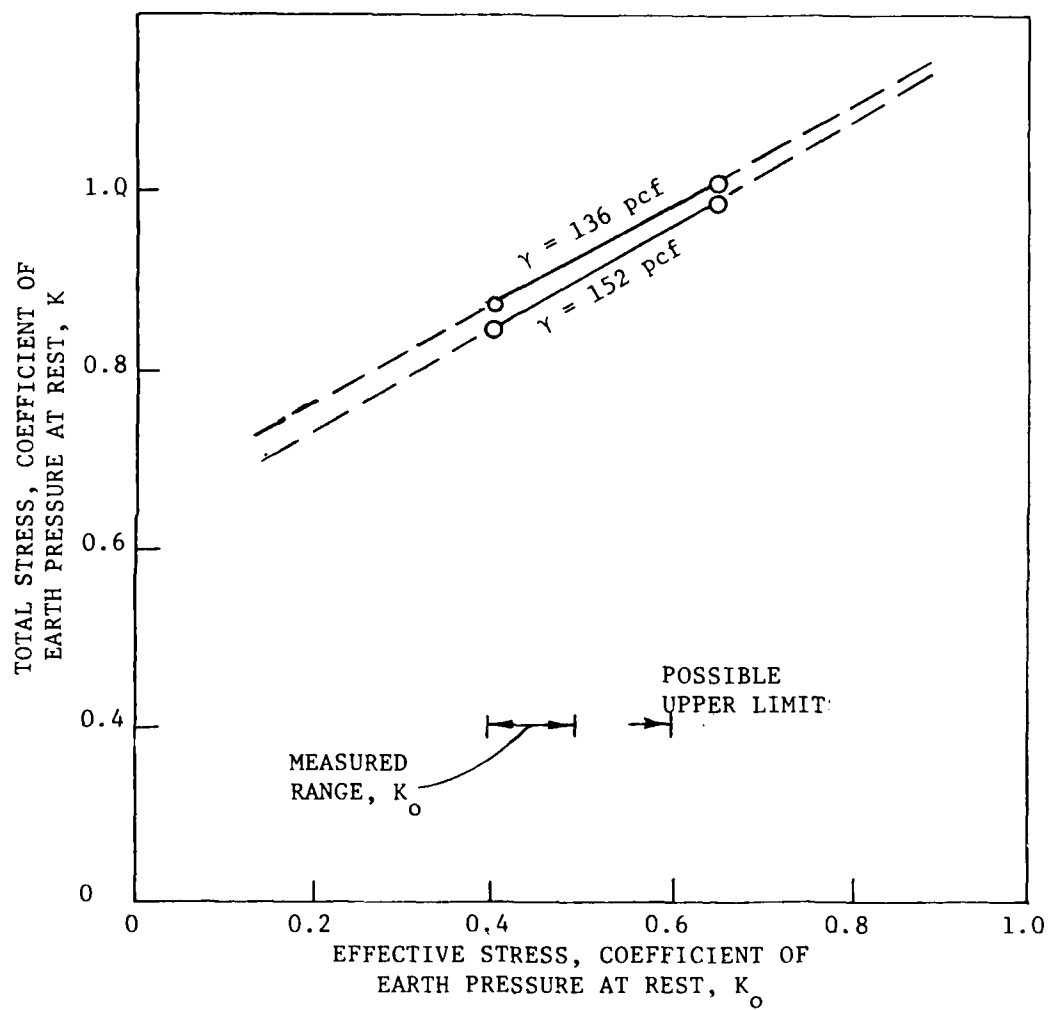
Figure 42. Range of at rest earth pressure coefficient  $K_o$  and  $K$  versus unit weight, 15 Mile Road/Edison Corridor Tunnel Failure Study
