TECHNICAL REPORT GL-81-2

# 15 MILE ROAD/EDISON CORRIDOR SEWER TUNNEL FAILURE STUDY DETROIT AREA, MICHIGAN

January 1981

Final Report

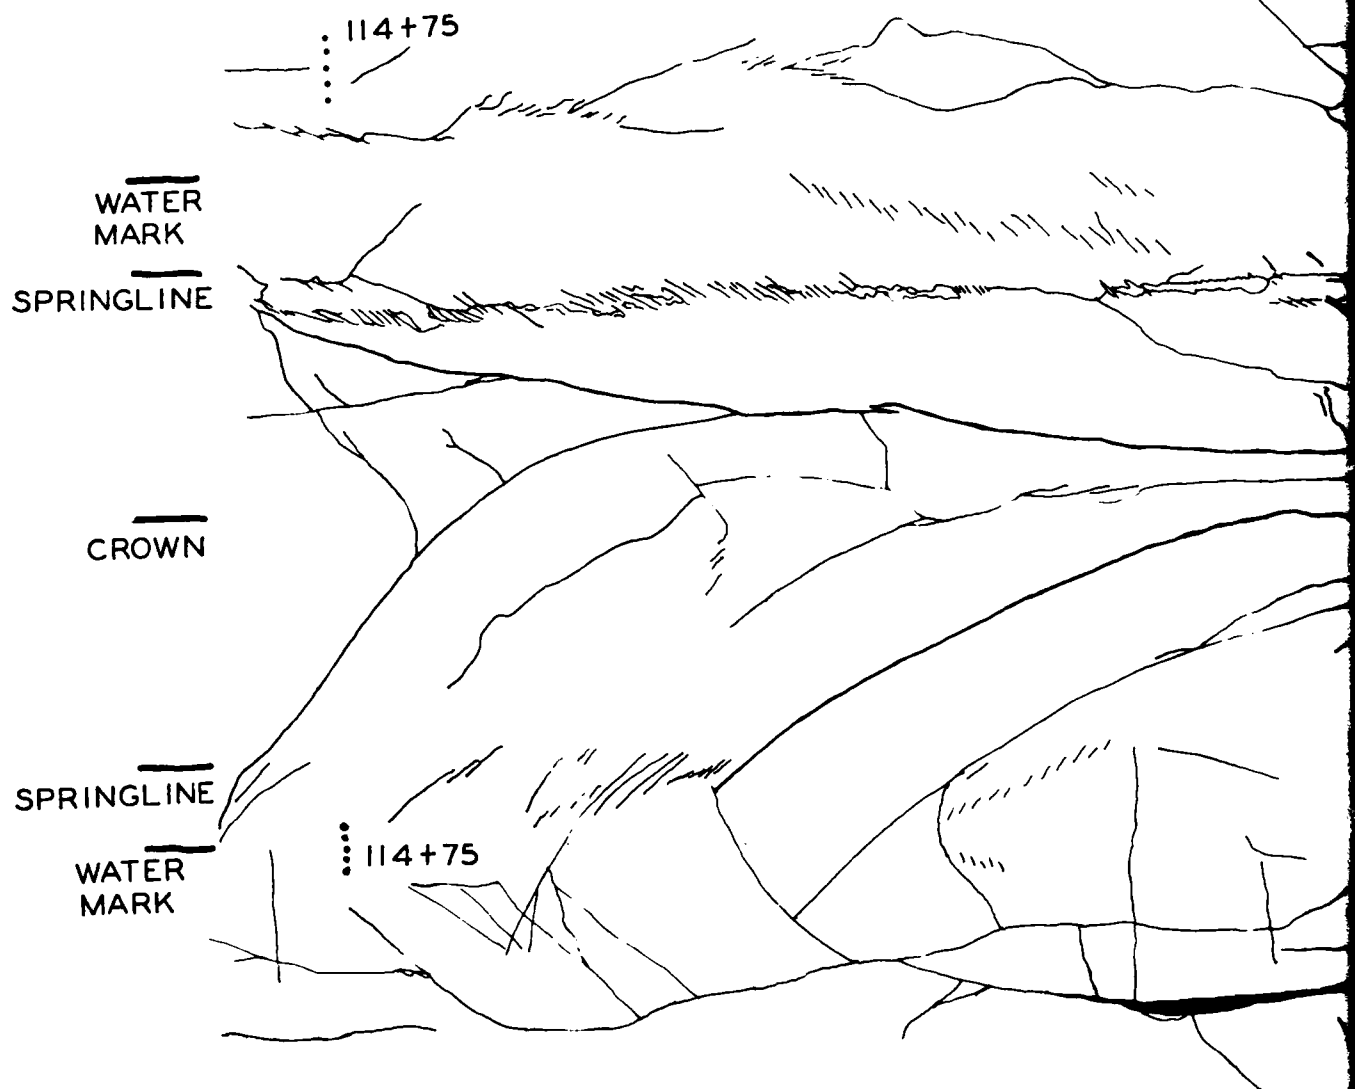
Figure 46.

46. Crack pattern, Distressed  
Area 3

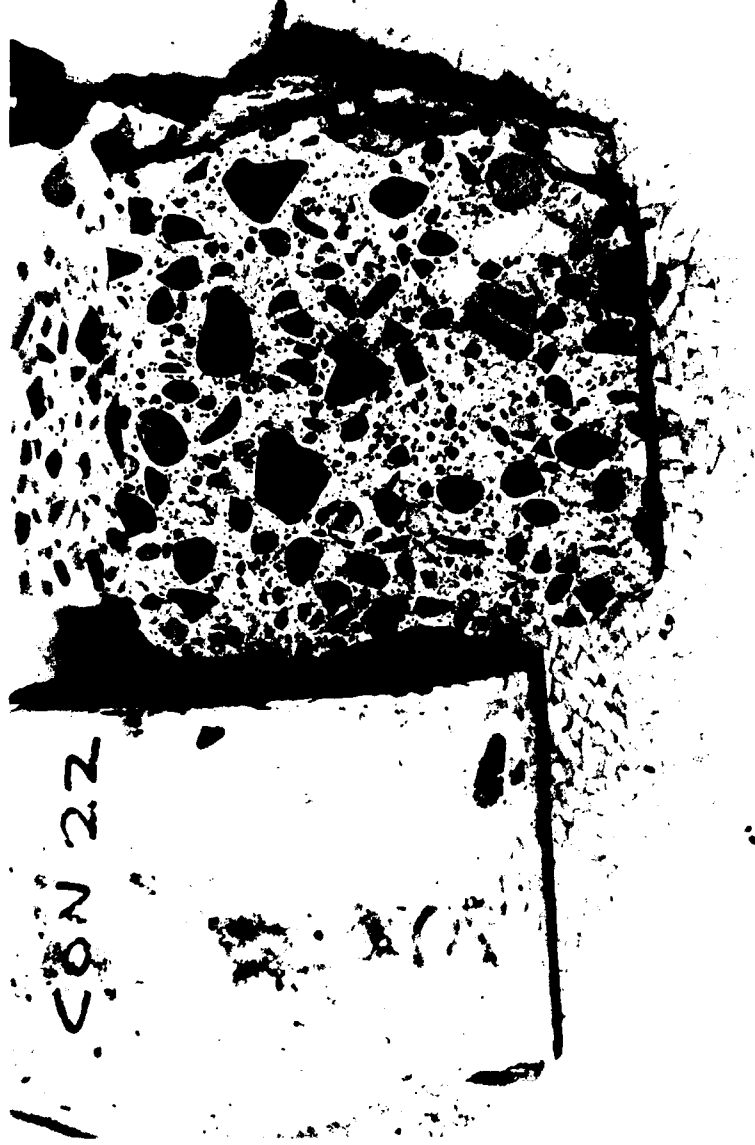
- (2) The concrete cores, with few exceptions, appeared to be well consolidated, homogeneous, and in good condition. The sawed and ground surfaces of cores from Stas 117+25 and 119+15 (nondistressed areas) shown in Figures 51 and 52, and Sta 133+13 (break area 1) shown in Figure 53 illustrate the appearance of the concrete. Visually, there is no significant difference in the appearance of the concrete in cores from either the distressed or non-distressed areas of the liner. One notable exception occurred in a piece of concrete recovered on 22 August 1980 by the Detroit District personnel during the

Figure 53. Similar surface as Figure 26, culvert floor core DET-4 CON-22,  
Sta 133+13, in Distressed Area 1

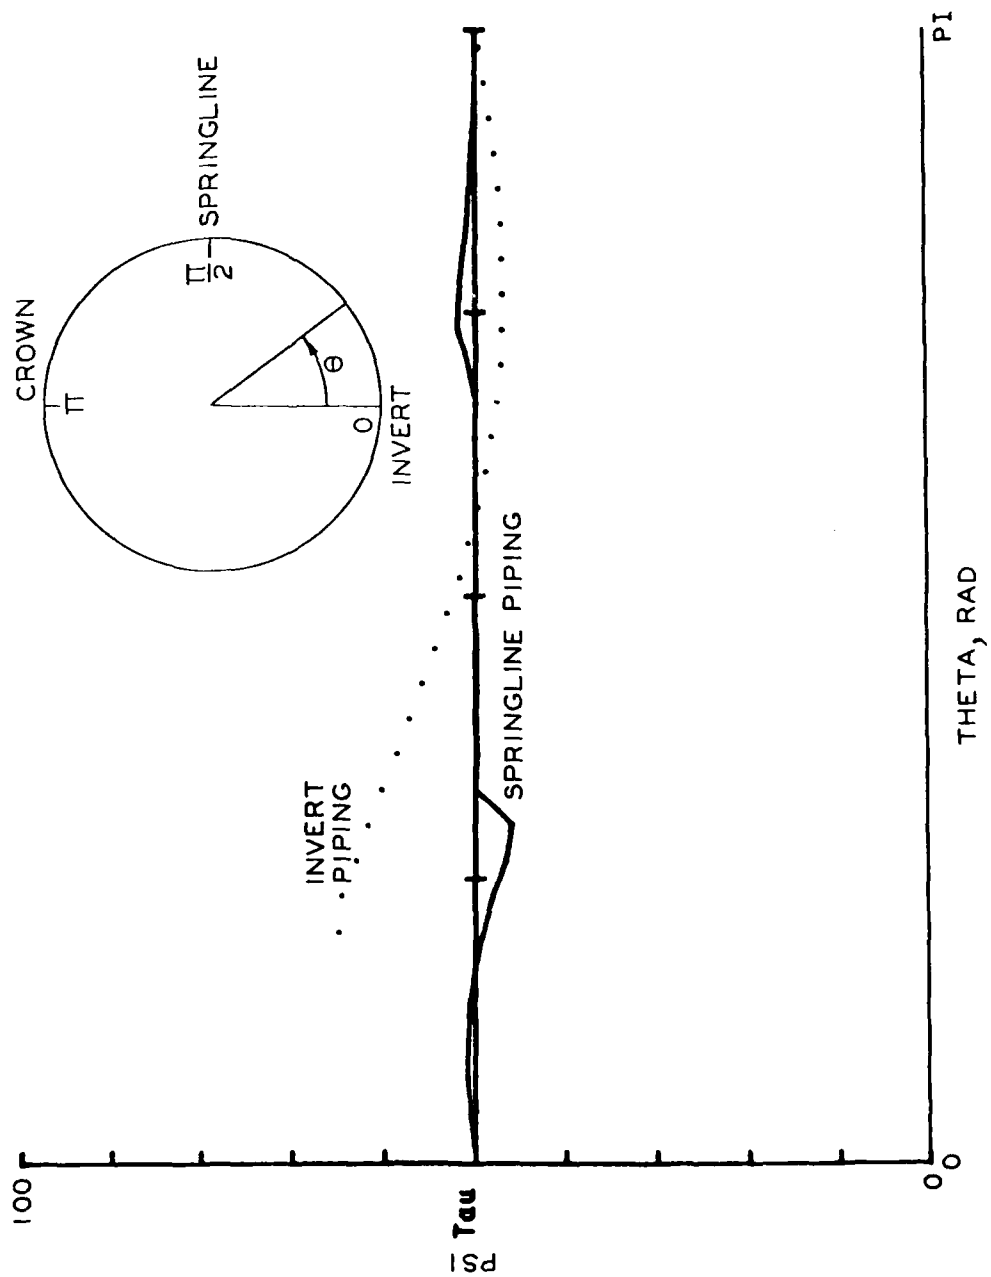
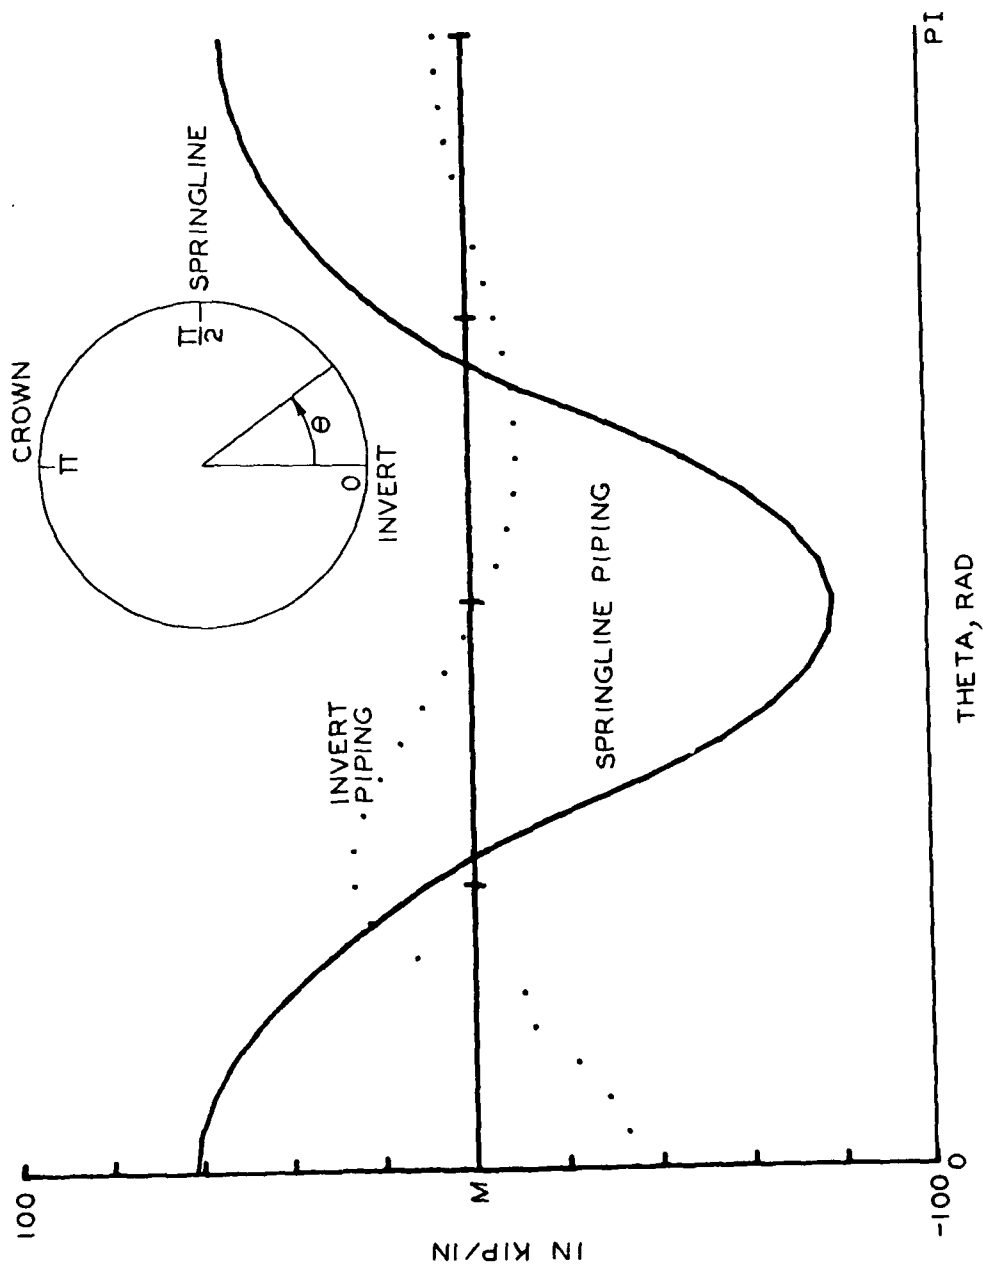
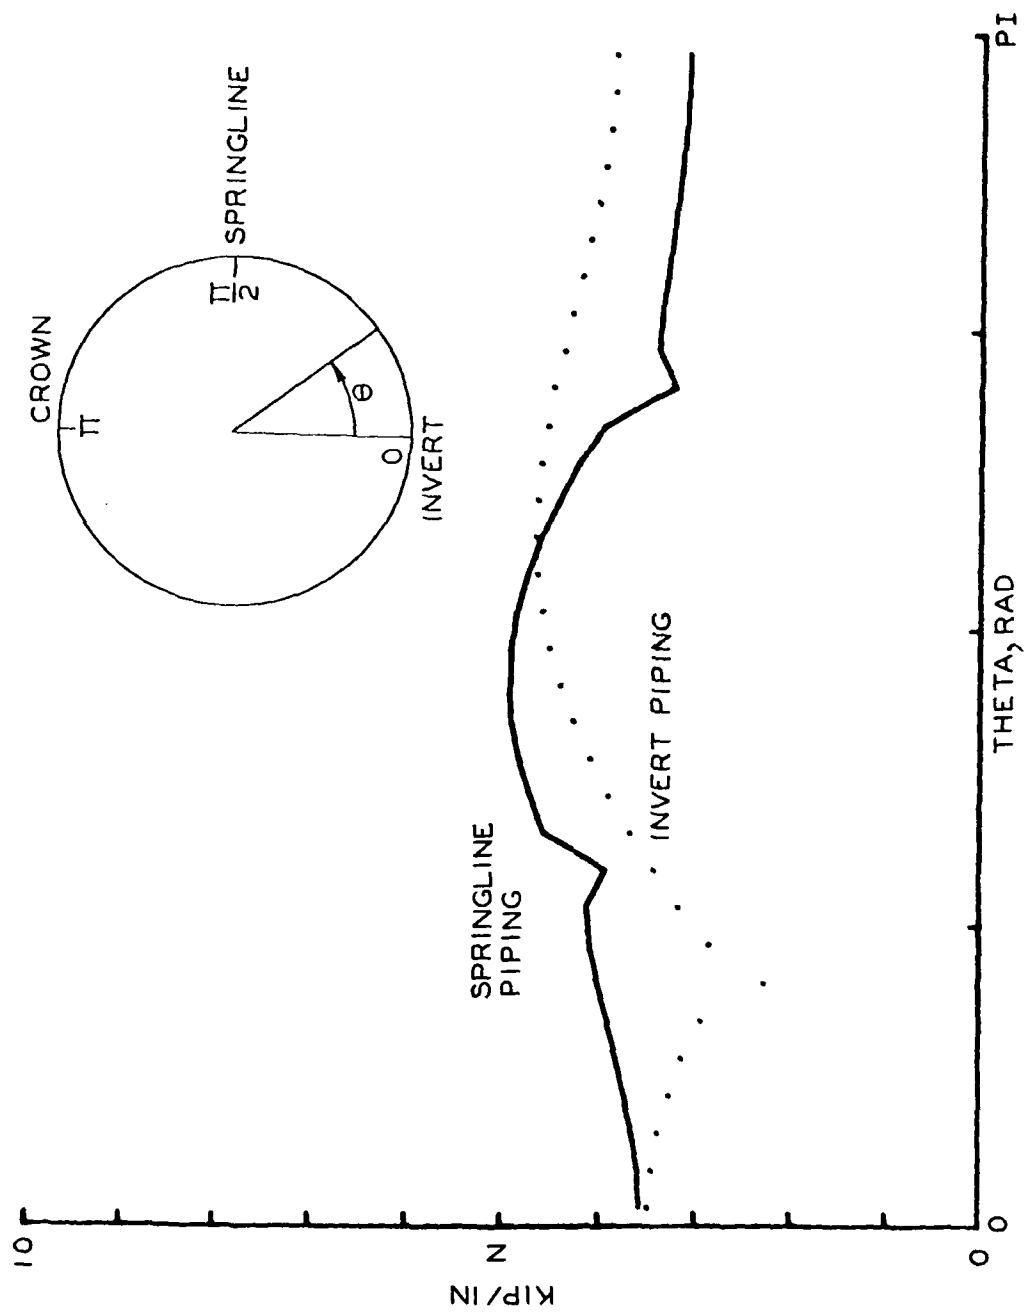
101. The results of these analyses are summarized in Figures 76 through 79. In both cases the interface pressure  $q$  and the shearing stress  $\tau$  across the structure medium interface are seen to be markedly nonuniform near the voids assumed to be caused by piping. The effect of this loading on bending moment  $M$  and axial thrust  $N$  is not particularly harmful for the case of a void under the invert. In this case the regions in which the tunnel's inner surface is stretched or compressed change from the unpiped cases, but the severity of the critical moment and thrust combination does not change appreciably from these unpiped cases. On the other hand, if a void occurs near the springline, the severity of the critical moment and thrust combination increases dramatically from the unpiped case. In this case the inner surface of the tunnel near the springline is compressed while the corresponding surfaces near the invert and crown are stretched. This pattern of deformation is similar to the distressed condition existing in the tunnel which has been previously discussed in paragraph 82.

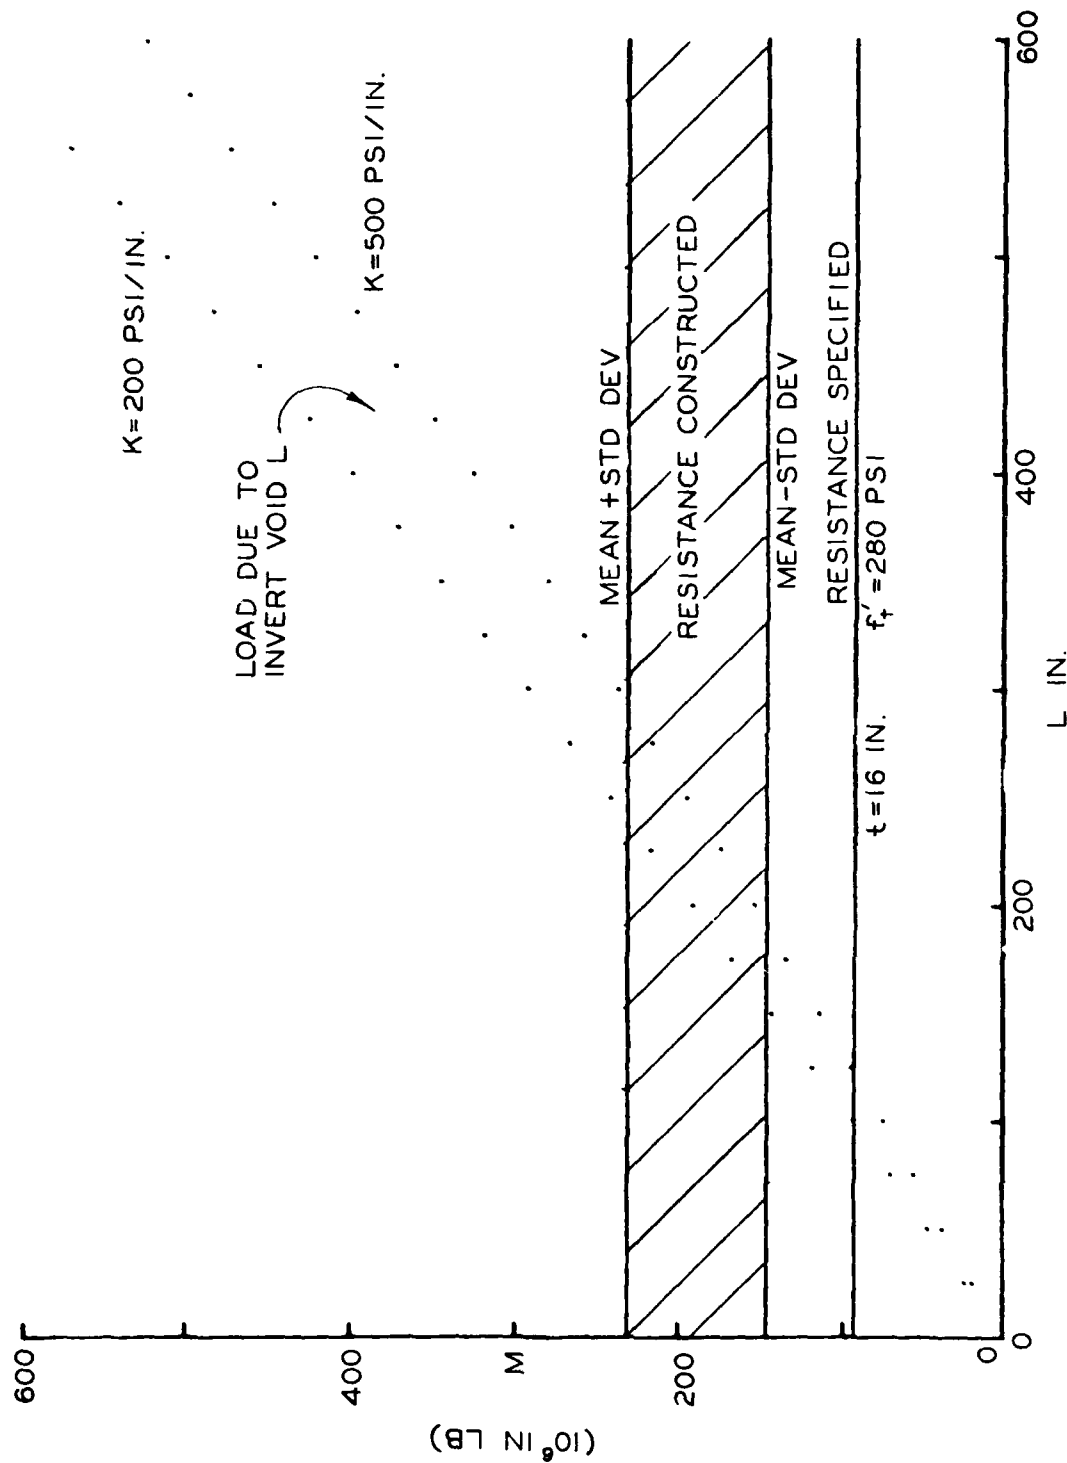
Figure 81. Reliability of concrete lining in longitudinal bending

105. Figure 81 shows the magnitude of this bending moment  $M$  as a function of the void length  $L$ . It was drawn for the springline overburden pressure  $p = 7800$  psf previously computed in Figure 41, for a lining modulus of elasticity  $E = 6 \times 10^6$  psi and for a moment of inertia  $I = 3.06 \times 10^7$  in.<sup>4</sup> corresponding to a hollow circular cylinder with inner and outer diameters equal to the nominal values of 153 in. and 185 in. The effect of foundation modulus variation between  $k \approx 200$  psi/in. and  $k = 500$  psi/in., which bracket the stiffness of the material under the tunnel, is also illustrated in this figure.

resistance is approximated by the product of the concrete tensile strength and the elastic section modulus of the tunnel in longitudinal bending. Accordingly, for the contract-specified 16-in. wall thickness and concrete mixture discussed in paragraph 89, the resistance to longitudinal bending is approximately  $93 \times 10^6$  in. lb as shown in Figure 81. The distribution of resistance in the lining as built depends on the distribution of wall thickness and tensile strength constructed. Using the Monte Carlo technique and the assumptions previously described in paragraph 91, it was estimated that the resistance of the majority of the concrete lining is contained within the hashed region of Figure 81. It is seen that the constructed lining has a resistance to longitudinal bending which generally exceeds that implicitly specified by the contract. It is further observed that the loss of foundation support due to invert piping for a longitudinal distance on the order of 200 in. could cause the tunnel to fail in longitudinal bending. This event would be accompanied by a circumferential cracking similar to that described in paragraph 73 near Distressed Area No. 3.

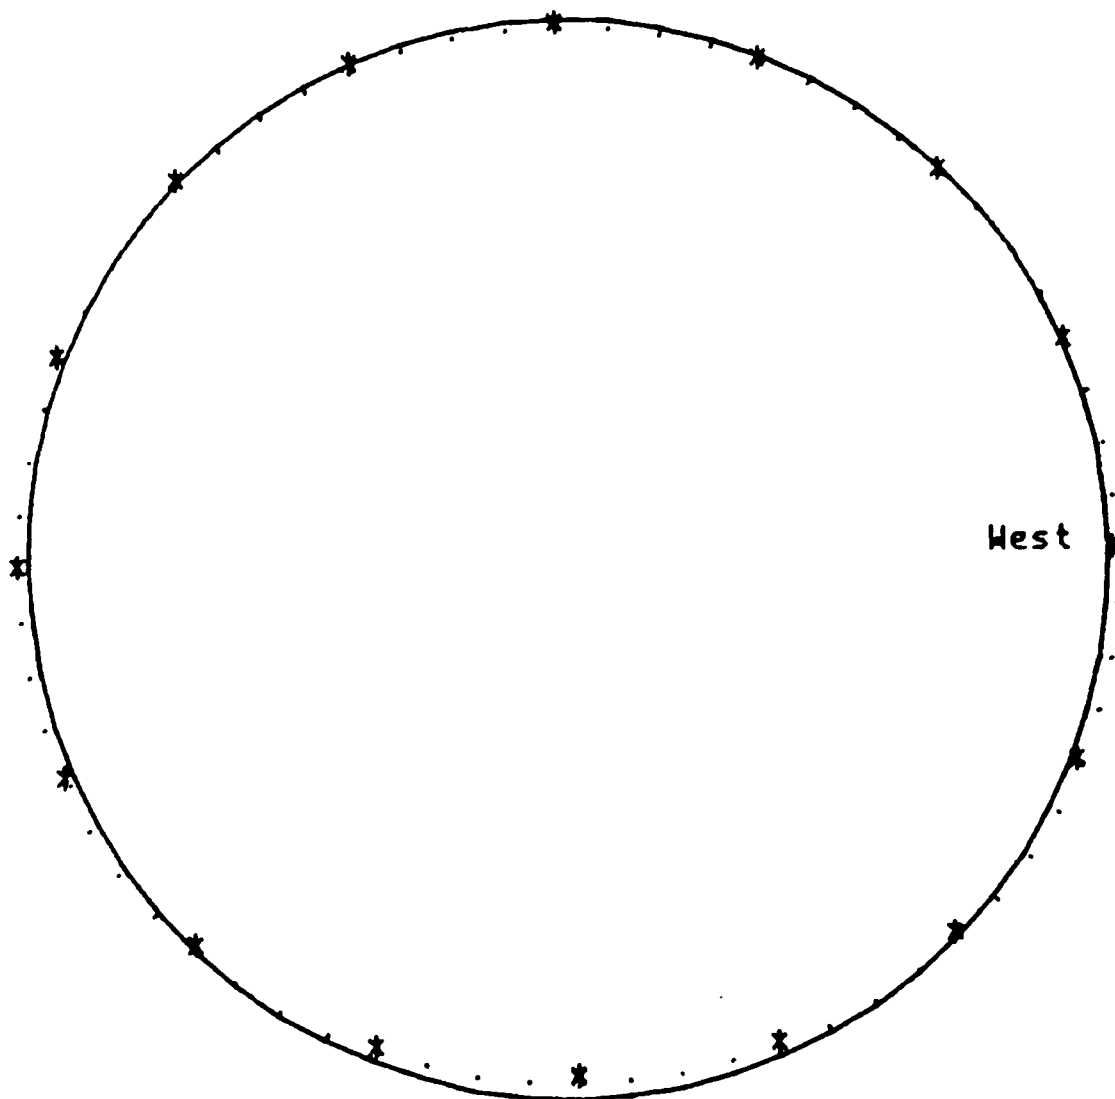
PCI-7 STA 111+00

w/r= 0.0217
