DEER LAKE DAM

(NDI ID NO. PA-00698,  
DER ID NO. 64-202)

PHASE I INSPECTION REPORT  
NATIONAL DAM INSPECTION PROGRAM

JANUARY 1981

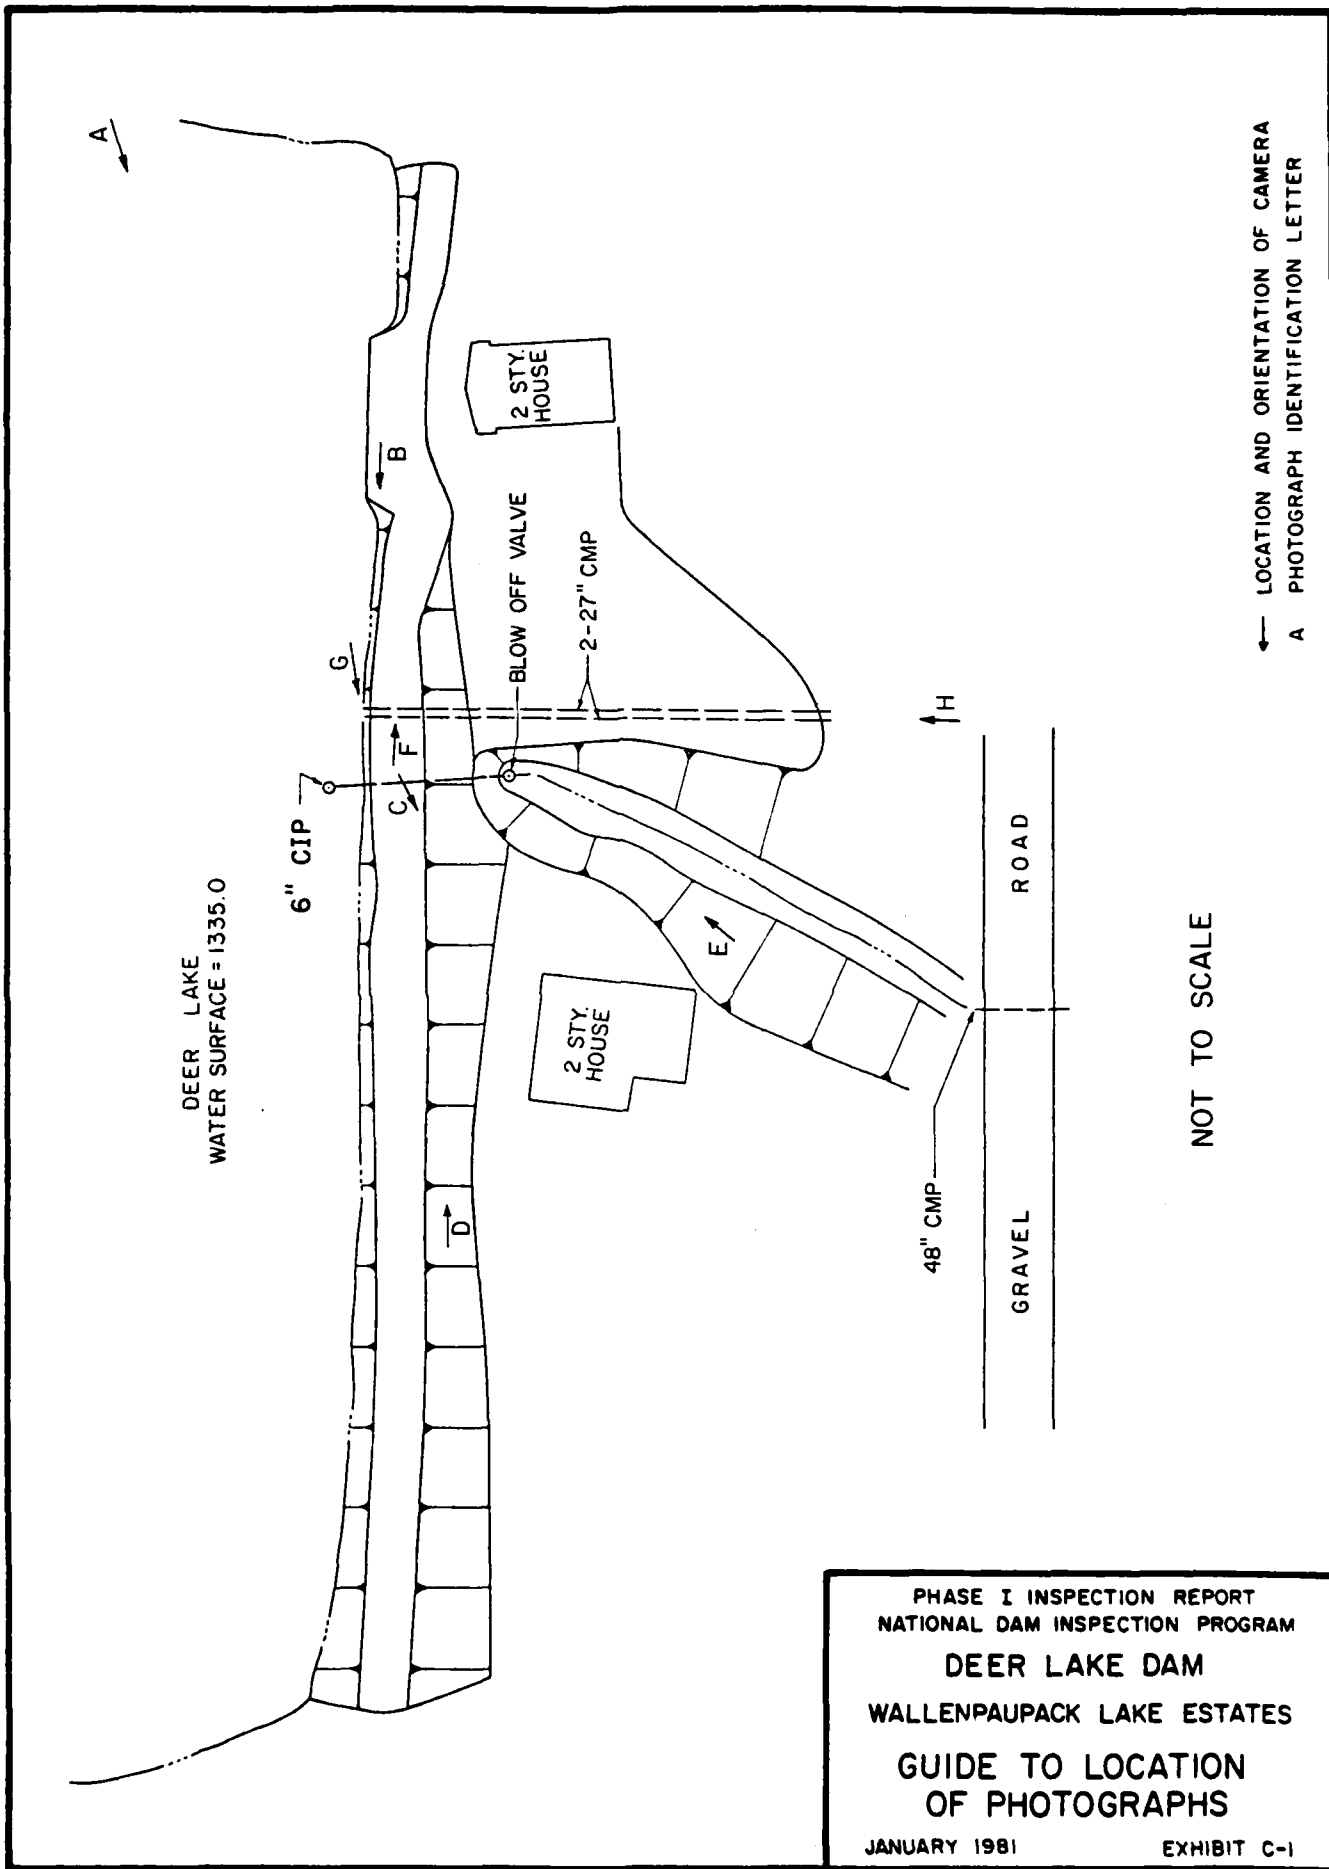
H. Spillway Exit

c. Appurtenant Structures. The spillway is in fair condition (Photographs G and H). Both the inlet and the outlet ends of the pipes have been damaged and partially crushed out of round. Minor erosion has taken place around the pipe inlets. Fill around the pipes has settled substantially along the entire length of pipe. The spillway pipes discharge through a dry masonry headwall well downstream of the dam into a heavily vegetated earth channel, which is in fair condition.

(3) Appurtenant Structures. Both the inlet and outlet ends of both spillway pipes have been damaged and partially crushed out of round. The end damage has reduced the capacity of both pipes. The trashrack, while preventing floating debris from entering and blocking the spillway pipes, may itself be susceptible to blockage, which would reduce the discharge capacity of the pipes.
