CRYSTAL LAKE DAM

NDI ID NO. PA-00096
DER ID NO. 64-6

PHASE I INSPECTION REPORT
NATIONAL DAM INSPECTION PROGRAM

JANUARY 1981

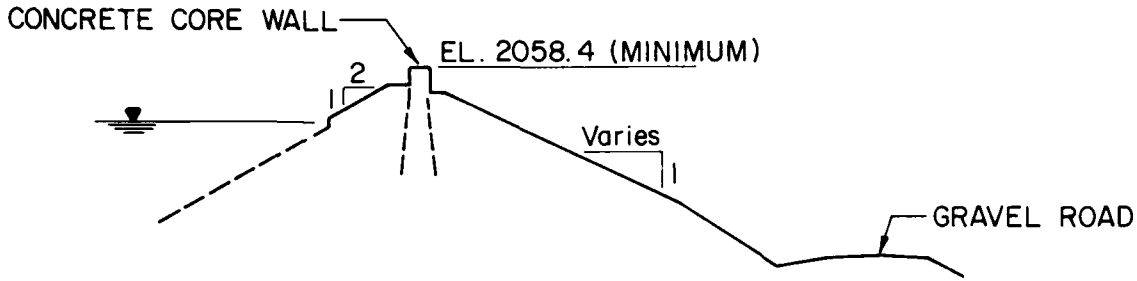
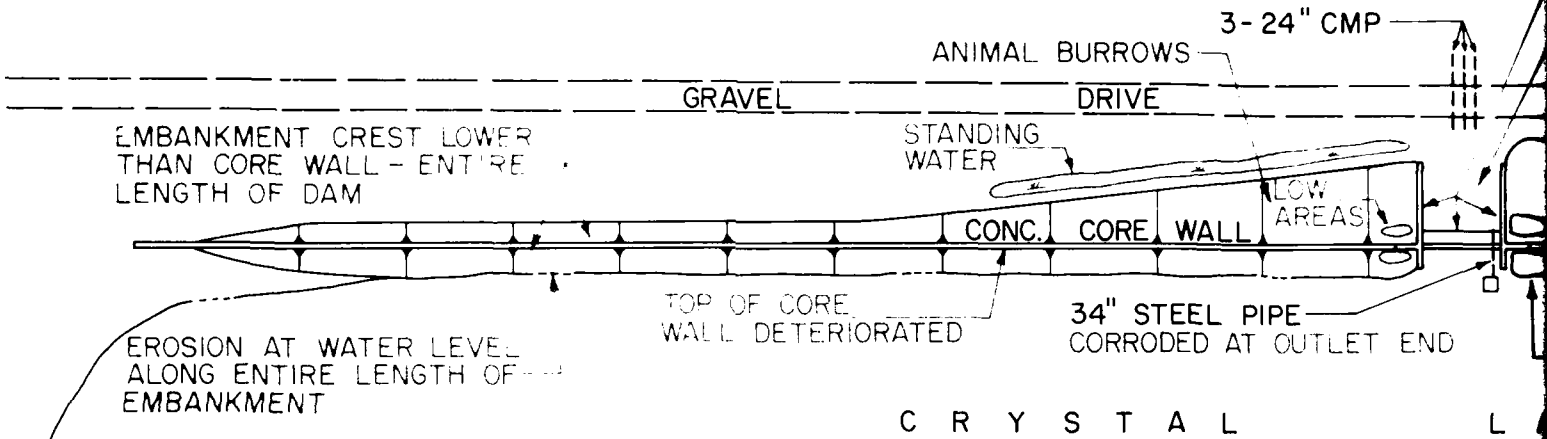
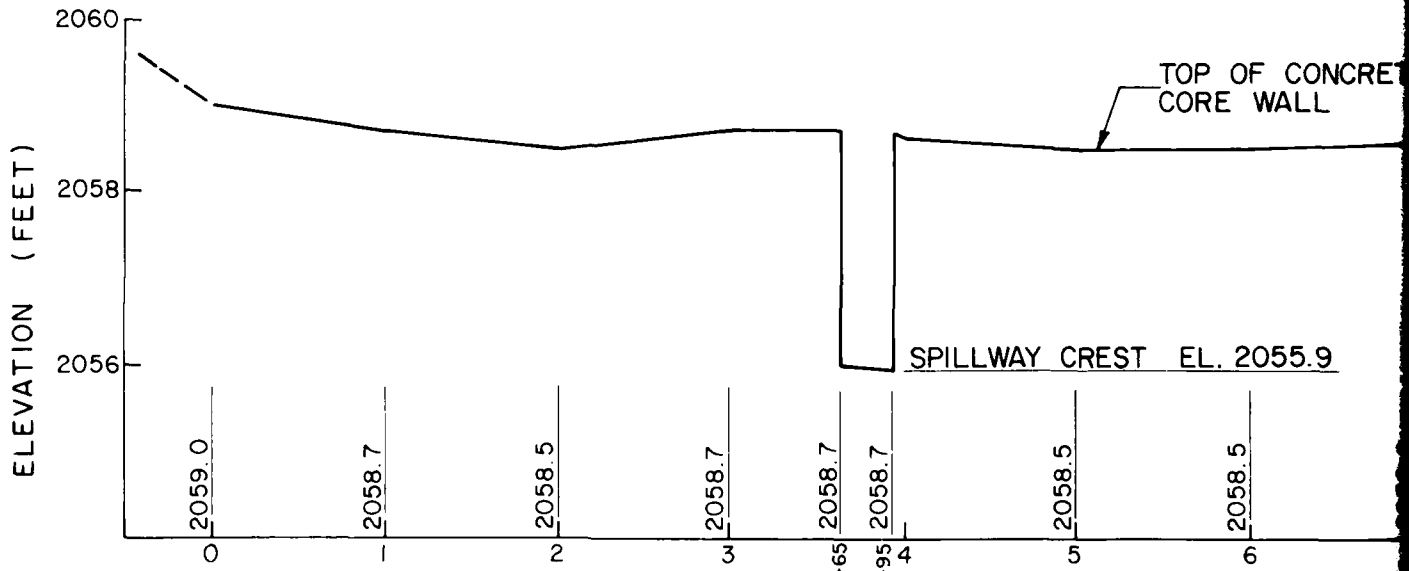
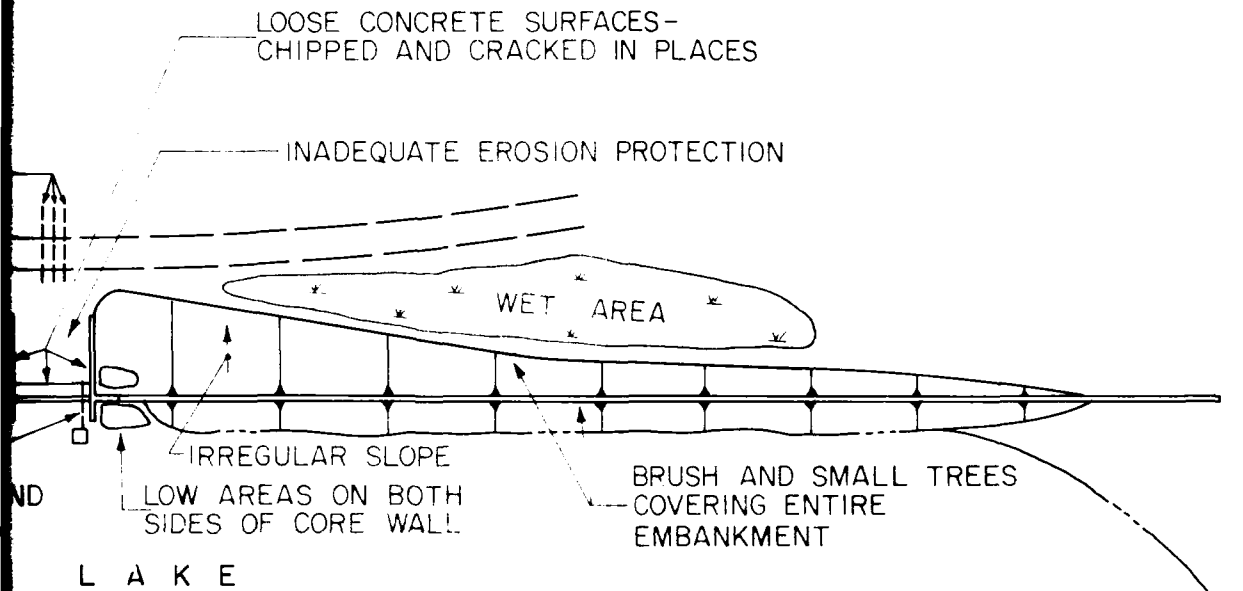
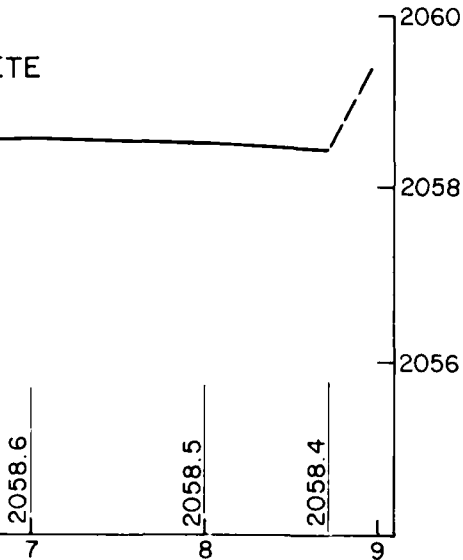
PHASE I INSPECTION REPORT
 NATIONAL DAM INSPECTION PROGRAM
 CRYSTAL LAKE DAM
 POCONO SPRINGS ESTATES, INC.
**RESULTS OF
 VISUAL INSPECTION**
 JANUARY 1981 EXHIBIT B-1

DATE OF INSPECTION: 27 OCTOBER 1980
 POOL ELEVATION: 2055 5 FEET
