**CONCRETE AND ROCK TESTS  
MAJOR REHABILITATION OF DRESDEN ISLAND  
LOCK AND DAM, ILLINOIS WATERWAY  
CHICAGO DISTRICT, PHASE II COMPLIANCE  
SCOUR DETECTION**

R. L. Stowe, B. A. Pavlov

March 1981  
Final Report

Prepared for U. S. Army Engineer District, Chicago  
Chicago, Ill. 60604

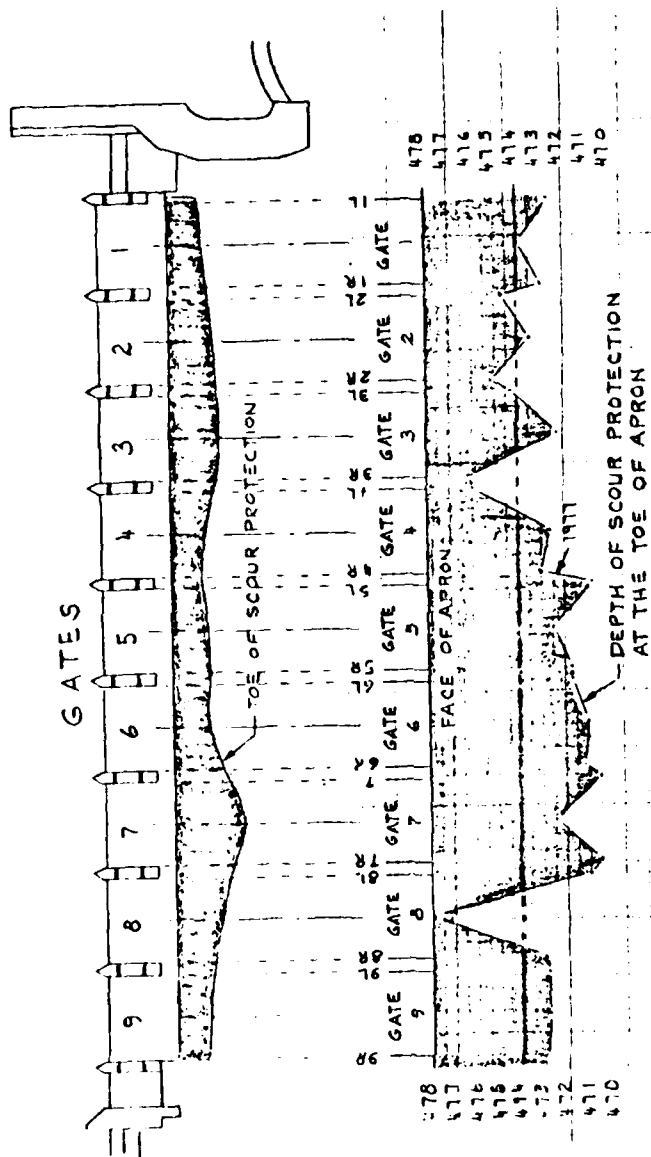
**DRESDEN ISLAND  
L/D  
MAJOR REHABILITATION  
SCOUR PROTECTION DAM  
PLAN AND PROFILE  
AUG. 1977 PLATE 33**

98. A study was made to see if any topographic feature downstream of the dam could be correlated with the interpreted faulting. At about 80 ft downstream of the apron and on scour profile 9R, scouring was found to be the deepest; see scour profile, gate 9R, on Plate A-51 in Appendix A. The bottom of the scouring in this area is at El 461.0 ft. Fault K intersects profile line 9R where the scour is at El 461.0 ft. The possibility that the scoured area is within the fault proper appears good. This is the only area so deeply scoured, and the area is some distance downstream of where the turbulent water is coming off the gate weirs. The other scour profile lines studied do not indicate any unusual topography other than trench features aligned normal to the dam. The trenches probably resulted from the water flow out of the gates. The deepest trenches are just downstream of the most frequently used gates.
