| REPORT DOCUMENTATION PAGE | | READ INSTRUCTIONS<br>BEFORE COMPLETING FORM |
|---|---|---|
| 1. REPORT NUMBER<br>NRL Memorandum Report 4501 | 2. GOVT ACCESSION NO.<br>AD-A098 894 | 3. RECIPIENT'S CATALOG NUMBER |
| 4. TITLE (and Subtitle)<br>SHOCK AND VIBRATION PERFORMANCE OF<br>WIND INDICATING EQUIPMENT, TYPE F | 5. TYPE OF REPORT & PERIOD COVERED<br>Final report on one phase of<br>an NRL problem. | 6. PERFORMING ORG. REPORT NUMBER |
| 9. PERFORMING ORGANIZATION NAME AND ADDRESS<br>Naval Research Laboratory<br>Washington, D.C. 20375 | 10. PROGRAM ELEMENT, PROJECT, TASK<br>AREA & WORK UNIT NUMBERS<br>63541N; 0291-0-1 | |

SHOCK AND VIBRATION PERFORMANCE OF WIND INDICATING EQUIPMENT,  
TYPE F.

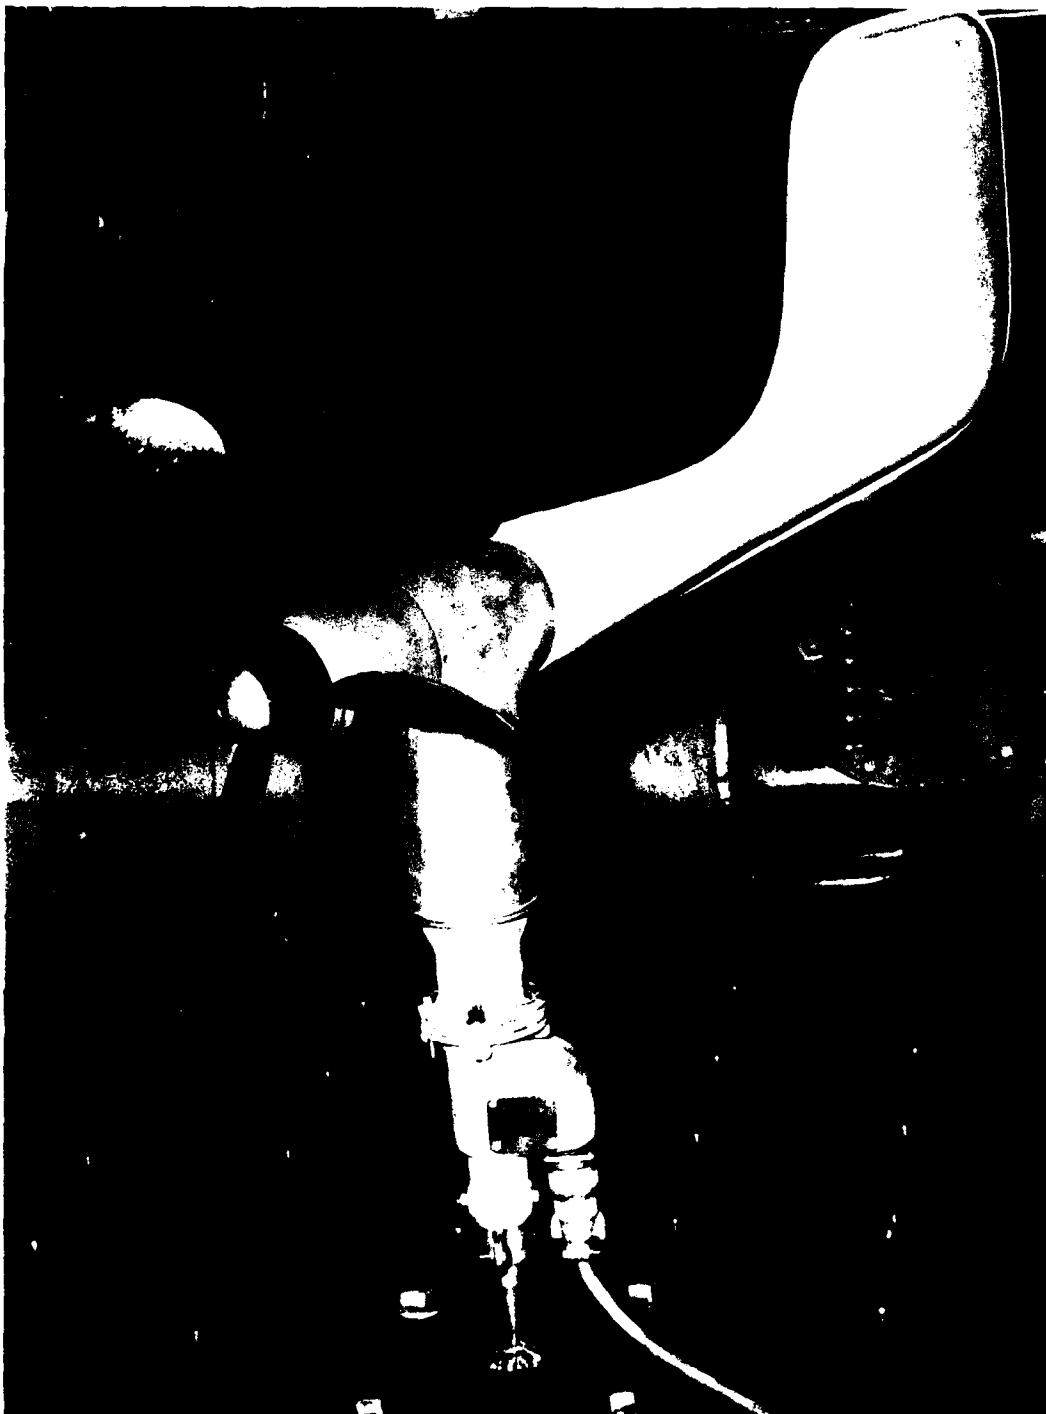
Fig. 1 — The detector mounted on the RVM for vibration in the Fore-and-Aft axis.  
It is bolted to a pintle of round bar stock welded to a 1/2-in. mounting-plate.

3.4.1. Exploratory - The RVM was operated through the frequency range 4-33 Hz at a nominal amplitude of 0.010-in, and from 34-47 Hz at an amplitude of 0.003 in nominal. A slight resonance involving the center assembly section was noted in the range 8-15 Hz; this was observed as an increase in the vibration amplitude of the lower shroud portion of the section. A similar behavior was found in the range 20-24 Hz, where there was also a noticeable increase in the vibration motion of the tail section of the vane.

3.4.3. Endurance - The endurance test consists of a two-hour dwell at resonance. It was conducted at 22 Hz, with an amplitude of 0.020 in. After 1-1/2 hr of the test, the detector suddenly dropped out of resonance. Inspection revealed that the pintle-bolt had fractured at the first thread (i.e., closest to the head). The bolt was removed and replaced with the CRES bolt normally supplied with the detector for this application. The final 1/2 hr of the Endurance test was then completed. No damage or malfunction of the detector was observable following the test.

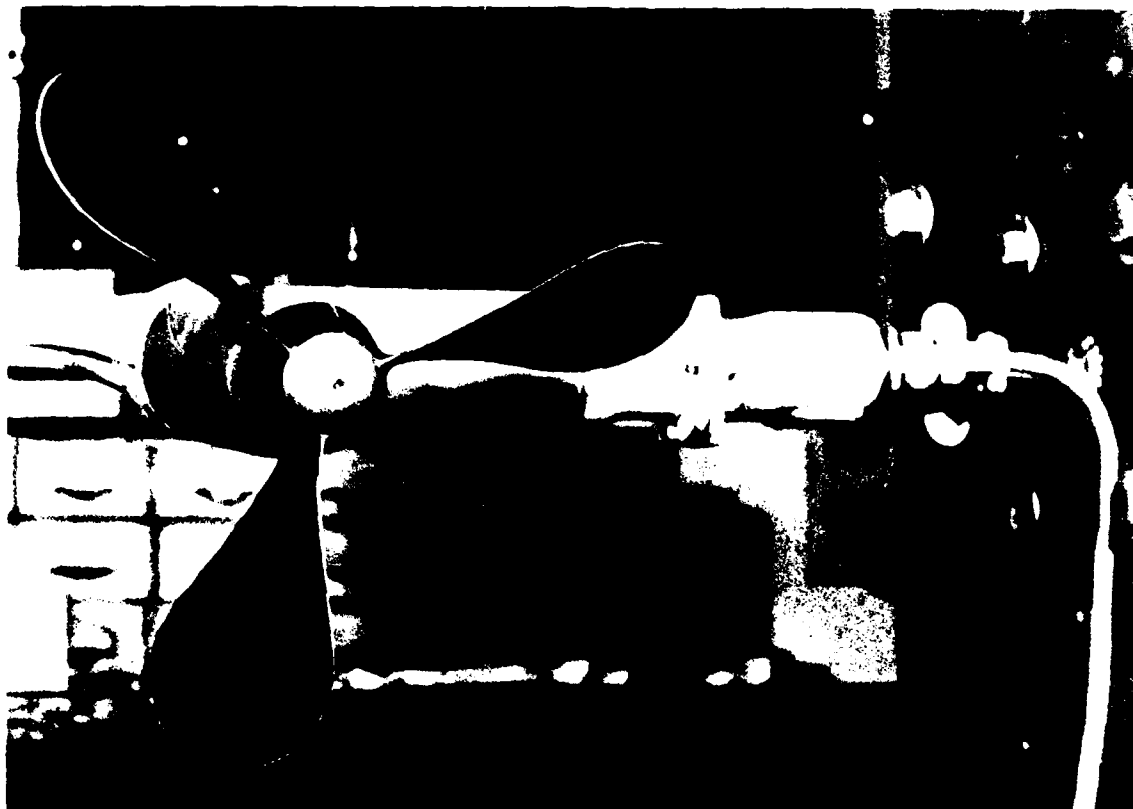
Fig. 2 The detector mounted on the LSM for Back and Top blows

was 185°, and speed indication was 10 knots. No damage was noted after either the 1-ft or 3-ft blows. The 5-ft blow caused considerable damage to the vane, as shown in Figs. 3 and 4 and listed below.

Following repairs, the unit functioned normally.

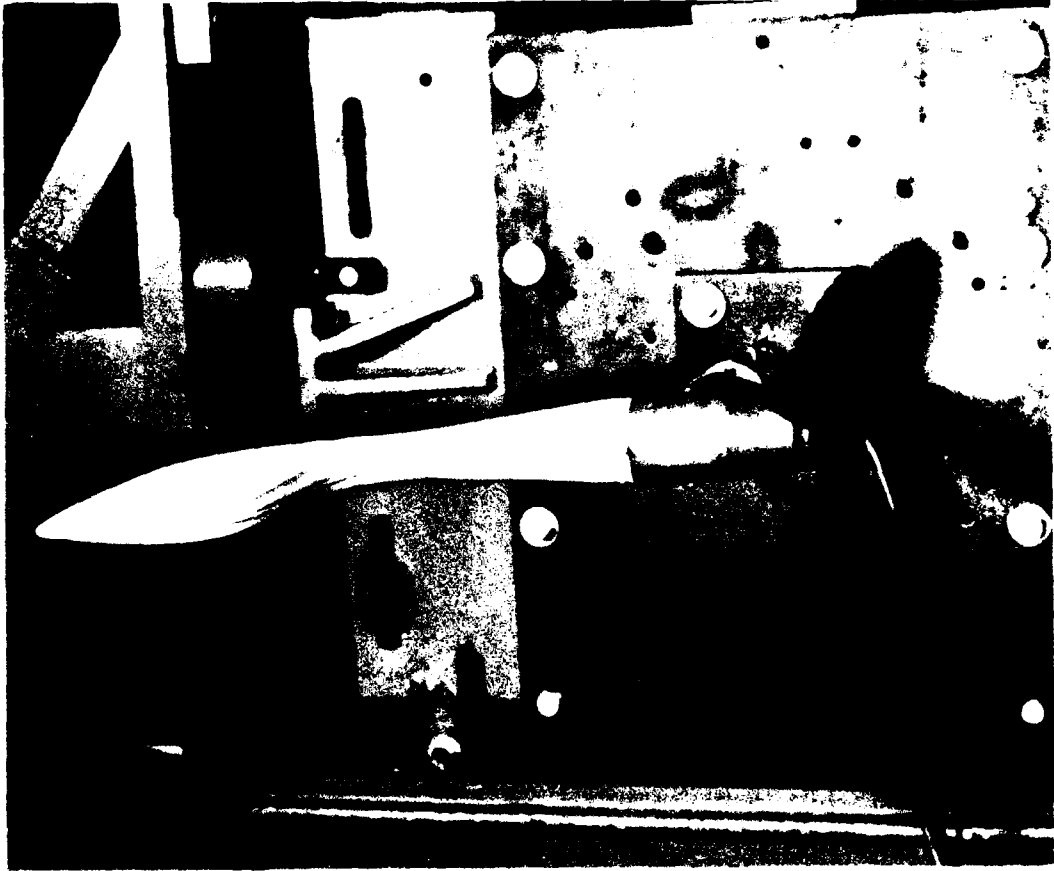
3.8.3. Edge Blows - Edge blows are struck with the swinging hammer after the anvil plate assembly has been rotated 90°, as shown in Fig. 6. In this arrangement, the reference wind direction indication was 190°, speed indication 7 kt.

Fig. 6 — The detector mounted on the LWSM for Edge blows

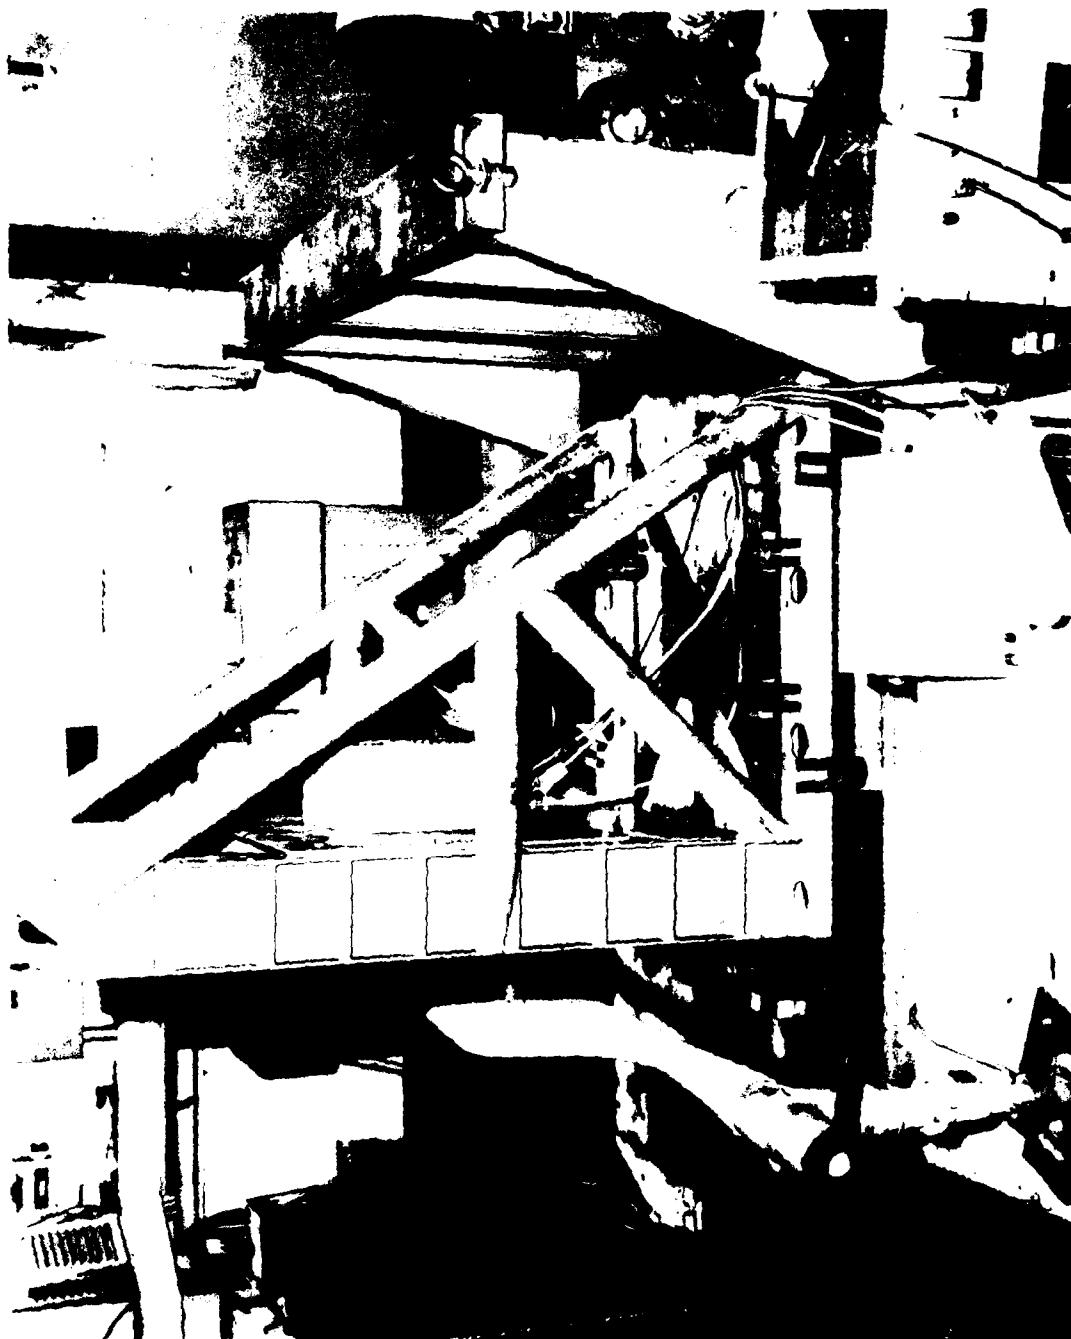
4.3.3. Endurance - The RVM was operated at 37 Hz, amplitude 0.005 in for a period of two hours. Although no malfunction was noted, post-test inspection found considerable play, at some positions, between a spiral shaft

Fig. 8 — The transmitter mounted on the Bulkhead Fixture on the RVM, oriented for vibration along the Vertical and Horizontal-Perpendicular-to-Front axes

and pinion in the wind speed section. The affected parts were PC No 243A and PC No 246B. No other peculiarities were noted.
