CUMBERLAND POND DAM

NJ00824

PHASE I INSPECTION REPORT E

NATIONAL DAM SAFETY PROGRAM

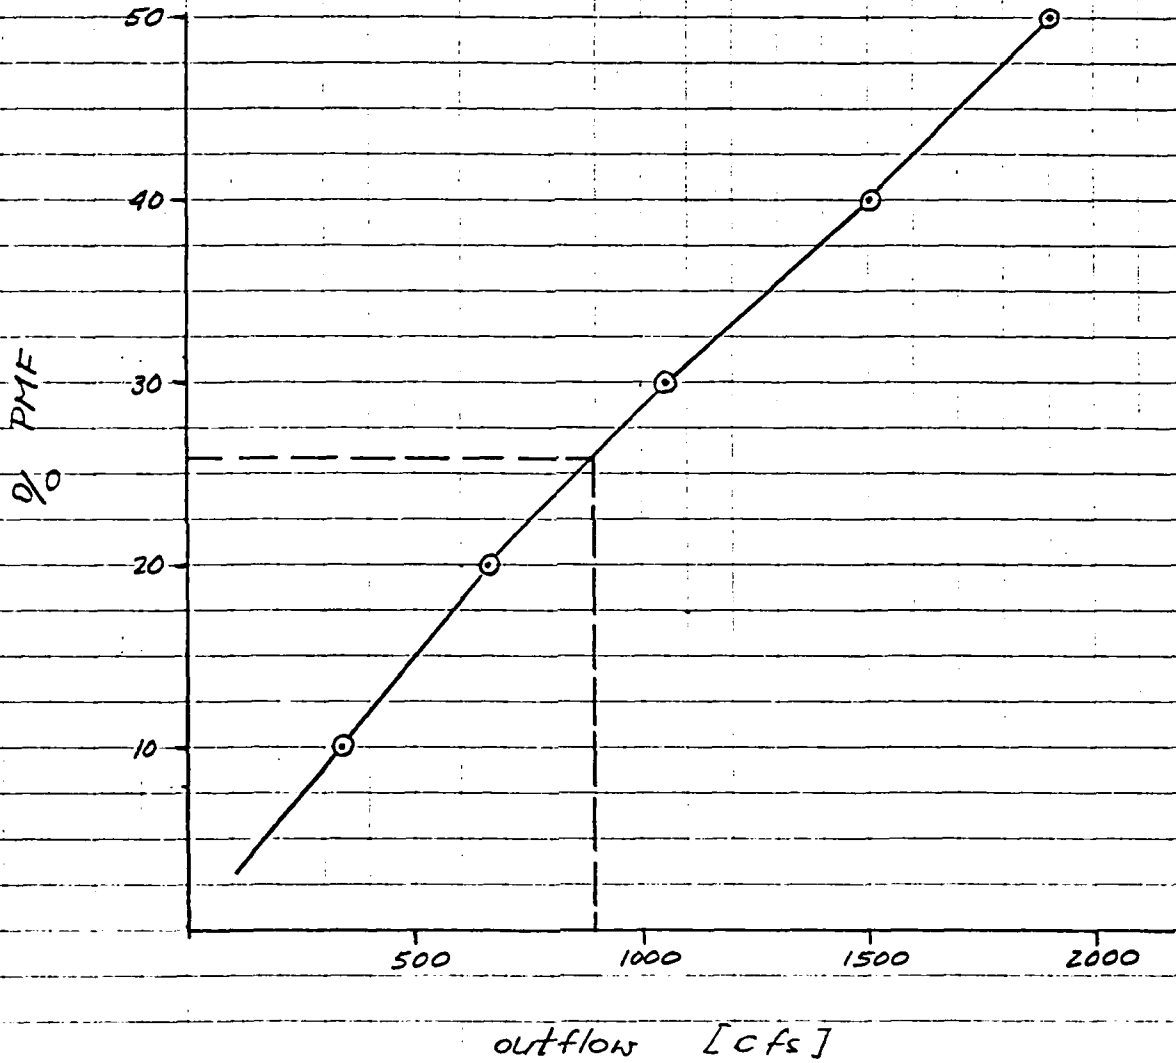
OVERTOPPING POTENTIAL

OVERTOPPING OF DAM OCCURS AT ELEV. 34.7

WITH AN OUTFLOW $Q = 896.0$ cfs

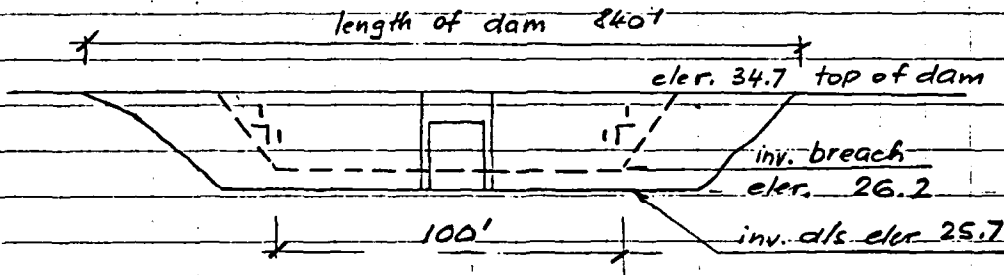
1. BREACH SECTION

Bottom of breach	elev.	26.2 [Ft]
	effect. length	100 [Ft]
side slope of breach		1:1
Water surface	elev.	29.0 [Ft]
Water surface elev. which will cause dam to fail	elev.	34.7 [Ft]
time to develop breach to max. size		2.0 [hr]
