National Dam Inspection Program, Pocono
Woodland Lake Dam (NDI I.D. Number
PA-00443, PennDER I.D. Number 52-179),
Delaware River Basin, Branch of Raymond-
skill Creek, Pike County, Pennsylvania.
Phase I Inspection Report,

PHASE I INSPECTION REPORT
NATIONAL DAM INSPECTION PROGRAM

Pocono Woodland Lake Dam: NDI I.D. No. PA-00443

Inspection Date: 12 November 1980

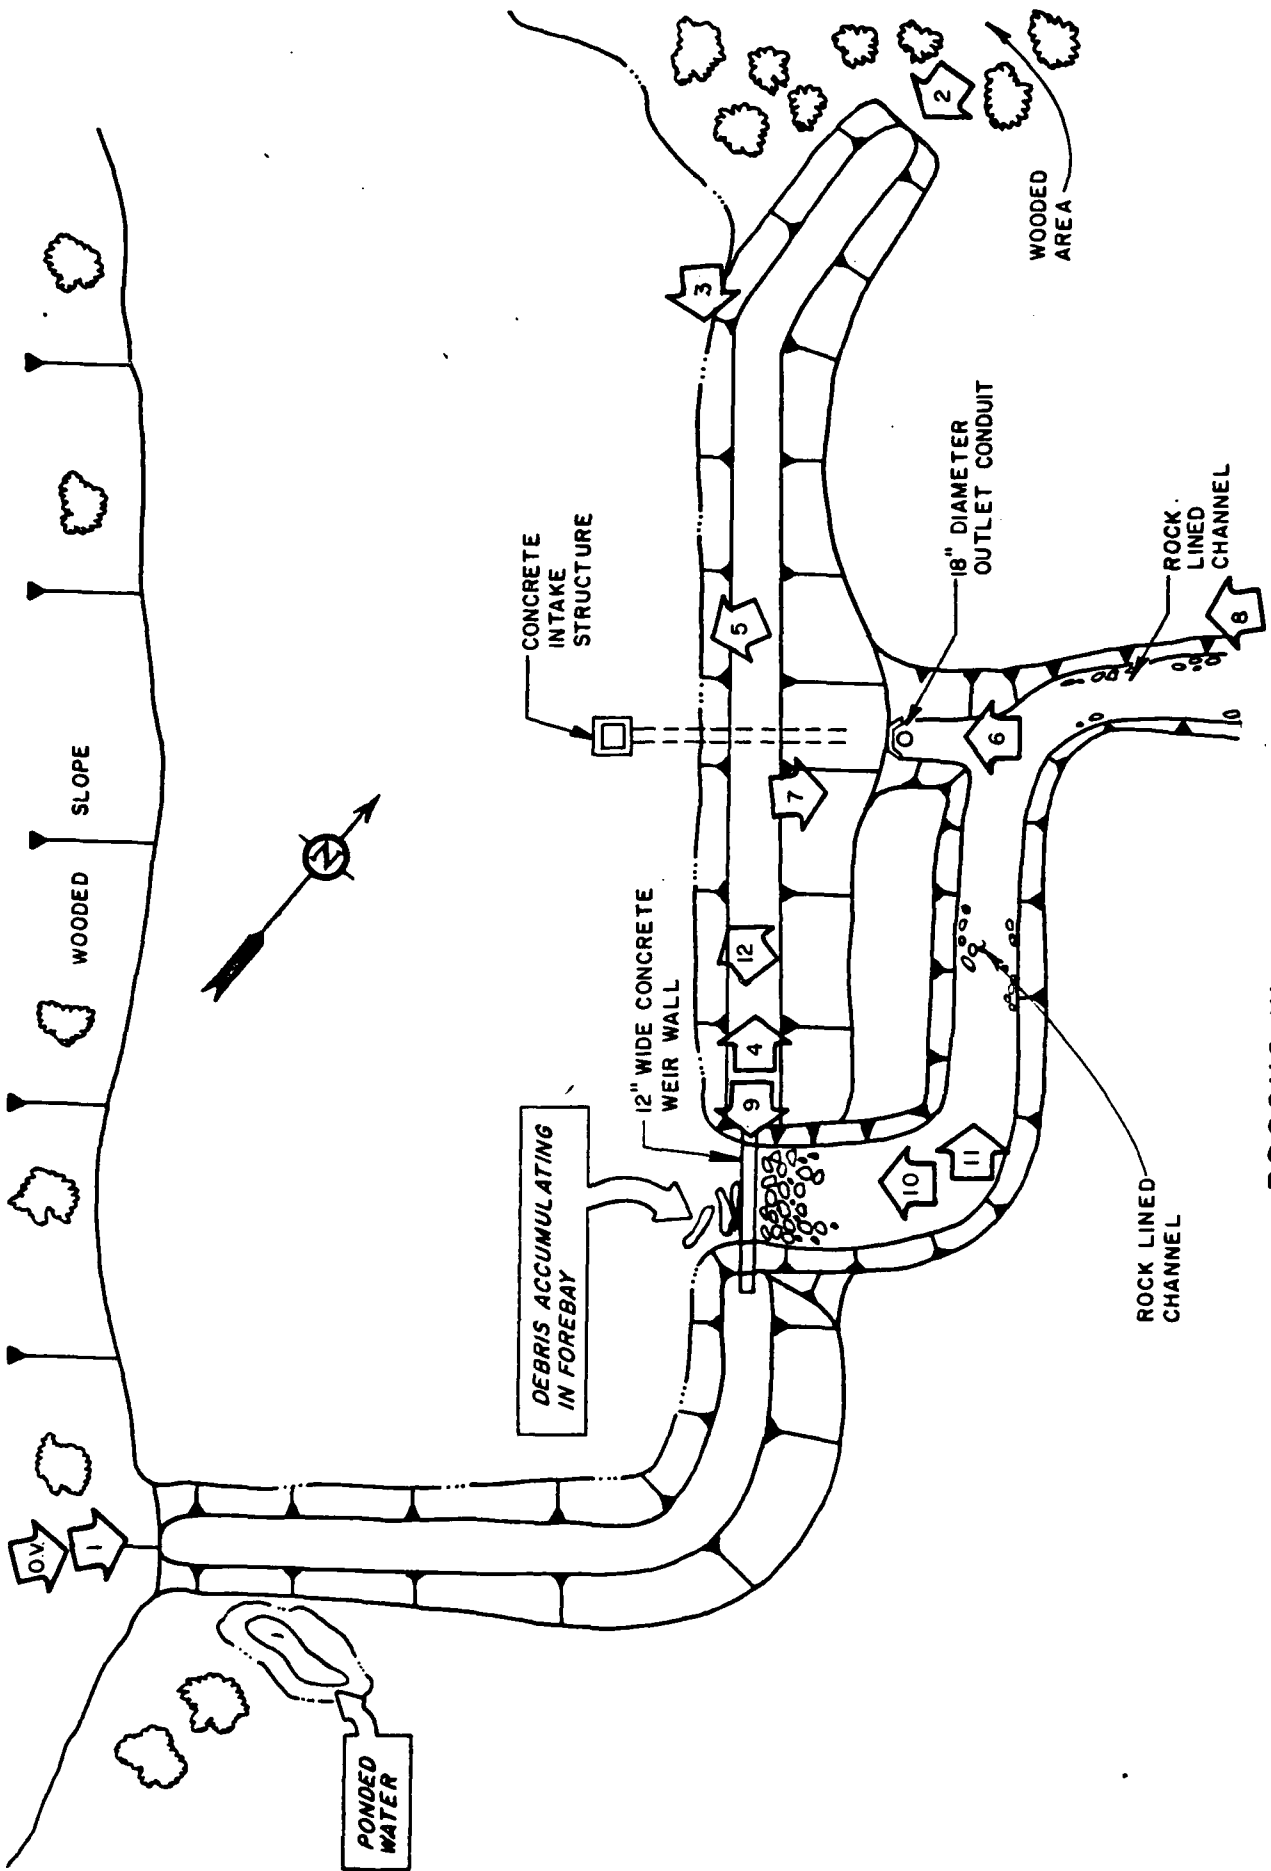
b. Embankment. The visual inspection indicated that the embankment is in excellent condition and well maintained (see Photographs 1 and 4). No seepage through the downstream embankment face was noted during the field inspection; however, standing water near the downstream toe of the south embankment was observed. This condition is not considered serious, but, the area should be reshaped to facilitate drainage of the surface water into the existing diversion ditch.

PHOTOGRAPH 1 Overview of Pocono Woodland Lake Dam as seen from the right abutment.

PHOTOGRAPH 2 View across the embankment crest looking toward the right abutment.

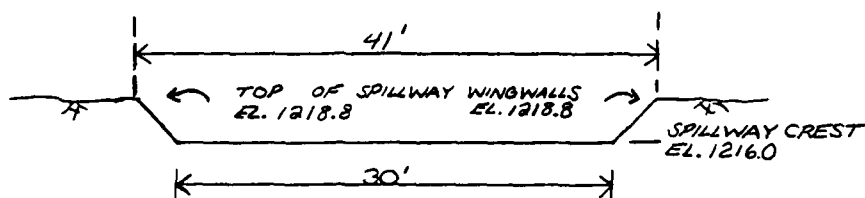
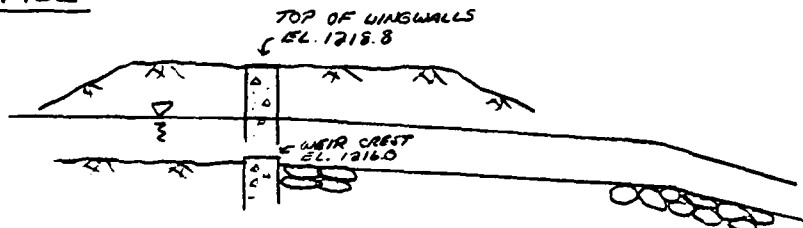
CROSS-SECTION:

(THE DIMENSIONS OF THE DOWNSTREAM SPILLWAY CHANNEL
ARE APPROXIMATELY THE SAME AS THAT OF THE WEIR SECTION
SKETCHED ABOVE.)

(SKETCHES BASED ON FIELD MEASUREMENTS
AND OBSERVATIONS)
