N.J. NO NAME  
DAM NO. 51  
NJ 00823

PHASE 1 INSPECTION REPORT  
NATIONAL DAM SAFETY PROGRAM

REPT. NO: DAEN/NAP-53842/NJ00823-81/03

MARCH 1981

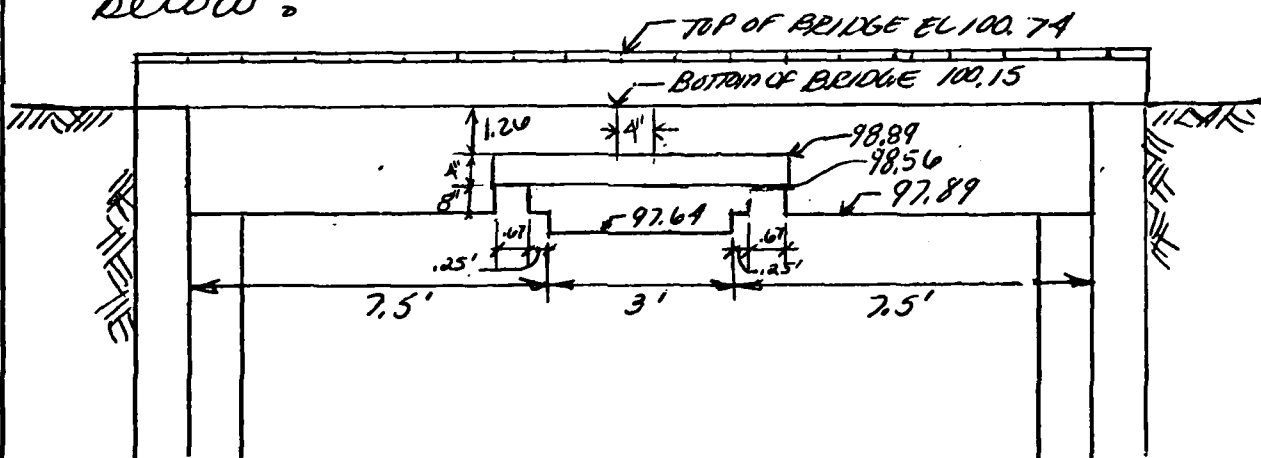
The visible portion of the spillway indicates that the structure is a notched broadcrested weir. It has a crest width of 1' and is 20 ft in length. At the centerline of the spillway is a 3 ft long 3" deep notch. The configuration of the weir and elevations are as shown below:

Approximately 12 ft downstream on the concrete apron exists a trapezoidal broadcrested weir with its crest at elevation 89.39. The weir has a sluiceway cut into it which appears to have been controlled by a 2' x 1.8' gate. It is presently deteriorated. For this analysis it will not be considered.
