**SUNSET LAKE  
RACEWAY DAM  
NJ 00764**

**PHASE 1 INSPECTION REPORT  
NATIONAL DAM SAFETY PROGRAM**

Sunset Lake Raceway Dam (NJ00764).  
Delaware River Basin, Cohansey River,  
Cumberland County, New Jersey. Phase  
I Inspection Report.

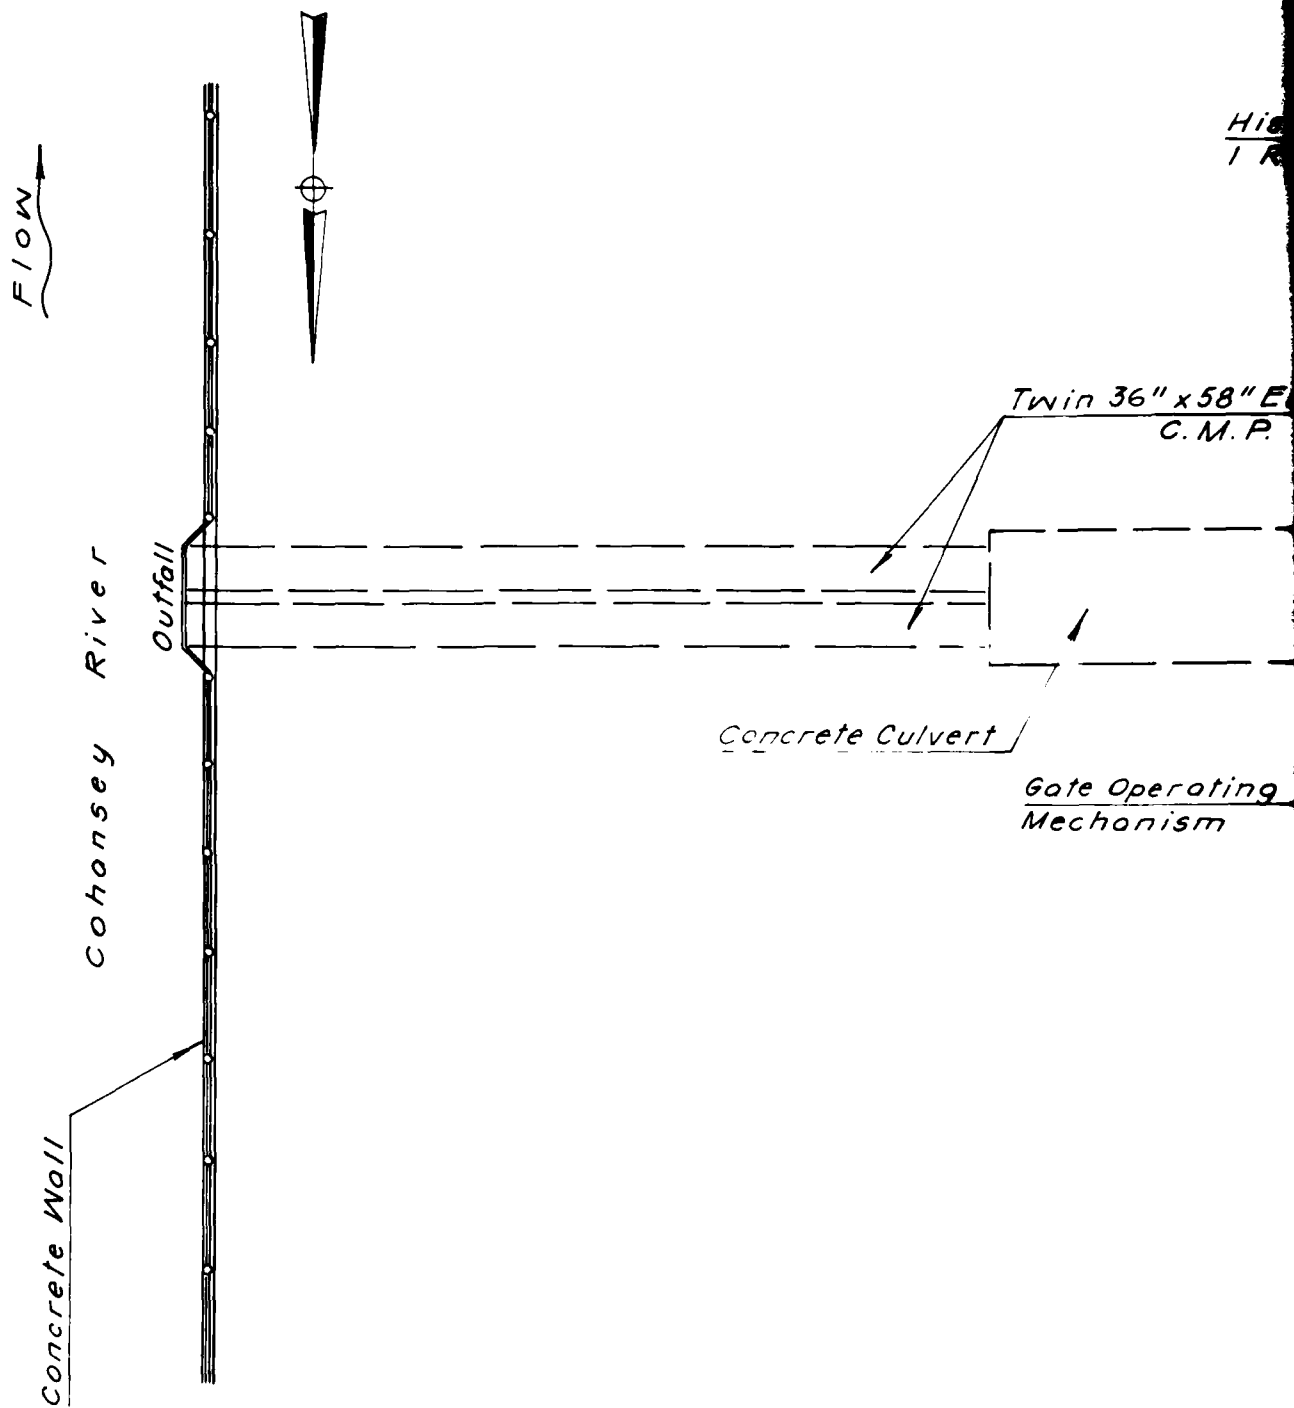
Information taken from "Plan of Raceway Spillway for Bridgeton City Park" prepared by W.A. Kirby, City Engr, 1947 and field inspections January 8 and 27, 1981
