**CEDAR LAKE DAM**

**NJ 00805**

PHASE 1 INSPECTION REPORT  
NATIONAL DAM SAFETY PROGRAM

REPT. NO. DAEN/NAP-53842/NJ00805-81/05

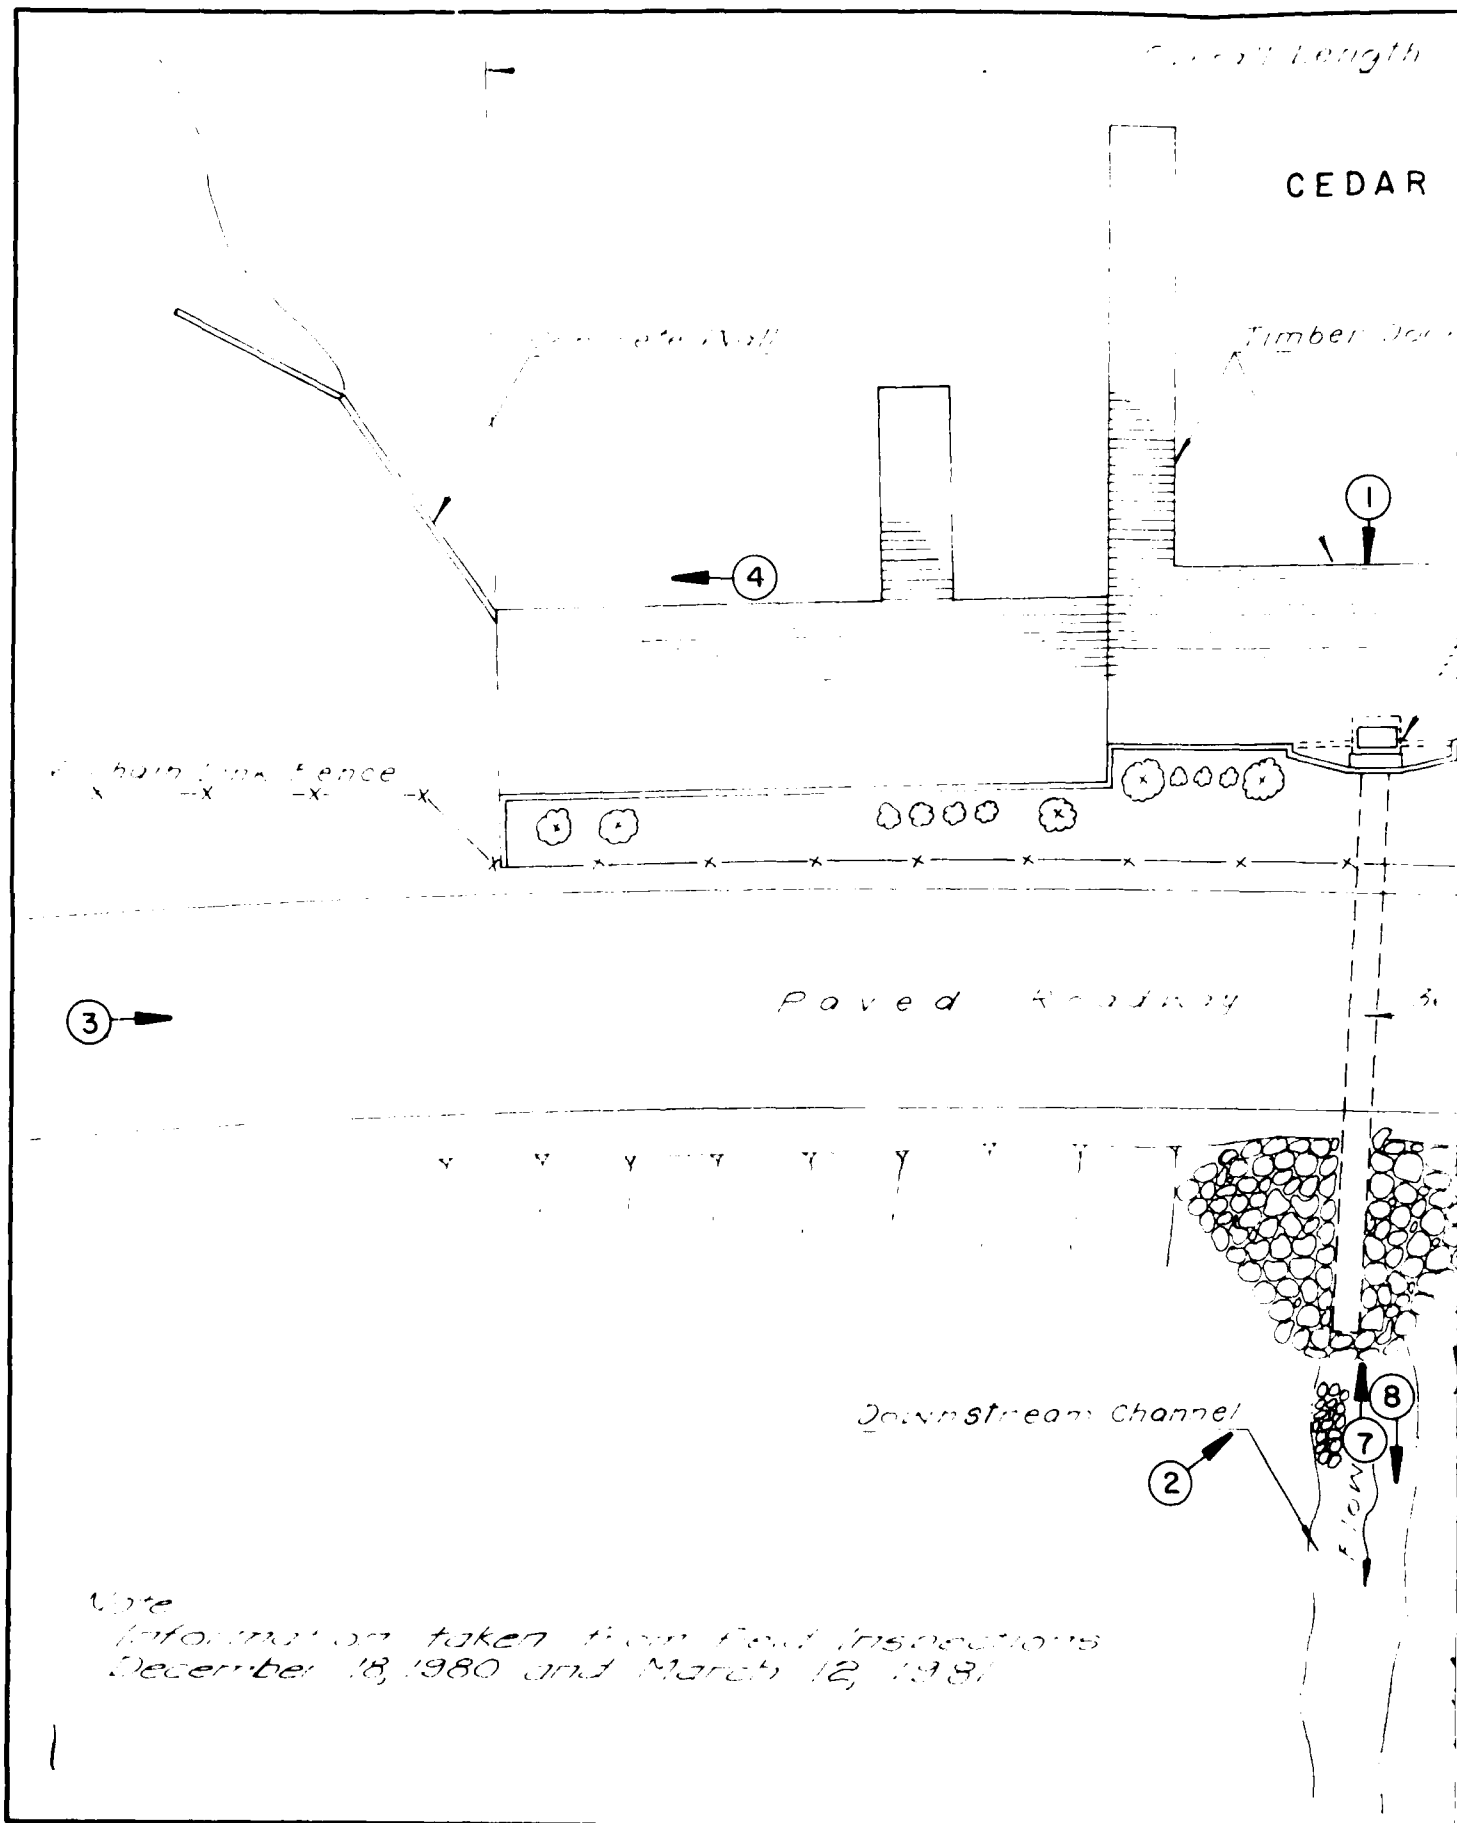
Length of Dam 260'

| VISUAL EXAMINATION OF | OBSERVATIONS | REMARKS OR RECOMMENDATIONS |
|---|---|---|
| GENERAL | Timber walls on upstream side in satisfactory condition. Downstream side irregular and covered with trees, bushes and boulders. Random fill placed on downstream side. | Trees and adverse vegetation should be removed. |
| ANY NOTICEABLE SEEPAGE | A small amount of seepage was observed at the toe of the embankment near the spillway outlet and in the bed of the downstream channel. Orange colored deposits observed. | Seepage should be monitored on a periodic basis. |

| VISUAL EXAMINATION | OBSERVATIONS | REMARKS OR RECOMMENDATIONS |
|---|---|---|
| RIPRAP | Riprap observed on the upstream face of the dam immediately adjacent to the spillway. Boulders dumped on downstream side around spillway culvert outlet. Voids in the soil within the boulders observed. | |

| VISUAL EXAMINATION OF | OBSERVATIONS | REMARKS OR RECOMMENDATIONS |
|---|---|---|
| 36" CULVERT PIPE | 36" CI pipe observed at the upstream end and a 36" CMP pipe at the downstream end. The alignment between the two sections was poor and the C.M.P. was severely rusted on its invert at the downstream end. Deteriorated invert observed to be paved with mortar on 3/12/81. | Discharge culvert should be repaired or replaced. |
| DISCHARGE CHANNEL | Boulders haphazardly placed downstream of the discharge culvert. Voids observed in the soil behind the boulders. | Soil on the downstream side should be properly compacted and stabilized. |

- 1) The spillway discharge culvert should be properly repaired or replaced.
- 2) Soil on the downstream side of the embankment should be properly compacted and stabilized.
- 3) Trees and adverse vegetation on the embankment should be removed.
