AFESC/ESL-TR-80-51

**FIELD TEST OF EXPEDIENT  
PAVEMENT REPAIRS  
(TEST ITEMS 16-35)**

**MICHAEL T. McNERNEY  
ENGINEERING RESEARCH DIVISION**

**NOVEMBER 1980**

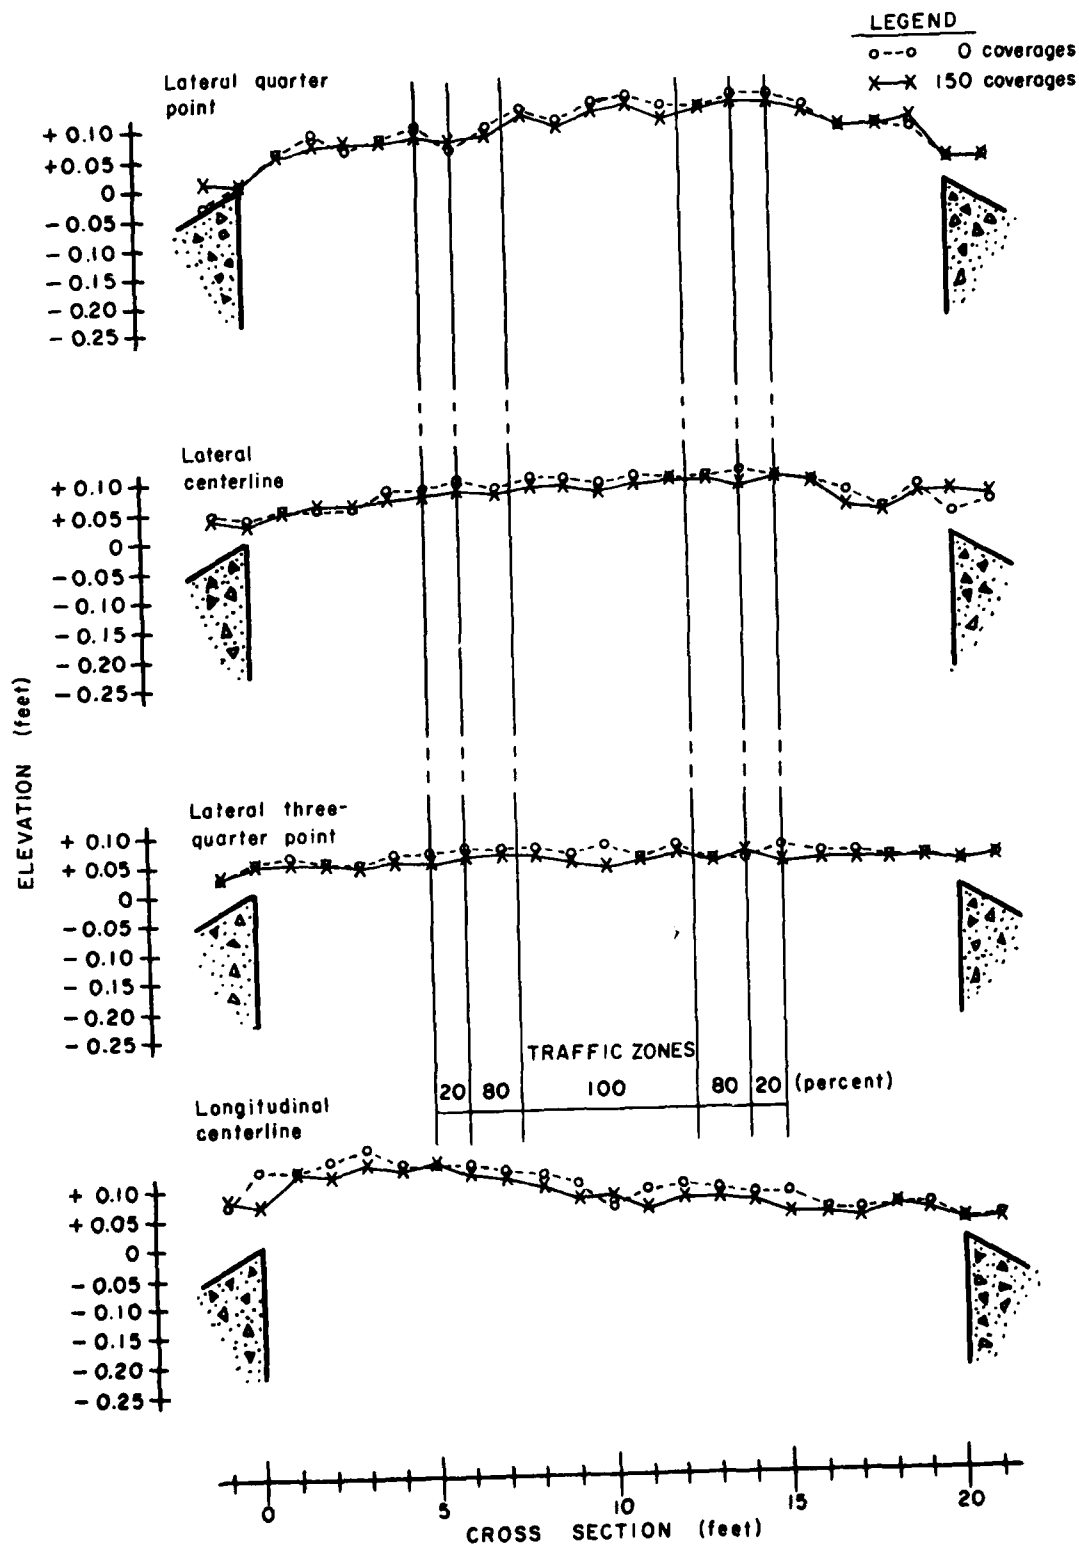
Figure 12. Surface Profiles, Item 16

The repair easily withstood 150 coverages of the F-4 load cart. Core samples of the test surface achieved tensile splitting strengths of 297, 492, and 762 psi. Figure 12 shows the results of profiles taken from the surface of the test pit. Deformation of approximately 1 inch indicates the subgrade had consolidated and the bond between the polymer concrete and the existing concrete did not hold. The MMA polymer concrete proved capable of supporting F-4 traffic without excessive repairs. Deformation occurred as a result of the densification of the subgrade and the lack of sufficient bonding between the polymer concrete and the adjacent concrete. The edges of the concrete pit required a clean surface before adequate bonding could occur.

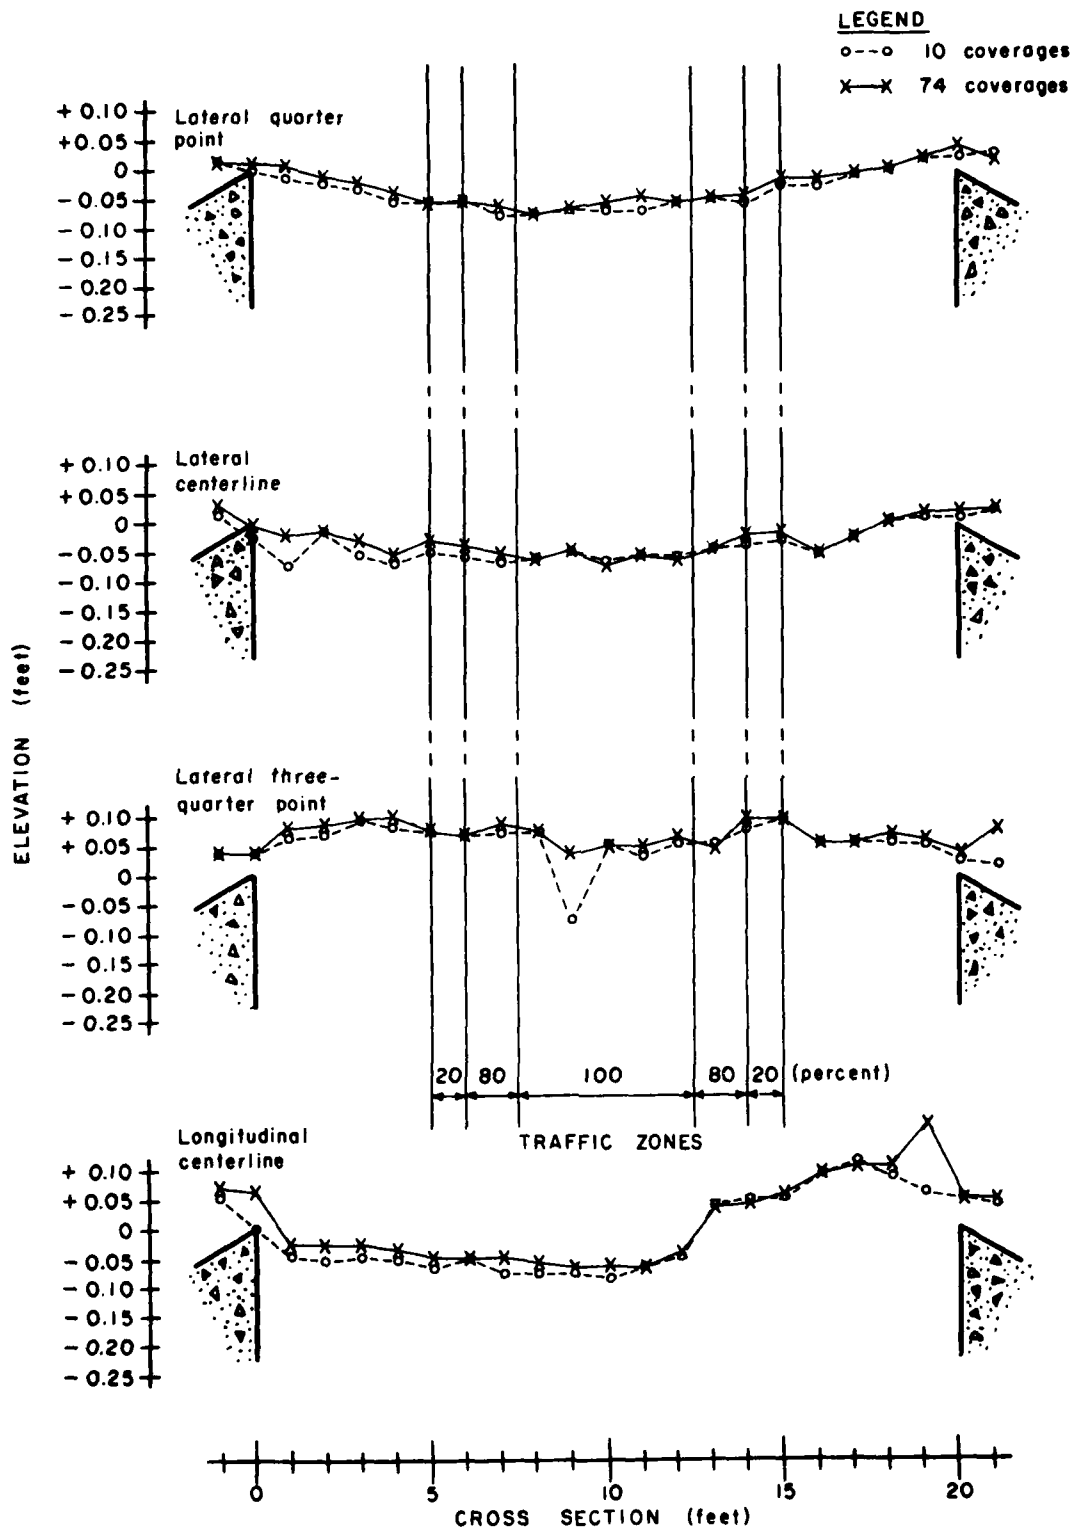
Figure 18. Surface Profiles, Item 33

Profiles were taken of the test surface (Figure 18); complete core samples could not be taken in the traffic lane of the first pour due to internal cracks. These cracks caused the flexing that was noted during the coverages.

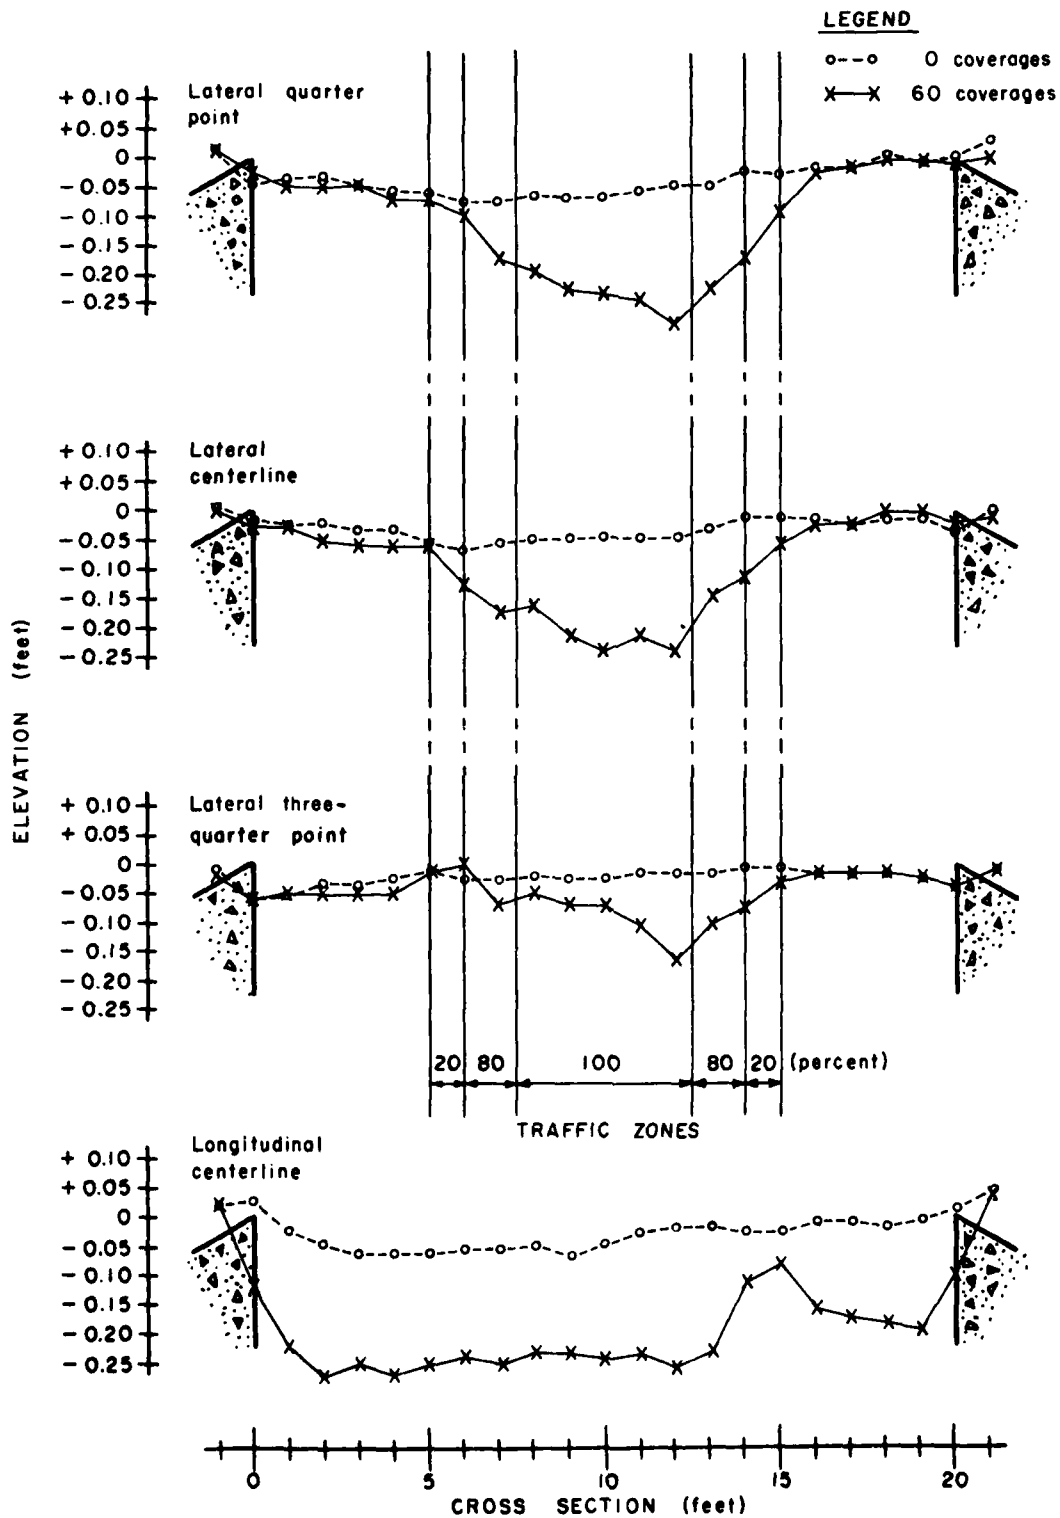
Figure 26. Surface Profiles Before Repair, Item 19

Profiles taken of the surface before repair are shown in Figure 26. Additional limestone was added to the test pit and compacted with two coverages of the RayGo 510A. The base course appeared worn and in need of repair after the completion of the 150 coverages. Profiles of the test surface after 150 coverages are shown in Figure 27. Density measurements obtained during load cart trafficking are recorded in Table 6.

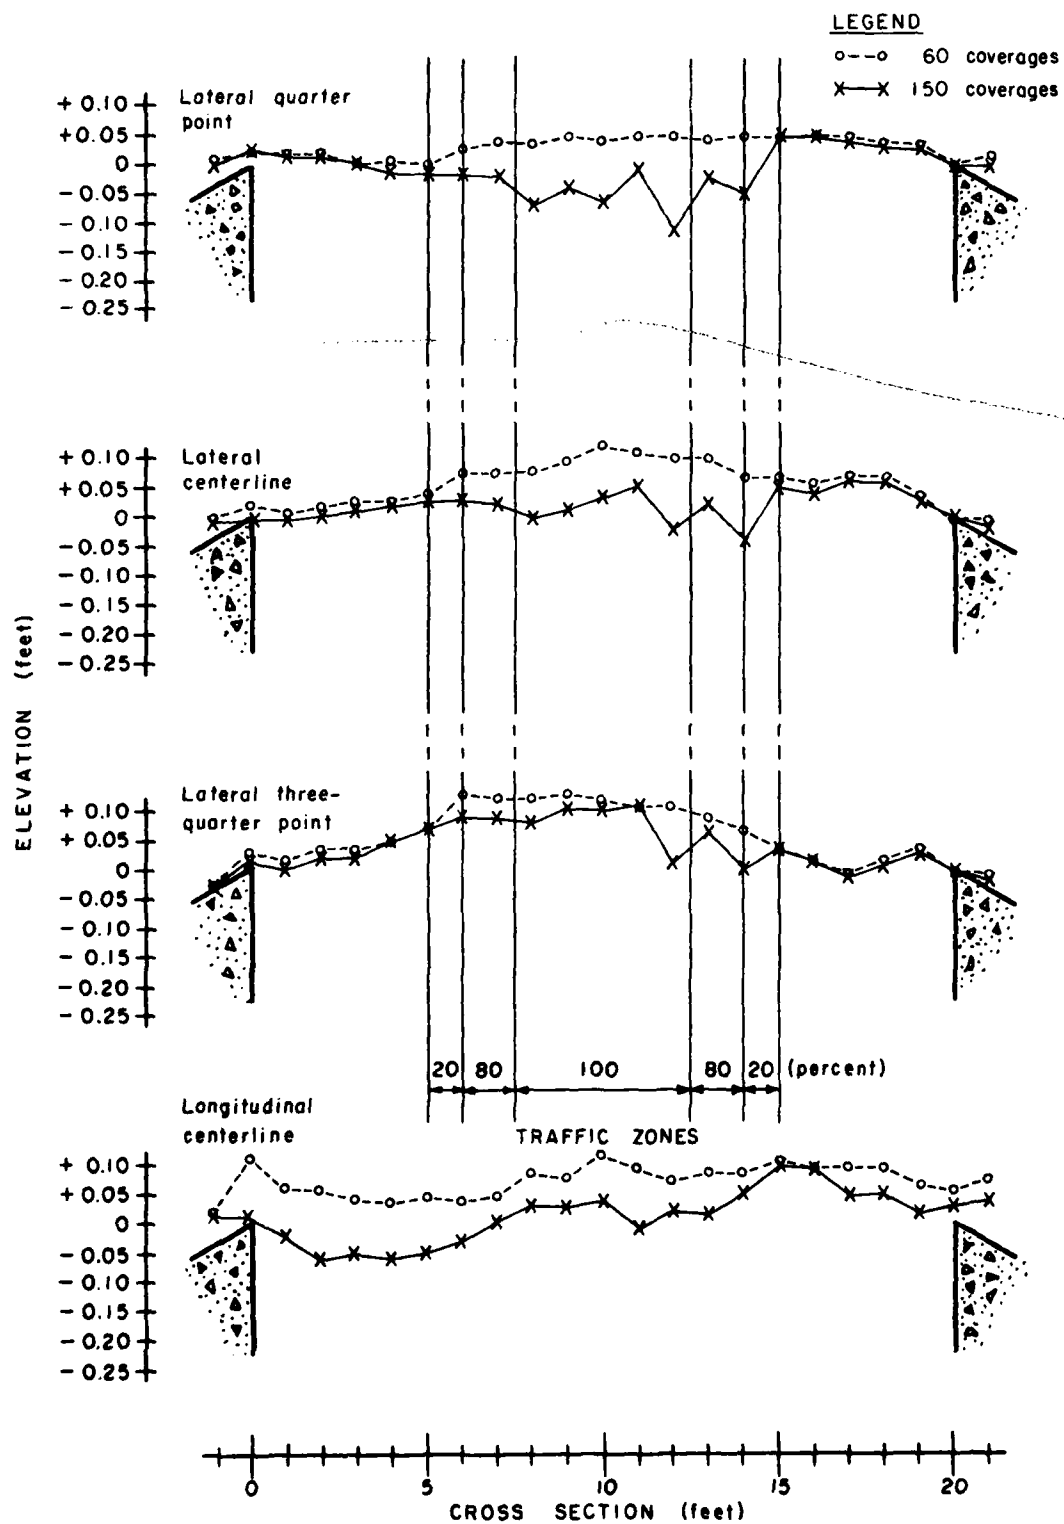
Figure 27. Surface Profiles After Repair, Item 19

CBR measurements of the surface showed a CBR of 56 in the traffic lane, a CBR of 47 out of the traffic lane, and a CBR of 7 on a spongy area in the traffic lane.

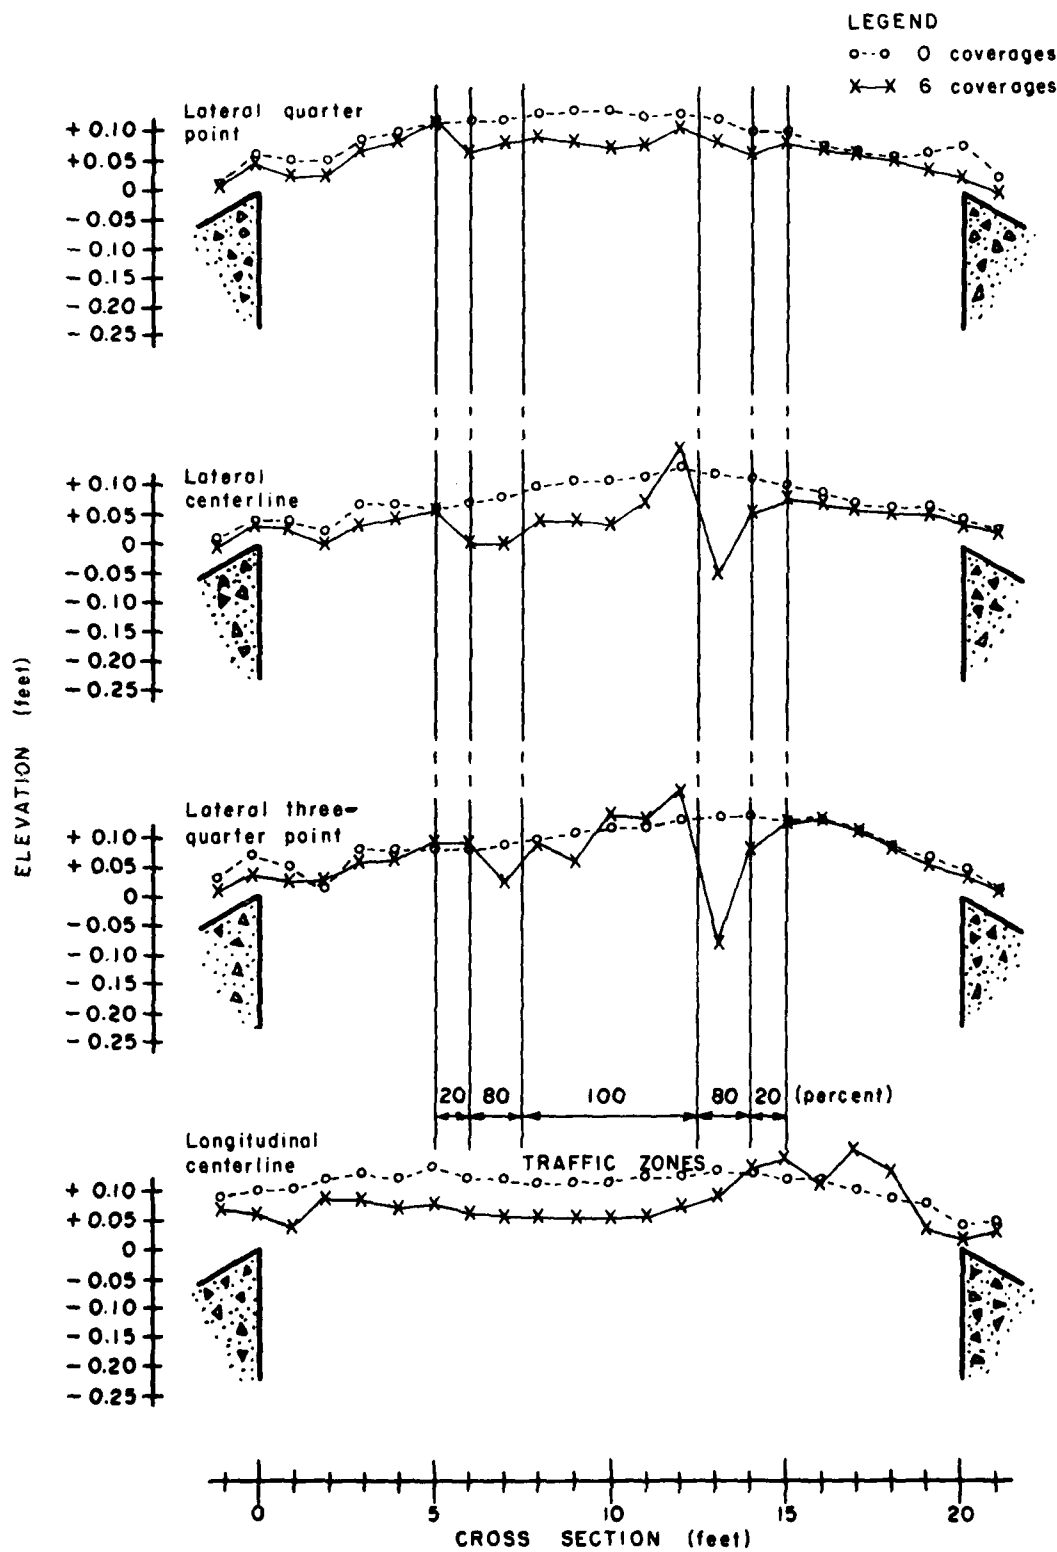
Figure 30. Surface Profiles, Item 21

Surface profiles relating to this test are given in Figure 30. Density and moisture content data obtained after the completion of six coverages of the load cart are given in Table 7.

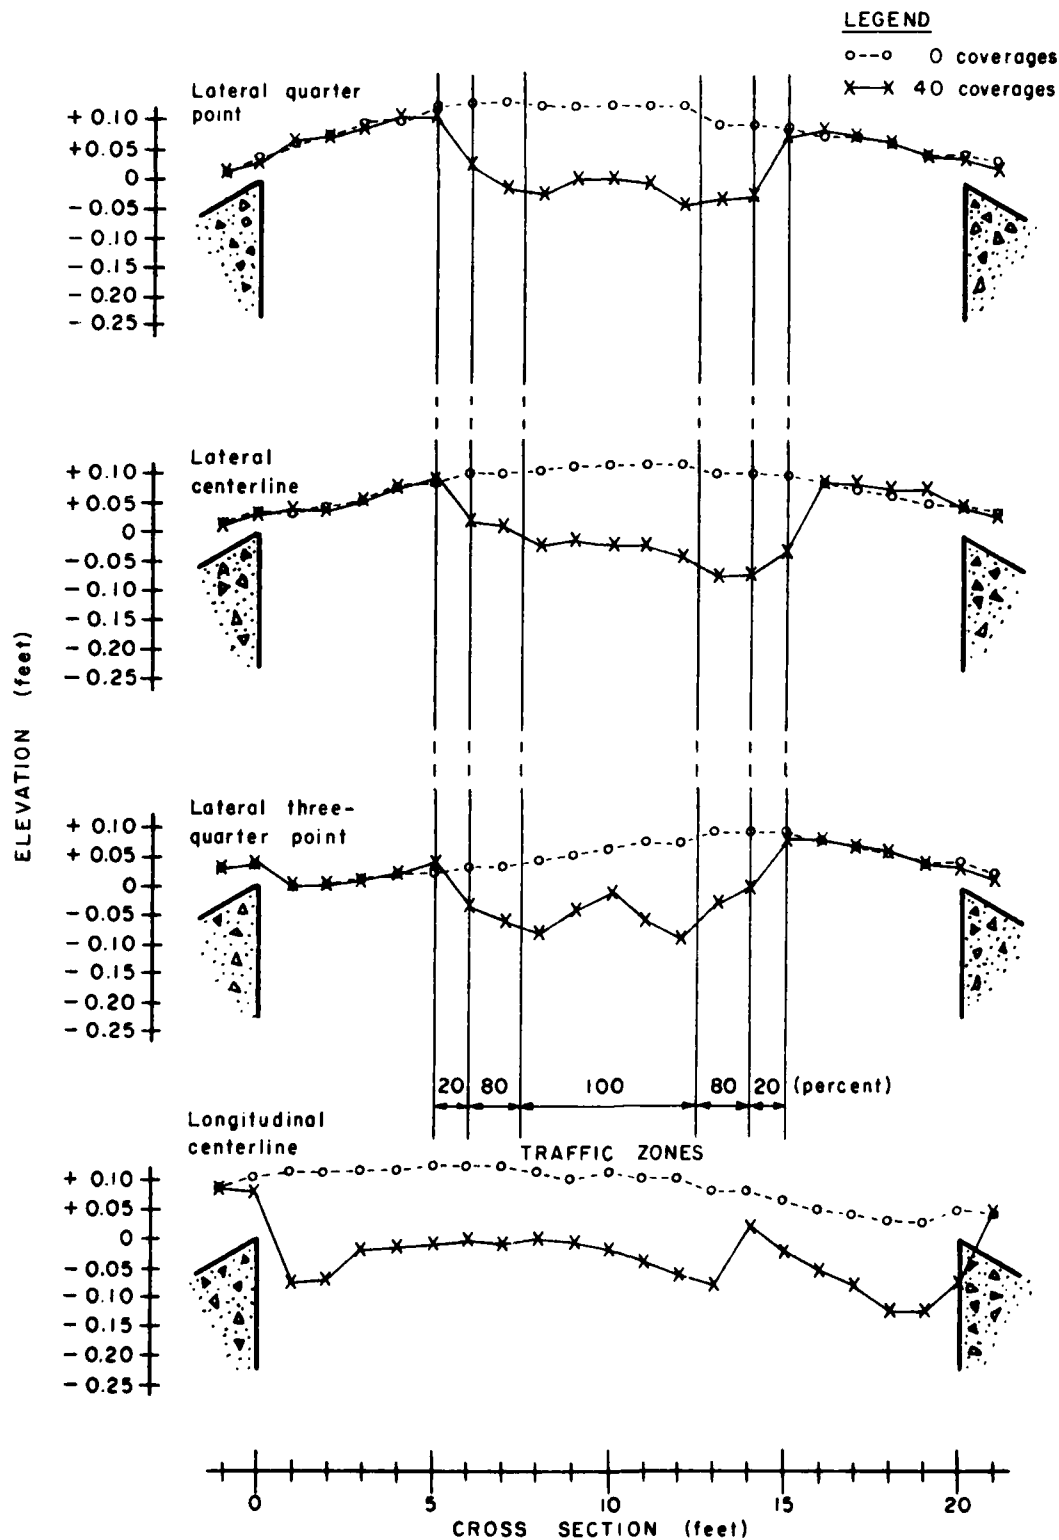
Figure 32. Surface Profiles Before Repairs, Item 22

Profiles obtained before repairs were made are shown in Figure 32. Crushed limestone was then added to the test pit and compacted with the RayGo 400A. One hundred fifty coverages were completed without further repair (Figure 33). Profiles taken at this point indicated maximum ruts of 2.25 inches and consolidation of 1 inch (Figure 34). After the initial 40 coverages, the rate of consolidation decreased as coverages increased. Moisture and density readings taken throughout trafficking are given in Table 8.

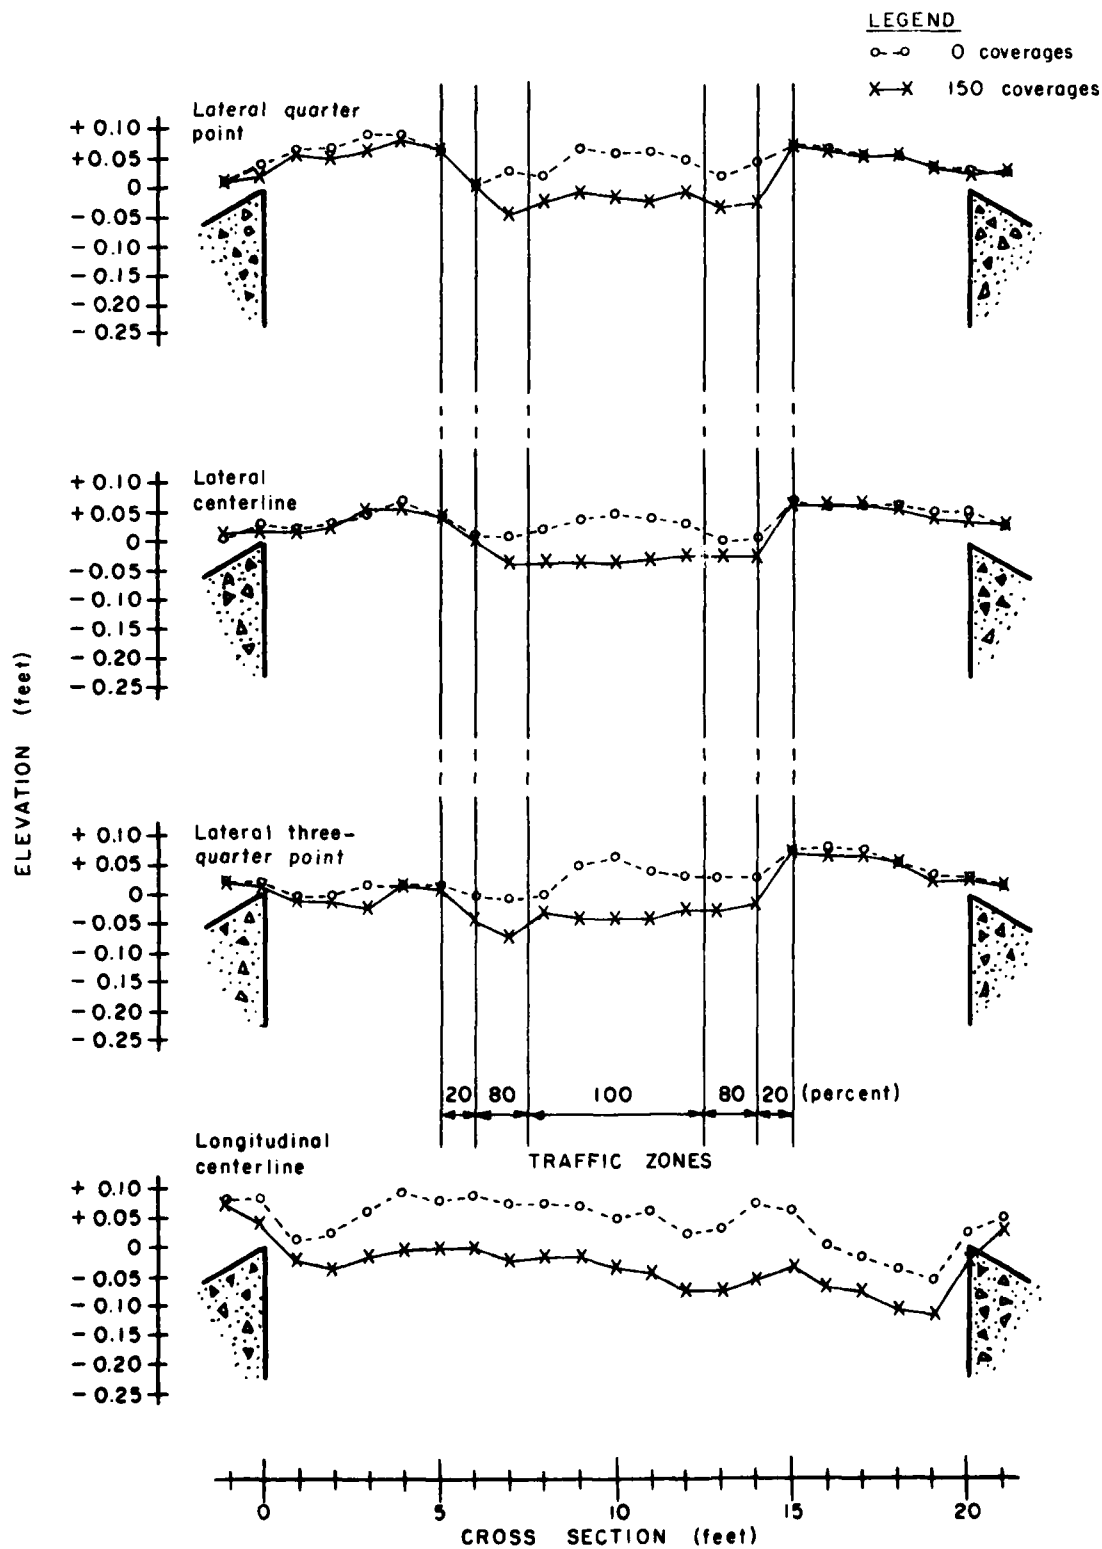
Figure 36. Surface Profiles, Item 24

Profiles of the test surface are shown in Figure 36. Density readings taken are recorded in Table 9. A  $k$  value of 420 pounds per cubic inch (pci) was calculated on the surface of the base course, and a  $k$  value of 115 pci was obtained at a depth of 27 inches.

The 24-inch crushed limestone base course compacted with the RayGo 400A compactor was capable of supporting F-4 and C-141 load cart traffic within the criteria set forth by the Corps of Engineers. It appears that some drying of the base course had occurred after completion of test item 22, reducing the moisture content from 3.9 percent to an average of 3.2 percent.

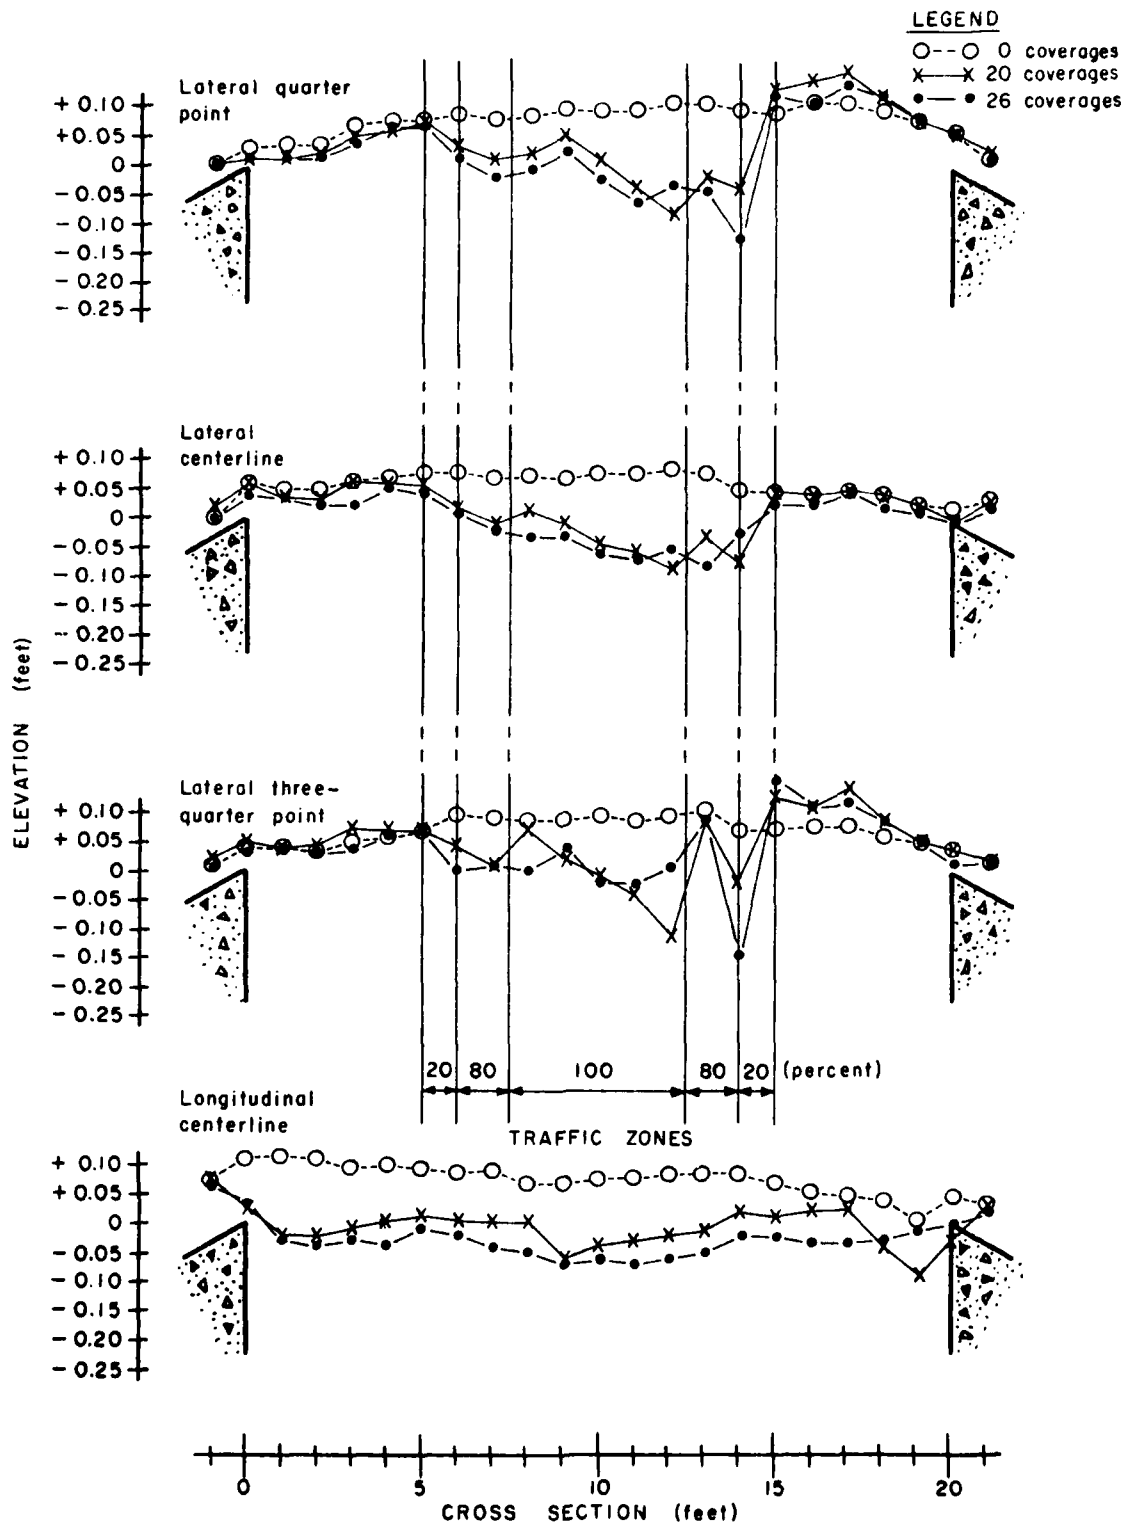
Figure 39. Surface Profiles, Item 25

Readings obtained at the point of failure indicated 7.7-percent moisture and a dry density of 145.1 pcf. After repairs were made, four more coverages were achieved before the surface again became unsuitable for further trafficking. Surface profiles taken at the start of trafficking, and after 20 and 26 coverages, are shown in Figure 39. A plate survey of the subgrade indicated a consolidation of 0.02 foot.

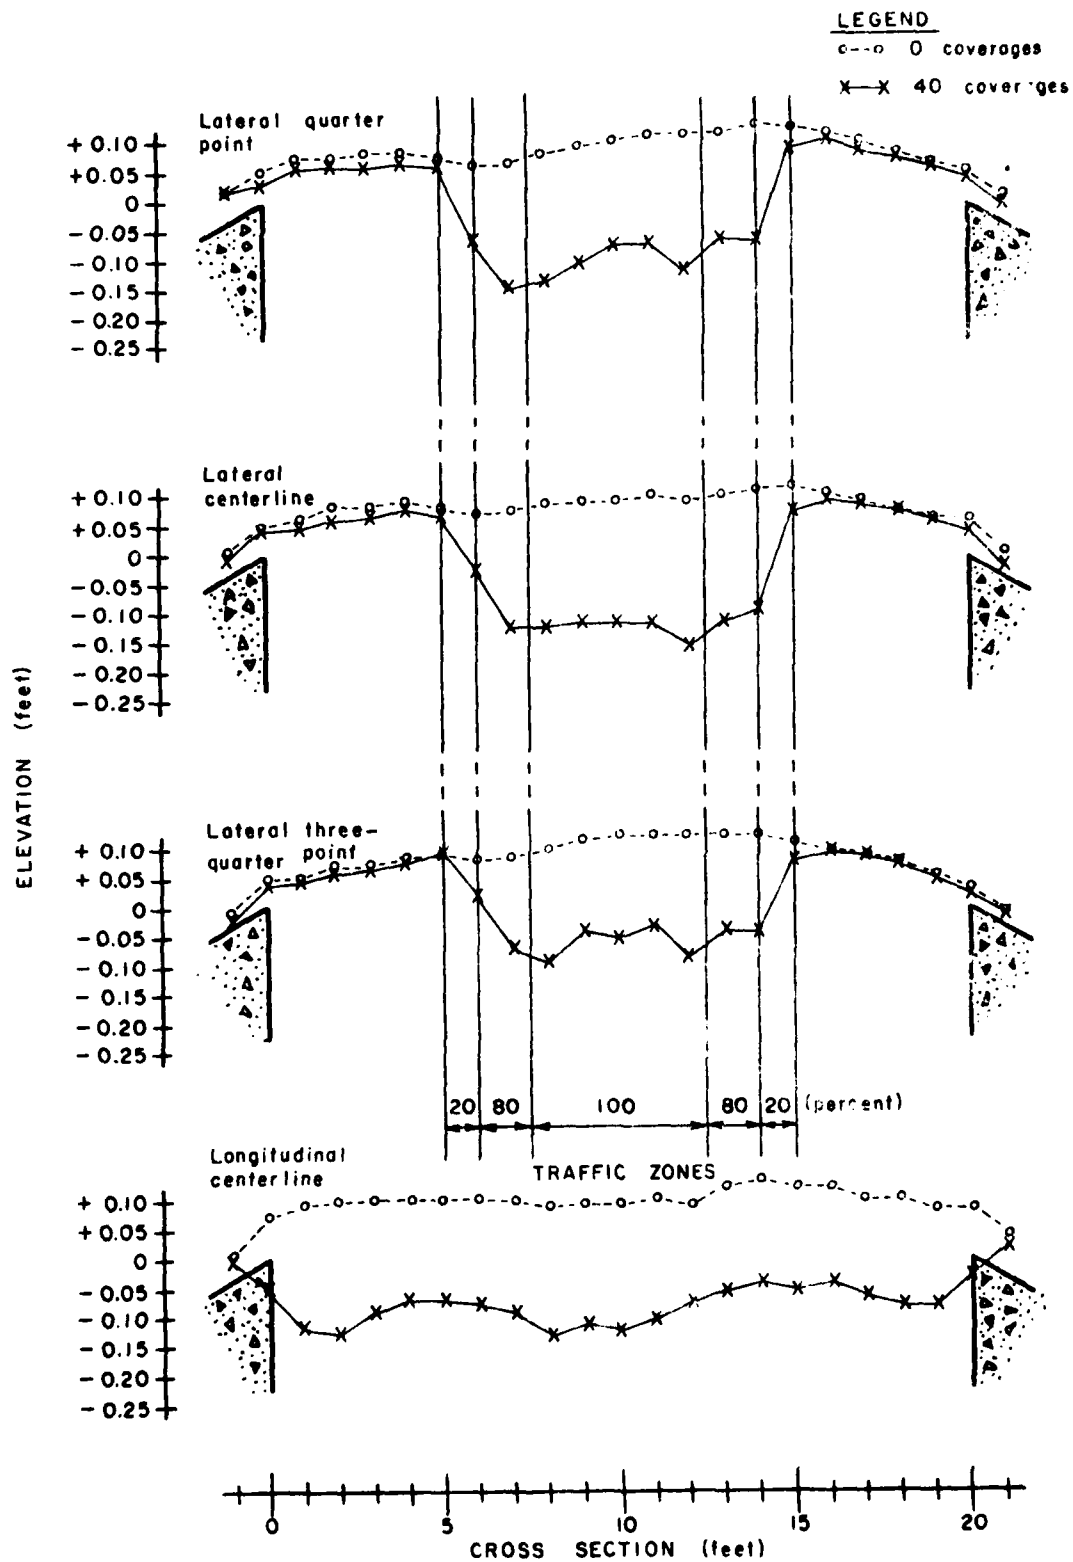
Figure 40. Surface Profiles Before Repairs, Item 26

(2) Results. After compaction, the limestone showed a moisture content of 2.8 percent and a dry density of 141.7 pcf. Twenty coverages of the F-4 load cart produced deformations of approximately 2 inches; deformations had increased to 3 inches after 40 coverages when it became necessary to add limestone and repair the surface. Figure 40 provides profile data prior to repairs. After 60 coverages, the surface deformation was as shown below (Figure 41).

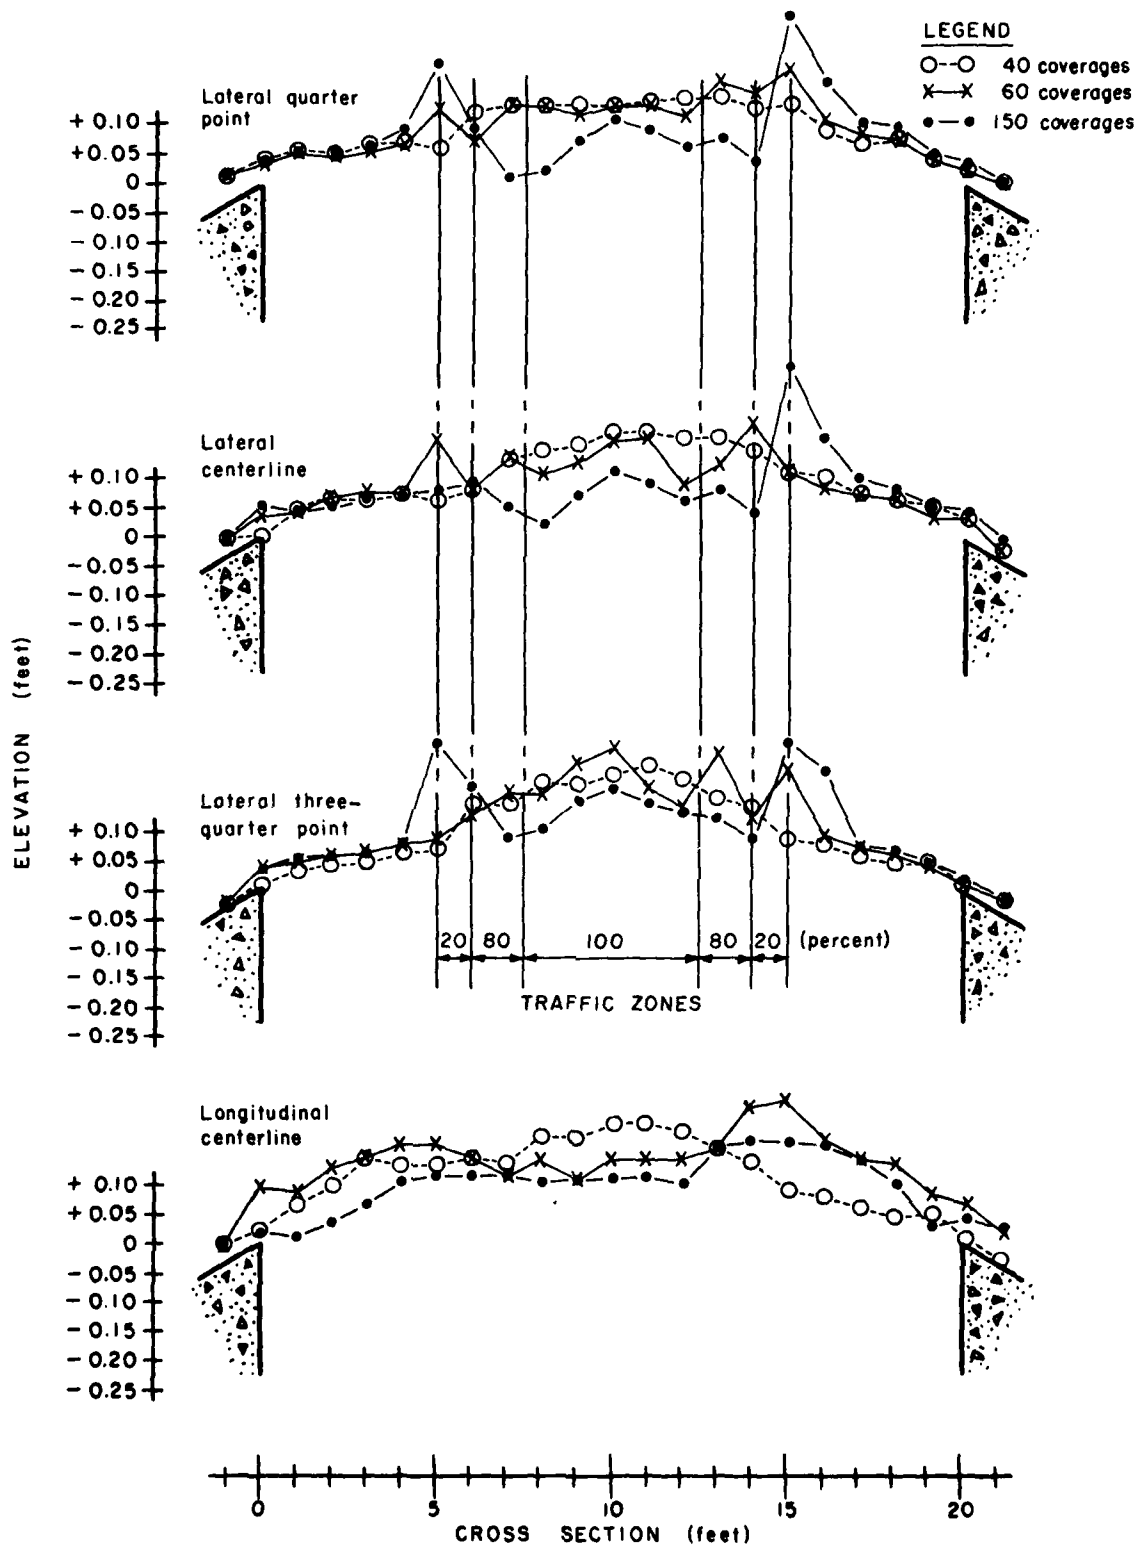
Figure 42. Surface Profiles After Repairs, Item 26

Figure 42 shows profiles at 60 and 150 coverages when trafficking was completed without further repairs. Consolidation in the traffic lane measured 1 inch with 3-inch ridges between ruts. The clay subgrade in the traffic lane had consolidated 0.1 inch. The crushed limestone base course with a moisture content of 2.2 percent after 150 F-4 load cart coverages was termed successful. The lesser moisture content was seen as a positive factor in stabilizing the repair.

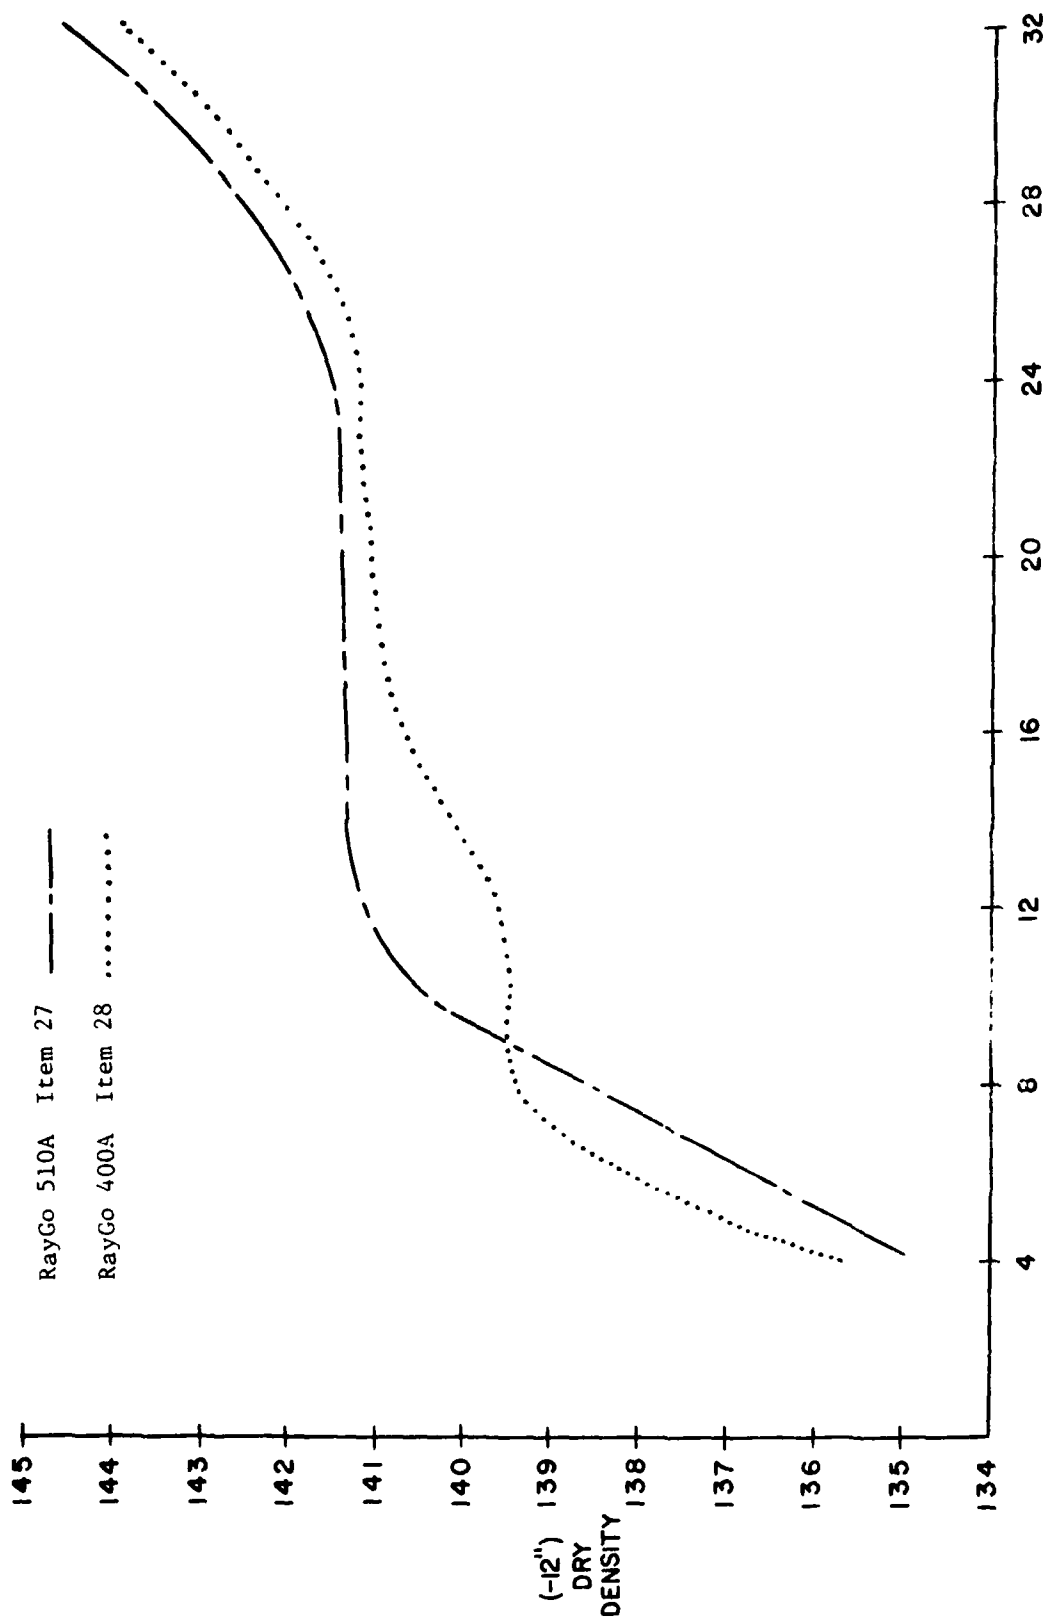
Figure 43. Compaction Results, Items 27 and 28

(3) Compaction. The RayGo 510A compacted test item 27 and the RayGo 400A compacted item 28. After four coverages by the vibratory rollers, the RayGo 510A had compacted the base course to a level 1.0 inch below the surrounding concrete, while the RayGo 400A had compacted test item 28 by 0.5 inch. After limestone had been added to each pit, grading and compacting were continued. After 16 coverages, both test items showed signs of elasticity where water had been drawn to the surfaces. After 32 coverages, water still remained on the surface, with test item 28 (RayGo 400A) showing a larger accumulation. Moisture and density readings taken at successive stages of compaction are shown in Table 11. A graphic comparison of compaction results is portrayed in Figure 43.

(4) Results. The F-4 load cart was used to traffic both test items, alternating between pits. After four coverages on each item, the load cart severely rutted the base course surface of test item 28 (compacted with the RayGo 400A) due to shear failure. Item 28 was termed a failure at this point; however, it was decided to make repairs and to

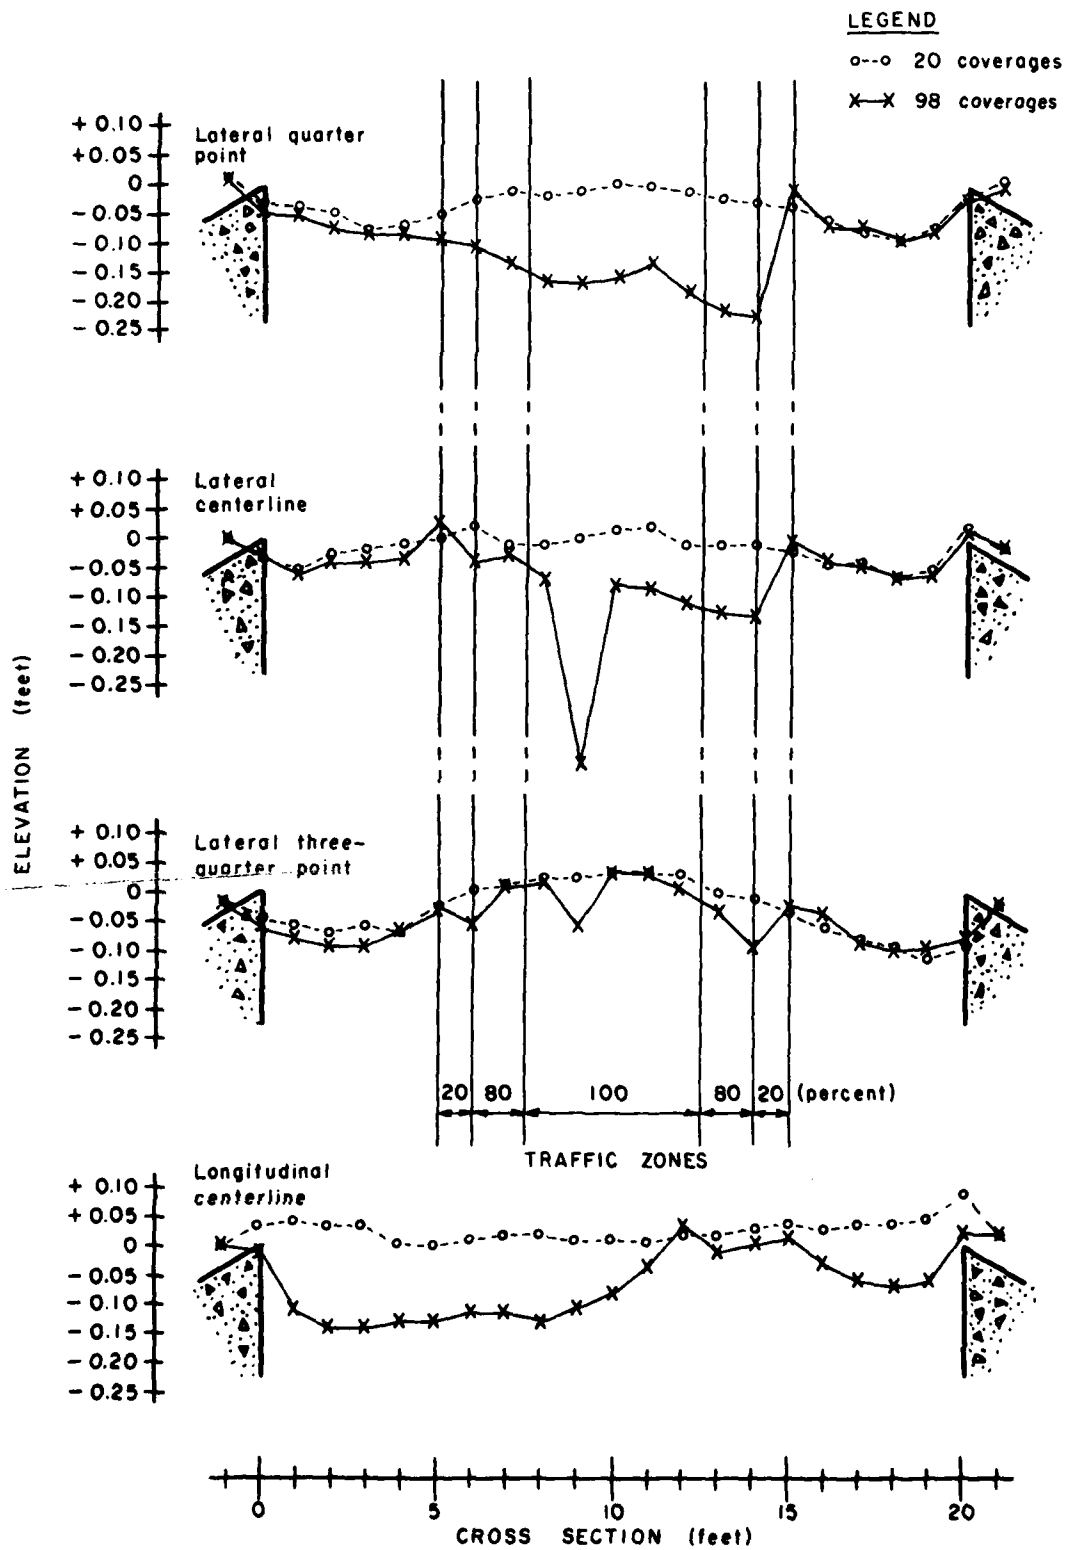
Figure 45. Surface Profiles, Item 27

Surface profiles of item 27 are shown in Figure 45.

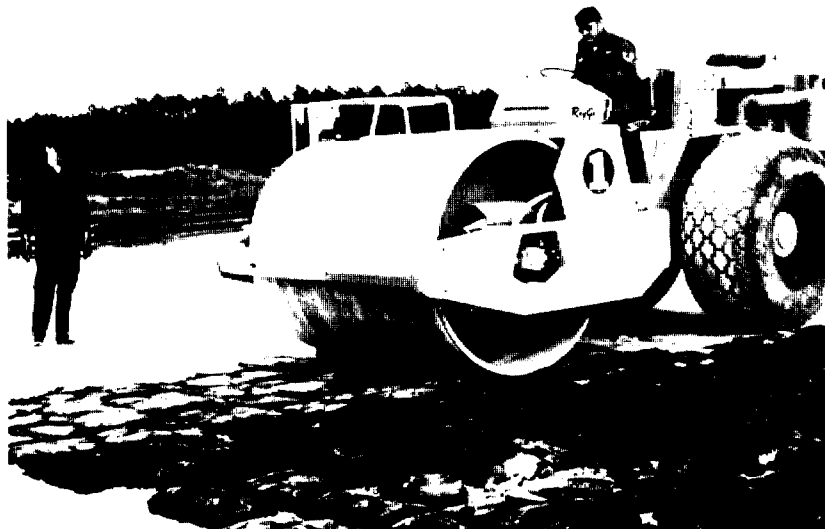
(3) Procedure. An existing crushed limestone base course prepared in item 19, and subjected to 150 coverages of the F-4 load cart, was leveled to 1 inch below the surface of the adjacent concrete. Approximately 120 bags of hardened asphalt were uncovered and placed on the surface of the pit, and compressed with 20 passes of the RayGo 510A vibratory compactor to a level even with the concrete pad (Figure 50).

Figure 50. Compaction of Amalgapave®, Item 20

Shoving under the roller was occurring, and numerous cracks appeared in the surface of the asphalt due to the low adhesive ability.
