AFESC/ESL-TR-80-51

**FIELD TEST OF EXPEDIENT  
PAVEMENT REPAIRS  
(TEST ITEMS 16-35)**

**MICHAEL T. McNERNEY  
ENGINEERING RESEARCH DIVISION**

**NOVEMBER 1980**

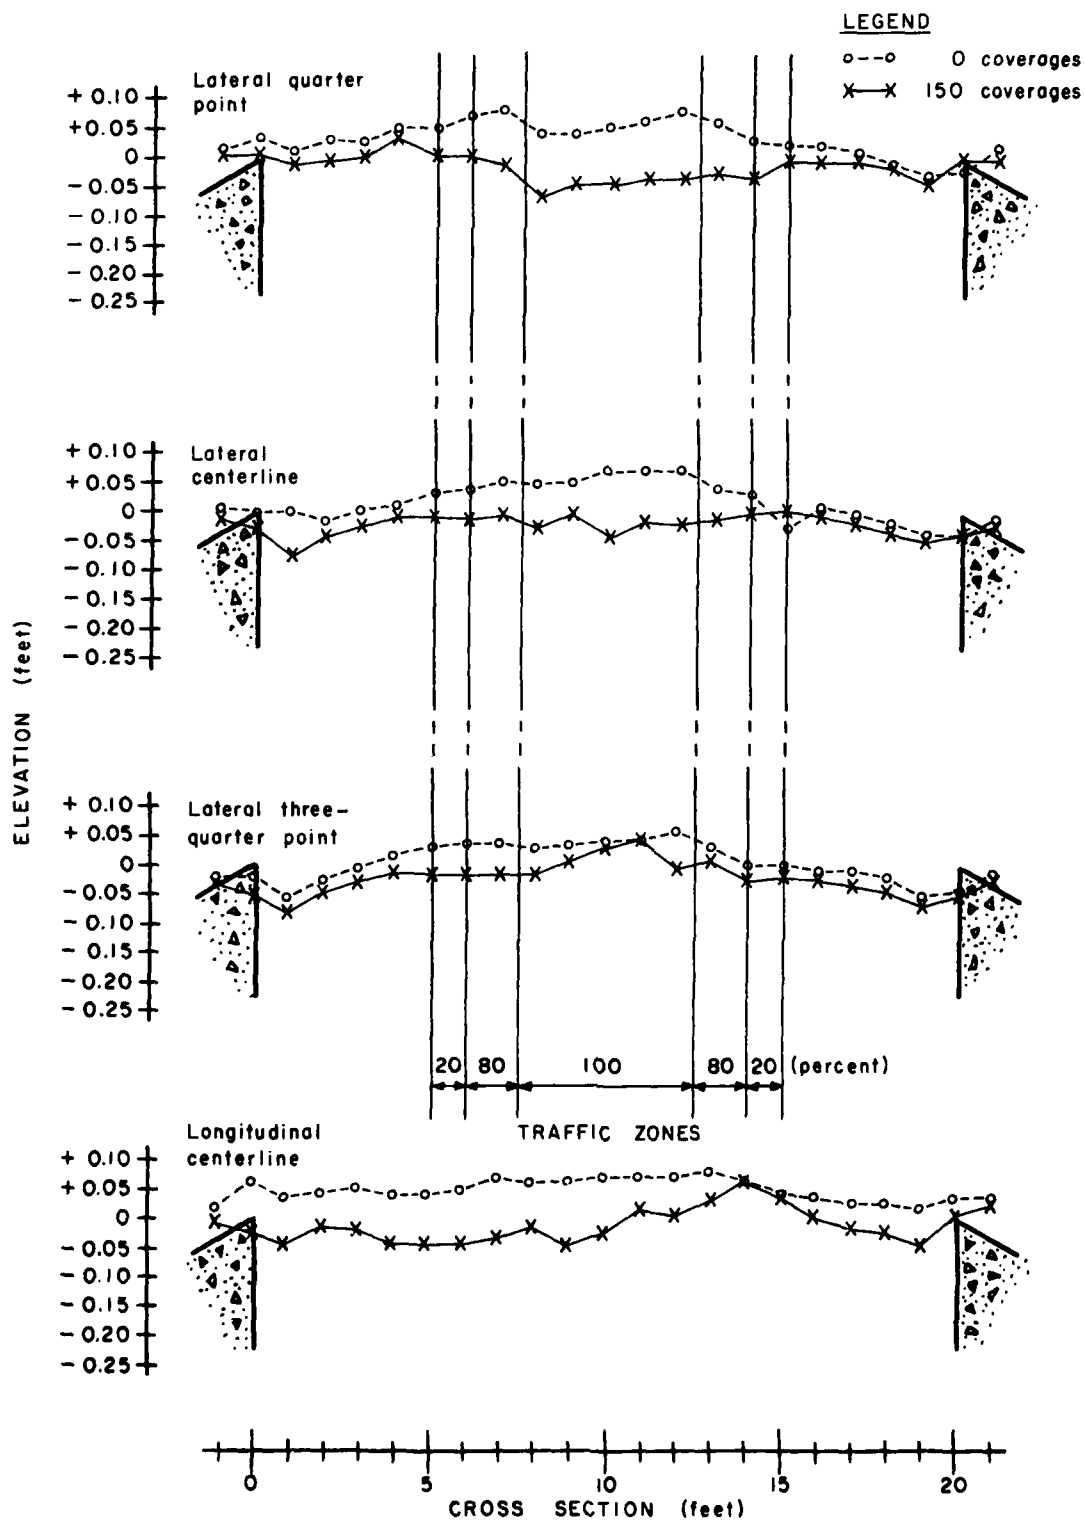
Figure 52. Surface Profiles, Item 20

Though not an entirely fair test for the Amalgapave®, it does show the problems inherent to long-term storage under adverse conditions.

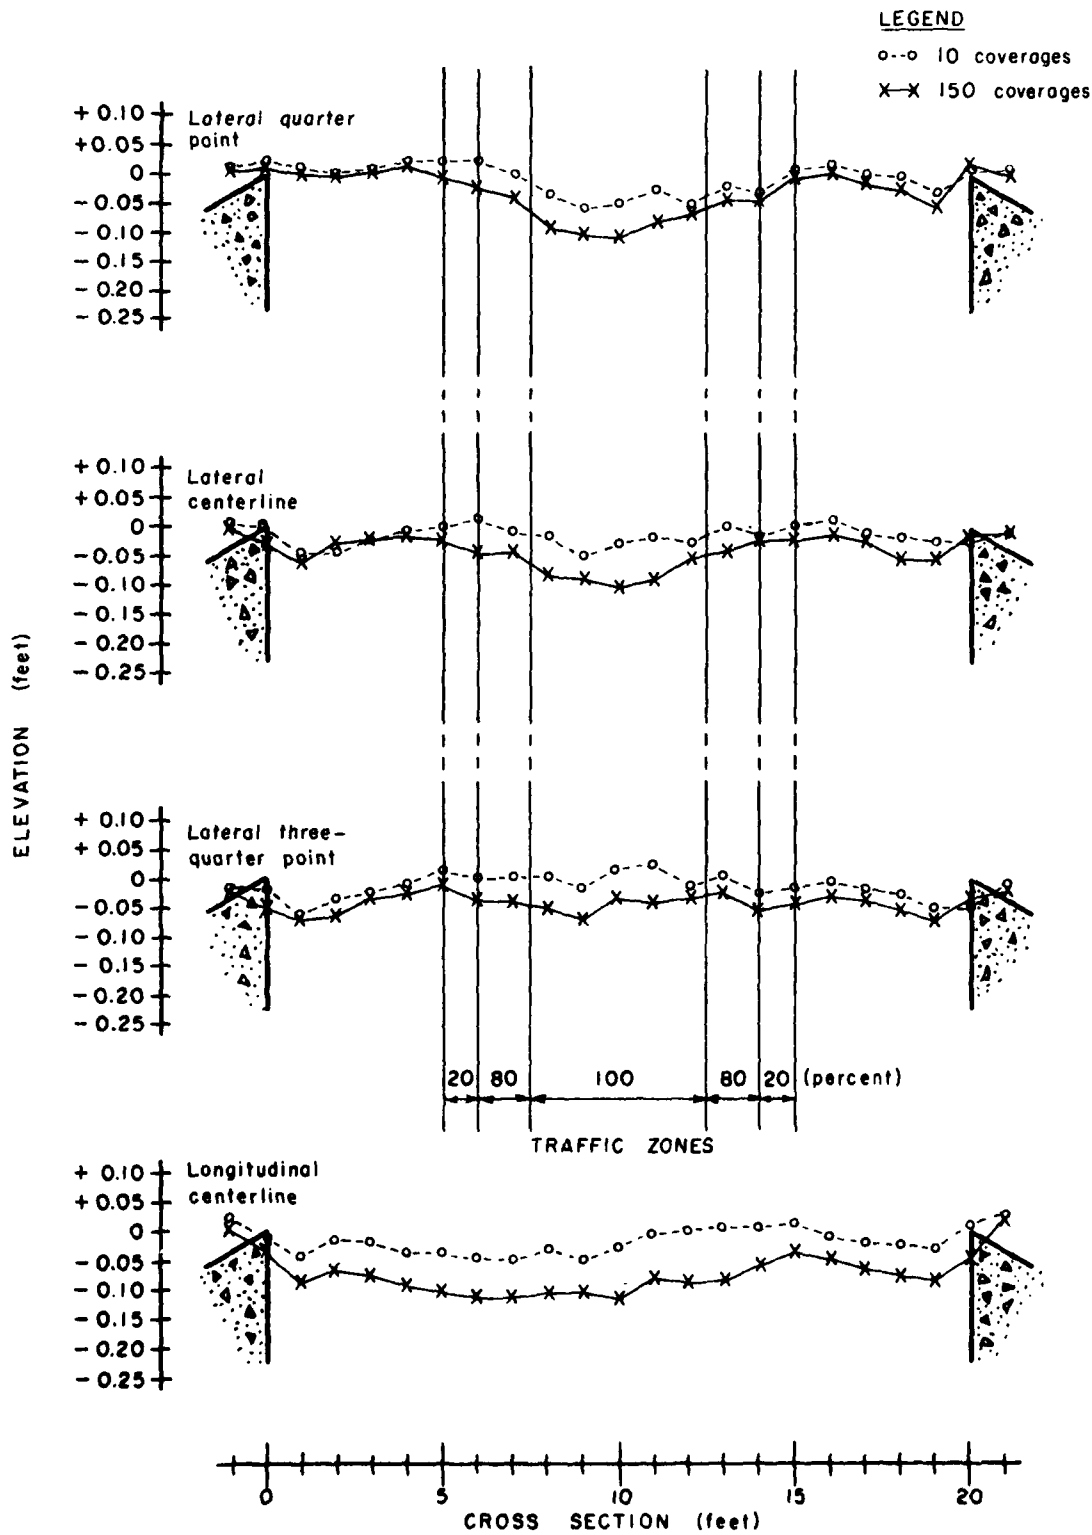
Figure 55. Surface Profiles, Item 23

Profiles of the surface (Figure 55) indicate a consolidation of approximately 0.5 inch. Results of test item 23 support previous data which had shown that after approximately 40 coverages the amount of consolidation of the limestone base course is minimal.

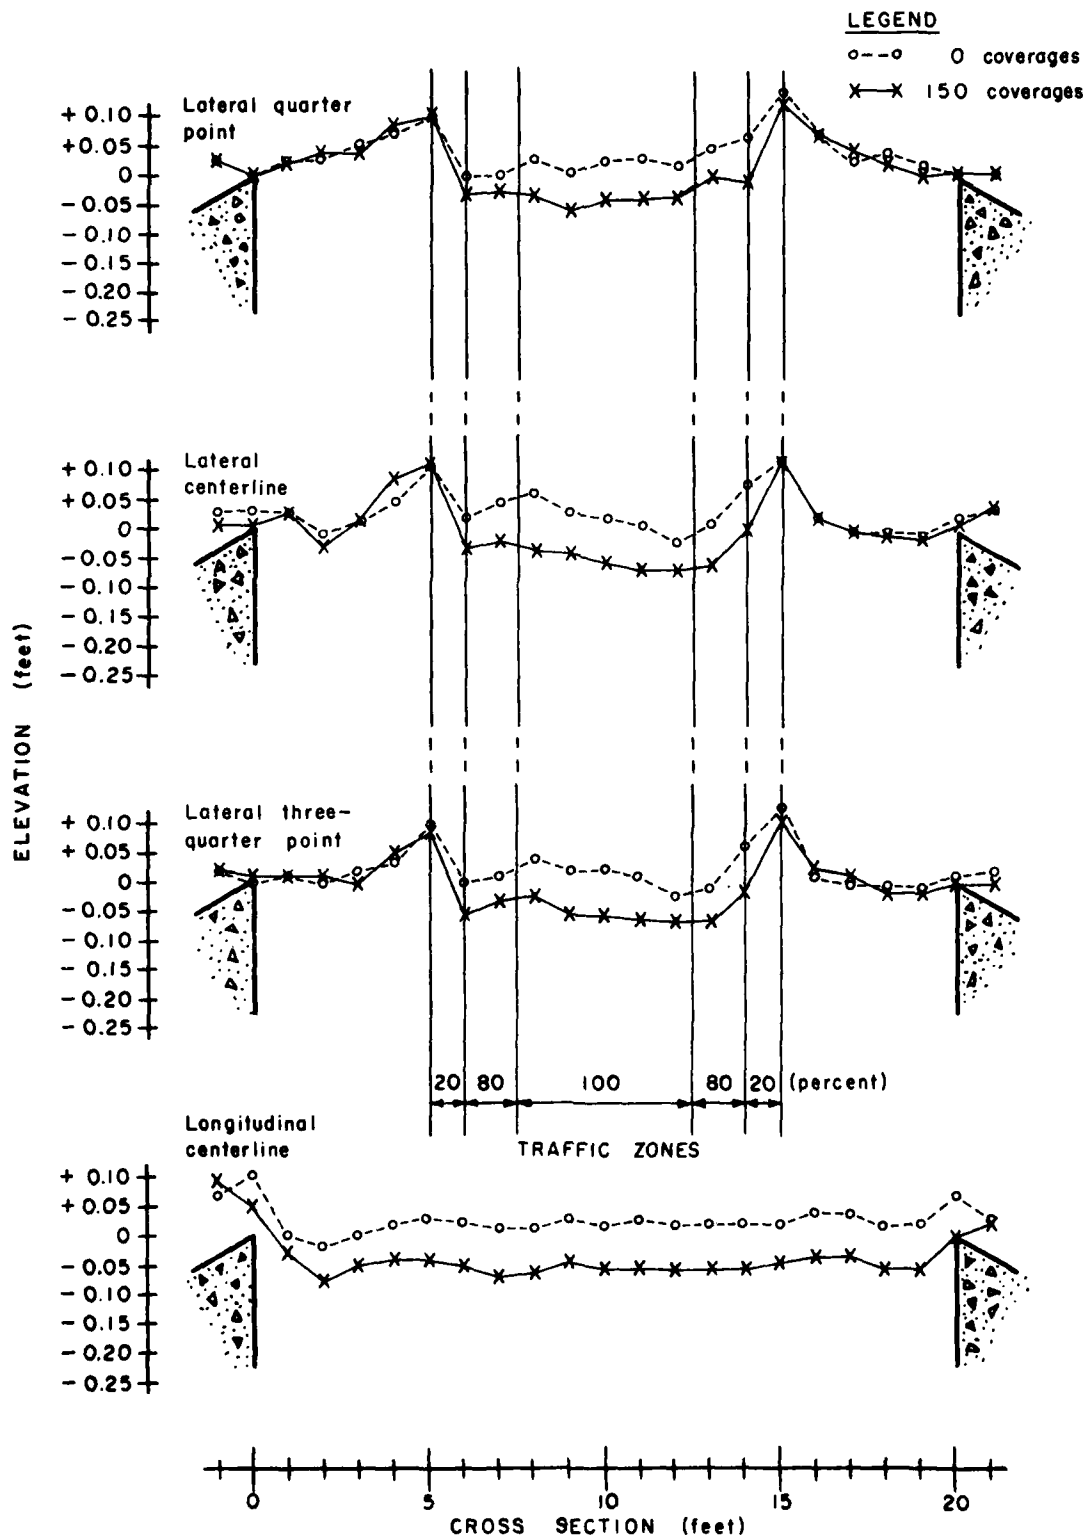
Figure 58. Surface Profiles, Item 31

The pivoting of the load cart wheels caused much of the wear previously described. The small test section using the flat steel tie-downs held firmly and showed no unusual wear; however, it did not receive the full load cart traffic to which the larger test item was exposed. Profiles of the test surface are illustrated in Figure 58; moisture and density readings are recorded in Table 17.

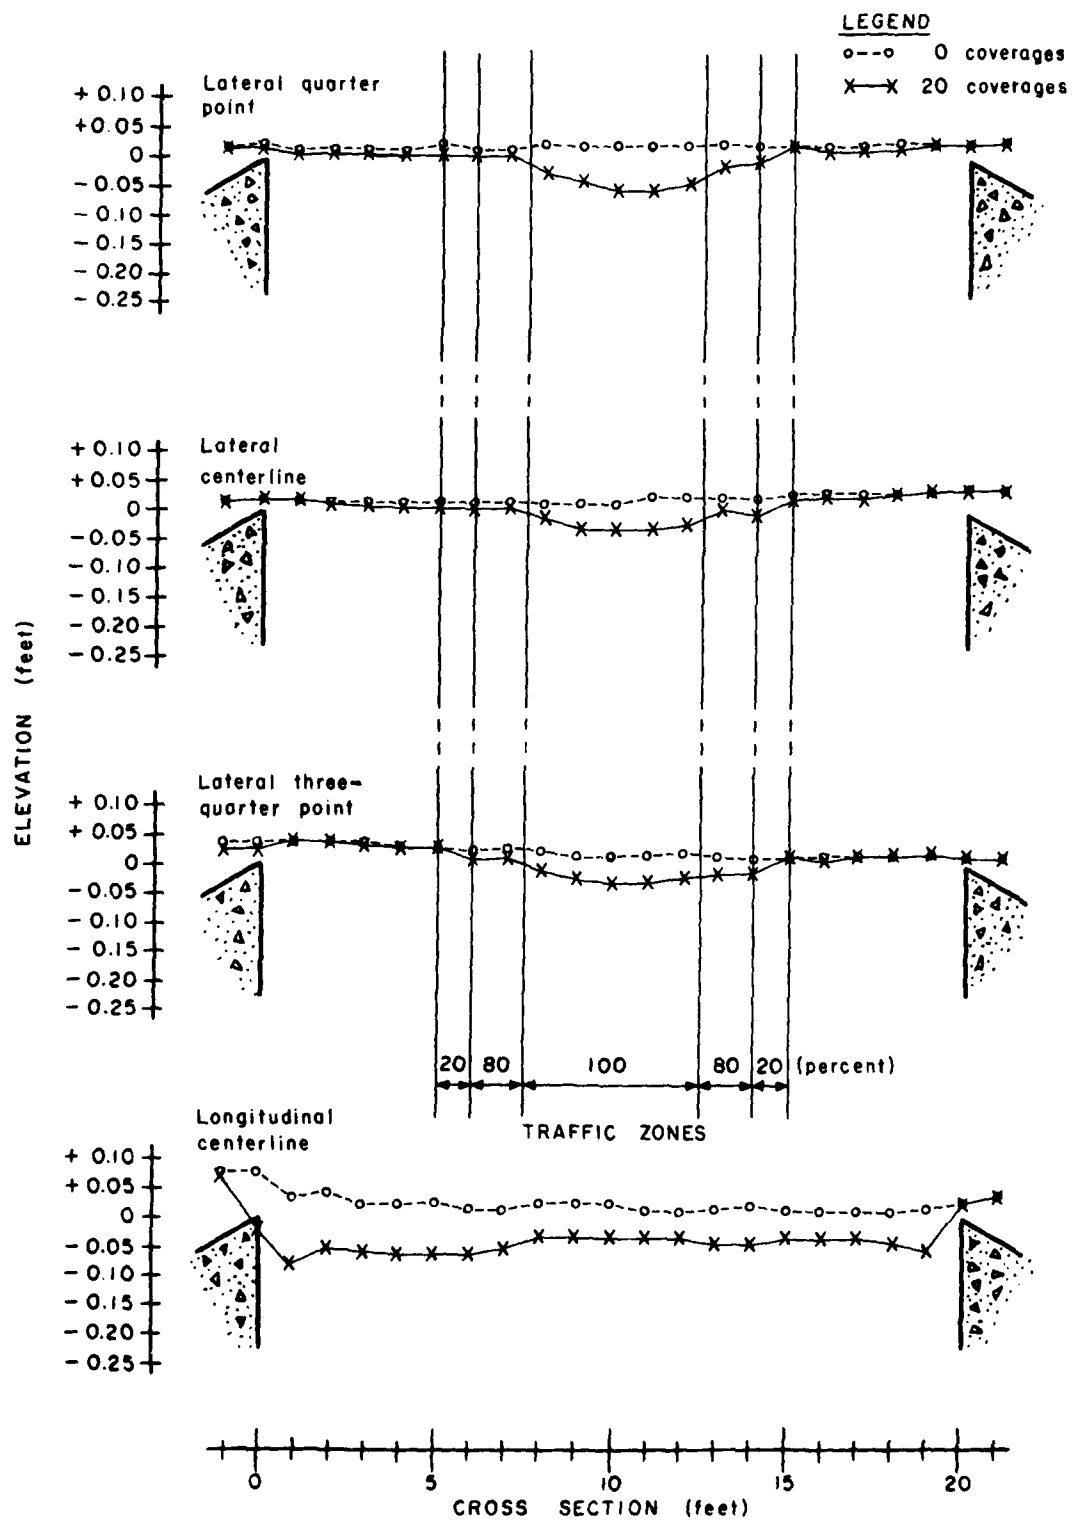
Figure 60. Surface Profiles Prior to Trafficking and After 20 Coverages, Item 34

The test surface was profiled after 20 coverages (Figure 60). After 40 coverages, a small hairline crack developed along the edge of the traffic lane. A deflection of 0.25 inch was recorded after 60 coverages but did not increase during the remainder of the test; however, several longitudinal hairline cracks had developed. Profiles obtained at the conclusion of trafficking are shown in Figure 61.
