MISCELLANEOUS PAPER SL-81-16

# STRUCTURAL STABILITY EVALUATION GULL LAKE DAM

June 1981

Prepared for U. S. Army Engineer District, St. Paul  
St. Paul, Minn. 55101

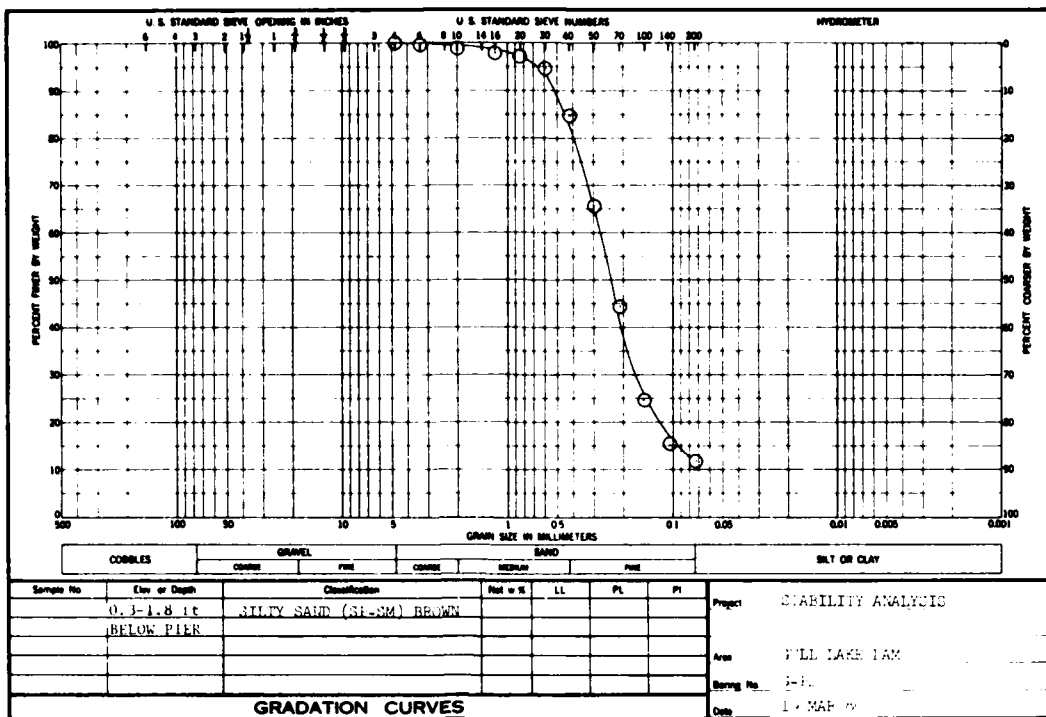
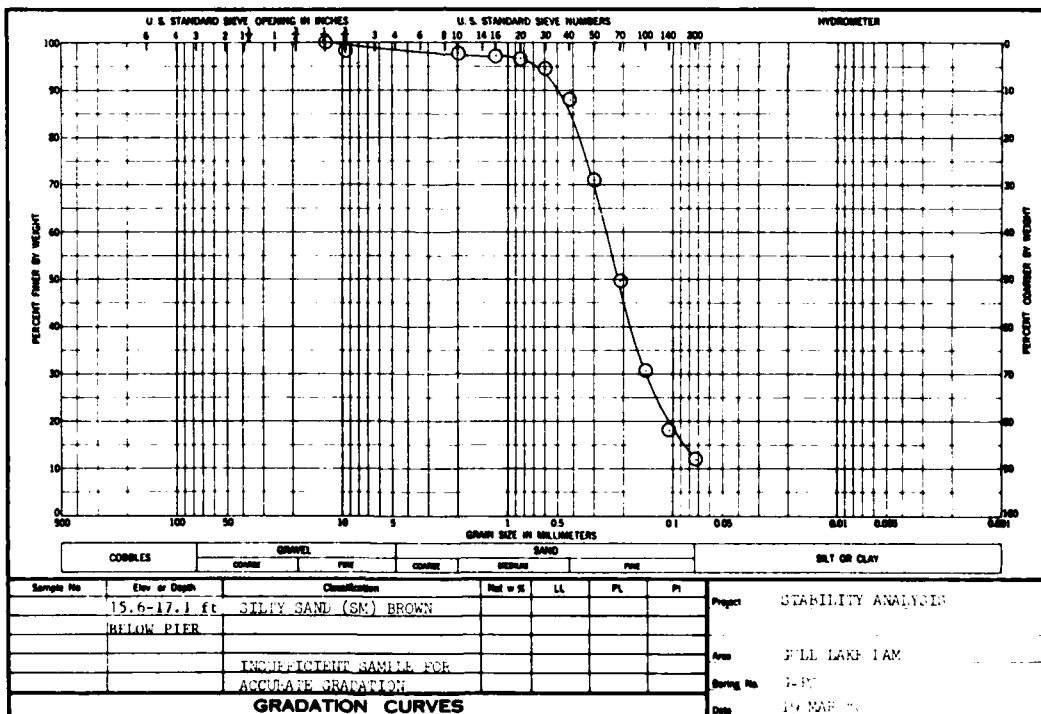
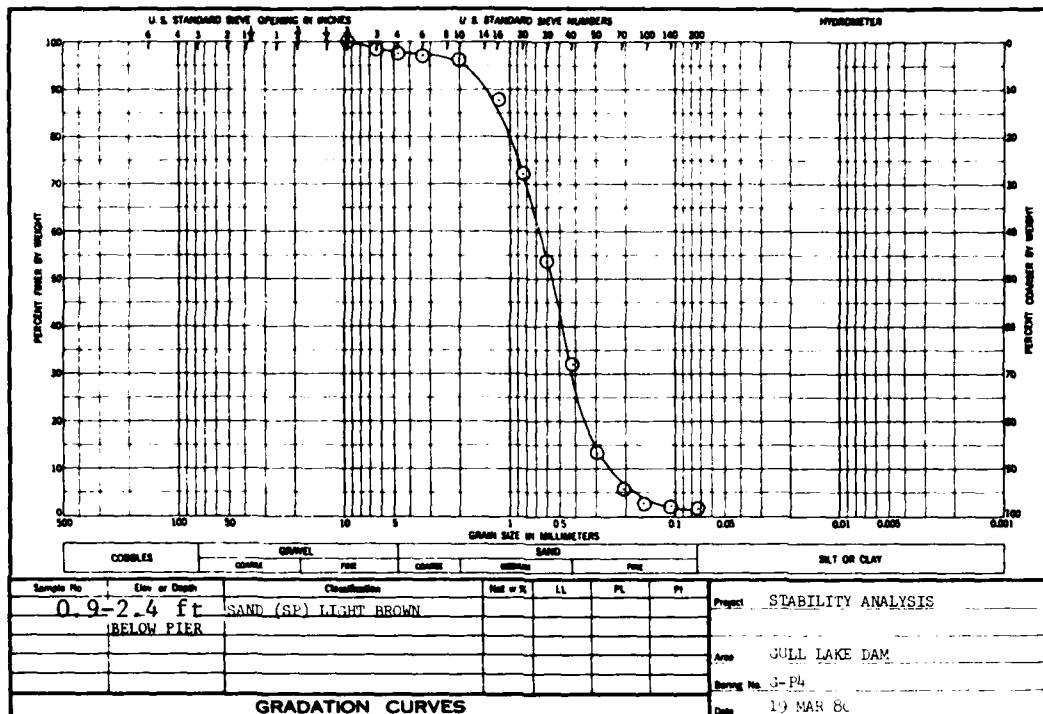
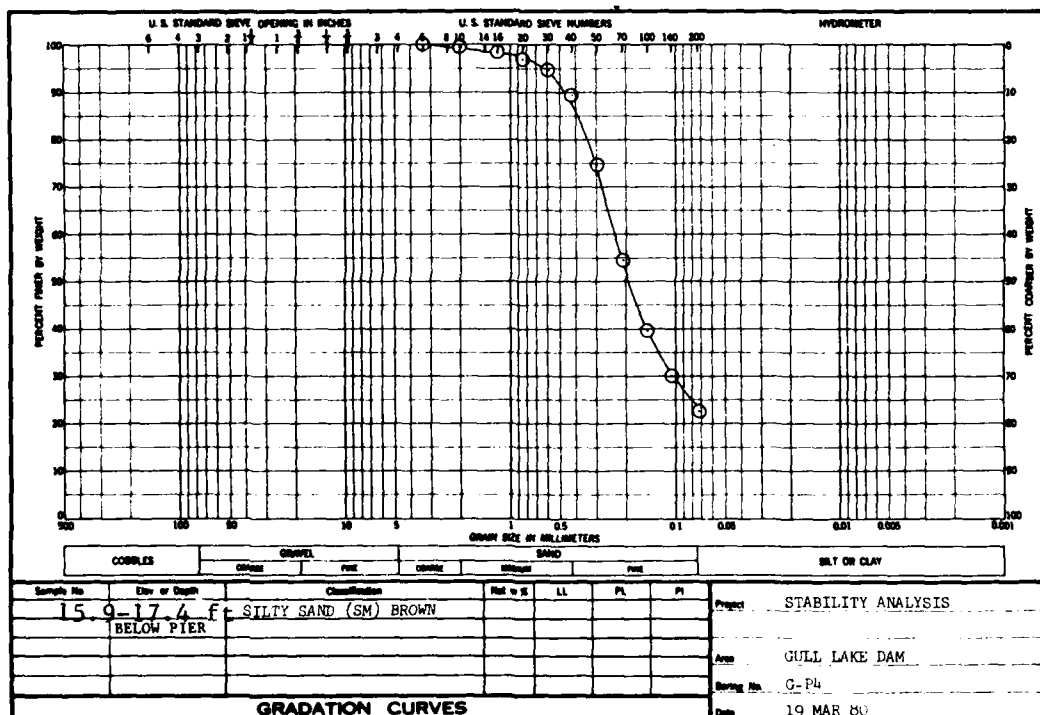
30. Disturbed samples of the foundation material were obtained and transported to the laboratory for classification. The foundation material under Gull Lake Dam is mainly a silty sand (Figures 9 through 12).

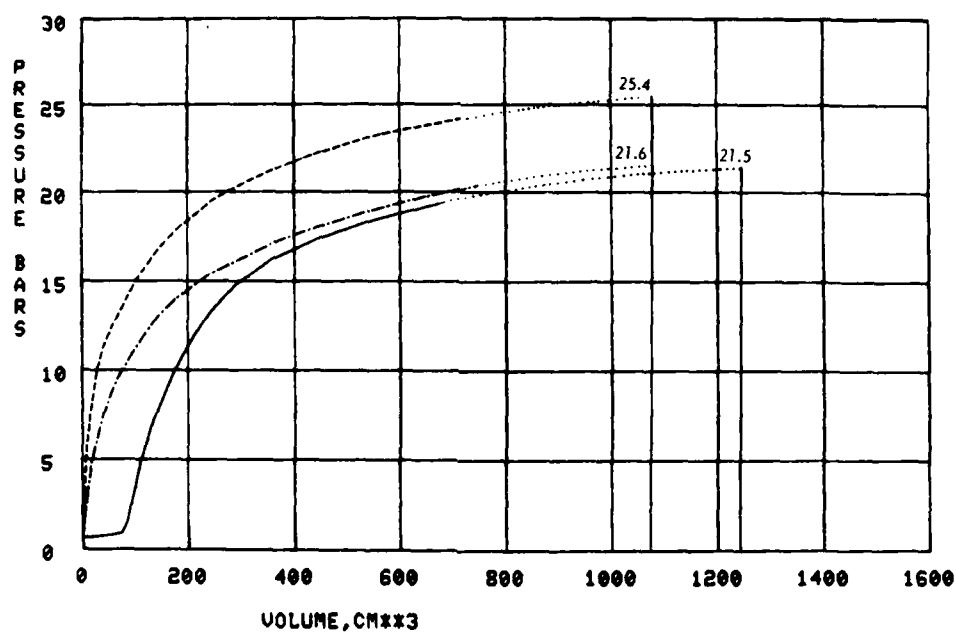
Figure 15. Pressure versus volume, curves extrapolated to obtain limit pressures, Gull Lake Dam, hole G-P2

33. Several methods were used in obtaining the limit pressure of the foundation material, but it was found that extrapolating the curves out to two times the initial volume of the cavity gave excellent results. The limit pressures were obtained and are presented in Figures 15 and 22 for hole G-P2 and G-P4, respectively.

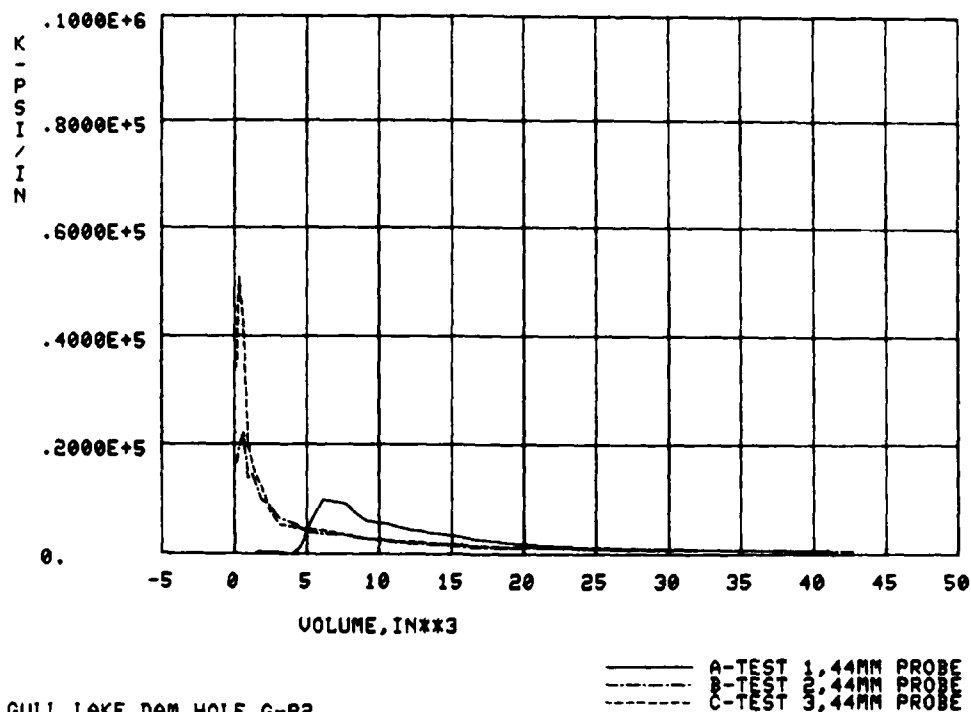
Figure 19. Modulus of subgrade reaction, Gull Lake Dam, hole G-P2

45. At Gull Lake Dam a conservative constant subgrade modulus would be used. The variation in subgrade modulus with depth into the foundation (Figures 19 and 26) does not show a distinct pattern that justifies using a variable subgrade modulus. Hole G-P2 indicates an increase in subgrade modulus with depth (Figure 19), but the data from hole G-P4 do not indicate this variation. It would take much more data to accurately define and use a variable subgrade modulus for the foundation at Gull Lake Dam. However, the test data were adequate for an average value analysis of the piling foundation. A subgrade of  $6000 \frac{\text{psi}}{\text{in.}}$  was used. If the piling layout was deemed adequate by this analysis, the whole dam could be considered adequate in stability.
