EVALUATION OF POWDER PROCESSED TURBINE ENGINE BALL BEARINGS. (U)  
JUN 81 P F BROWN, G A BOGARDUS, J R MINER F33615-75-C-2000

AFWAL-TR-80-2110

## EVALUATION OF POWDER PROCESSED TURBINE ENGINE BALL BEARINGS

United Technologies Corporation  
Pratt & Whitney Aircraft Group  
Government Products Division  
P.O. Box 2691  
West Palm Beach, Florida 33402

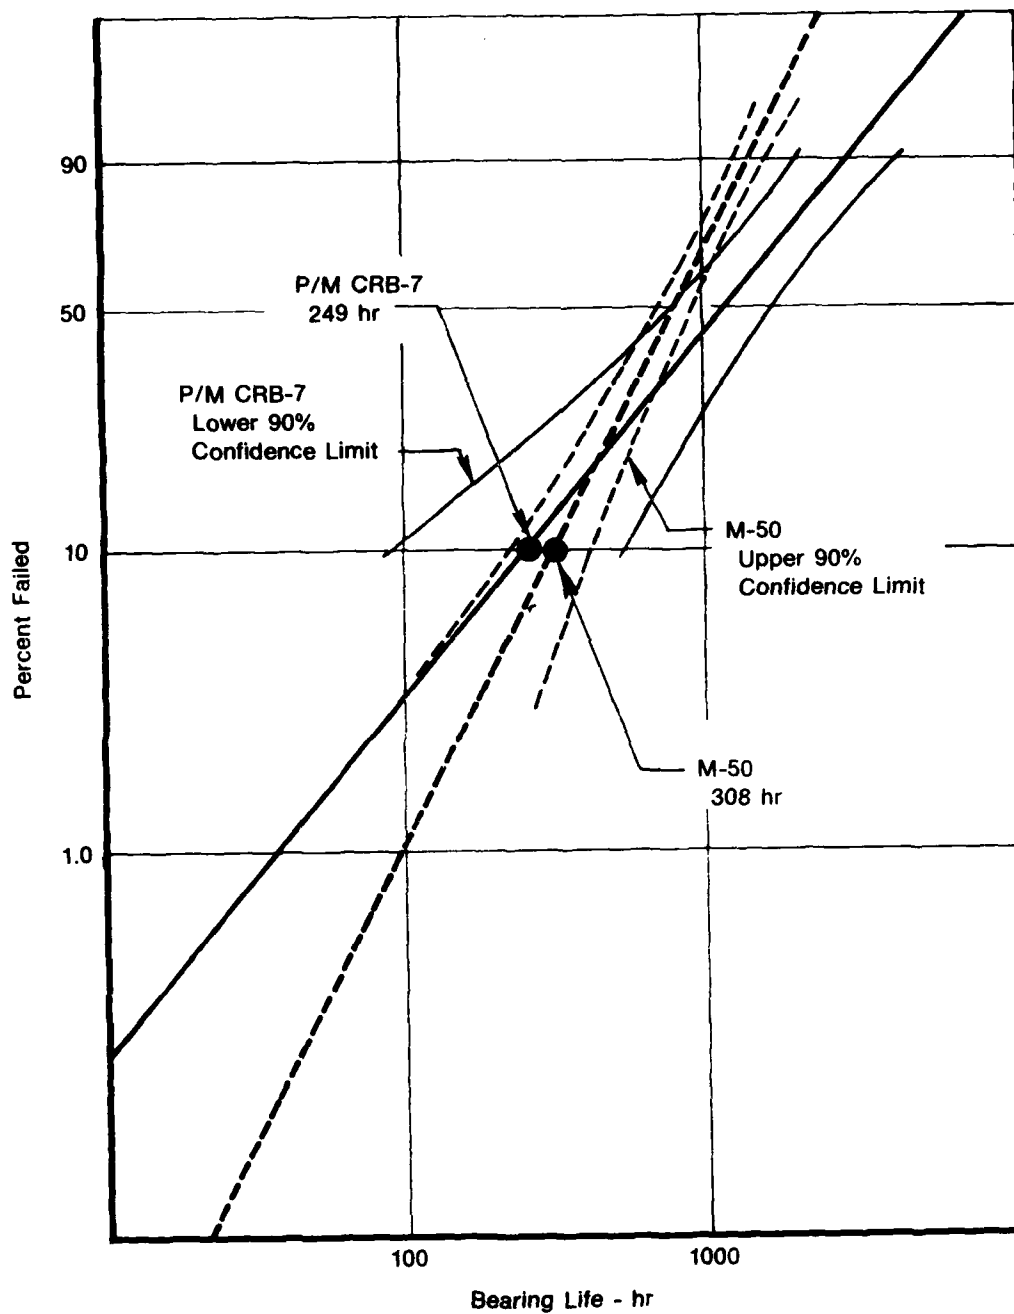
The results of the endurance test portion of the program, as conducted on the modified P/M CRB-7 ball thrust bearings, are summarized in Table 14. A total of four rolling contact fatigue failures were classified as such from among the twelve bearings tested. Utilizing existing Wiebull analysis computer program procedures and using the test times of 157.4, 500.0, and 942.0 hours associated with the four failures, a B-10 life of 249 hours and a slope of 1.23 was calculated. This compared favorably with the predicted or theoretical B-10 life of 308 hours with an ideal slope of 2.0 as calculated for an equivalent VIM-VAR M-50 alloy bearing. The results of the two Weibull analyses are shown in Figure 27, and indicate that as the 90% confidence bands overlap there is no significant difference between the B-10 life of the CRB-7 powder metal alloy and the theoretical B-10 life for the M-50 bearing.

Figure 27. Weibull Analysis Comparison of P/M CRB-7 And M-50 Alloy. A B-10 Life of 49 Hours Was Determined For The P/M CRB-7 Alloy And Compares Favorably With The 308 Hours of The M-50 Alloy.
