**Name Of Dam:** UNIVERSITY COMMONS DAM  
**Location:** RICHMOND, VIRGINIA  
**Inventory Number:** VA. NO. 76008

# PHASE I INSPECTION REPORT NATIONAL DAM SAFETY PROGRAM

**SCHNABEL ENGINEERING ASSOCIATES, P.C./  
J. K. TIMMONS AND ASSOCIATES, INC.  
February, 1981**

FEBRUARY, 1981

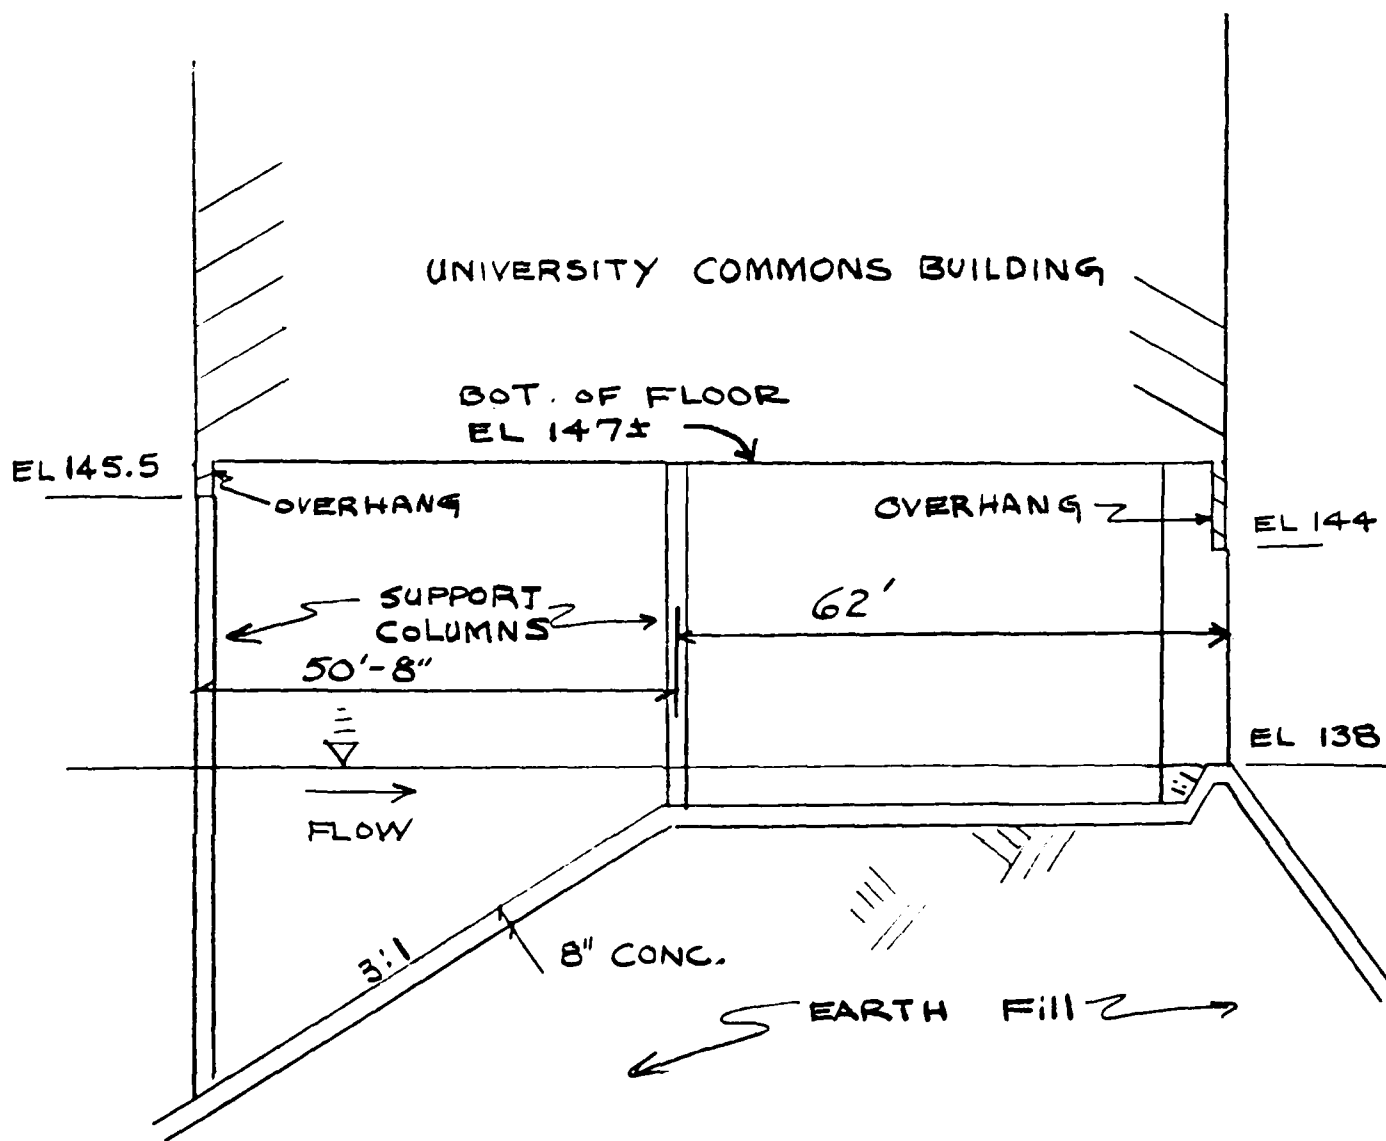
SECTION THROUGH DAM & BUILDING

FIELD SKETCH  
UNIVERSITY COMMONS DAM  
NO SCALE 11-17-80
