NMRI-81-47

81 - 47
HUMAN ENGINEERING EVALUATION
OF THE
HYPERBARIC RESEARCH FACILITY
(PHASE 1)

J.I. Brady and M.D. Curley

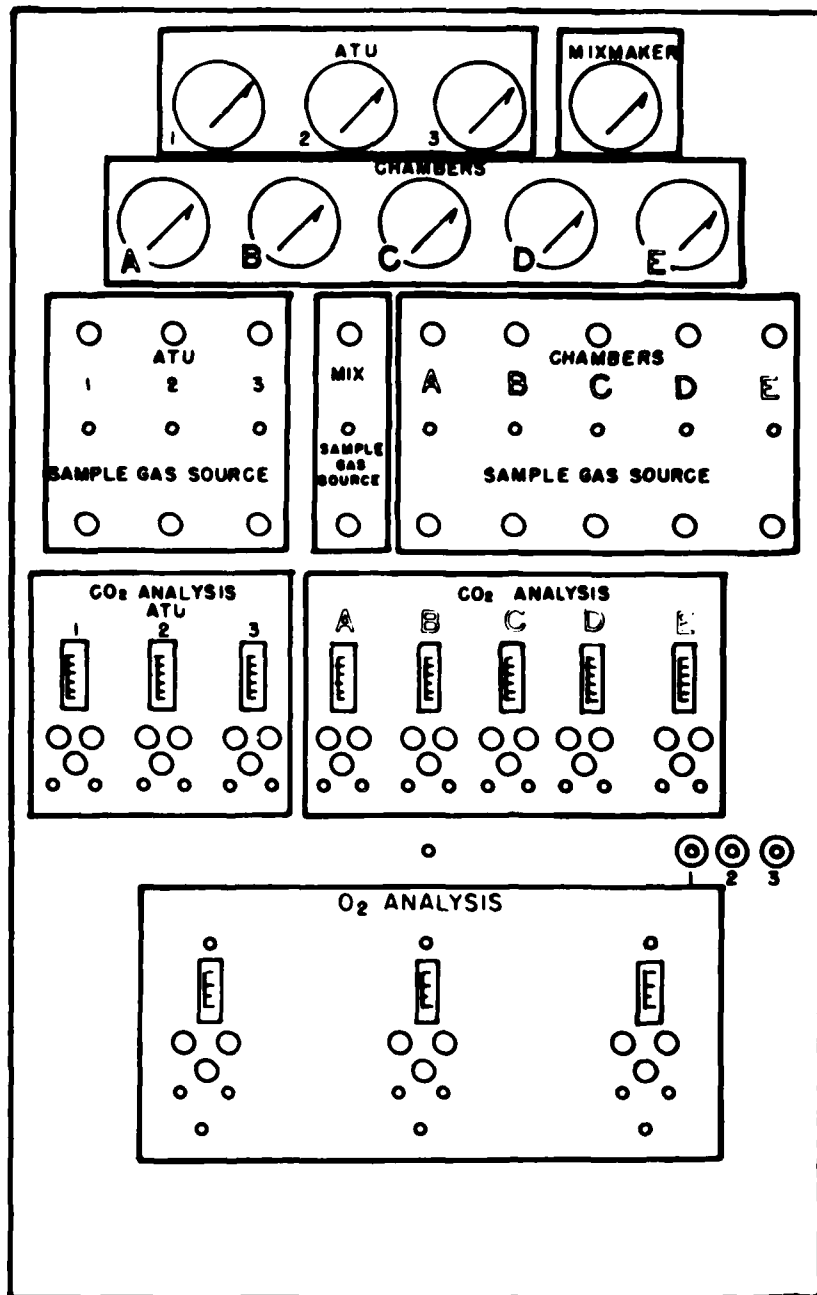
Fig. 29. A proposed layout for the gas analysis patch panel. Gauges and valves are labeled in a simple, easily understandable manner and components of similar function are grouped together graphically and color-coded.

operator. Figure 29 shows the recommended changes. This layout does not require the movement or alteration of any of the hardware (although several more efficient designs could be devised). It simply employs functional grouping and color coding. This design should improve operator recognition and readability while reducing errors. (Priority 2)

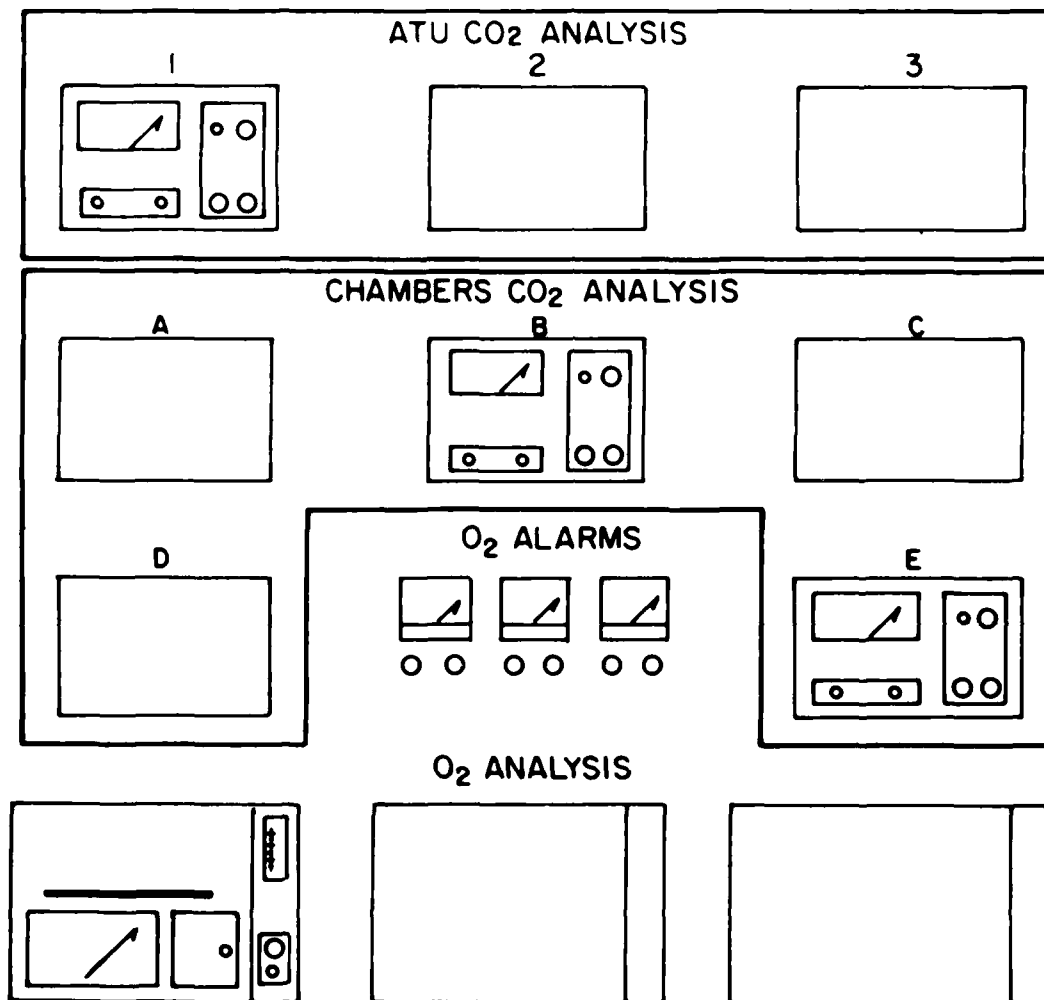
Fig. 31. A proposed layout for the gas analysis instrumentation panel. Again, functional grouping, color-coding, and large simplistic labeling have been employed to improve readability and decrease recognition time.

- (53) Figure 30 shows the present gas analysis instrumentation panel. The recommended changes are similar to those above (see Fig. 31). (Priority 2)
- (54) Figure 8 showed the face of a local control panel. Greater clarity of function can be obtained by concise gas paths and simple noncoded labeling. The recommended scheme is shown in Fig. 32. (Priority 2)

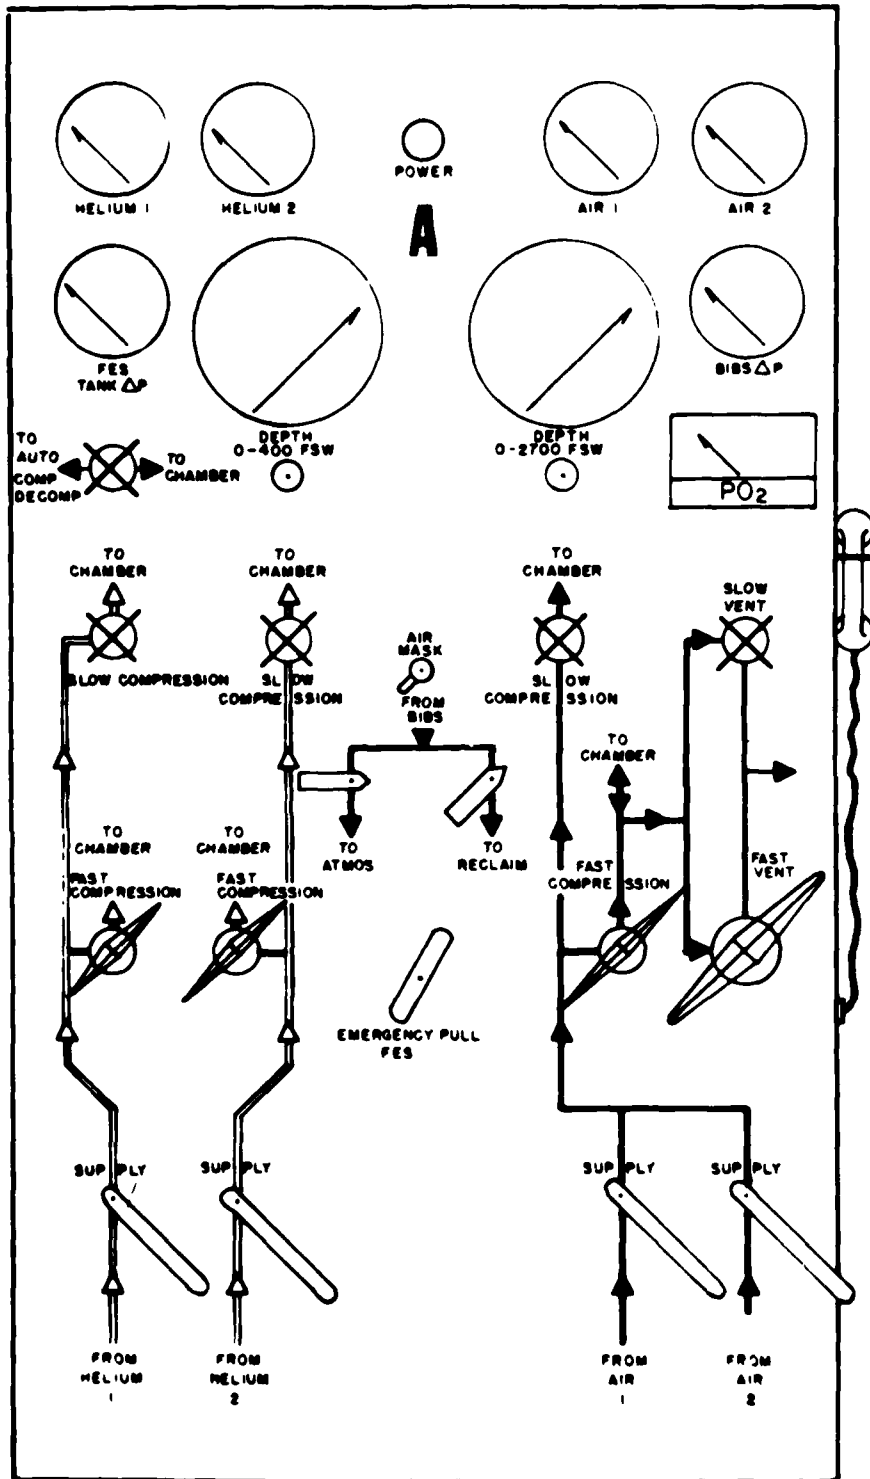
Fig. 32. A proposed layout for the local control panel. Gas paths would be appropriately color-coded.

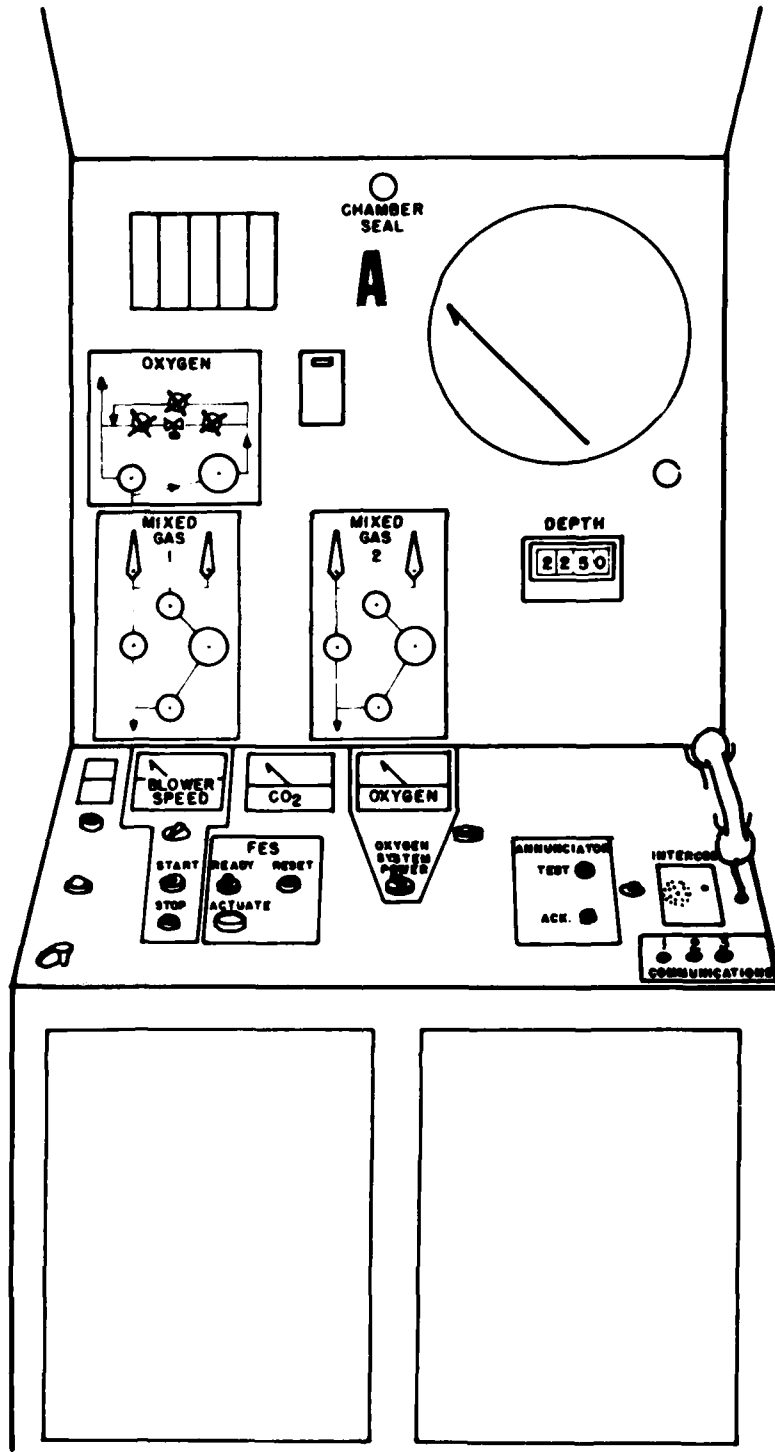
Fig. 34. A proposed layout for the operating panels.

- (56) The operating panels (Fig. 33) can be similarly modified to improve their organization in a meaningful and logical manner. Figure 34 shows a layout for recommended changes. (Priority 2)

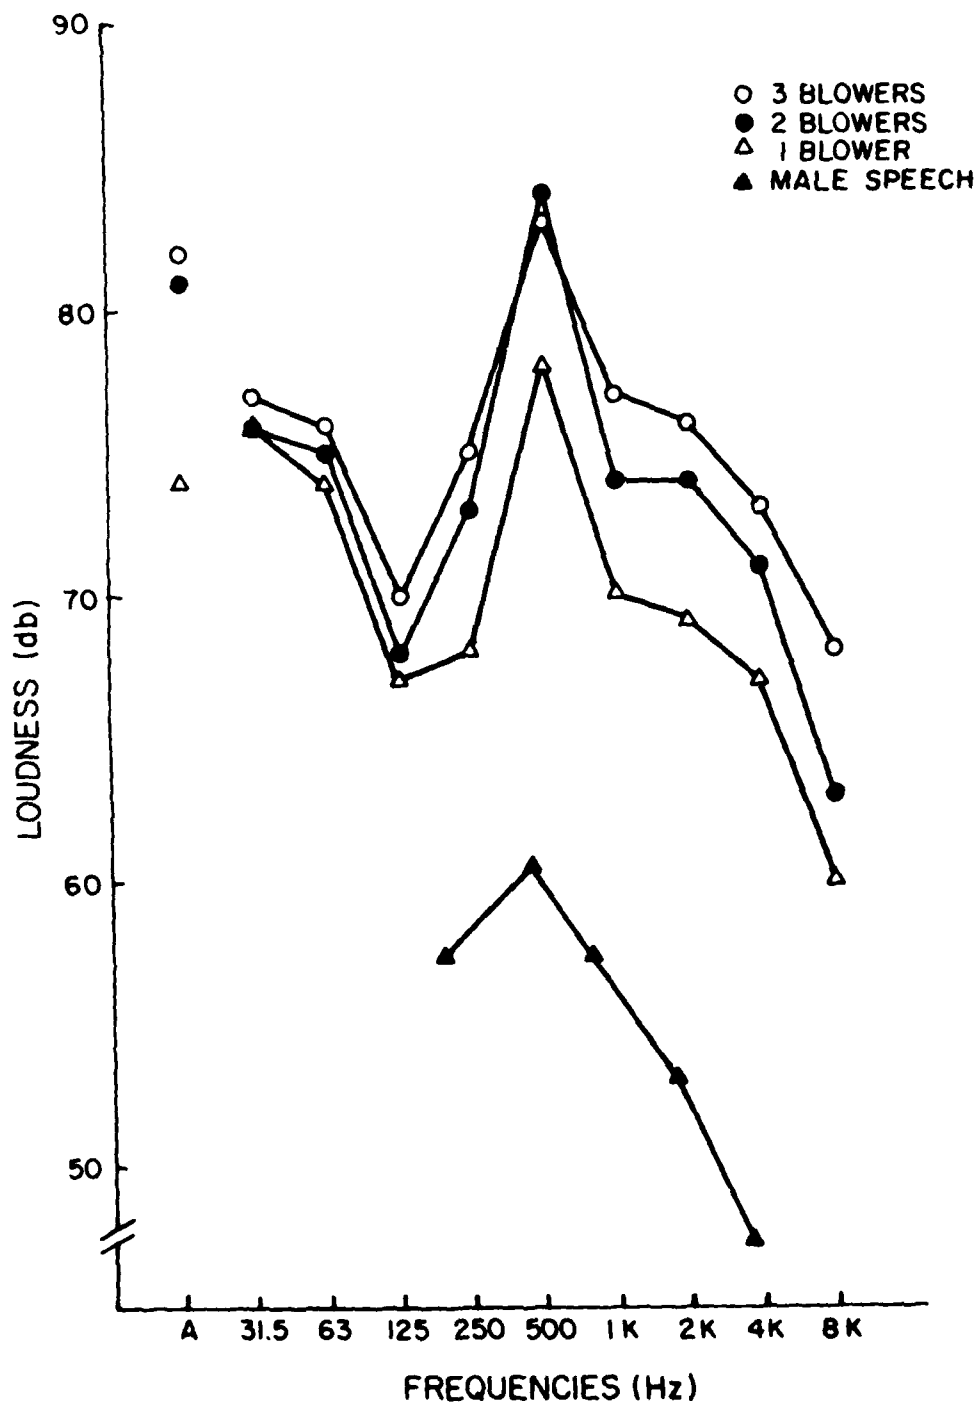
Fig. 38. Octave band analysis of the noise at the A chamber ACS loop.

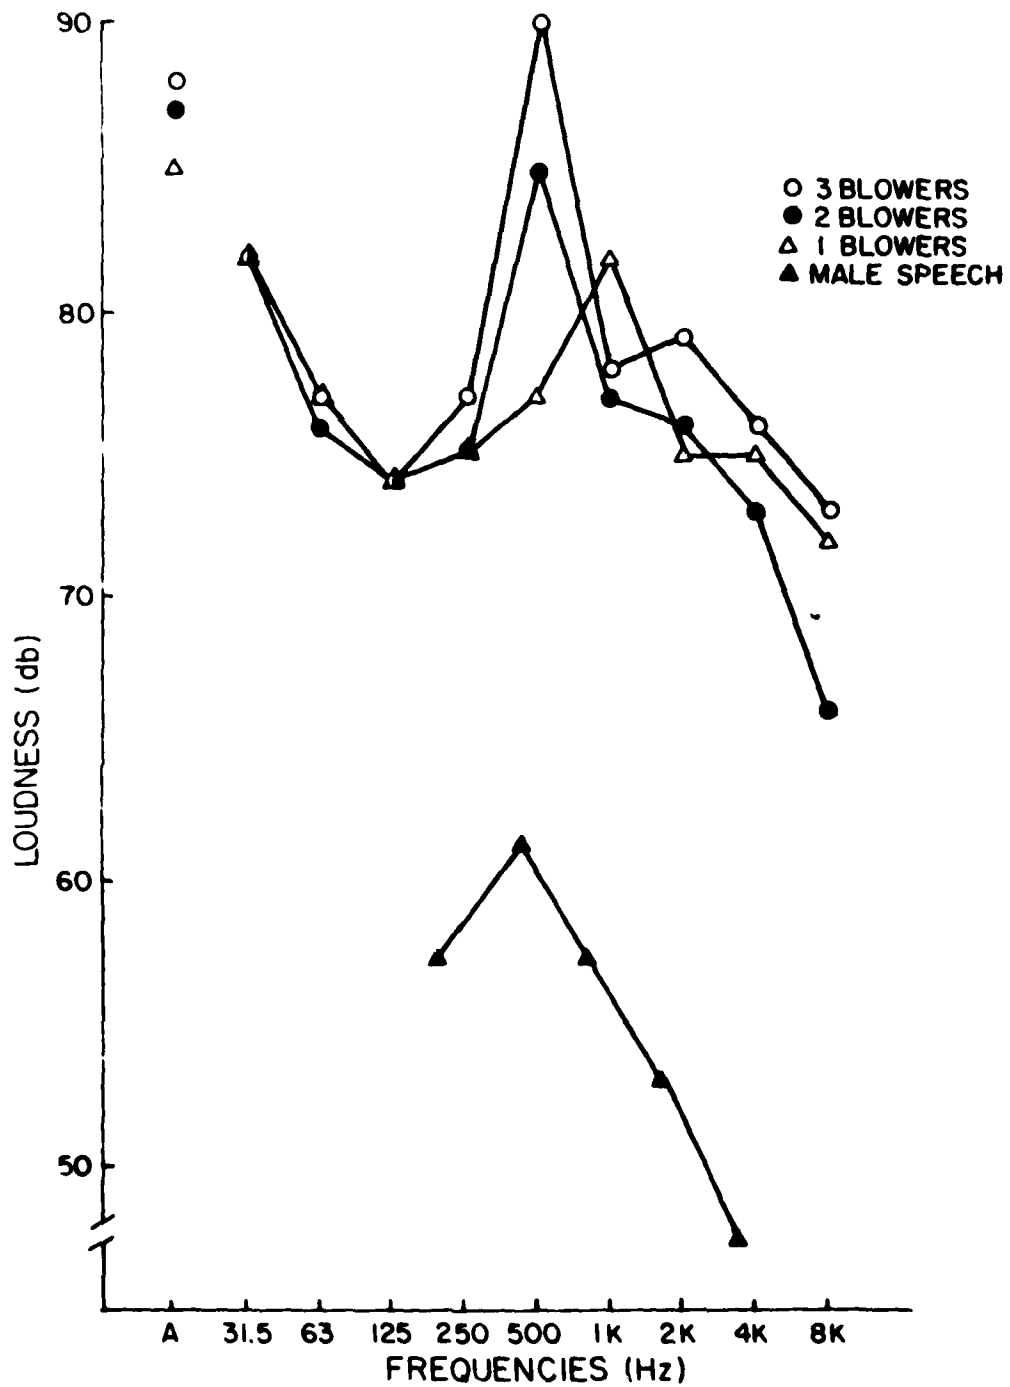
Fig. 39. Octave band analysis of the noise at the D chamber ACS loop.
