Special Report 81-10

FABRIC INSTALLATION TO MINIMIZE REFLECTION CRACKING ON TAXIWAYS AT THULE AIRBASE, GREENLAND

Robert A. Eaton and Randy Godfrey

UNITED STATES ARMY CORPS OF ENGINEERS
COLD REGIONS RESEARCH AND ENGINEERING LABORATORY
HANOVER, NEW HAMPSHIRE, U.S.A.

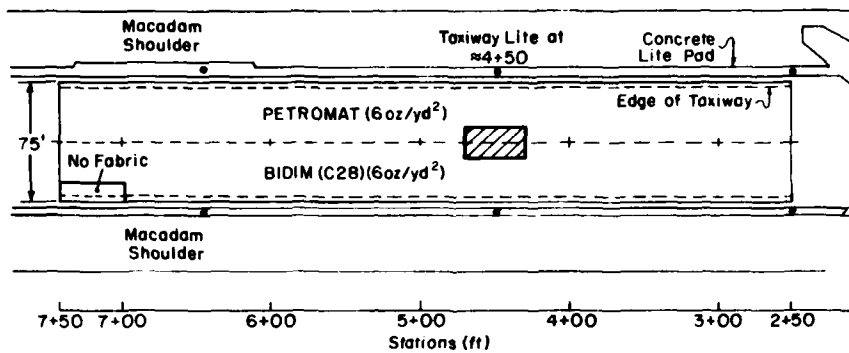
Figure 2. Plan view of taxiway 3 (shaded area shown in Fig. 6).

Fabric installation started on lane 1 at the southeast corner of taxiway 3 at station 2+50 (PETROMAT side), and proceeded directly north, approximately 8 ft away from the 3-1/2-ft-wide concrete light pad (Fig. 2). The temperature of the milled surface and of the tack coat, and the ambient temperatures were monitored with a Trendacotur model 402A thermocouple readout device supplied by one of the manufacturer's representatives. While the fabric was being laid, the surface temperature was $52^{\circ} \pm 2^{\circ}\text{F}$, the ambient air $46^{\circ} \pm 5^{\circ}\text{F}$, and the AC 2.5 tack coat application temperature was approximately 260°F (Appendix A).

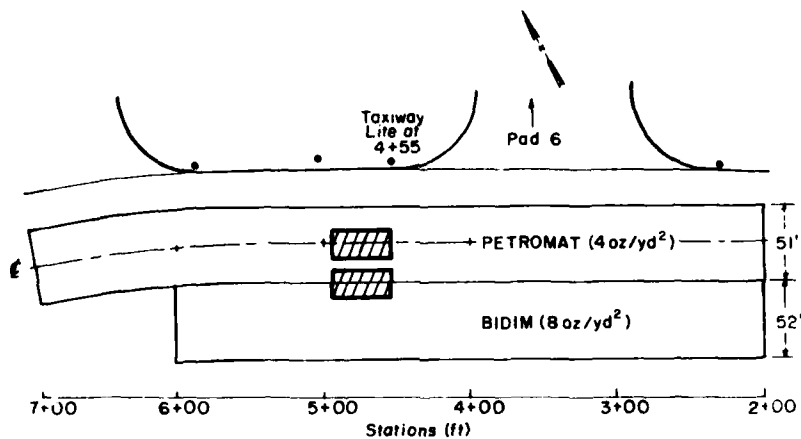
Figure 3. Plan view of taxiway 1.

The 4-oz/yd² PETROMAT was placed on the north side of the test area from station 2+00 to 7+00. The 8-oz/yd² BIDIM fabric was placed adjacent to the PETROMAT from 2+00 to 6+00 (Fig. 3).

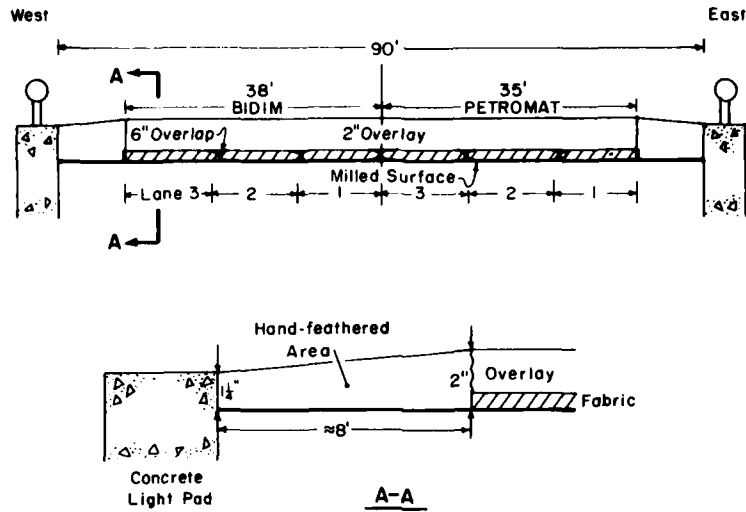
Figure 14. Cross section of taxiway 3 (not to scale).

The fabric wrinkled 30 ft from the start of lane 1 (station 2+80) (see Fig. 14 for location of lane 1) because of a misalignment with the tack coat. The fabric was cut with a pocketknife and then overlapped by 6 in. (Fig. 15). It wrinkled again at station 4+80 and was again cut and overlapped by the same amount. After the first roll ran out, the left-hand brake device was disassembled and the pipe was taken out and
