# SMITHVILLE DAM

## NJ 00043

PHASE 1 INSPECTION REPORT  
NATIONAL DAM SAFETY PROGRAM

JULY 1981

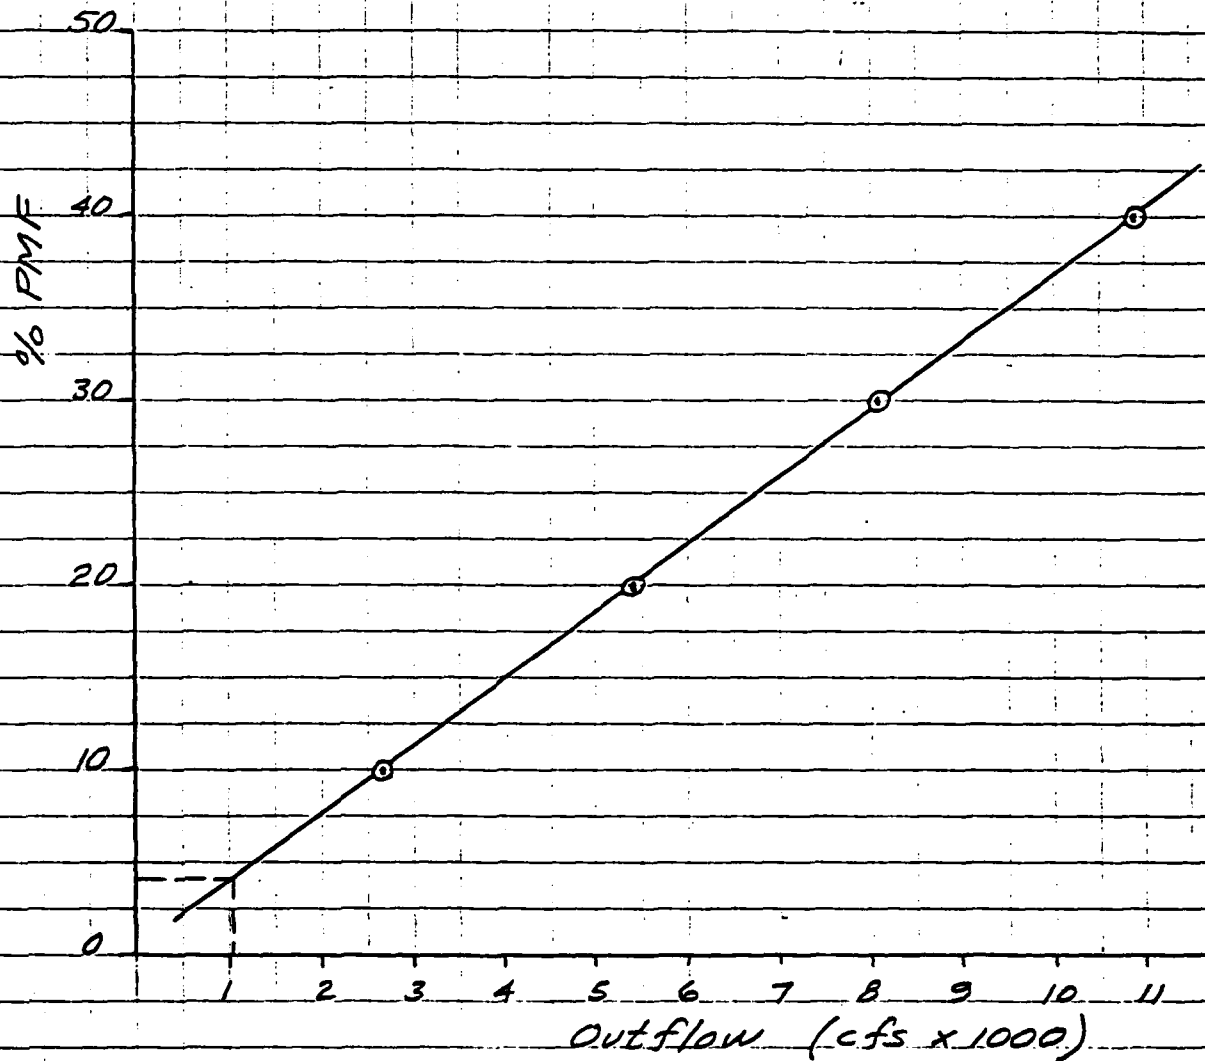
OVERTOPPING POTENTIAL

Overtopping of dam occurs at elev. 22.0  
with discharge  $Q = 1062$  cfs.

Dam can pass approx. 4% PMF
