LAKE TISHOMINGO DAM
JEFFERSON COUNTY, MISSOURI
MISSOURI INVENTORY NO. 30039

PHASE I INSPECTION REPORT
NATIONAL DAM SAFETY PROGRAM

PREPARED BY: ST. LOUIS DISTRICT CORPS OF ENGINEERS
FOR: GOVERNOR OF MISSOURI

JANUARY 1978

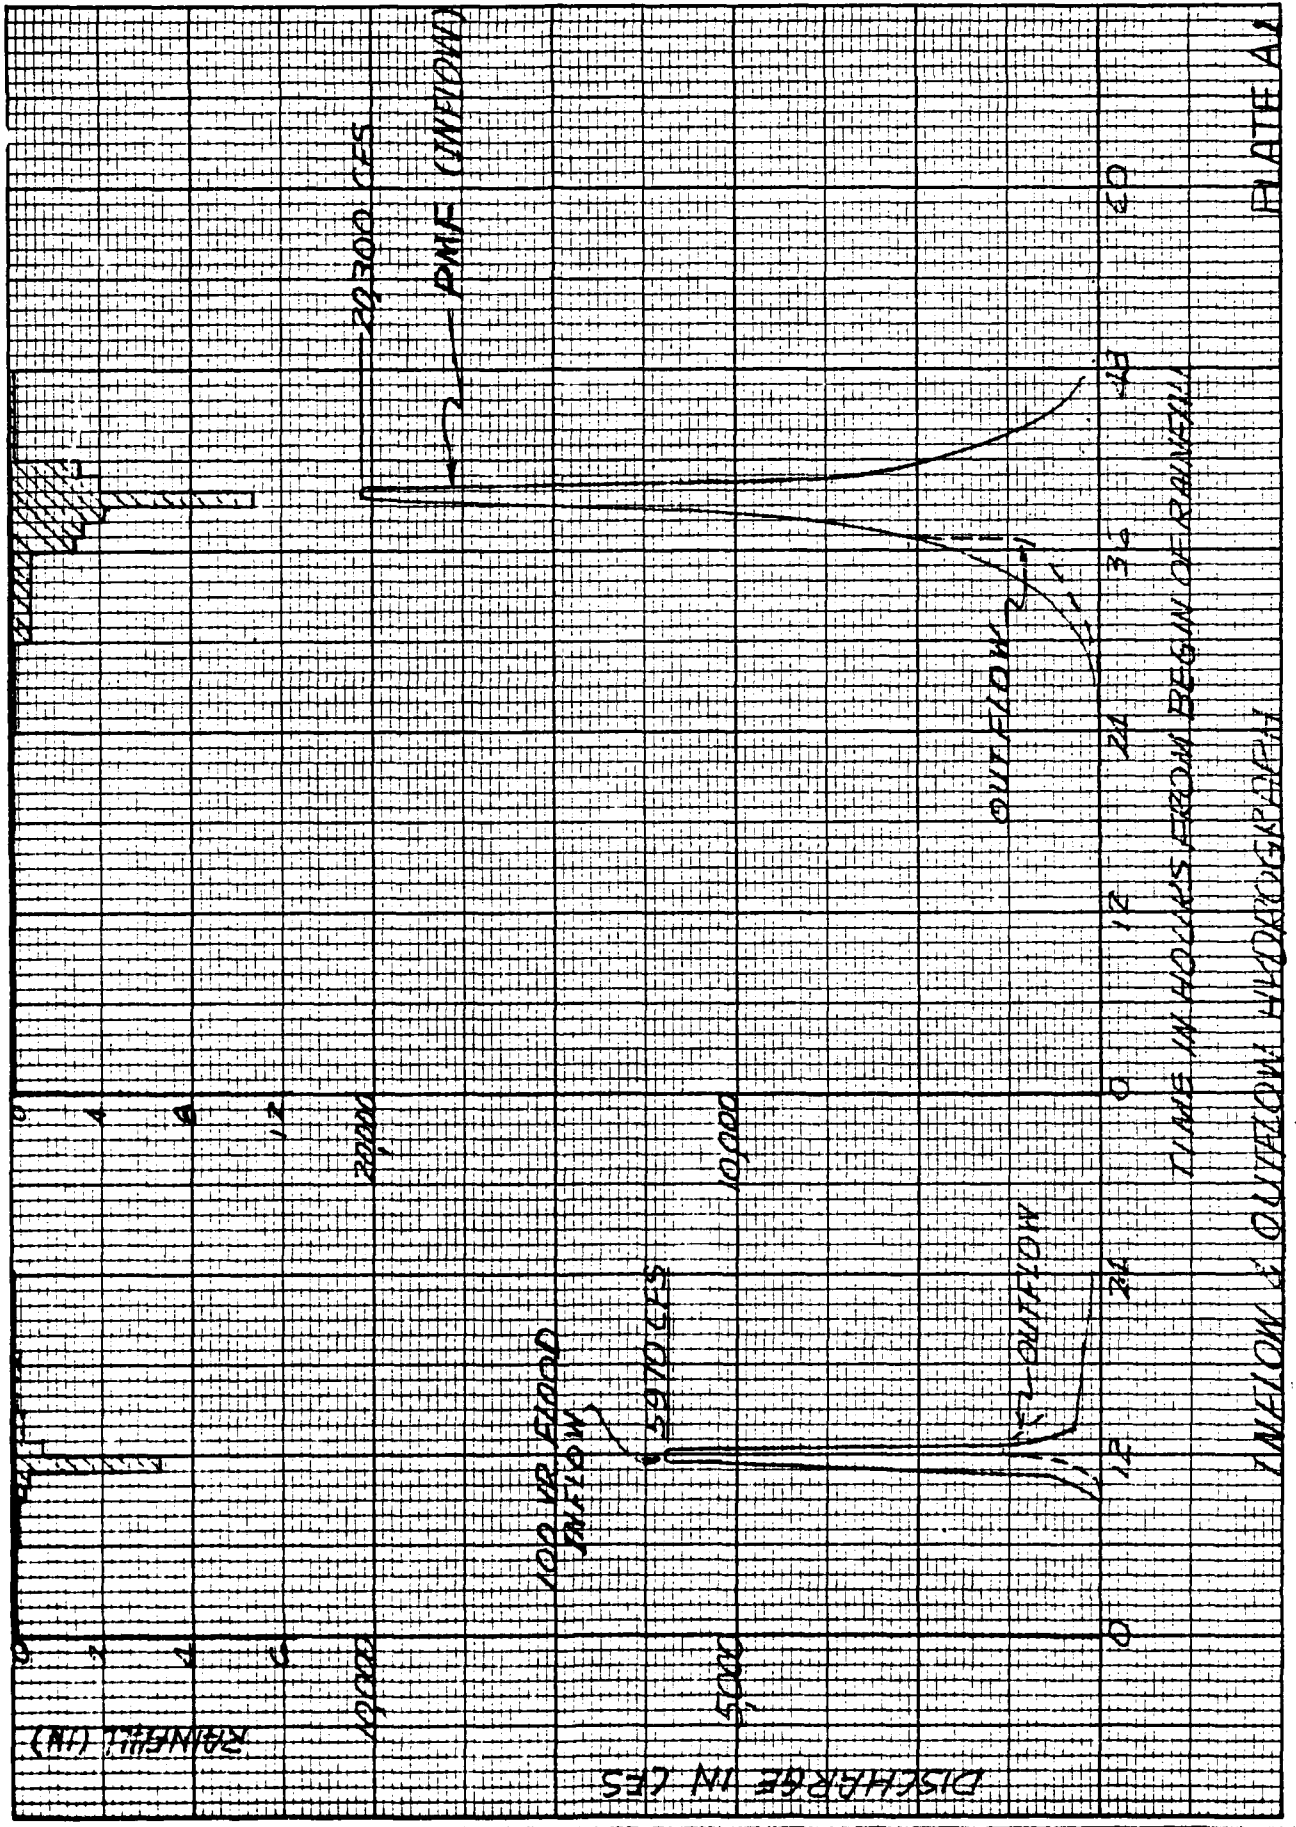
PLATE A1

1. Triangle unit hydrograph and HEC-1 are used to develop the inflow hydrographs (see Plate A1) and hydrologic inputs are as follows:
 - a. Twenty-four hour, 100-year rainfall of St. Louis, or probable maximum precipitation from hydrometeorological report No. 33.
 - b. Drainage area = 3 square miles.
 - c. Travel time of runoff = 60 minutes.
 - d. Initial loss = 1 inch.
 - e. Average loss rate = 0.08 inch per hour.
2. Spillway release rates are based on the broad-crested weir equation: $Q = CLH^{1.5}$ (C=3.0, L=50 feet), where H is the head on weir.
3. Floods are routed through the spillway to determine the capability of the spillway. Outflow hydrographs are shown on Plate A1.

INFLOW & OUTFLOW HYDROGRAPH
