RADC-TR-81-180

**RADC-TR-81-180**  
Final Technical Report  
July 1981

## **FAILURE MECHANISM STUDY OF GaAs TECHNOLOGY**

**Hughes Aircraft Company**

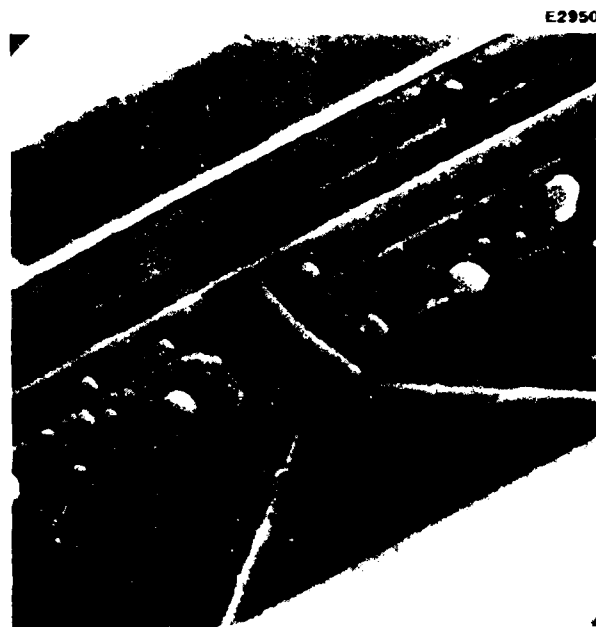
Figure 3-20 Type H-11, No. 183 FET. (a) SEM photograph at 2500X of the gate pad to gate stripe transition showing metallization voids and nodules; (b) 6000X photograph of the upper left corner of the drain contact pad in Figure 3-19(a).

Our recommendation for improving the reliability of the Type H-11 FET is obvious: Continue to improve the metallization processes.

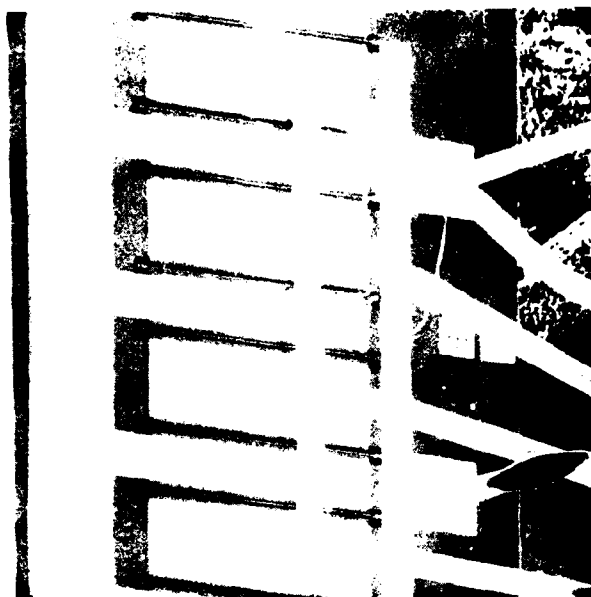
Figure 4-4 Type D-250/6 FET, from Test B.  
(a) 200X, showing burned gate wire. (b) Gate burnout. HF was used to remove the glass without removing all of the debris.

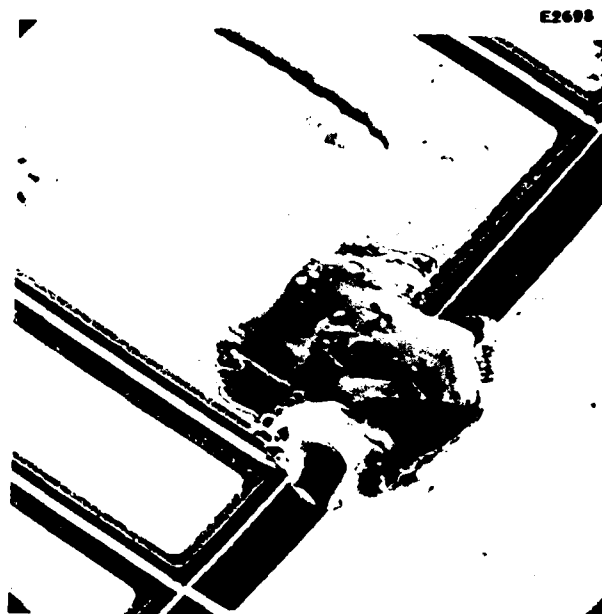
Figure 4-6 (a) Type T-500/8, #11, at 1000X. (b) Type D-250/6, #14, at 2000X.

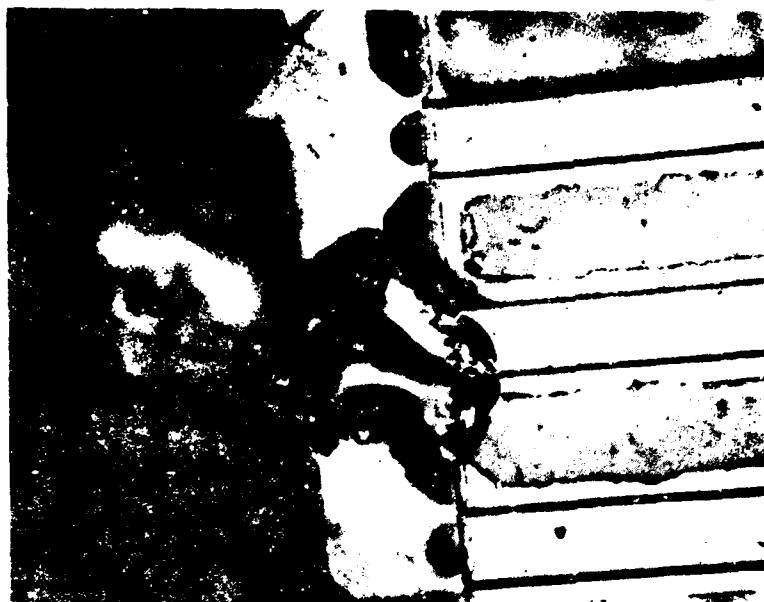
The Type M FET failure, Figure 4-9, was of the "flashover" type at the gate pad. Though we could not see the site well, there was some evidence that the gate finger had erupted, also. This device also exhibited the "flashover" effect from the gate pad to the source and drain.

Figure 4-9 Type M-400/6, #11, Test D. (a) Optical photograph (color original) at 500X. At the top of the photograph note one source pad which remained on-chip after prying of the chip from the heat sink. (b) SEM photograph.

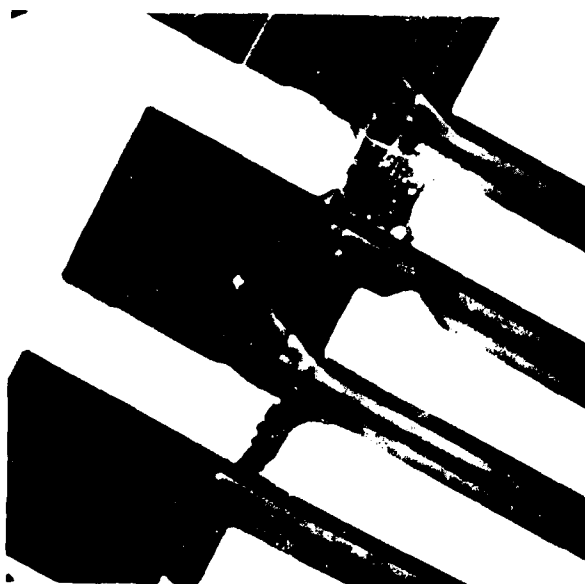
In the cases of the Type M, D and T FETs, Figure 4-10, the predominant failures were all of the "flashover" type, with smaller failures elsewhere. Primary site was at the gate pad/gate finger junction, again. In the Type N FET, Figure 4-11, the failure caused two source fingers to be melted, with those fingers not apparently shorted to the gate or drain.

Figure 4-11 Type N-250/11-P, #9, Test E.  
(a) 400X. (b) 1000X. Note  
melted source fingers, with  
some melting of the drain  
finger.

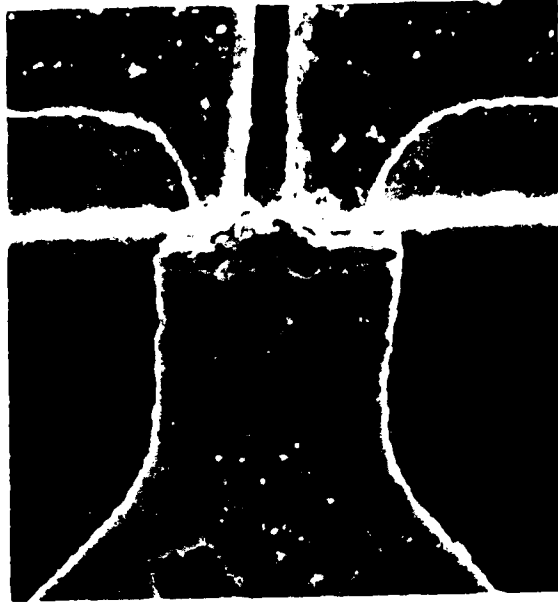
Devices 9J and 10J exhibit gate metallization problems similar to those of device 12J. Figure 4-13(a) shows a gate pad and finger with metallization voids, device 9J. Figure 4-13(b) depicts another gate pad and finger transition on the same device, showing metallization voids and a tenuous transition across the gallium arsenide step from gate pad to the recessed gate finger. SEM photographs of the 10J device are not included in this report, as they show similar features to those depicted in Figures 4-12 and 4-13.

Figure 4-13 SEM photographs of the Type M-400/6 device. (a) 6000X; (b) 9600X.

It may be that TI received devices from a lot that for their purposes was inadequately screened by the manufacturer. We recommend that the purchaser ask the manufacturer for lot certification of the gate metallization process and that samples of incoming FETs of the Type M-400/6 be subjected to demounting and gate inspection both as received and after a burn-in period under bias.

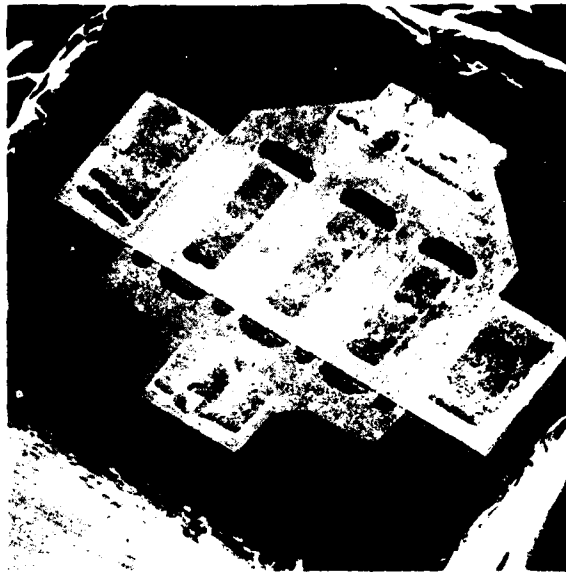
Figure 4-15 SEM photographs of new Type M-400/6 FET.  
(a) Overall view at 195X; (b) Gate  
pad to gate finger transition at 7800X.

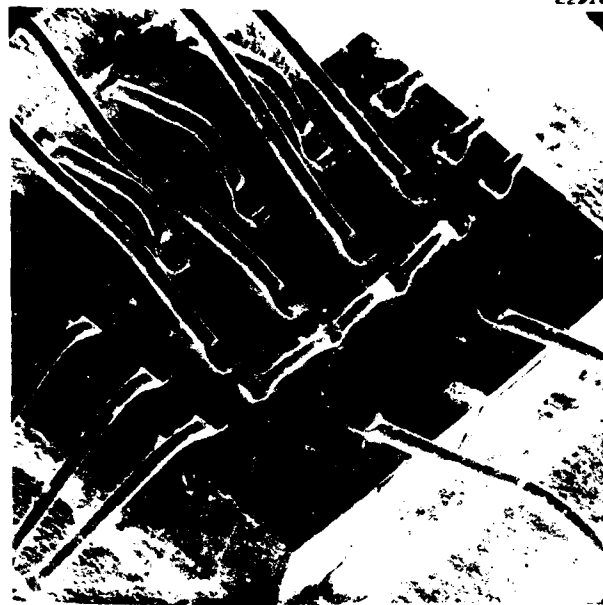
Devices #37, #44, and #45 were stressed at 185°C and, as expected, survived considerably longer than the similar devices that were stressed at 200°C. Figures 4-19, 4-20, and 4-21 show SEM photographs of these three FETs. Device #37, shown in Figure 4-19, did not fail. Figure 4-19(a) clearly shows the high quality of die cleavage, mounting, and wire bonding of this FET type. Figure 4-19(b) shows a close-up view of the wire bonds, mesa edge, electrode configuration, and passivating layer.

Figure 4-19 SEM photographs of the Type D-250/6 #37 device. (a) 120X; (b) 800X.

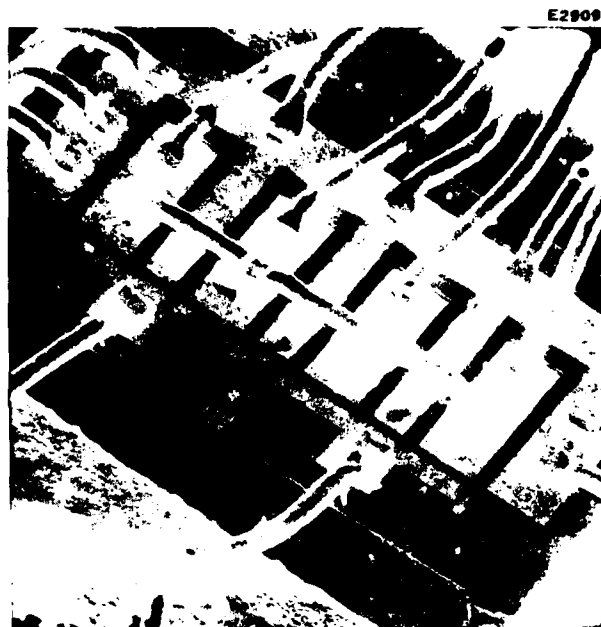
Device #44 showed gradual degradation of output power until the failure limit of -1 dB was reached at 1350 hours. SEM examination showed an apparent discoloration on the gold surface of the drain pad, located slightly above the arrow in Figure 4-20(a). An EDAX investigation verified that the stain consisted of light elements and hence is surface contamination. Other evidences of contamination are also apparent in Figure 4-20(a). In all likelihood, the foreign matter was not present on the packaged chip, but was introduced during handling procedures after the package had been opened. Thus, the stains played no part in failure of the device.

Figure 4-20 SEM photographs of the Type D-250/6 #44 device. (a) 165X; (b) 10,800X.

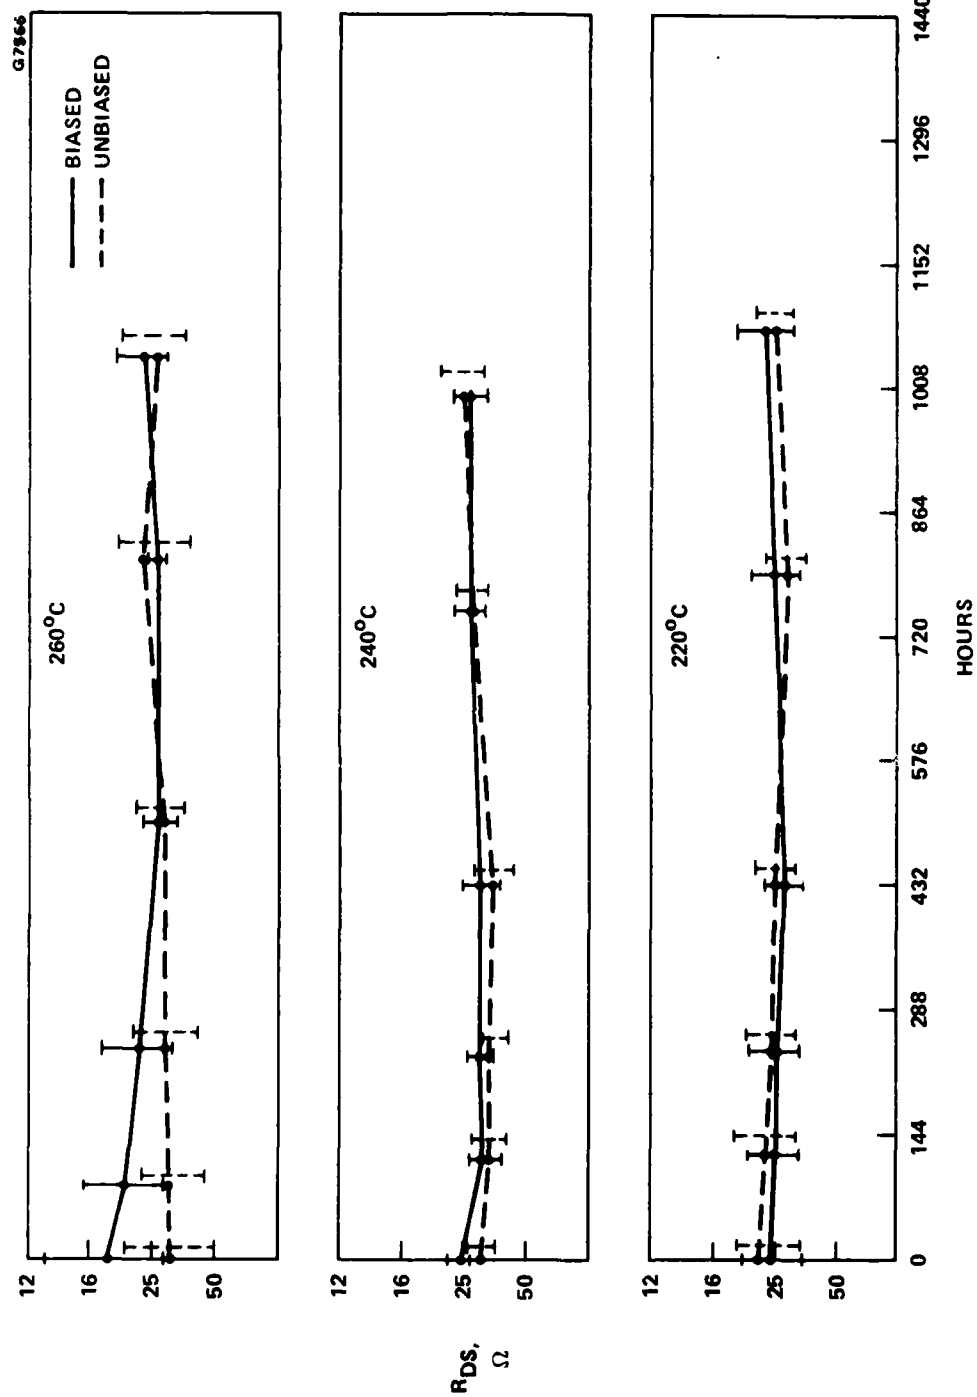
Figures 5-1 and 5-2 show the behavior of  $R_{DS}$  with time. As we see, the annealing behaviors of the two types of alloyed contacts are remarkably similar. There are no systematic differences between biased or unbiased, thick or thin contacts. In several of the plots there is an initial increase of  $R_{DS}$  on heating.  $R_{DS}$  soon stabilizes, however, and there is no further change out to some 1000 hours, even at 260°C. Consequently, our recommendation is that all devices be subjected to an initial burn-in period without bias.

Figure 5-1 Change of ohmic contact resistance upon heating for thick Au-Ge/Ni ohmic contact alloyed at 480°C. Biased samples are held at 10 mA. The horizontal bars indicate  $\pm 1$  standard deviation in current at a measurement voltage of 0.5 volts. For clarity the bars on unbiased device measurements have been offset to the right. Note inverted ordinate scale.

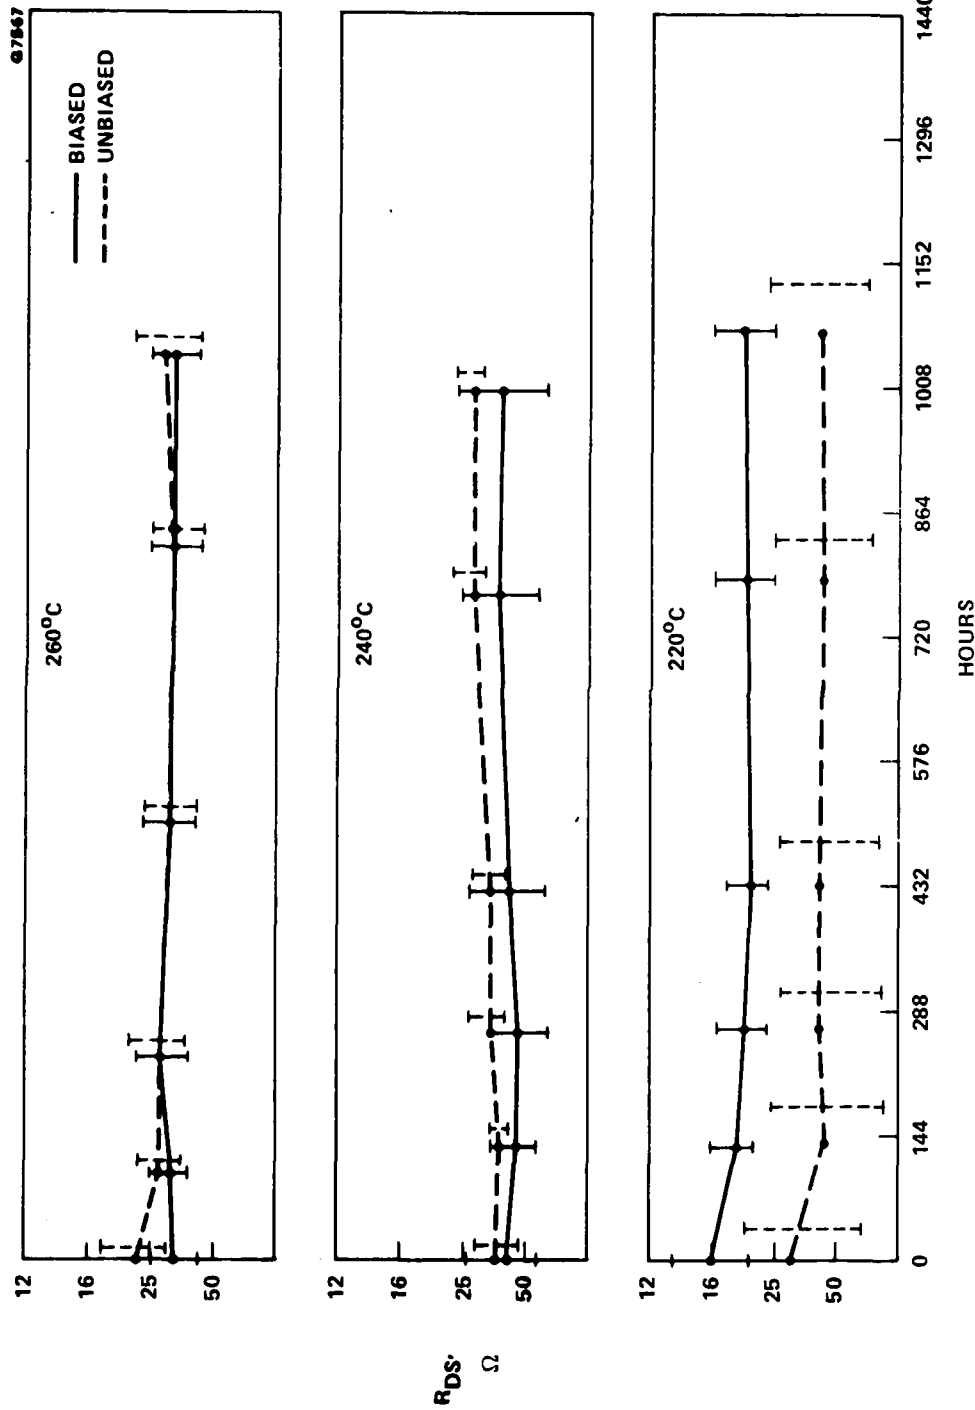
Figure 5-2 Change of ohmic contact resistance upon heating for thin Au-Ce/Ni ohmic contact allowed at approximately 360°C. Biased samples are held at 10 mA. The horizontal bars indicate  $\pm 1$  standard deviation in current at a measurement voltage of 0.5 volts. For clarity the bars on unbiased device measurements have been offset to the right. Note inverted ordinate scale.

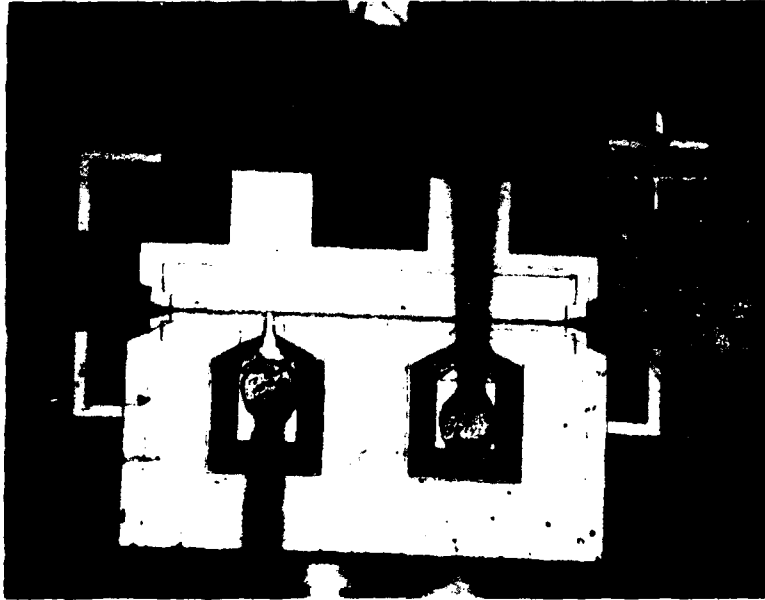
Figure 5-10 FET type E-10 bonded for gate-to-gate resistance tests.

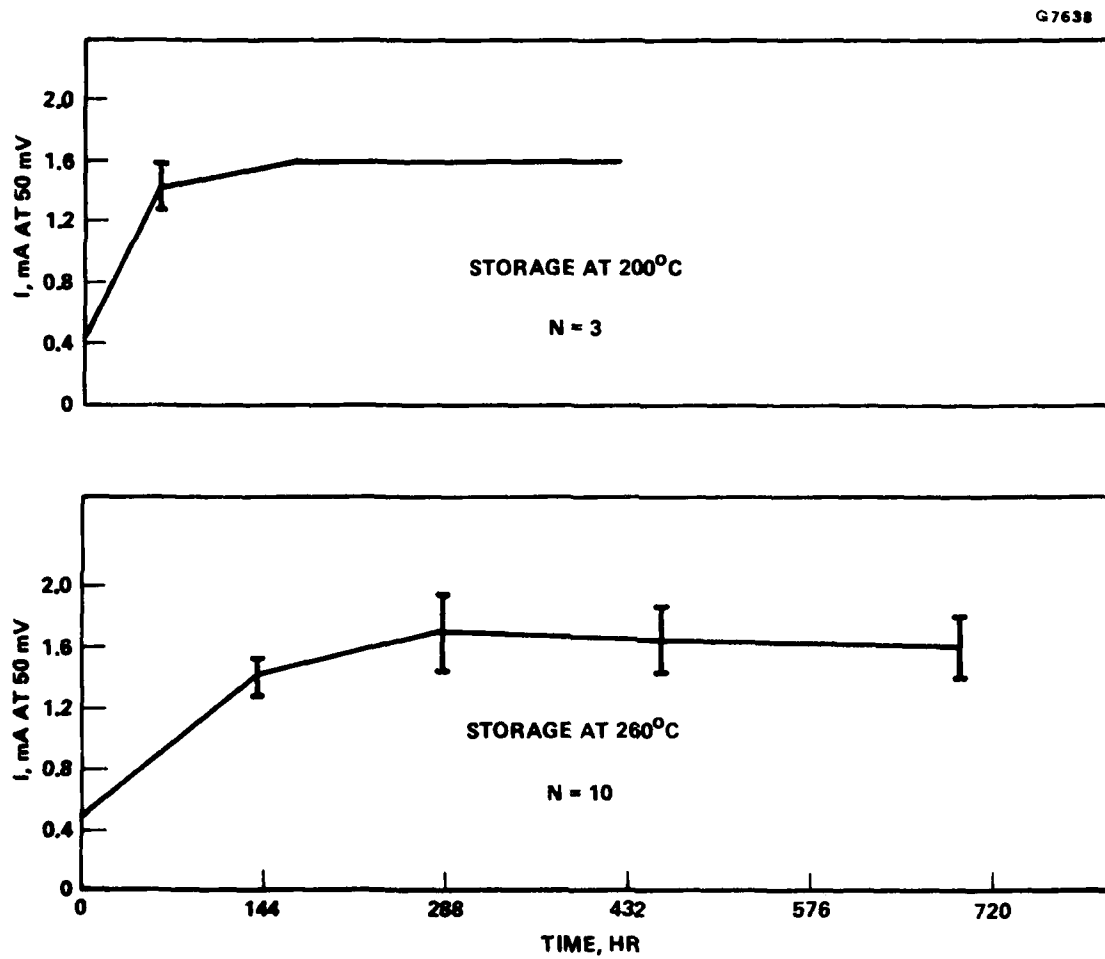
The plots of Figure 5-11 show an initial decrease in resistance by a factor of 3 during the first hours. Had we measured the 260°C batch over shorter intervals, we probably would have found a shorter transition to low resistance than at 200°C. Note that studies of the ohmic contact resistance, Figures 5-1 and 5-2, show an initial increase of resistance. Our recommendation again is that devices be given an initial burn-in period.

A careful look at the 260°C curve in Figure 5-11 beyond 288 hours indicates that the long term trend is for a slow increase in resistance. We do not know if this is due to the Al gate or to the transitions. We believe that the initial change is due to lower resistance in the refractory metal interface. Both test groups approach 31 ohms as an asymptote, and this value is close to the computed value for the Al gate stripe.

The data at 260°C indicate that changes in the resistance of the Al stripe are probably not a factor in device degradation in high temperature stress tests on low noise FETs. The curves of Figure 5-11 also reveal a possible solution for the rapid initial change in device parameters that is sometimes seen in life testing. In the Au-Al gate pad-gate electrode technology, annealing of the device may be needed to stabilize it. Of course, the metallization investigated here is different from that of other vendors, and each case should be treated uniquely.

Figure 5-11 Current at 50 mV through a 0.5  $\mu$ m gate stripe heated without bias at 200°C and 260°C. N = number of devices starting the test. The horizontal bars indicate  $\pm 1$  standard deviation.

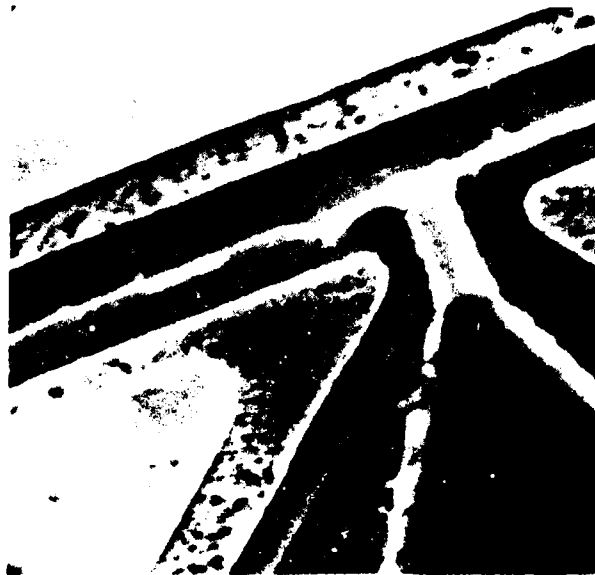
Figure A-4 Type B-21 #10 FET that lost gate control (a)  $\times 302$ , (b)  $4480\times$ .

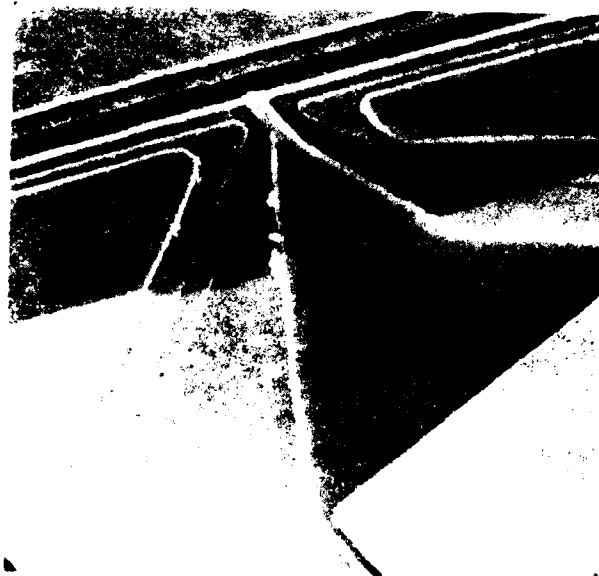
Figure A-5 Type H-21 #7 FET that showed a decrease in saturated drain current. (a) 160X. (b) 1600X.

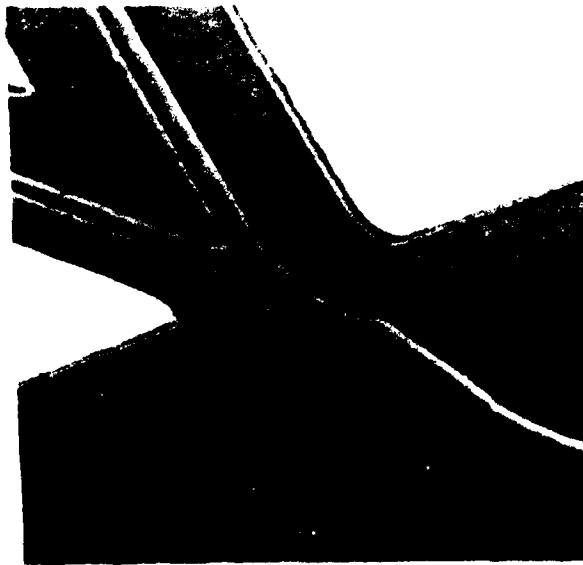
Two Type N-21 FETs are shown in Figure A-6. Fabrication of the mesa step, the metallizations, the wire bonding, and the general appearance of this FET type are clearly superior. As all devices in the "Not Failed" column of Table A-2 were FETs from manufacturer N, we also conclude that Type N devices are highly reliable.

Figure A-6 Type N-21 FET. (a) #17 that showed a decrease in  $I_{DSS}$ . 230X.  
(b) #20 that did not fail. 2400X view of gate terminus.

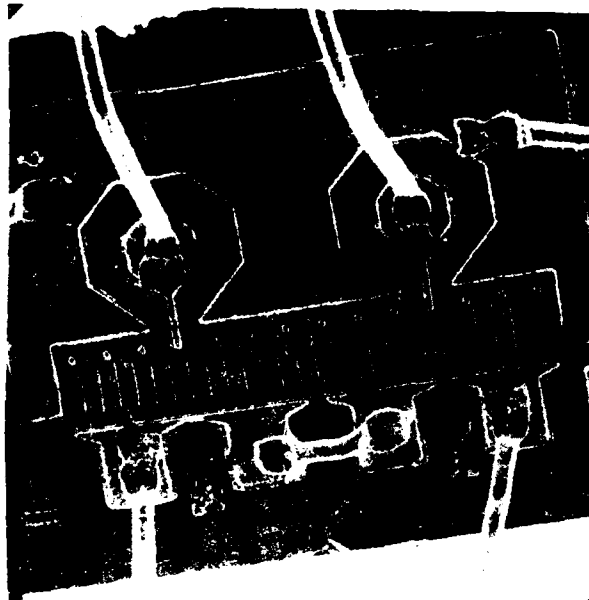
Figure A-11 Type A-51 FETs that showed a decrease in drain current.  
(a) #1-B at 200X. (b) Left region of #4-D at 600X.

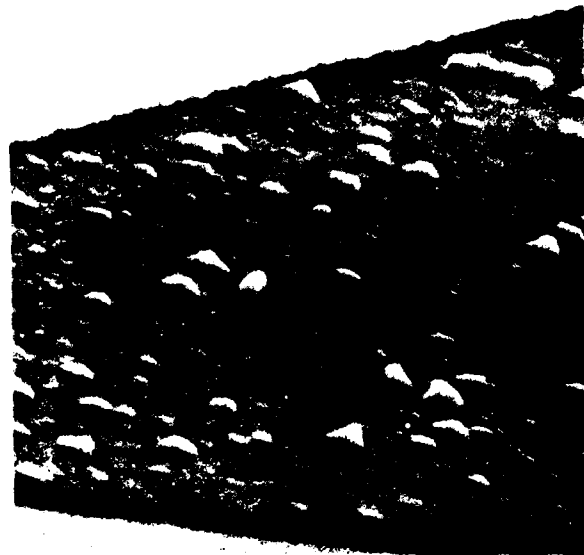
Figure A-13 Type H-1A1 #34 FET that showed a decrease in  $I_{DSS}$ . (a) 1000X. Note ridge in gallium arsenide and nodules in aluminum. (b) Close-up picture of nodules at 6000X. The view has been rotated  $180^\circ$  from (a).

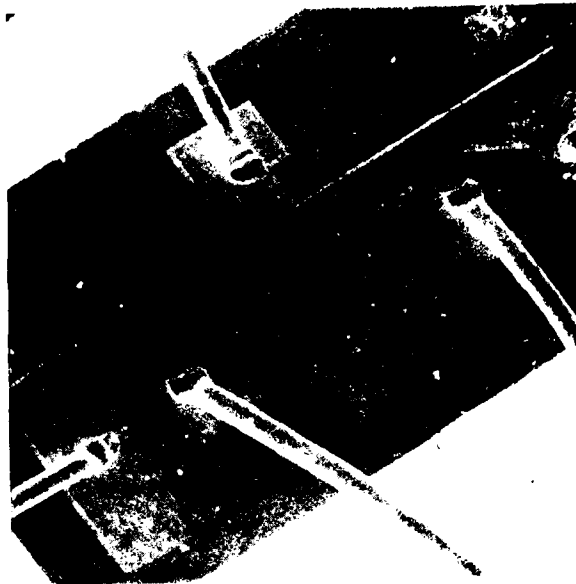
A.1.2.3 Type D-11 FET - The next FET to be placed on the RF stress test was a type D-11 device, serial number 2R. Test conditions were similar to those for the Type E-1 FET. The device logged 1087 hours of operation at 200°C baseplate temperature with -10 dBm RF input power and about 6.5 dB gain at 5.7 GHz. The RF gain was monitored regularly and changed by not more than 0.4 dB over the course of the test. This FET did not fail during the RF constant stress test. Subsequent measurements showed a leaky gate diode characteristic and excessive pinch-off voltage.

We terminated the test and delidded the package to examine the FET chip. Figure A-21(a) shows an overall SEM photograph of the failed device. Figure A-21(b) shows a magnified view of the left gate connector. Slight mottling of the source and drain ohmic contact metallizations is evident. The gate transition is imperfectly formed. However, it was not apparent that this construction defect affected either the DC measurements or RF performance. The gate metal is gold, and the gate width is nominally one micrometer.

Figure A-21 (a) SEM photograph of the Type D-11 #2R FET at 200X; (b) Close-up of the left gate connector region at 3000X.
