MONROE CITY SOUTH LAKE DAM
MONROE COUNTY, MISSOURI
MO. 10538

PHASE I INSPECTION REPORT
NATIONAL DAM SAFETY PROGRAM

NOVEMBER 1979

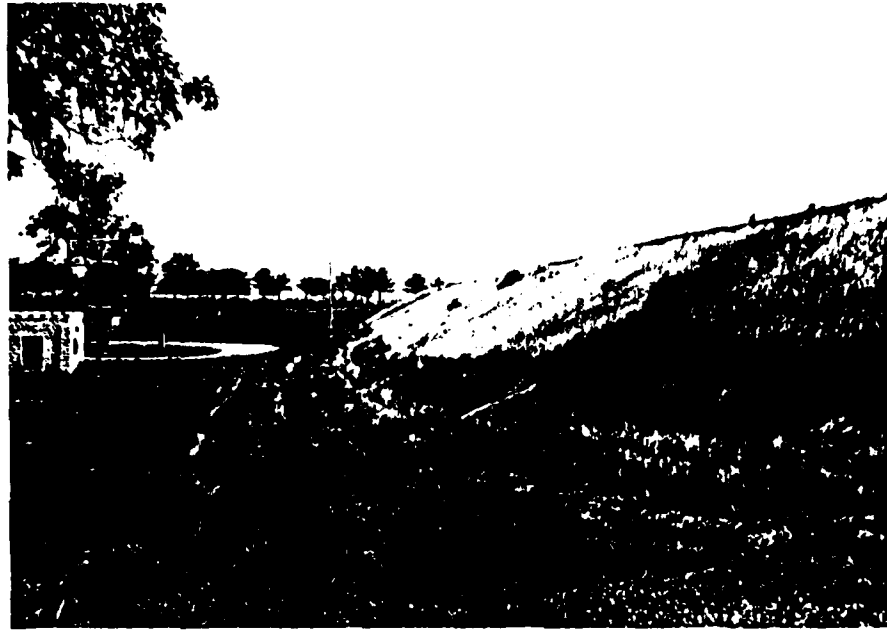
Photo 1

- Photo 1. - View of the downstream embankment slope.
- Photo 2. - View of the crest and the upstream embankment slope.
- Photo 3. - View of the upstream embankment slope.

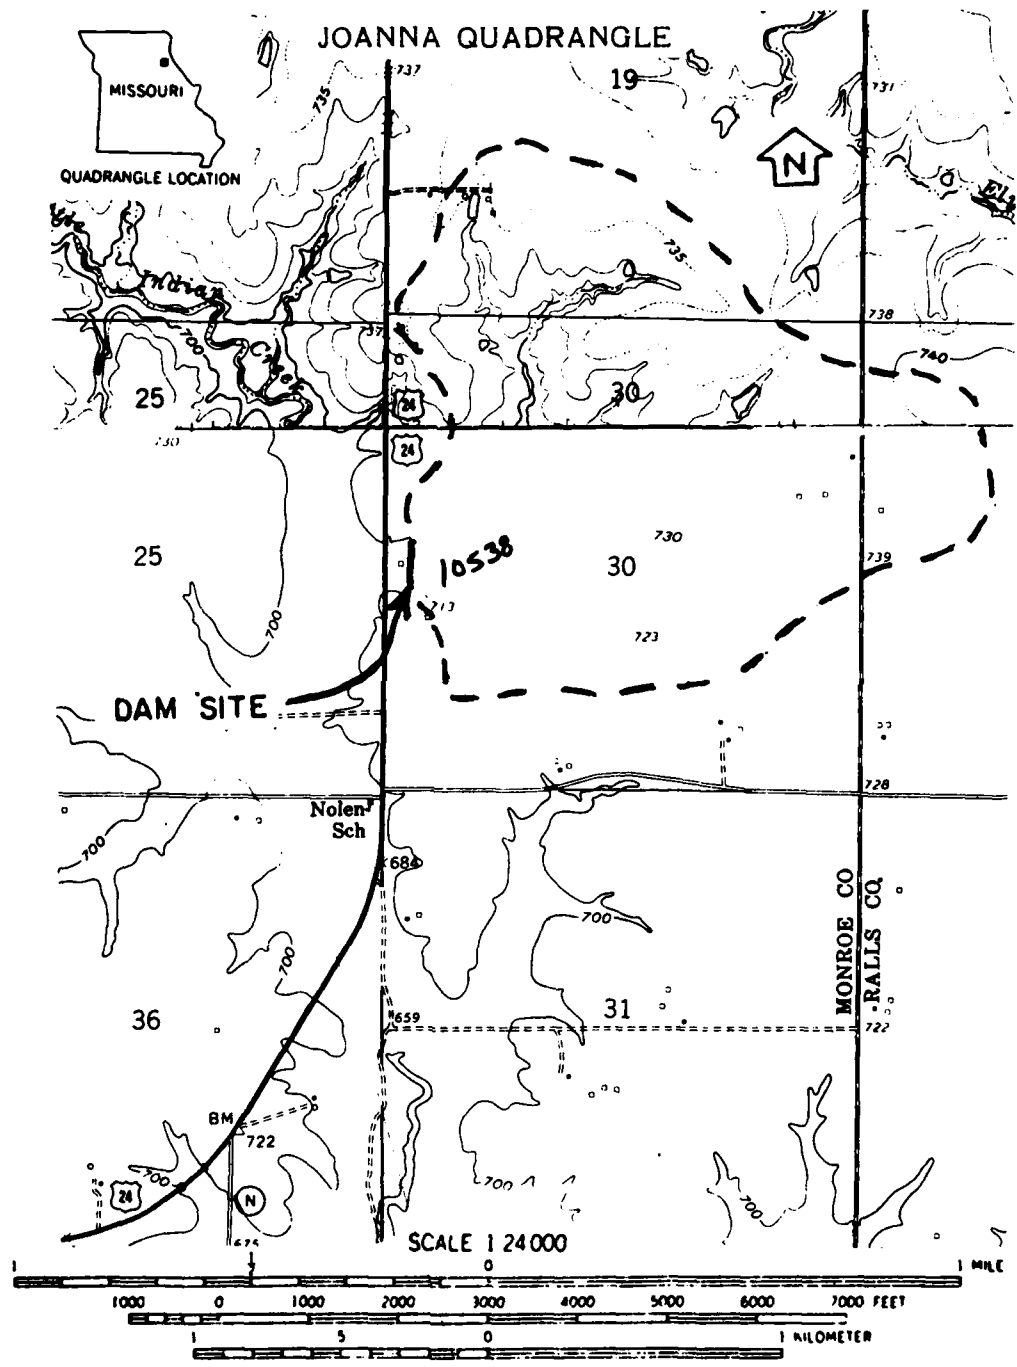
MONROE CITY SOUTH LAKE DAM (MO 10538)
DRAINAGE BASIN

The watershed area of Monroe City South Lake Dam upstream from the dam axis consists of approximately 668 acres. The watershed area is mostly farmland with some forested areas. Land gradients in the higher regions of the watershed average roughly 1 percent, and in the lower areas surrounding the reservoir average about 2 percent. The Monroe City South Lake Reservoir is located offstream of Little Indian Creek. At its longest arm the watershed is approximately 0.7 mile long. A drainage map showing the watershed area is presented as Plate 1 in Appendix B.

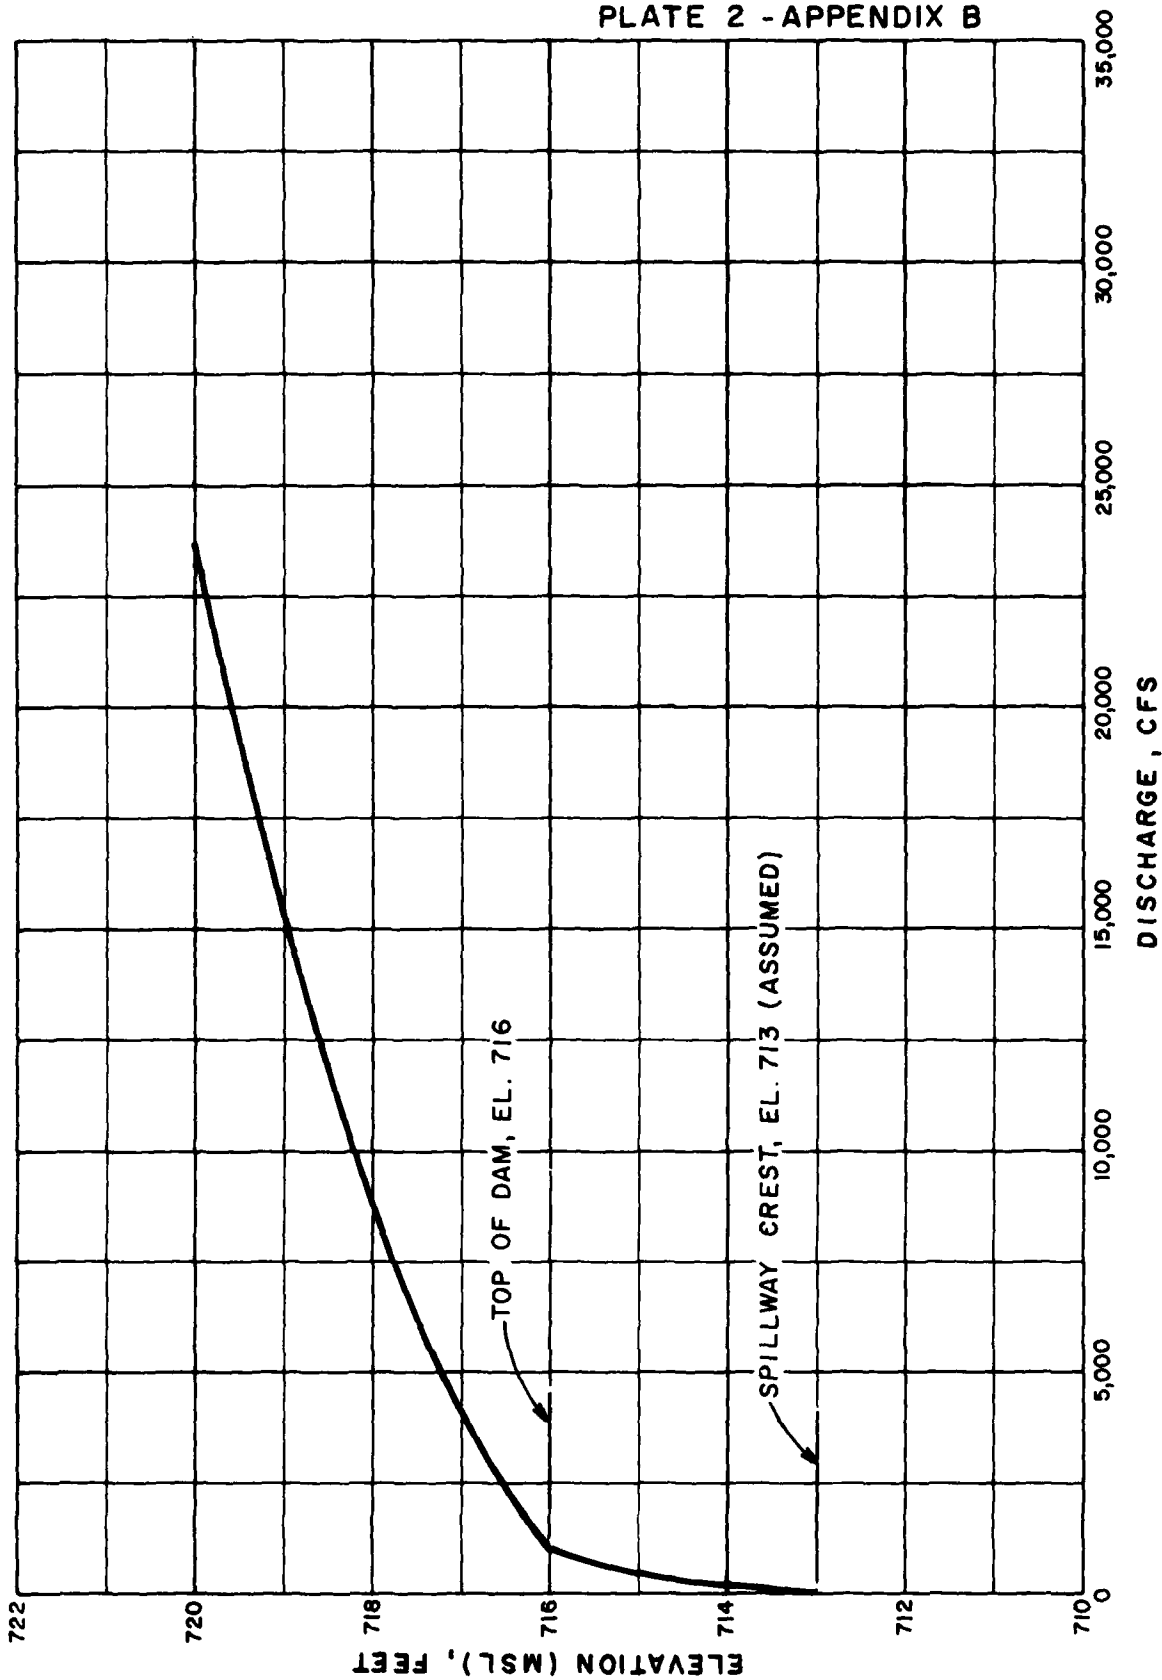
MONROE CITY S. LAKE DAM (MO. 10538)
SPILLWAY & OVERTOP RATING CURVE

The stage-outflow relation for the spillway was prepared from field notes and sketches prepared during the field inspection. The reservoir stage-capacity data were based on the U.S.G.S. Joanna and Monroe City, Missouri Quadrangle topographic maps (7.5 minute series). The spillway and overtop rating curve and the reservoir capacity curve are presented as Plates 2 & 3, respectively, in Appendix B.
